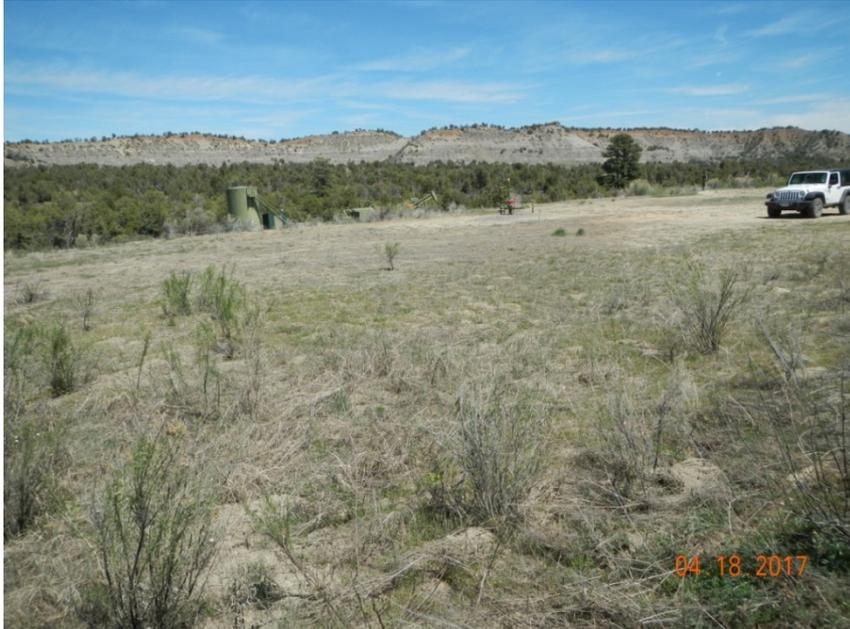
Photo 1: View of the project area from the southwestern corner facing center.

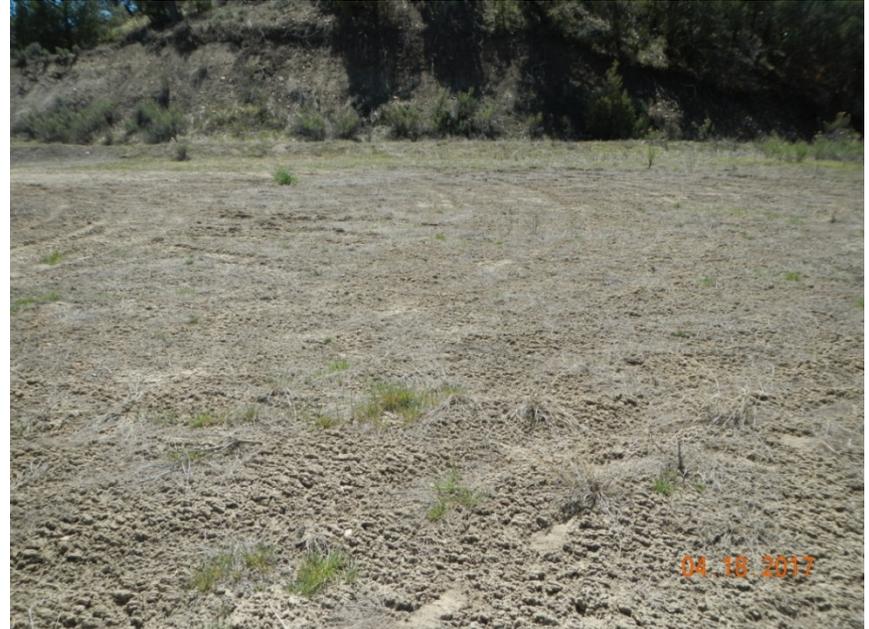
Photo 2: View of the western portion of the project area from the southwestern edge facing southward. Revegetation is sparse in this area and needs to be monitored and re-seeded in fall 2017 if vegetative cover is not increasing.

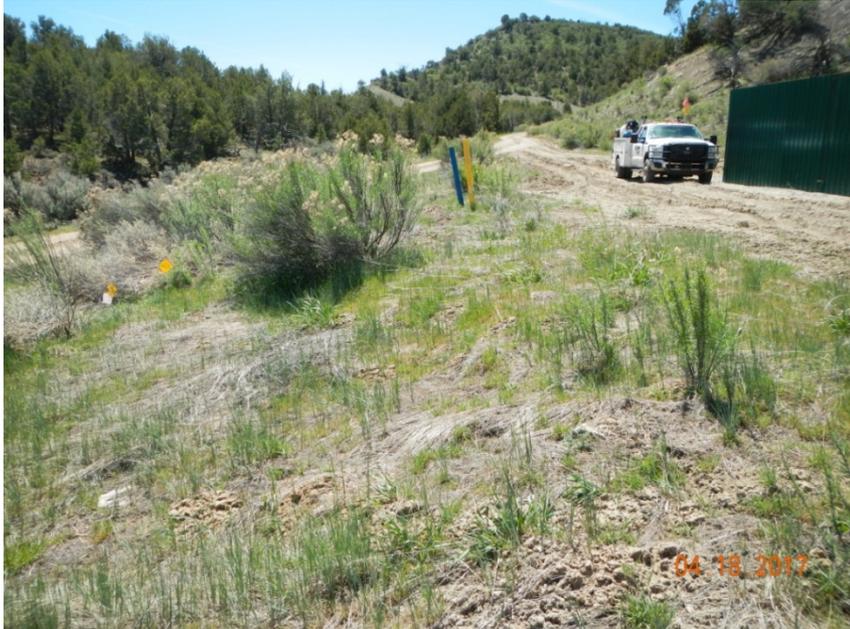
Photo 3: View of the eastern portion of the project area from the northeastern corner facing southward. Revegetation is progressing in this area.

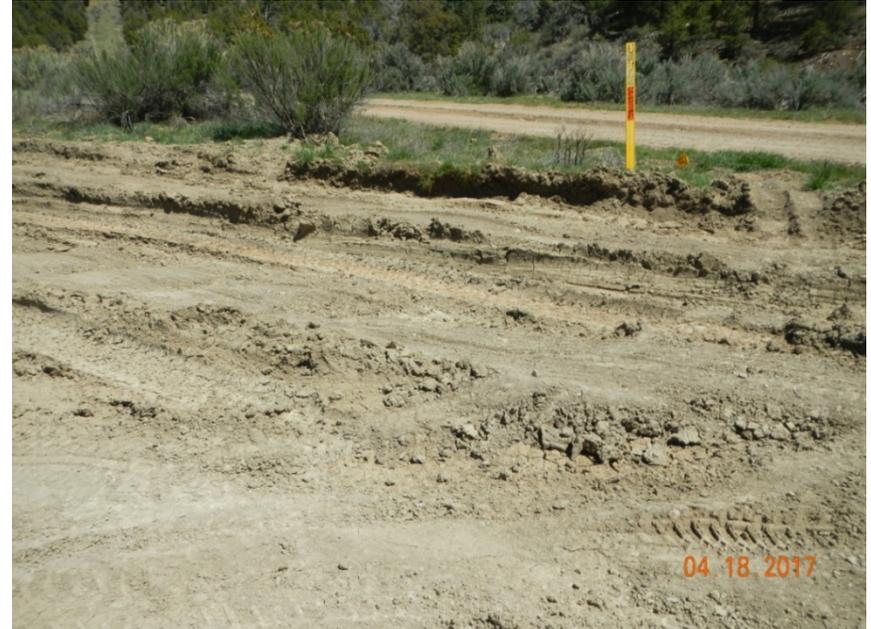
Photo 4: View of deep rutting and damaged vegetation from truck tires at the well pad entrance. This area needs stabilization.
