Inspection Photos
Location Name: Rollie J Vincent A1
API: 05-123-12556

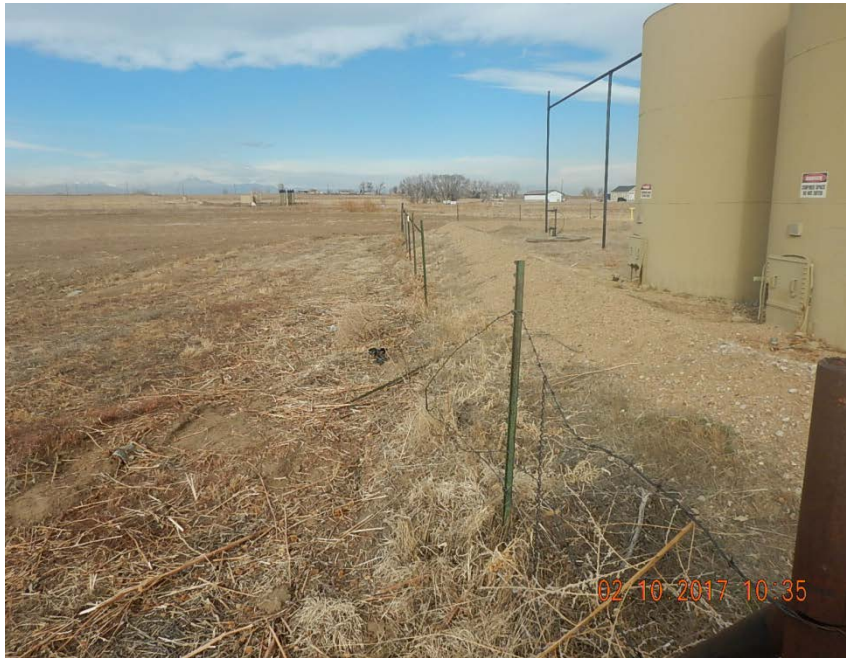
Photo from prior inspection for comparison purposes

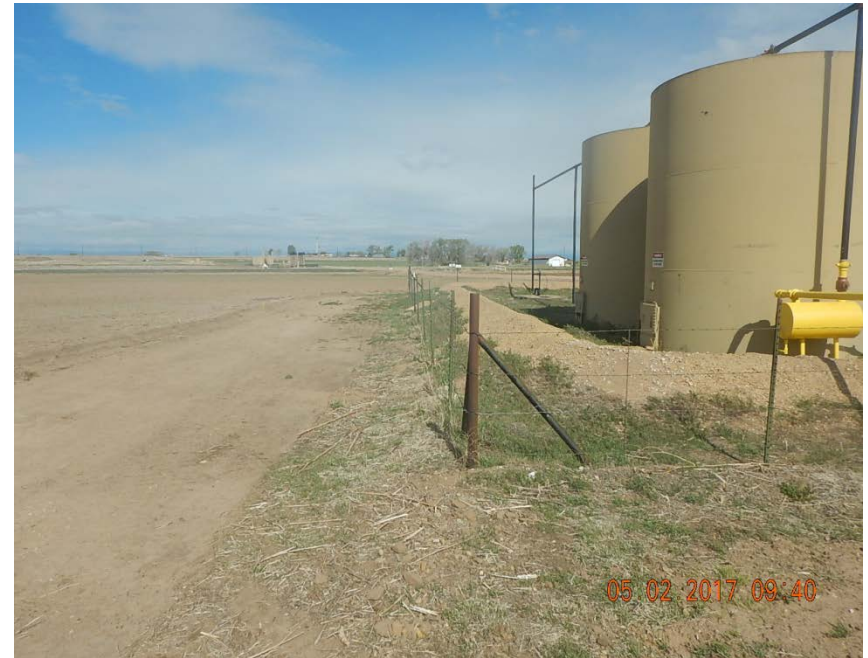
Photo 1: Fencing repaired

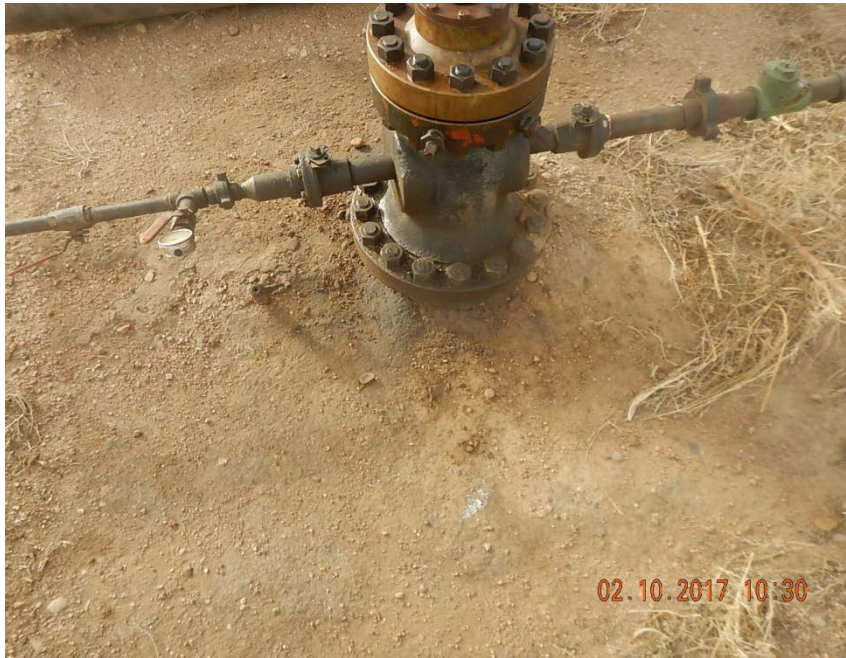
Photo from prior inspection for comparison purposes

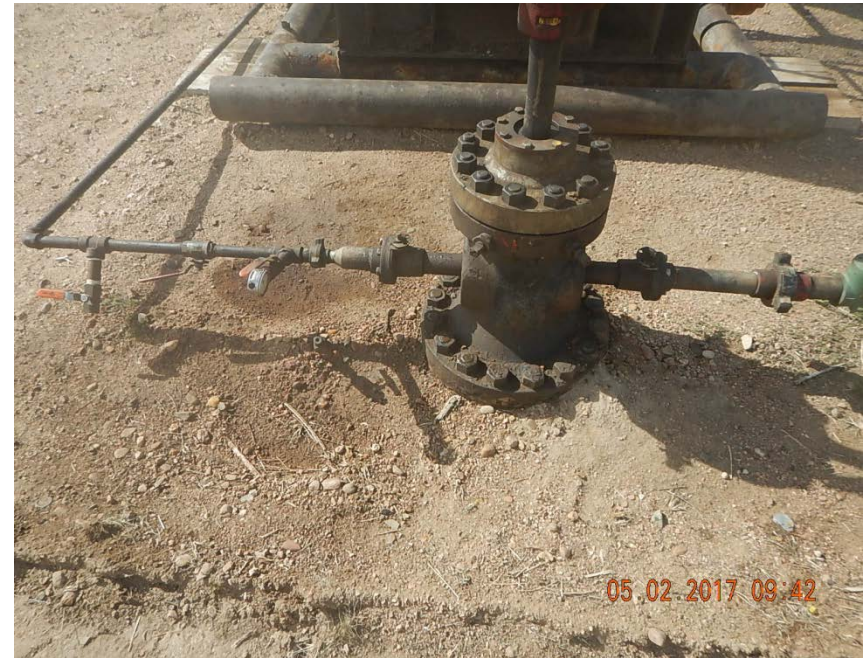
Photo 2: Stained soil at wellhead removed, stained soil near wellhead.

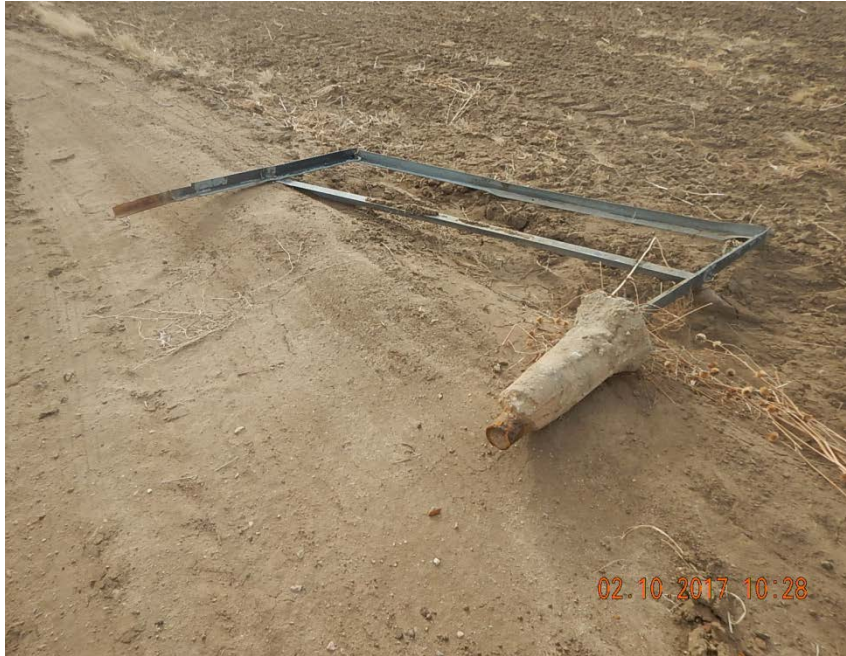
Photo from prior inspection for comparison purposes

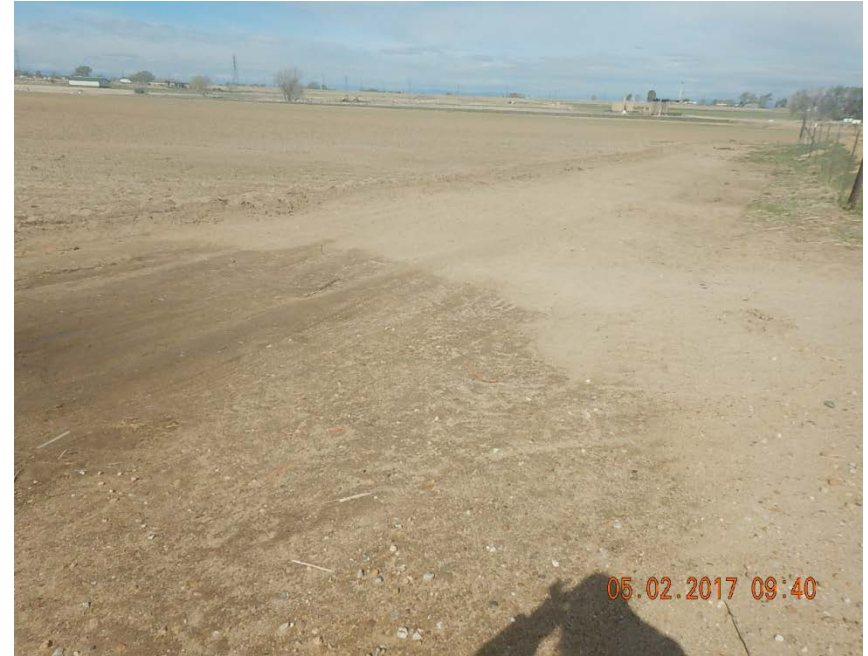
Photo 3: Unused fencing removed

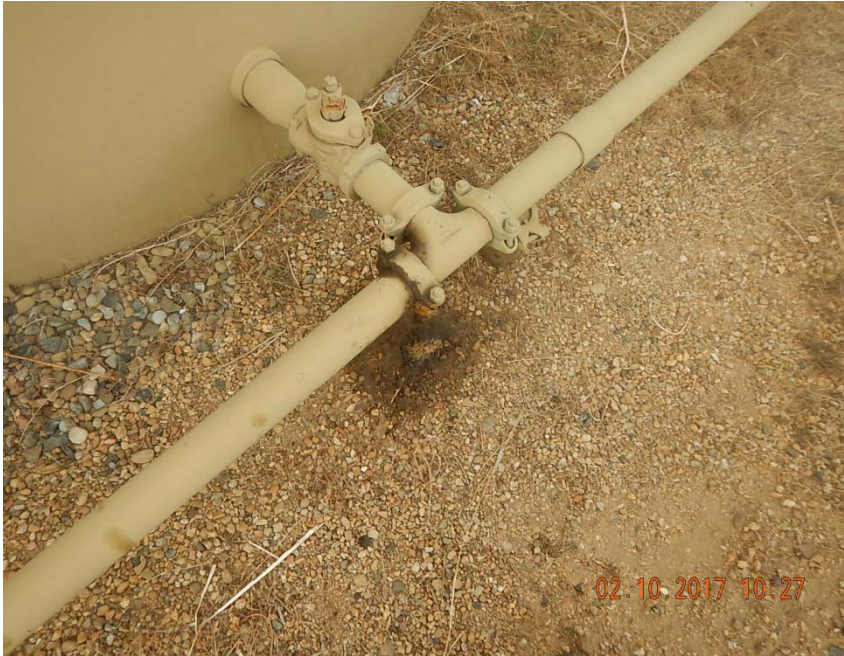
Photo from prior inspection for comparison purposes

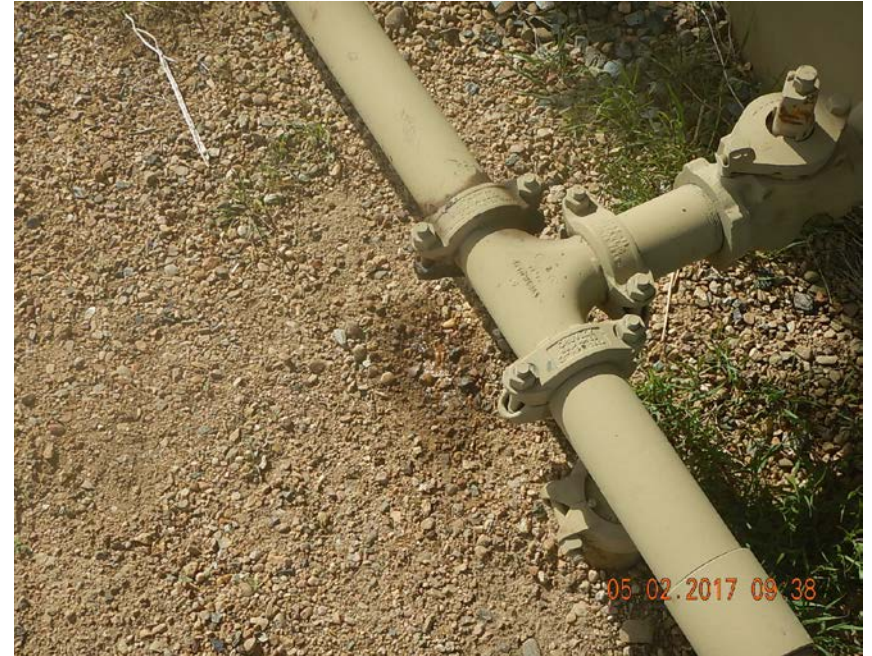
Photo 4: Stained soil removed, new stained soil at fitting.

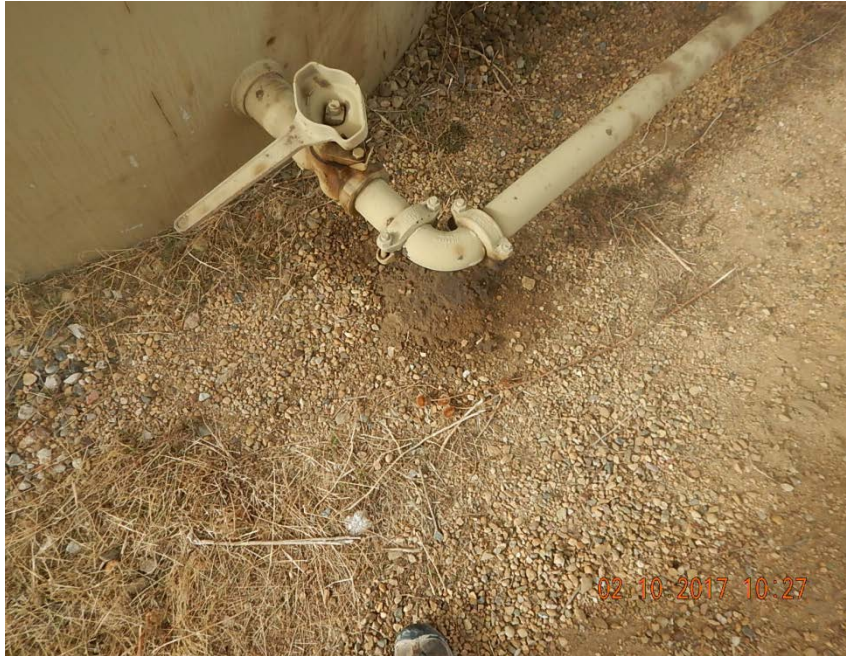
Photo from prior inspection for comparison purposes

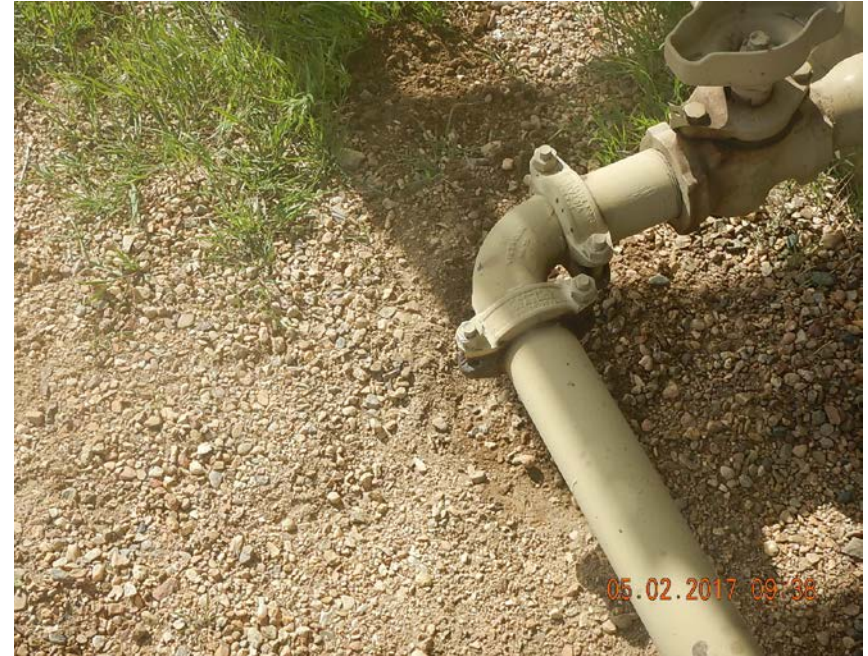
Photo 5: Stained soil removed

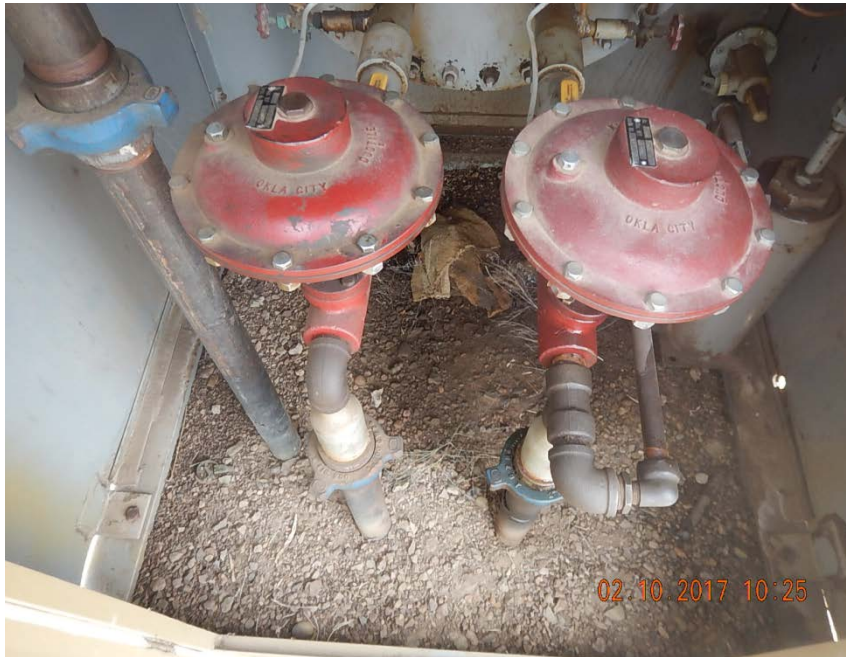
Photo from prior inspection for comparison purposes

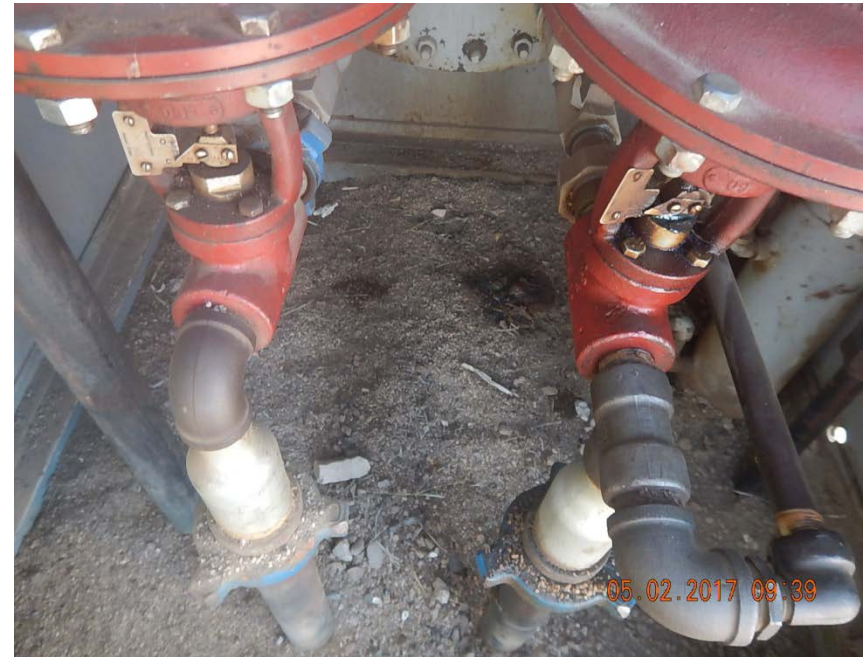
Photo 6: Stained soil removed, new stained soil in separator house
