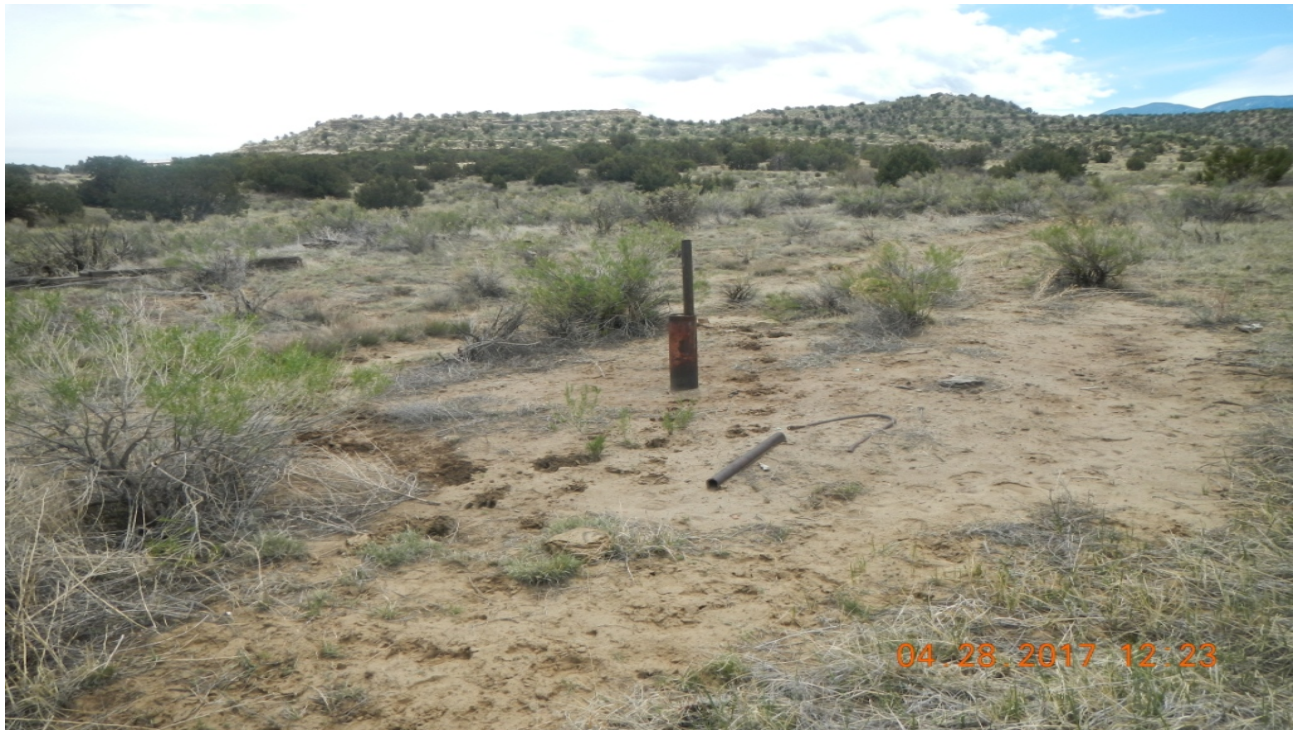
**photo 1:** Well casing at the location.

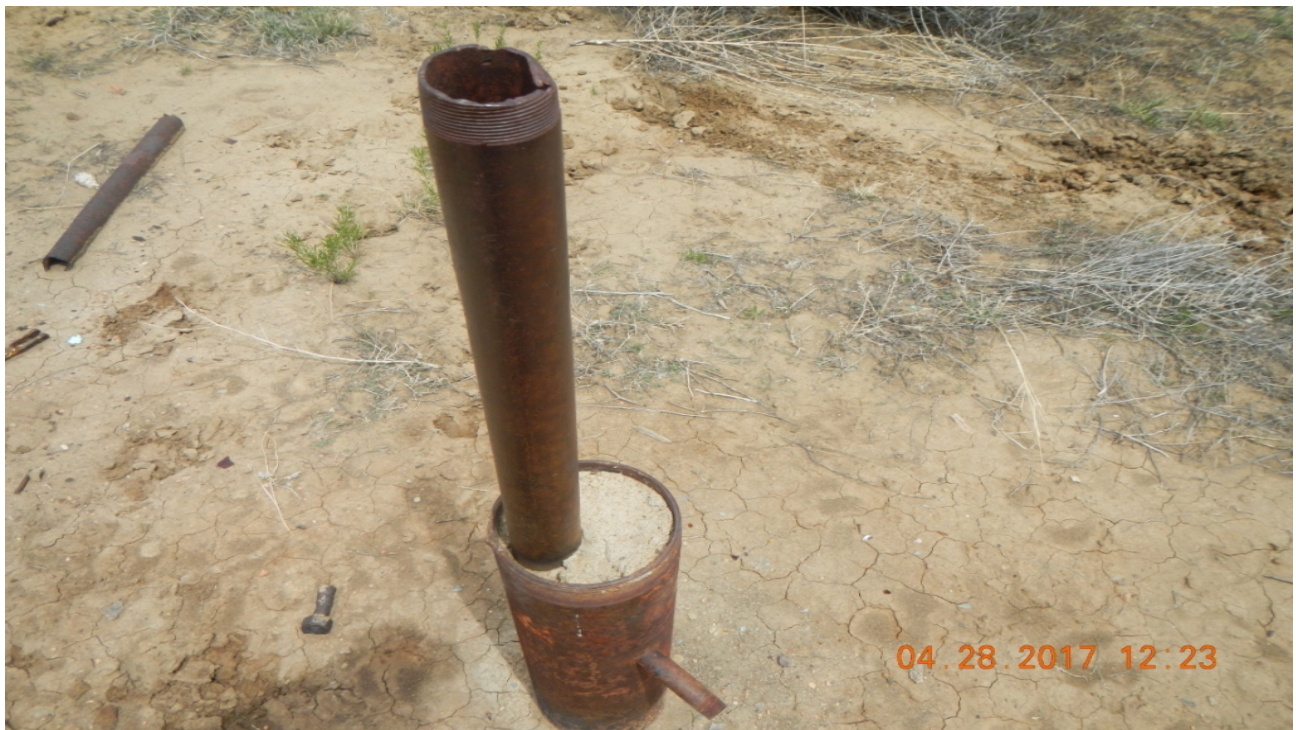
**photo 2:** View of casing which looks to be cemented.

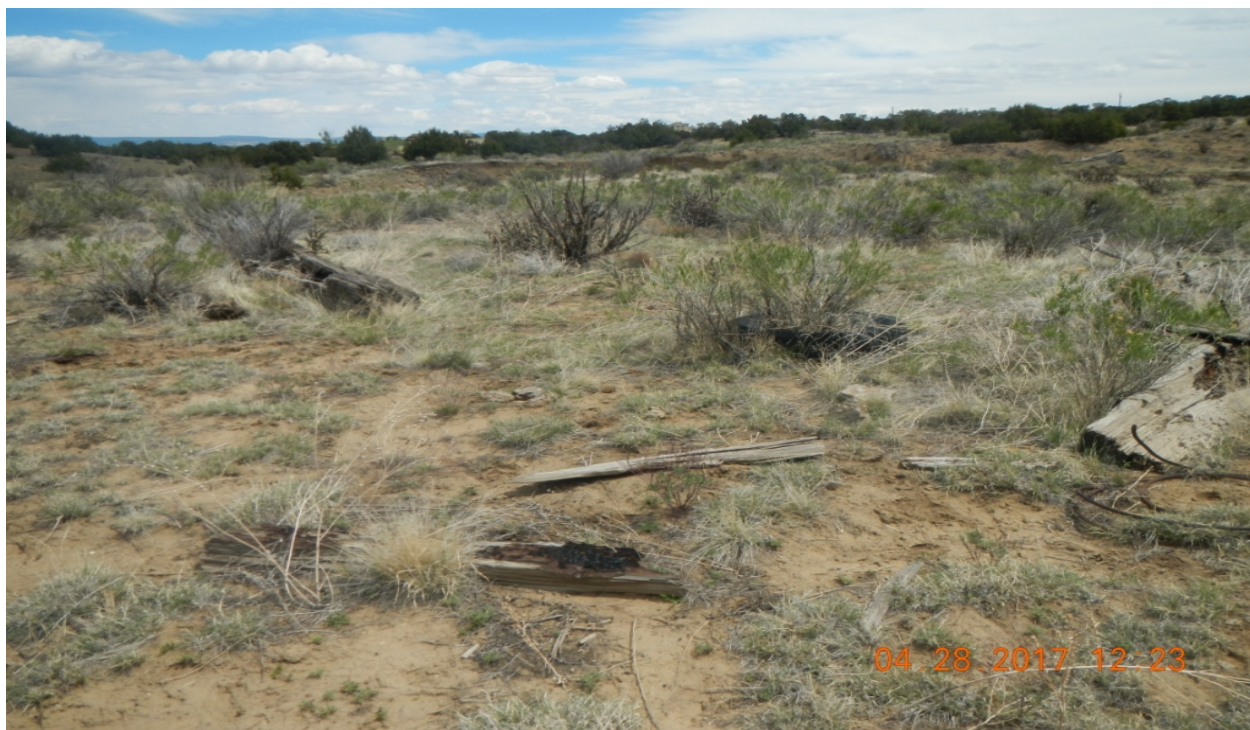
**photo 3:** Facing northeast toward the location. There is various debris which remains.

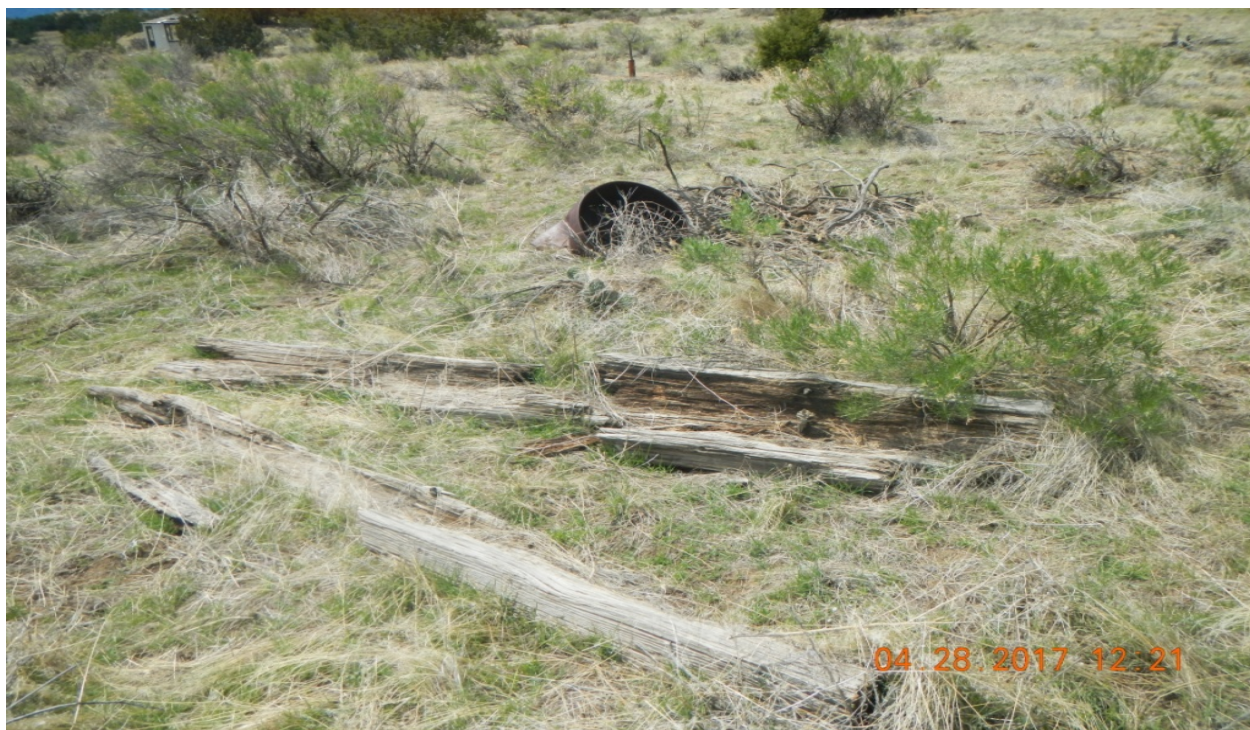
**photo 4:** Various debris remains.
