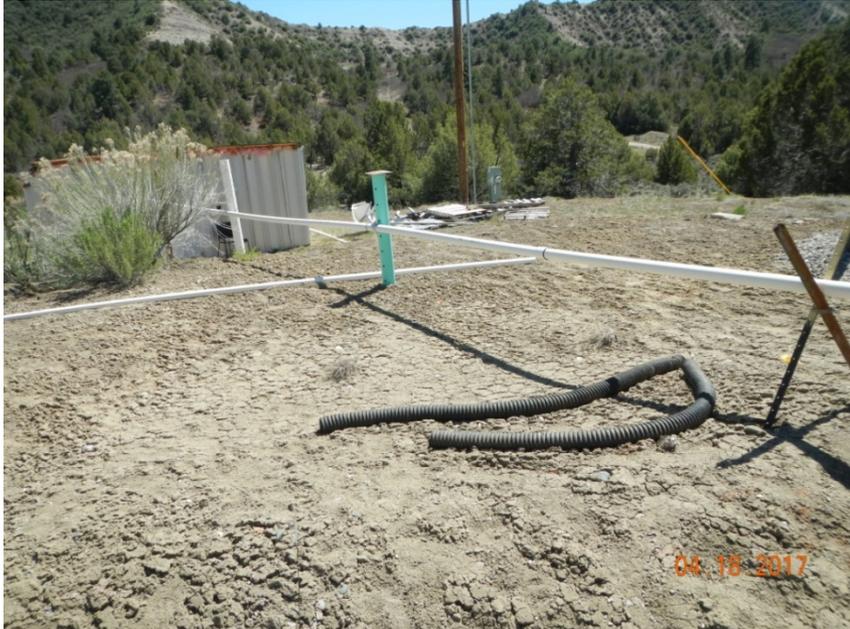
Photo 1: View of what appears to be surface owner equipment and debris within the southeastern portion of the project area.

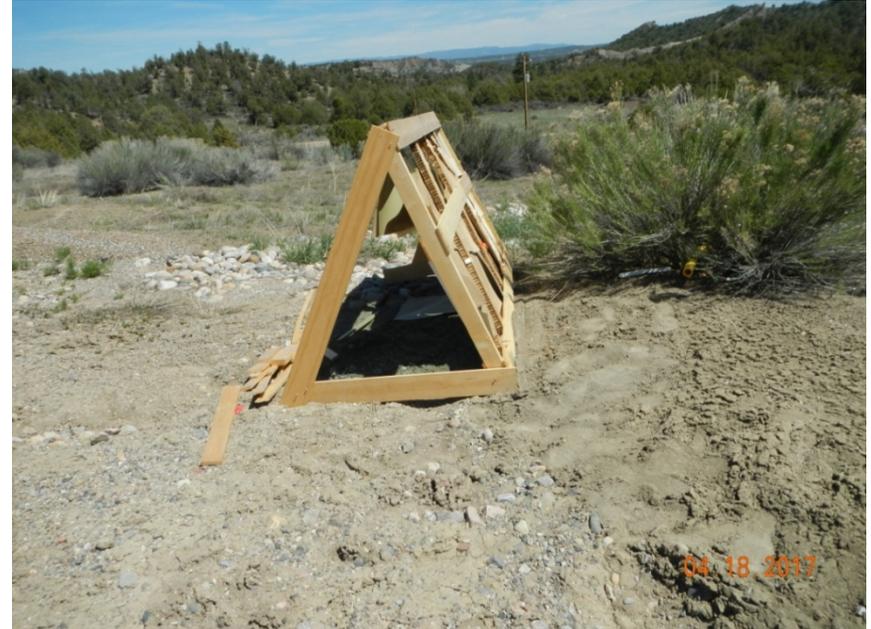
Photo 2: View of more surface owner equipment and debris within the southeastern portion of the project area.

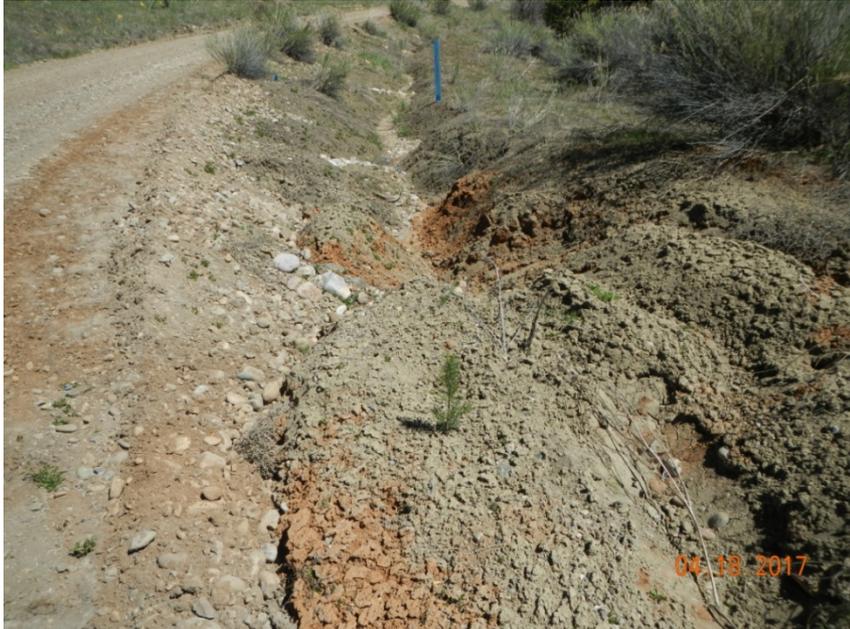
Photo 3: View of exposed soil and erosional channels forming along the southern edge of the access road at the well pad entrance.

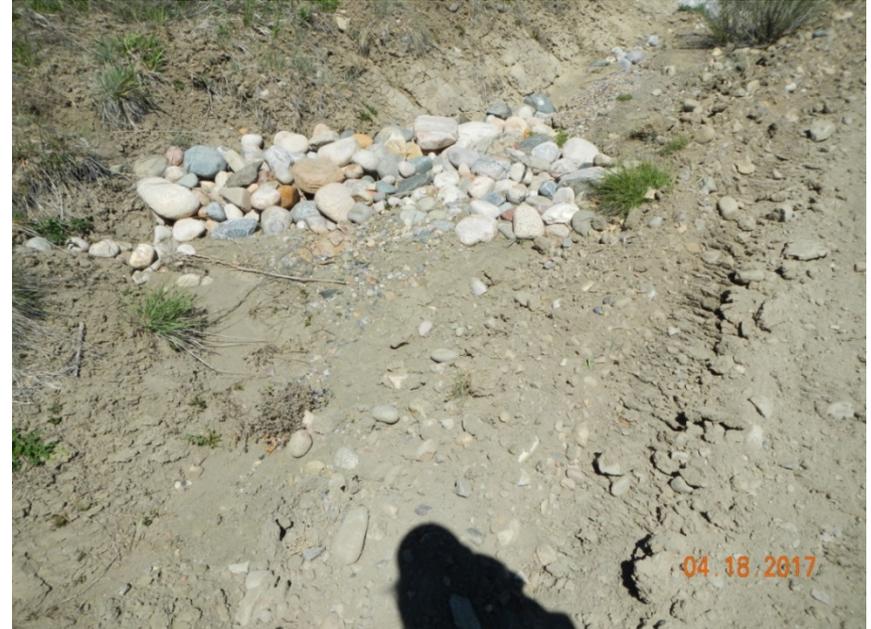
Photo 4: View of check dam that is largely full of sediment and needs maintenance.

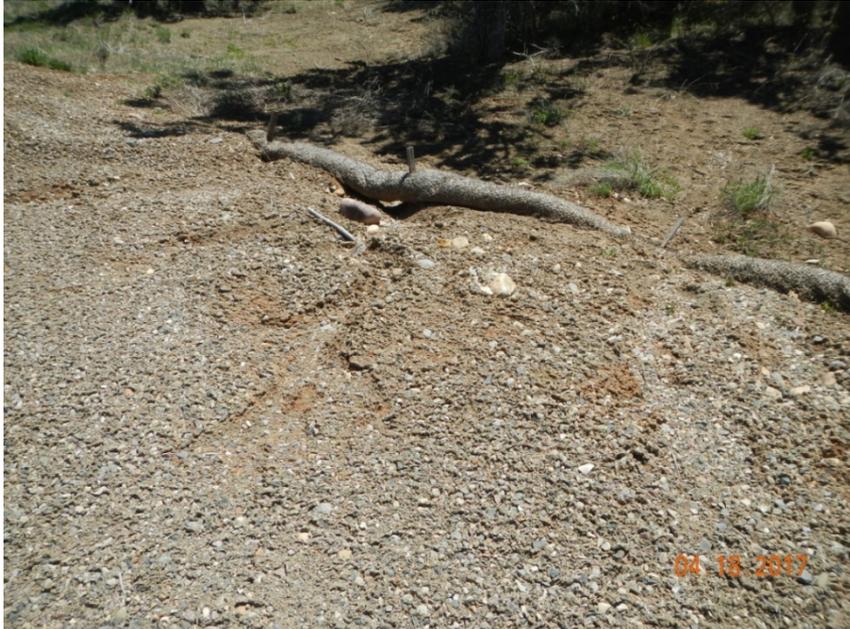
Photo 5: View of wattles in the southern portion of the project area that are not functioning and need repair or replacement.

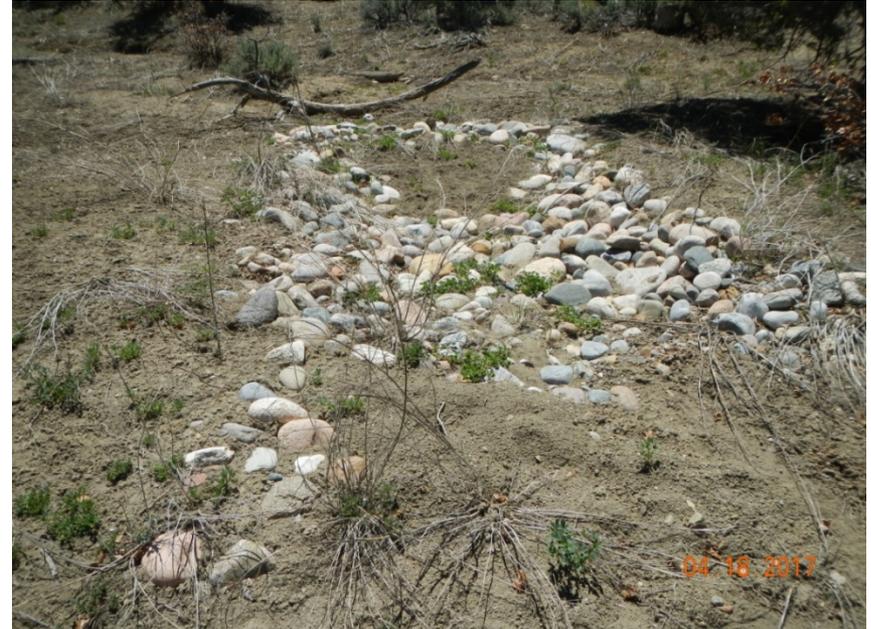
Photo 6: View of cobble rundown in the southwestern portion of the project area that is filling with sediment and needs maintenance.
