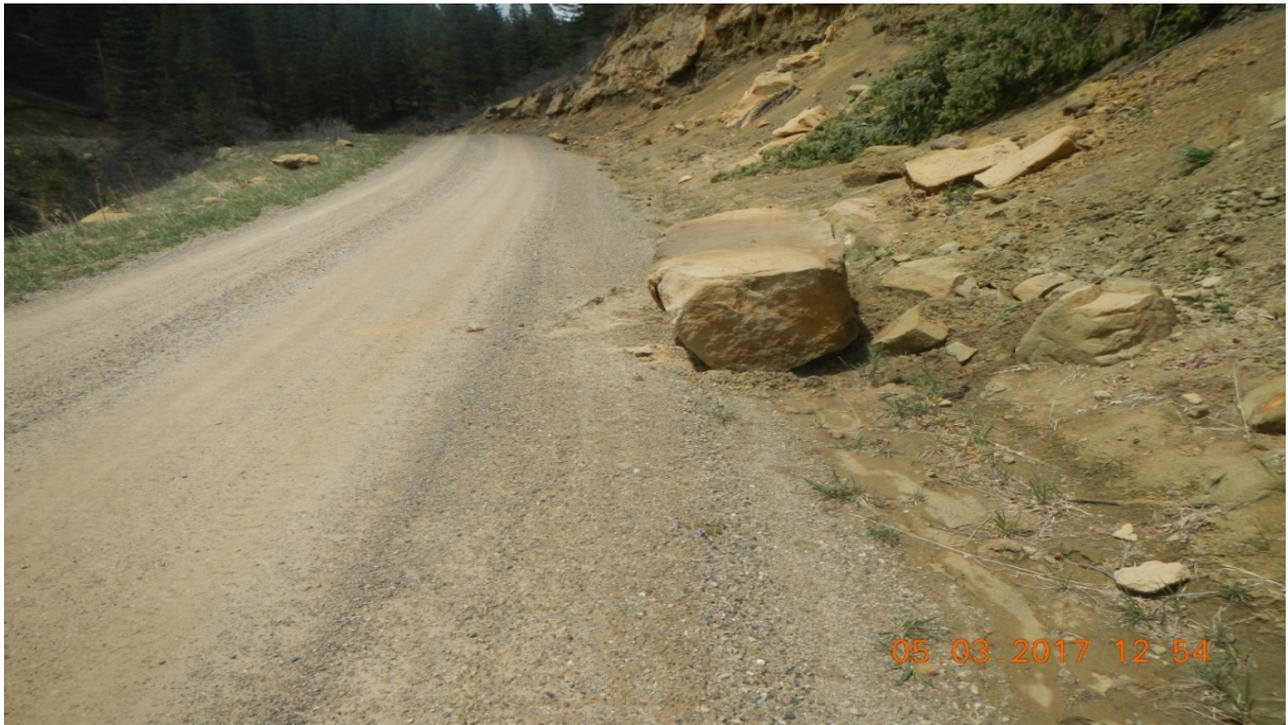
**photo 1:** Facing west along main road at approximate Lat/Long: 37.22886,-104.94239. A boulder has fallen near the side of the road which will restrict stormwater flow.

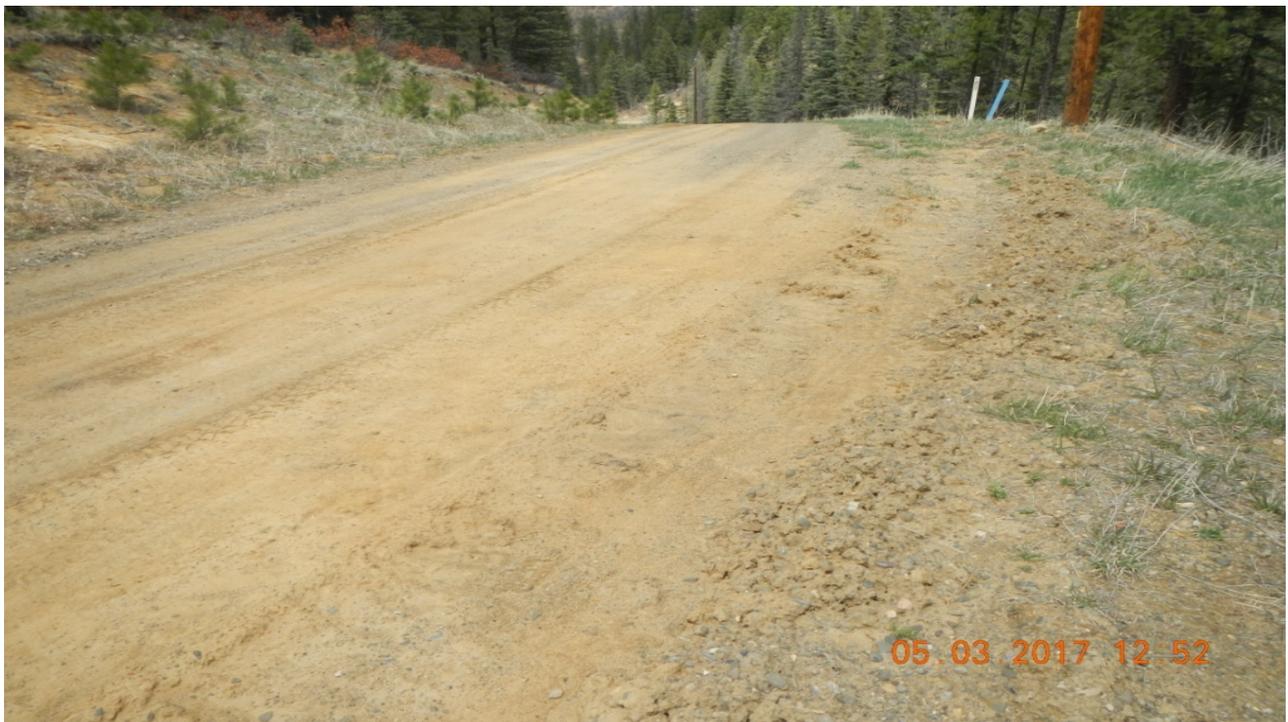
**photo 2:** The gravel has been scrapped of the road and there is little gravel that remains at this area along the main road at approximate Lat/Long:37.22886,-104.94272.

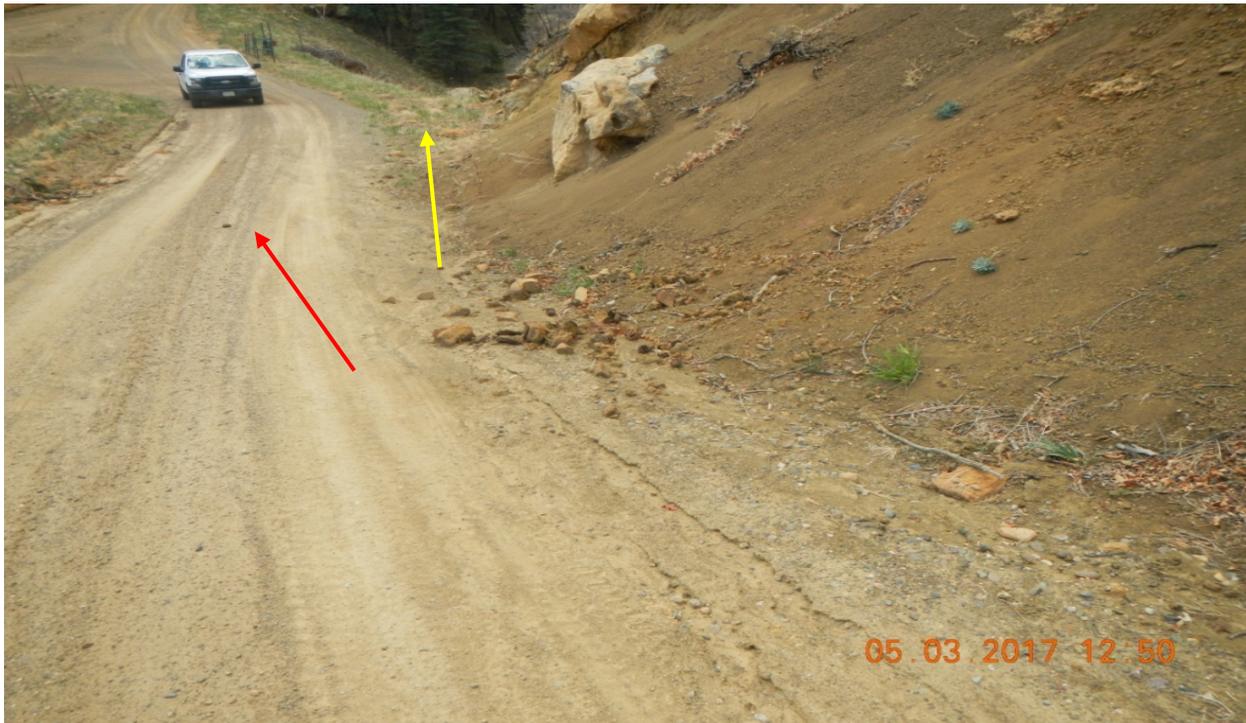
**photo 3:** Approximate Lat/Long:37.22630,-104.94464. Stormwater is flowing and pooling on the road in the direction of the red arrow. The diversion ditch along the side of the road is filled in and not draining as it should in the direction shown by the yellow arrow.

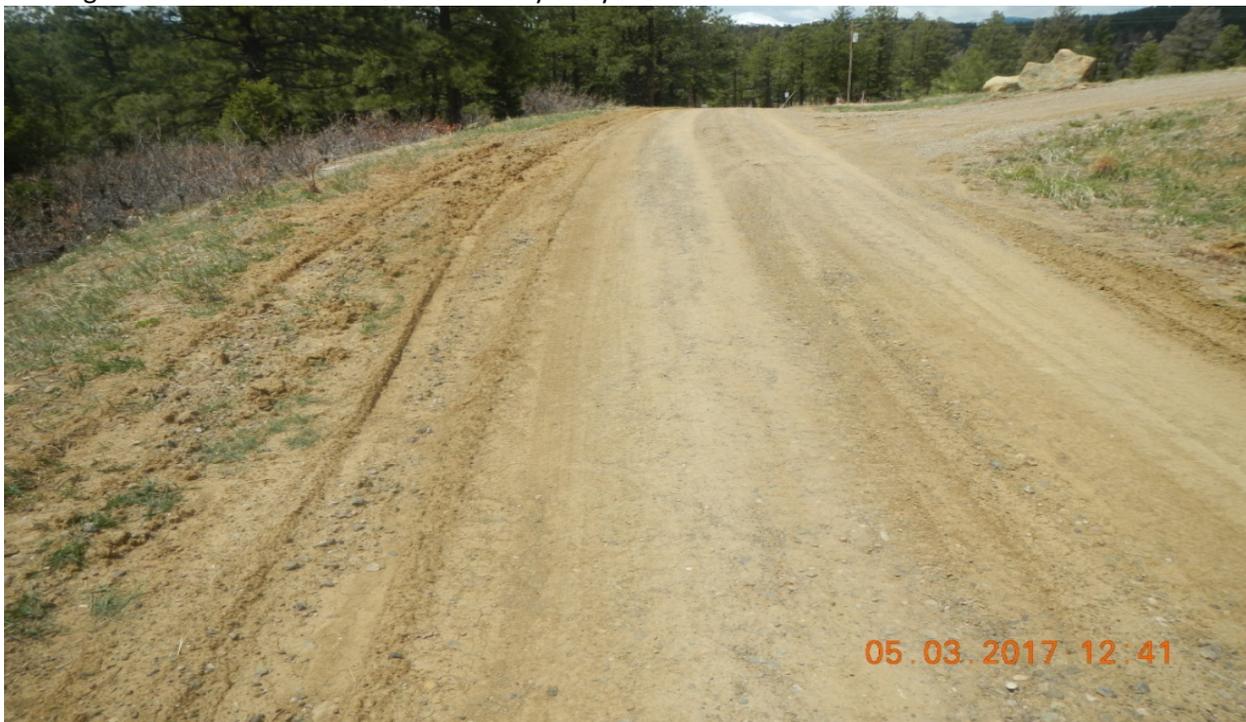
**photo 4:** Approximate Lat/Long:37.22408,-104.94292. Vehicles are creating disturbance outside of the access road.

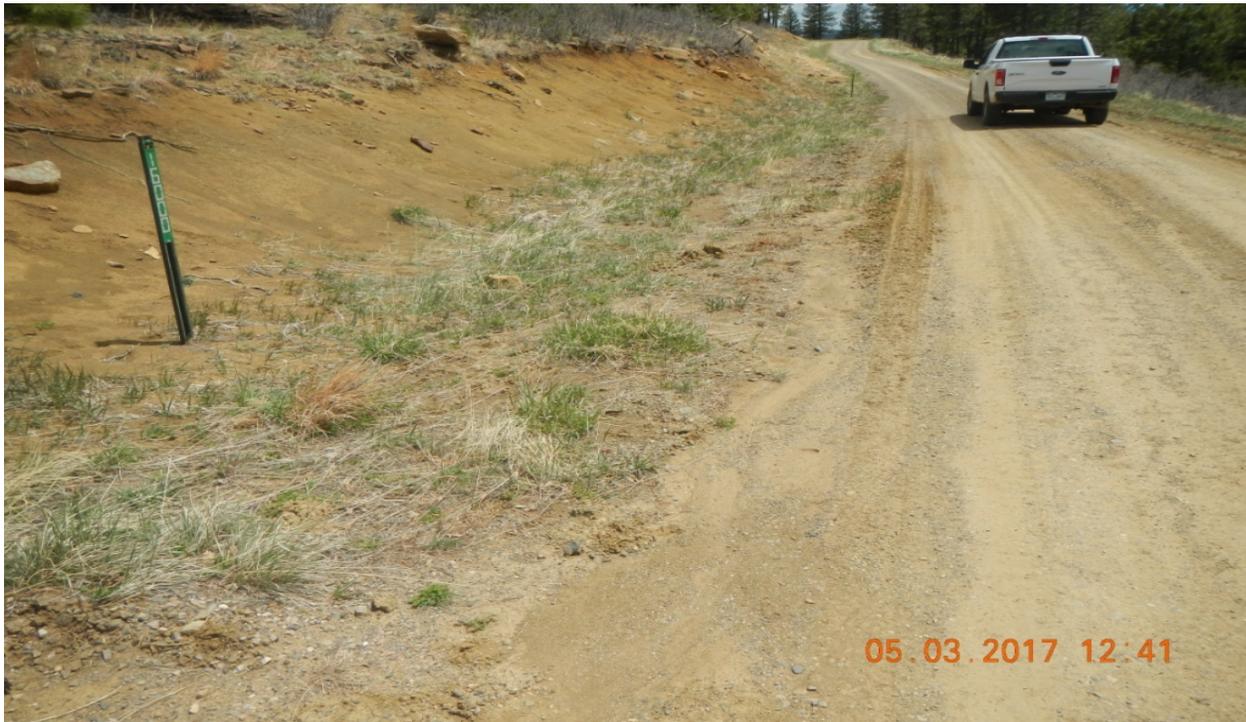
**photo 5:** Approximate Lat/Long:37.22408,-104.94292. Sediment has filled into the drainage ditch which is not allowing stormwater to flow toward the culvert.
