# Construction and Stormwater Inspection

May 2, 2017

Operator: ENERPLUS RESOURCES (USA) CORPORATION - #10177

Inspection Photos  
Location Name: MAPLE #8-67-36-25C  
Location ID: 449800

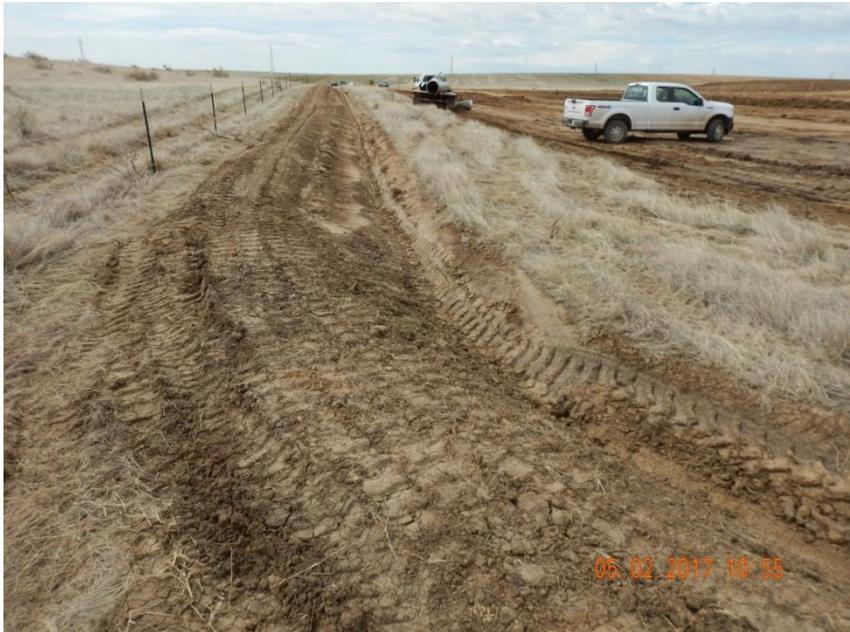
**Photo 1.** Photo taken from the northeast perimeter of the location, facing South. Ditch and berm BMP has been installed around the entire perimeter of the location.

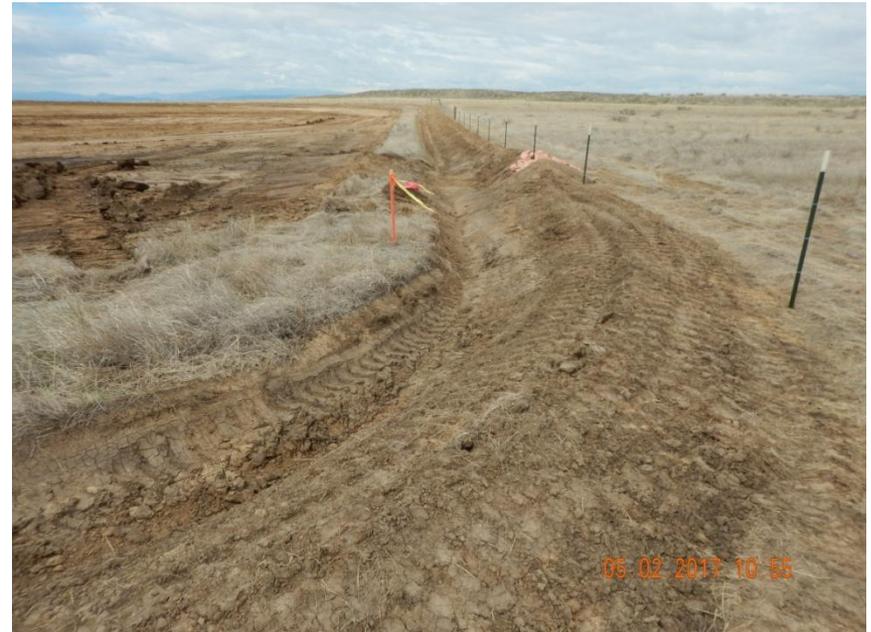
**Photo 2.** Photo taken from the northeast perimeter of the location, facing West. Ditch and berm BMP has been installed around the entire perimeter of the location.

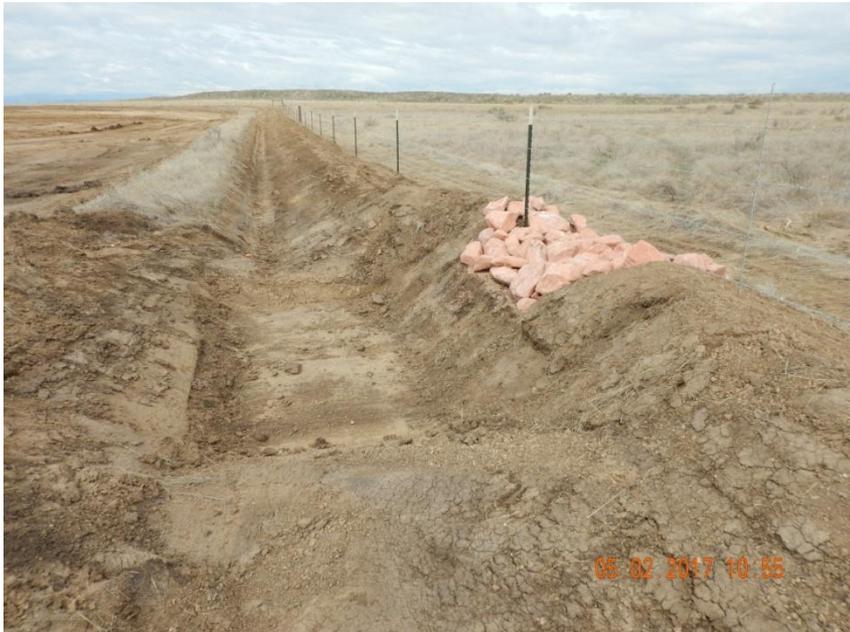
**Photo 3.** Photo taken from the northeastern location, facing South. Sediment trap has been installed and appears to be in the completion process.

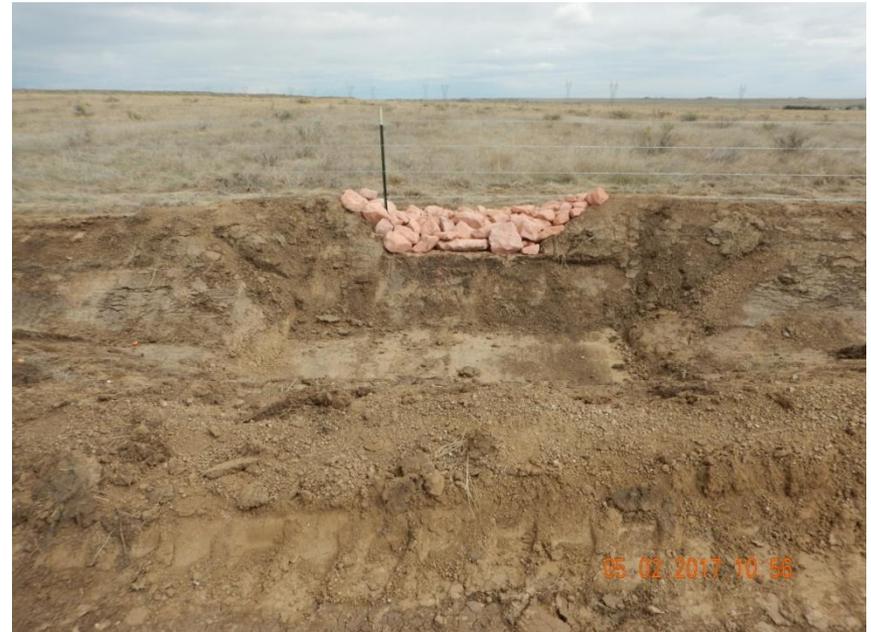
**Photo 4.** Photo taken from the sediment trap, facing North. Stabilized outlet protection has been installed.

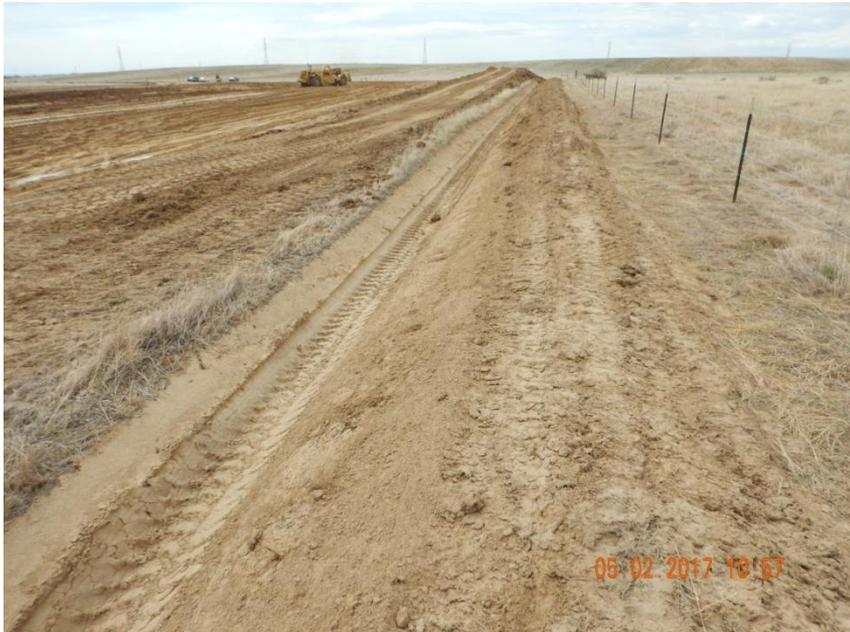
**Photo 5.** Photo taken from the northwest perimeter of the location, facing South. Ditch and berm BMP has been installed around the entire perimeter of the location.

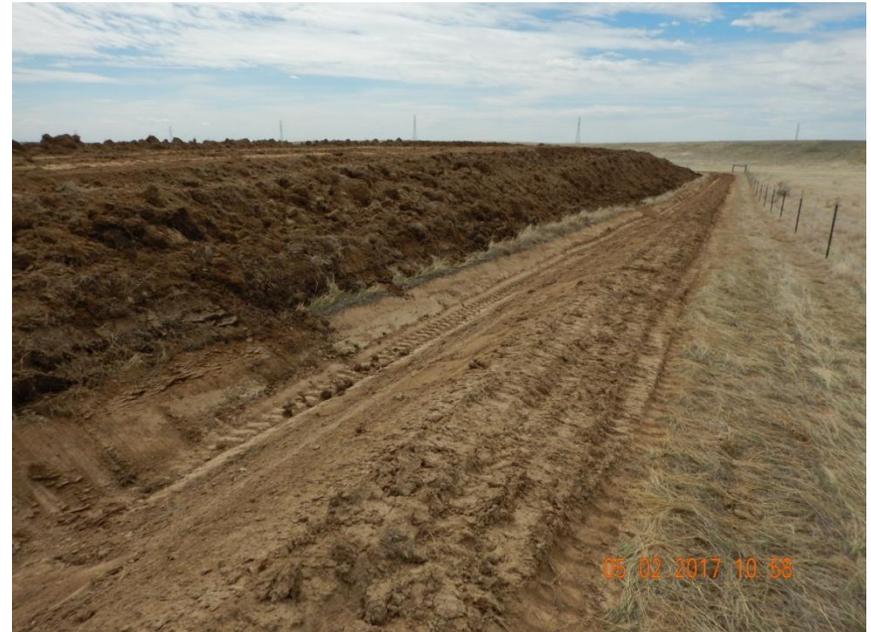
**Photo 6.** Photo taken from the western location, facing South towards the topsoil stockpile.

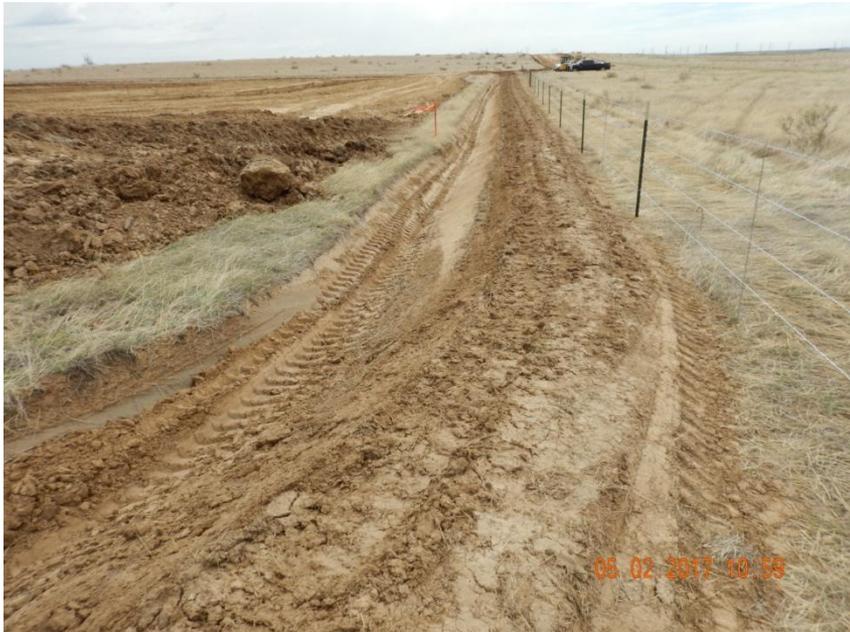
**Photo 7.** Photo taken from the southwest perimeter of the location, facing East. Ditch and berm BMP has been installed around the entire perimeter of the location.

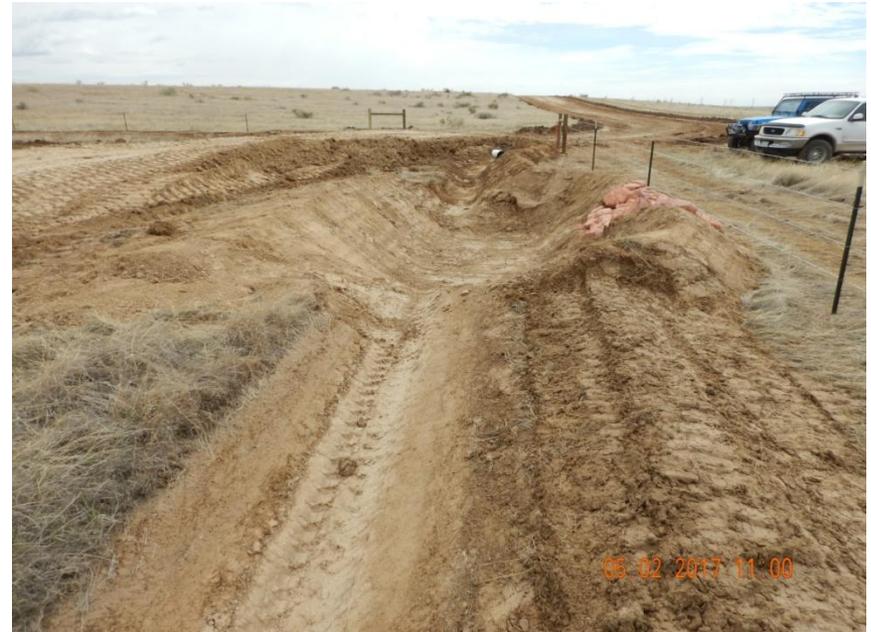
**Photo 8.** Photo taken from the entrance of location, facing East. Sediment trap has been installed and appears to be in the completion process.

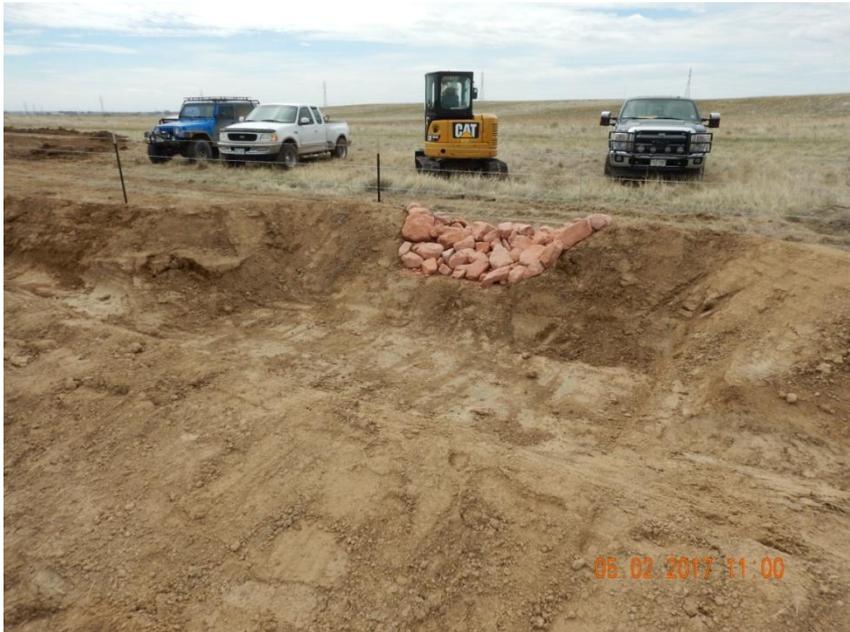
**Photo 9.** Photo taken from the sediment trap, facing South. Stabilized outlet protection has been installed.

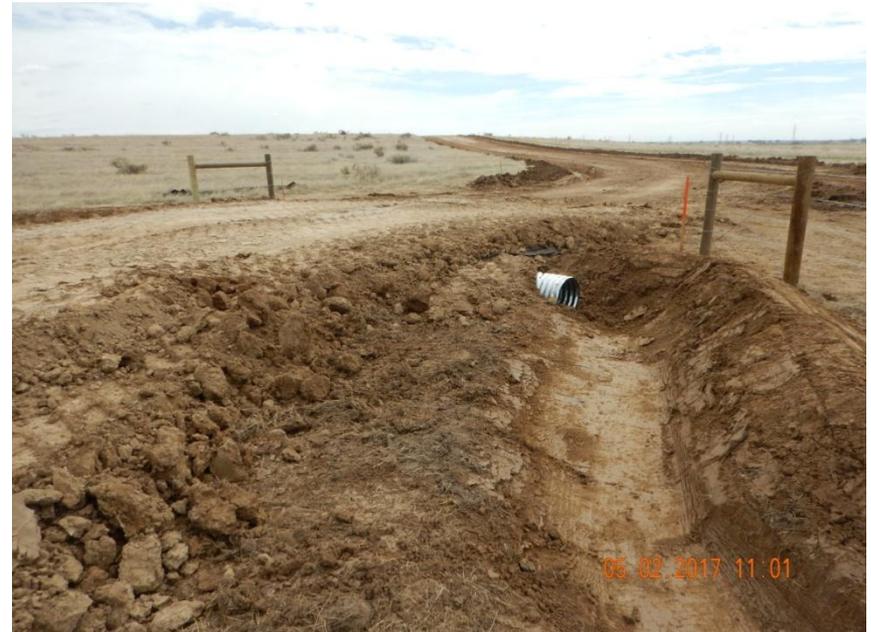
**Photo 10.** Photo taken from the entrance of location, facing East. Culvert has been installed in conjunction with the ditch and berm BMP.

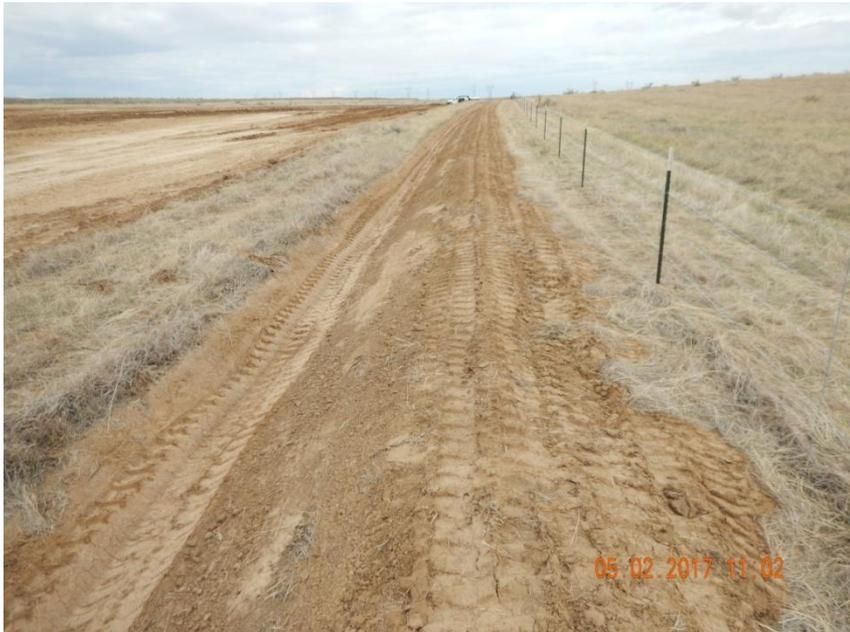
**Photo 11.** Photo taken from the southeast perimeter of the location, facing North. Ditch and berm BMP has been installed around the entire perimeter of the location.

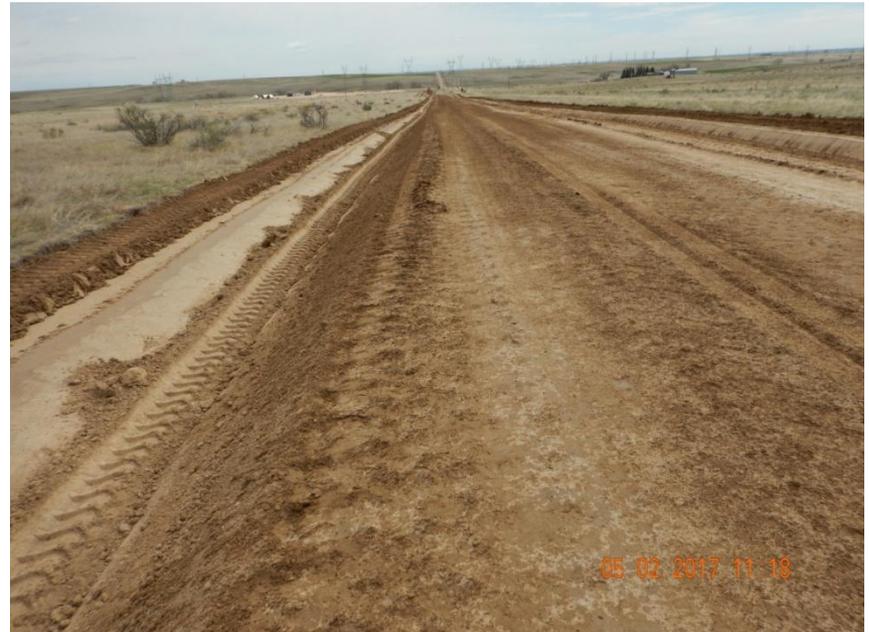
**Photo 12.** Photo taken from the north side along a portion of the access road, facing East. Diversion ditch has been installed along both sides of the access road.

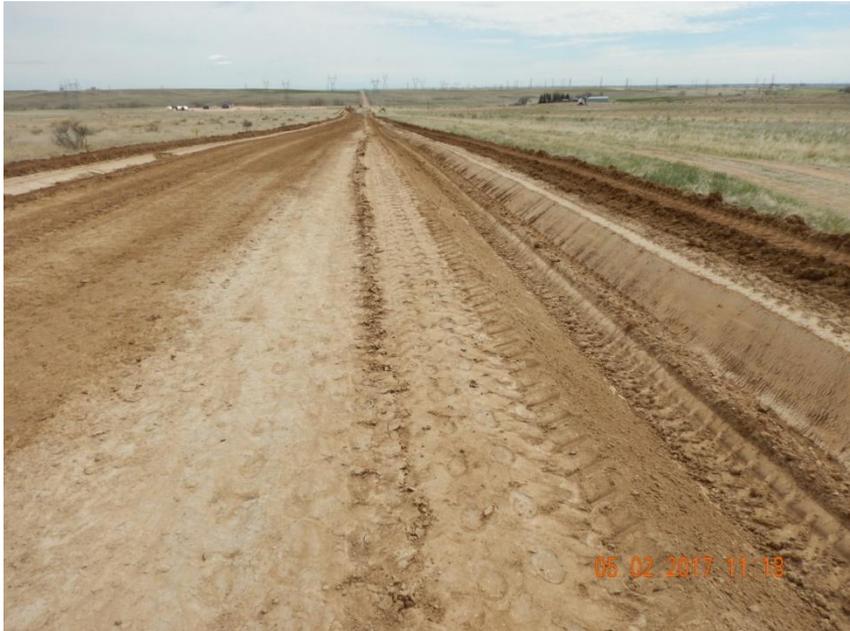
**Photo 13.** Photo taken from the south side along a portion of the access road, facing East. Diversion ditch has been installed along both sides of the access road.

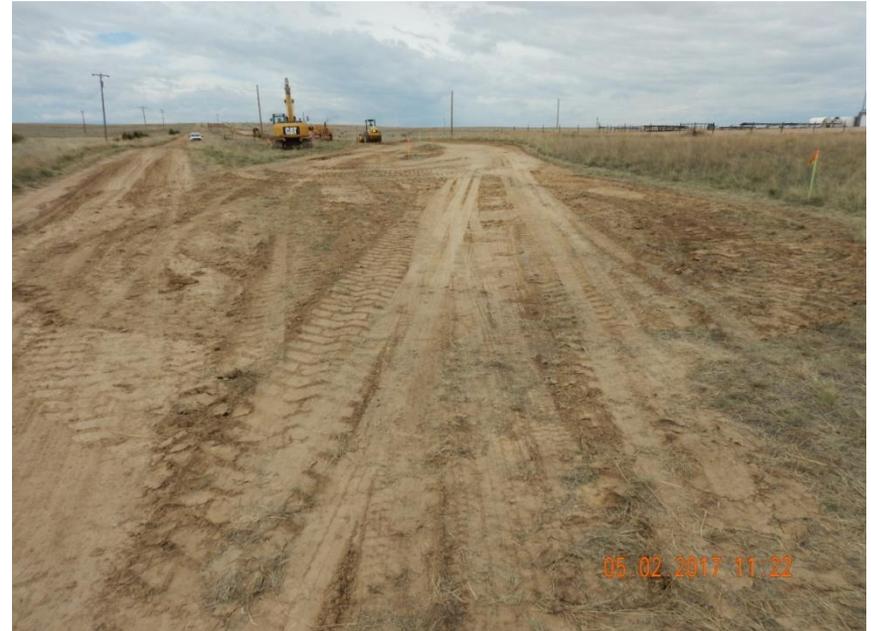
**Photo 14.** Photo taken from the start of the access road off CR 86 & CR 25, facing West. Construction of the access road is still IN-PROCESS.
