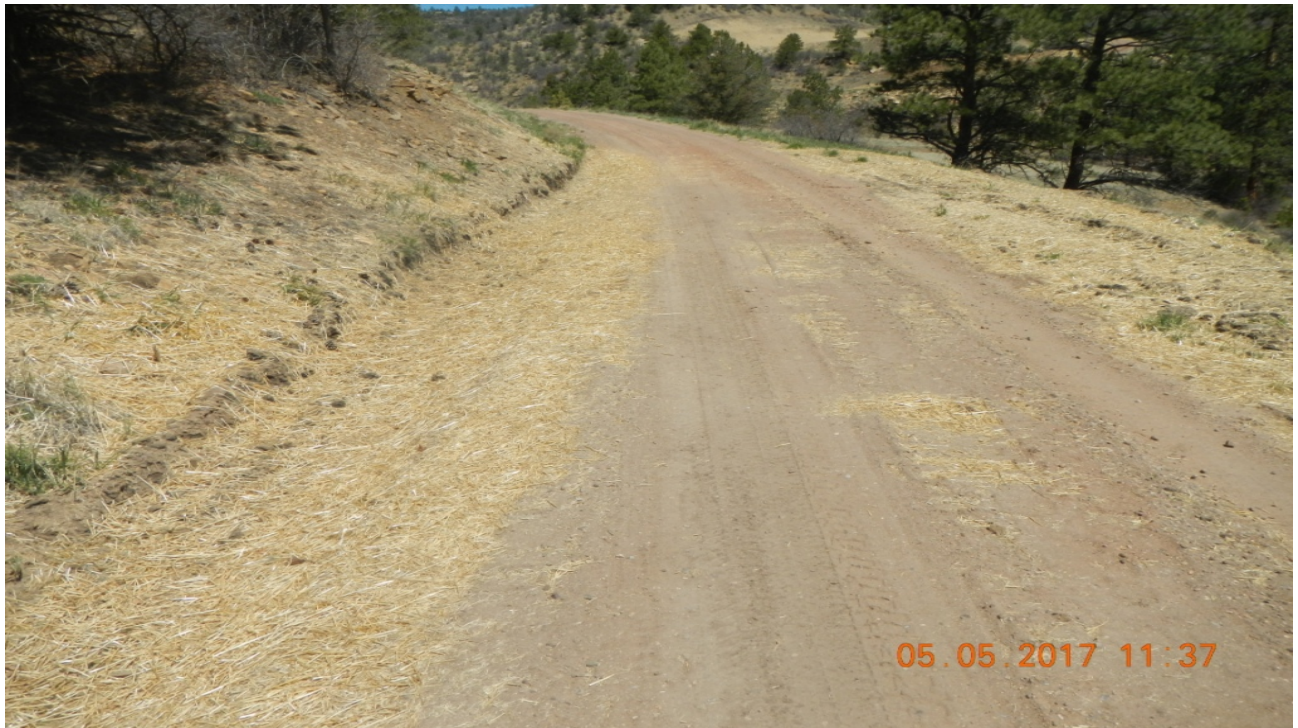
photo 1: Facing north along the access road.

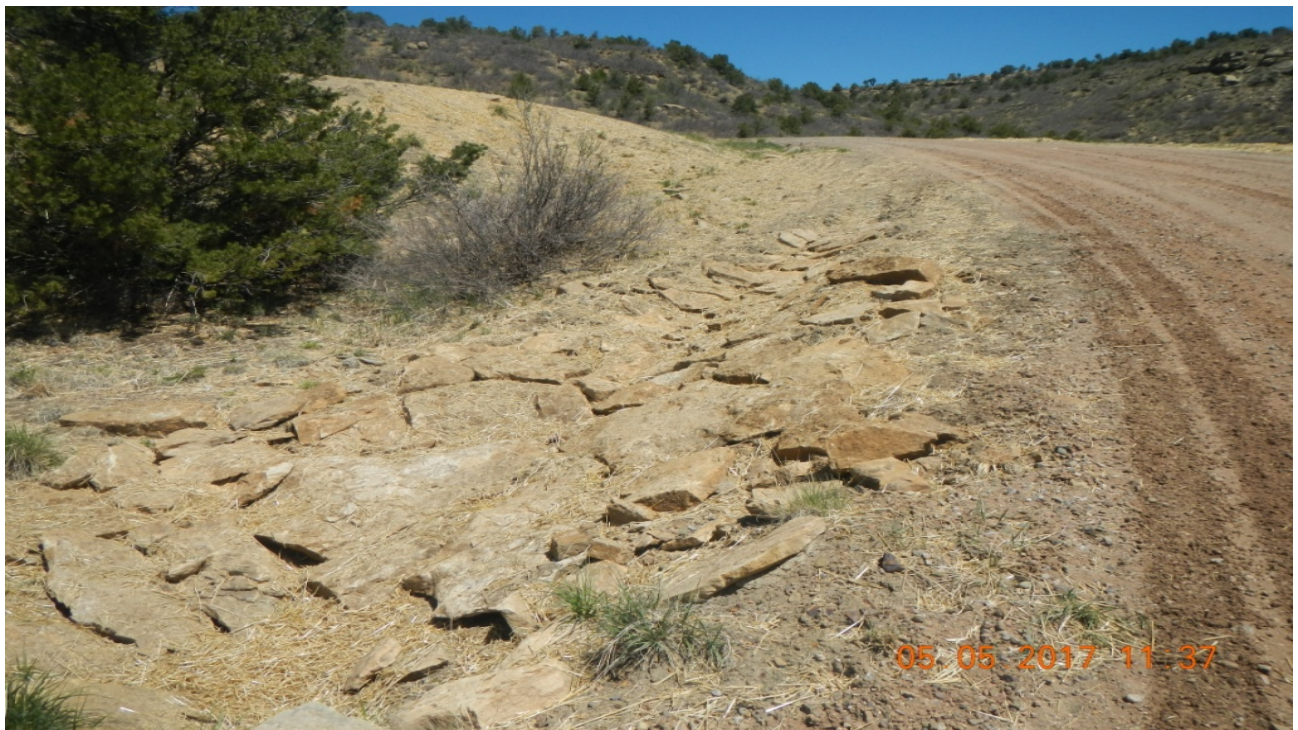
photo 2: Facing north along the access road near the location.

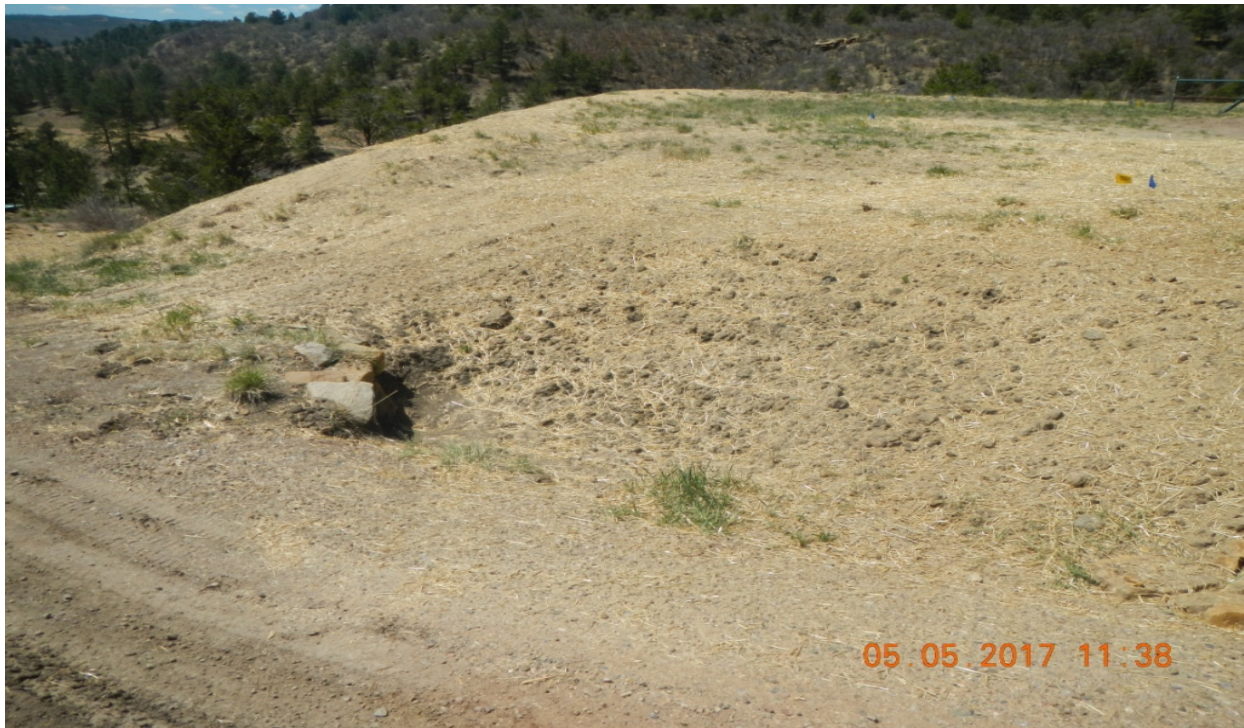
photo 3: The culvert at the location has been maintained and areas of the pad were seeded and mulched.

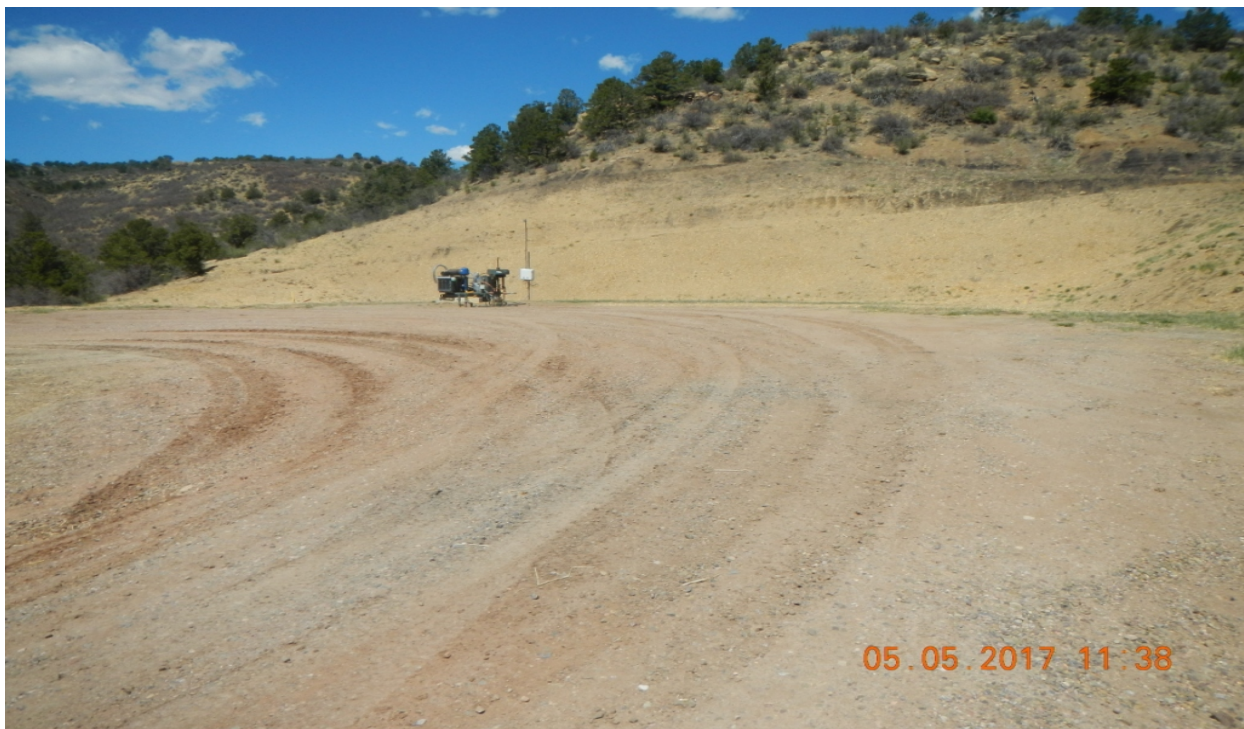
photo 4: Facing northwest toward the location.

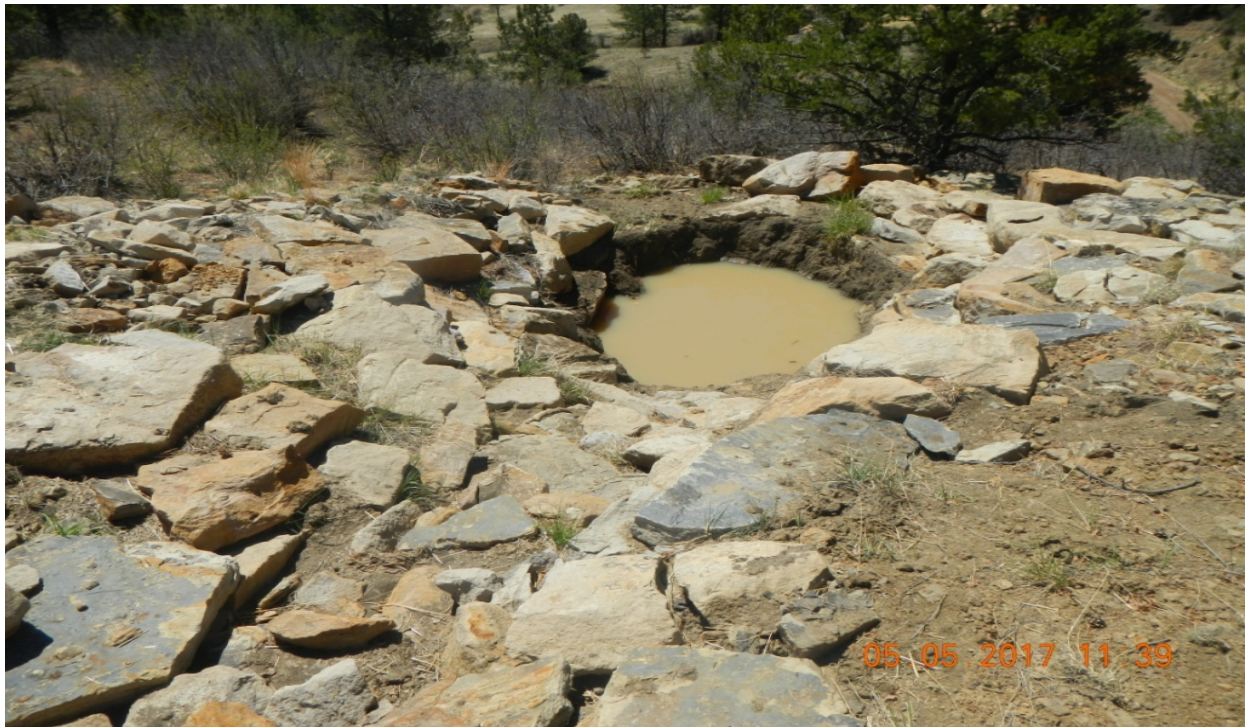
photo 5: The sediment trap at the southwest side has been maintained.

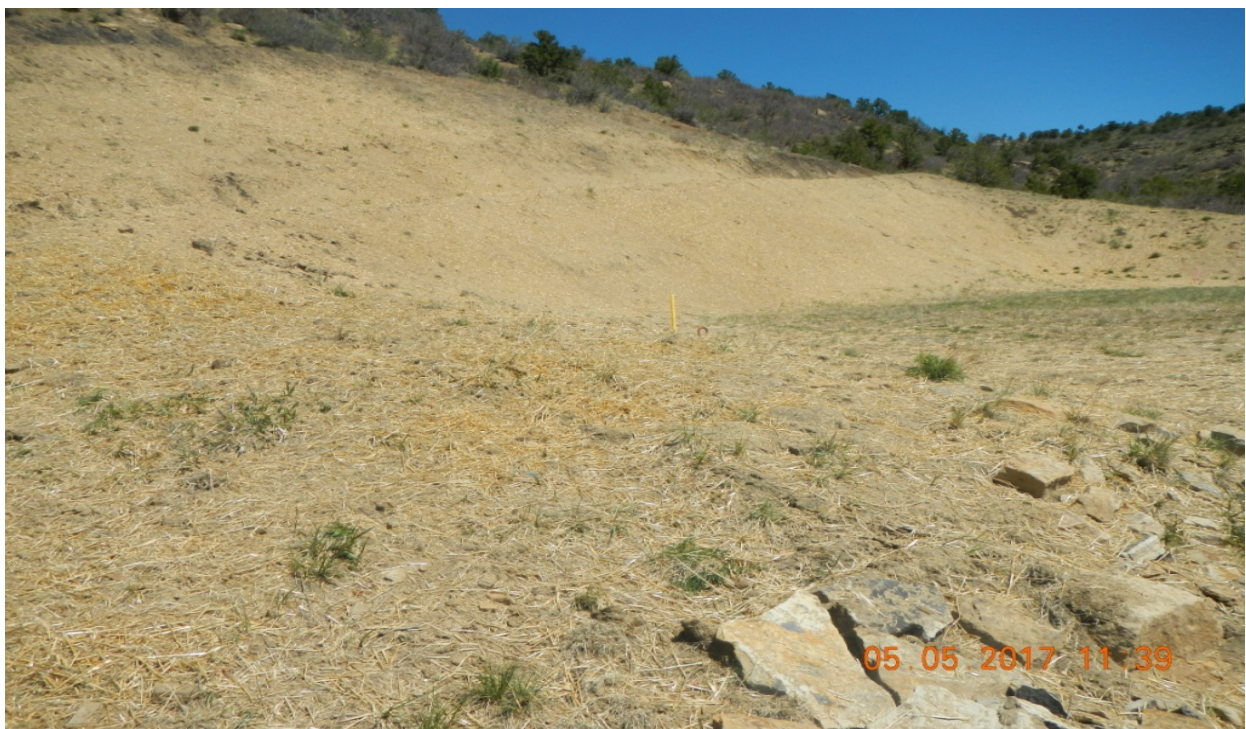
photo 6: Facing north toward the west cut slope.
