# Inspection Photos

Operator: HRM Resources LLC #10548

Location ID: 313925

Inspection Doc. Number: 682501959

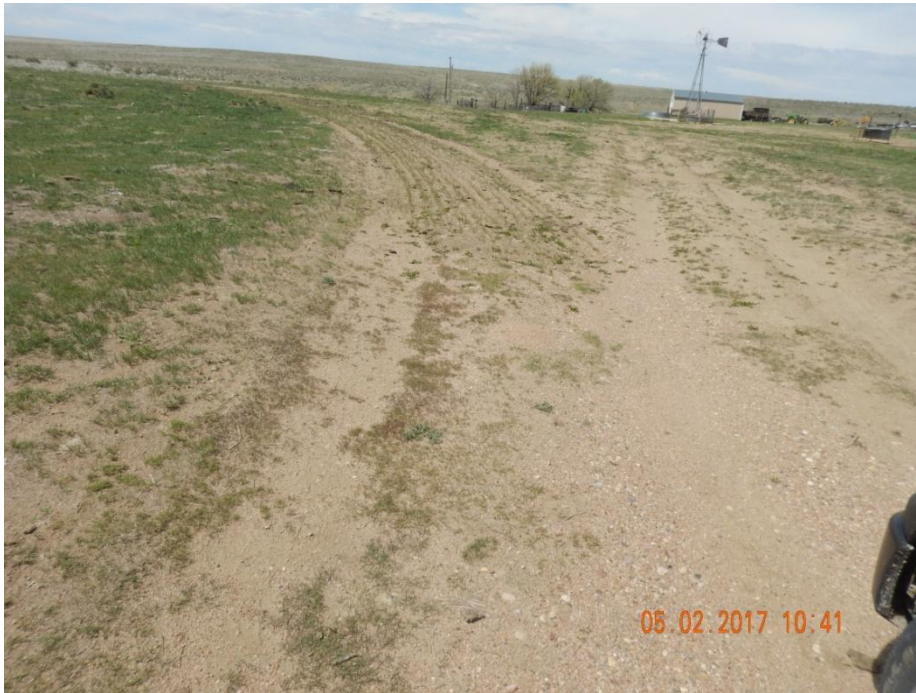
**Photo 1:** Photo taken north of location, from point where access road splits. Fork leading to the left of photo is access road leading to location.

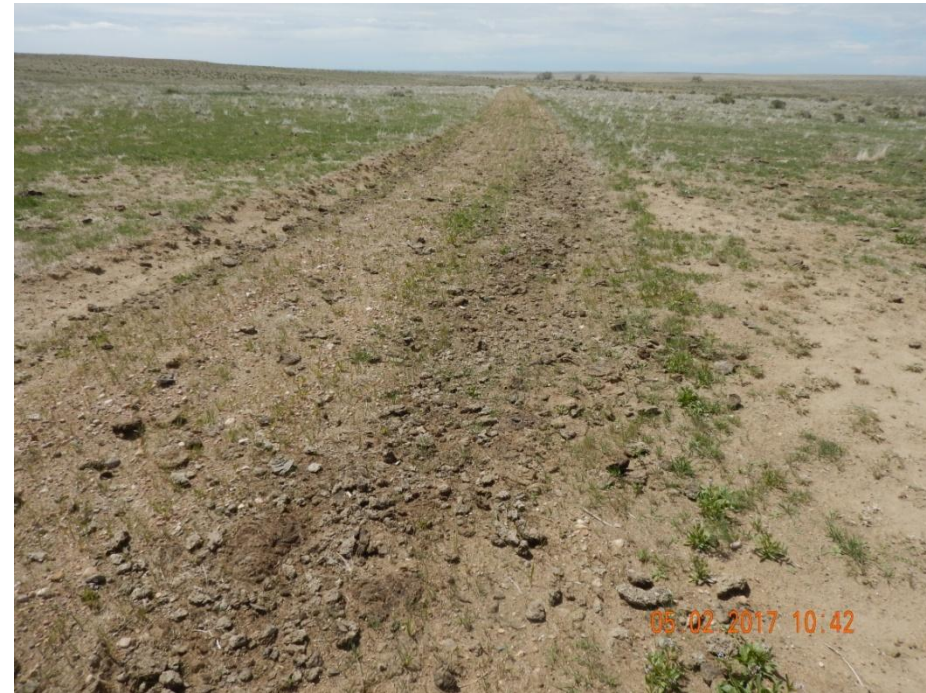
**Photo 2:** Photo taken from access road north of the location, facing south. Photo shows reclamation work appears to have been conducted.

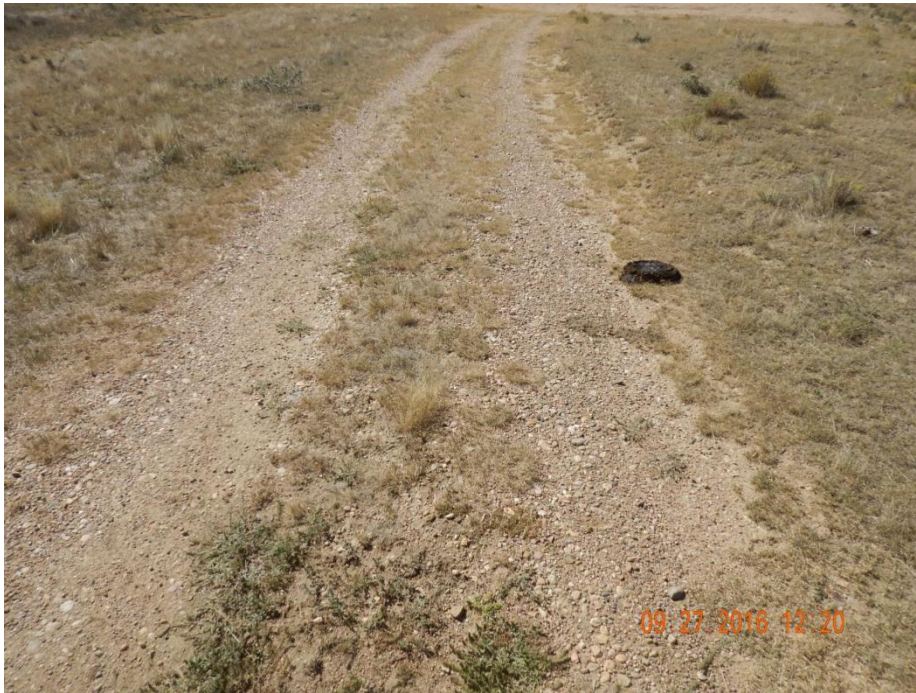
**Photo 3:** Photo from previous inspection dates 9/27/2016. Photo shows ruts and gravel of access road.

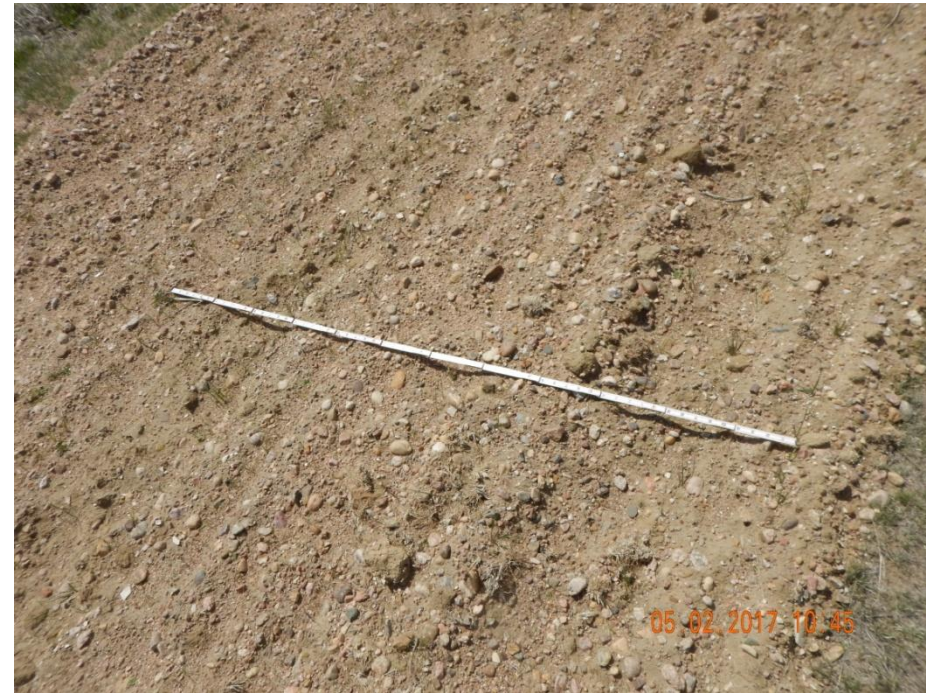
**Photo 4:** Photo taken from access road, west of the location. Photo shows that though it appears access road had been reseeded, gravel has not been removed per corrective actions from inspection doc. #682501380. 6 foot measuring stick for reference.

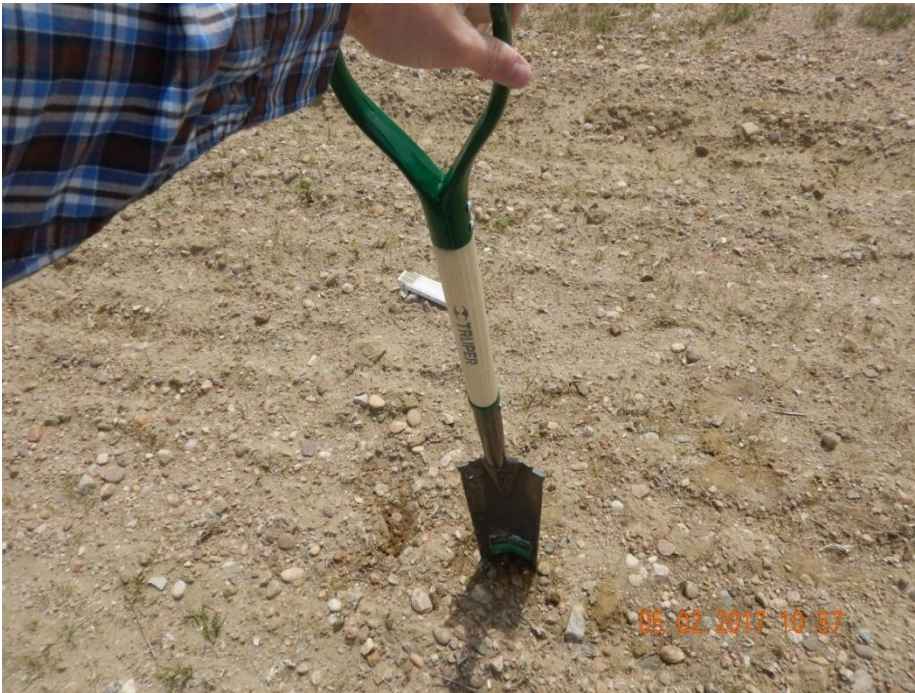
**Photo 5:** Photo taken from access road, west of the location. Reclamation specialist tested road to see if compaction alleviation had been performed. Photo shows shovel was only able to penetrate soil ~2-3 inches before hitting a compaction zone at ~3-4 inches.

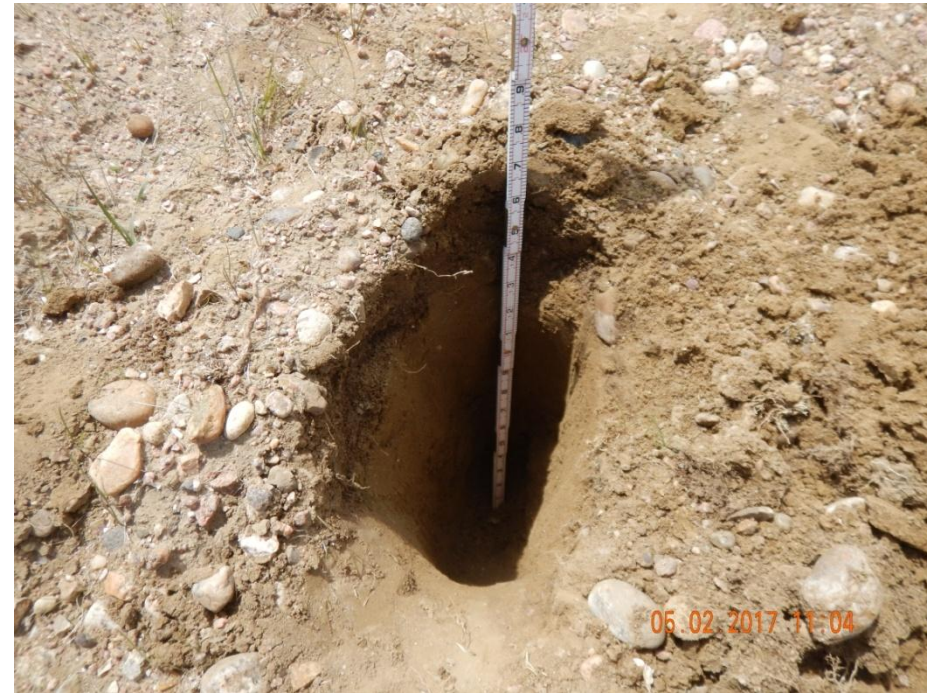
**Photo 6:** Photo taken from access road, west of the location. Photo shows test pit dug by reclamation specialist to determine if compaction alleviation had been performed. Photo shows pit is ~20 inches deep. A compaction zone had been identified beginning ~3-4 inches deep sub-surface.

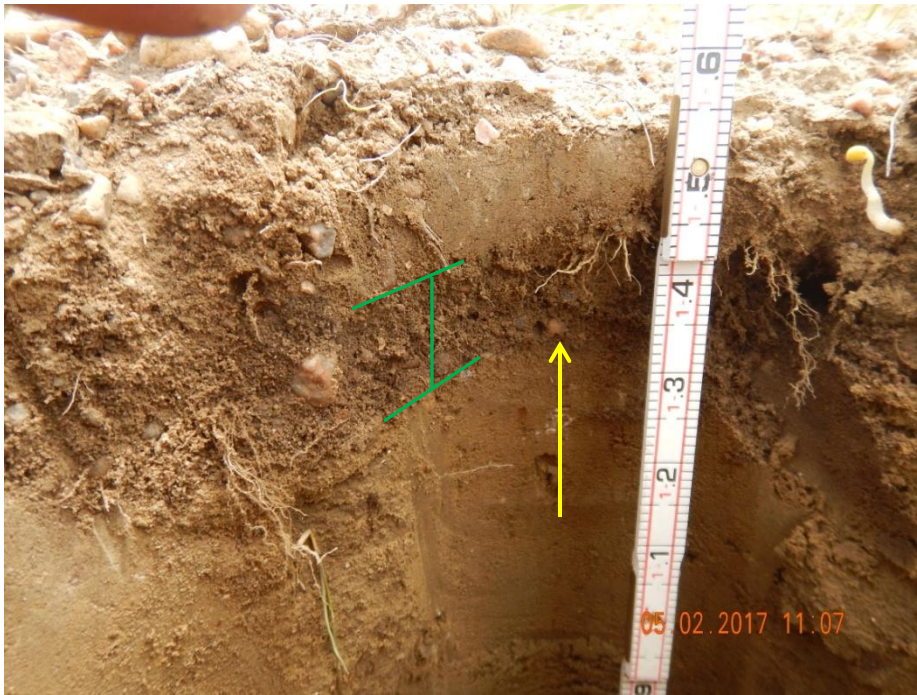
**Photo 7:** Photo shows test pit dug by reclamation specialist to determine if compaction alleviation had been performed. Photo shows a compaction zone beginning ~3-4 inches deep sub-surface (yellow arrow). Green line shows layer of subsoil where compaction has hindered water infiltration and root penetration by vegetation that had been previously established; very little organic matter (root development, etc...) was evident below area of compaction.

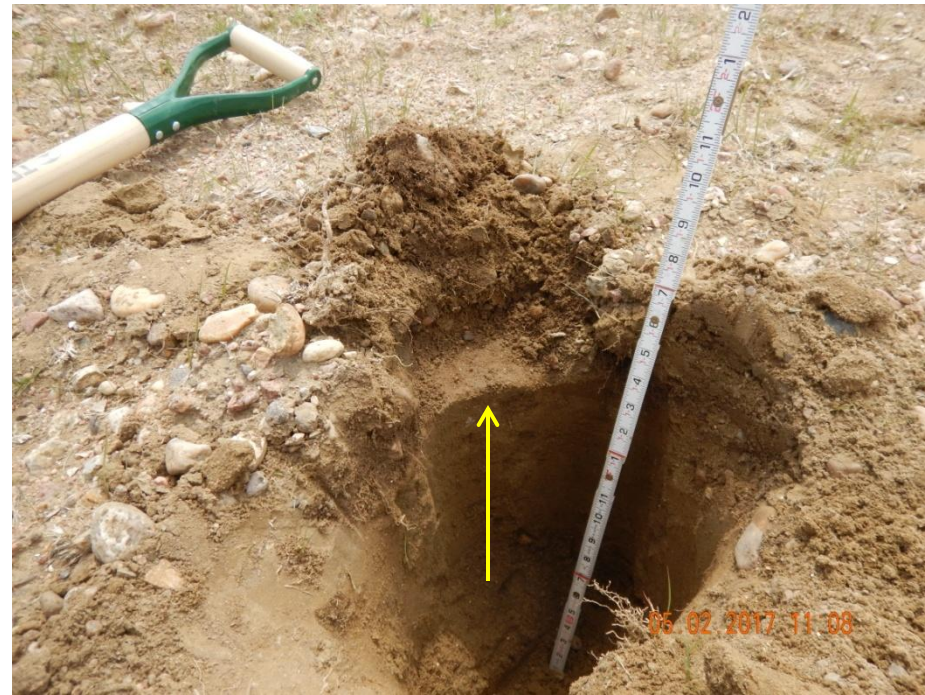
**Photo 8:** Photo shows test pit dug by reclamation specialist to determine if compaction alleviation had been performed. Photo shows a compaction zone beginning ~3-4 inches deep sub-surface (yellow arrow). The top 4 inches of soil was easily lifted off to reveal a "bench" at where compaction zone begins. Re-contour work may have been attempted followed by a seeding, however, this photo shows compaction alleviation had not been performed.

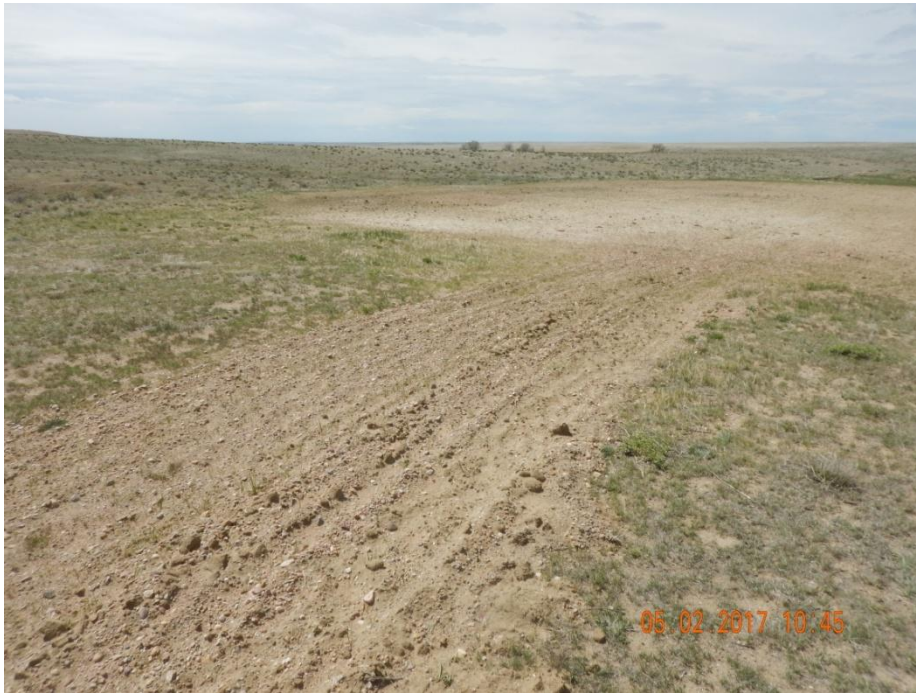
**Photo 9:** Photo taken from the north end of the location, facing southeast. Photo shows pad location. A test pit was dug by reclamation specialist on the pad to determine if compaction alleviation had been performed. Reclamation specialist was unable to find any major layers of compaction.

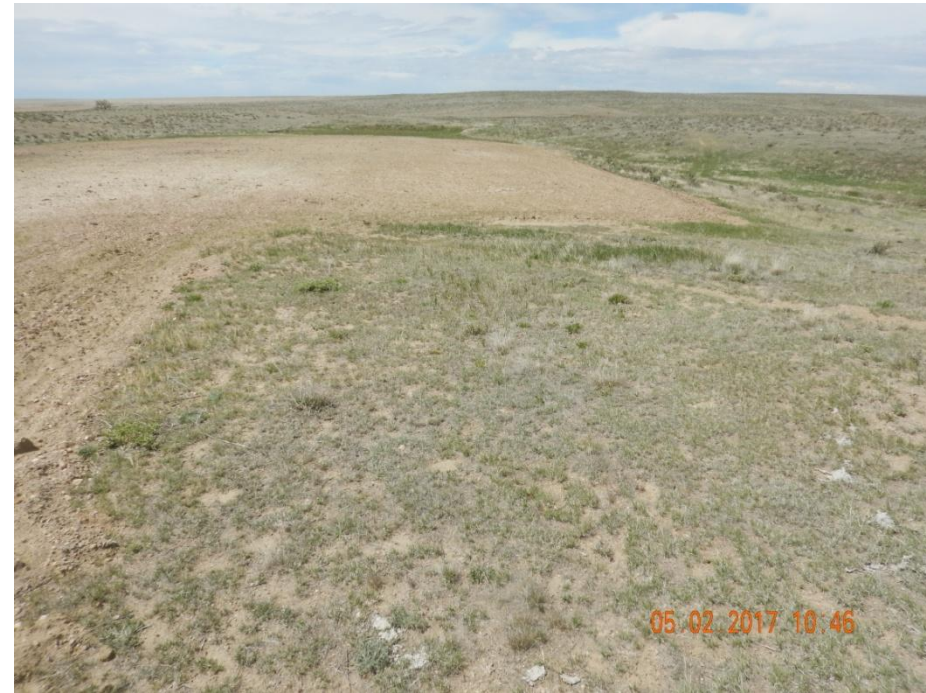
**Photo 10:** Photo taken from the north end of the location, facing southwest. Photo shows pad location. A test pit was dug by reclamation specialist on the pad to determine if compaction alleviation had been performed. Reclamation specialist was unable to find any major layers of compaction.

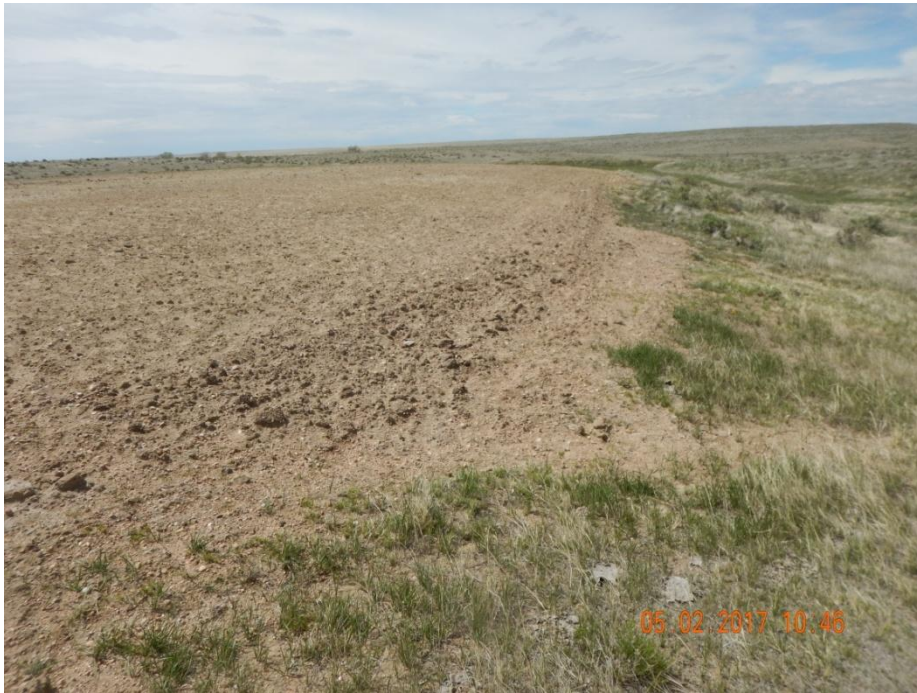
**Photo 11:** Photo taken from the northwest corner of the pad, facing south. Photo shows areas of the pad that previous inspections had identified erosion concerns. Photo shows erosion has been repaired, however, it does not appear that BMPs have been implemented per the CA. Area appears to be stabilized at time of inspection; continue to perform stormwater management and maintenance until final reclamation passes.

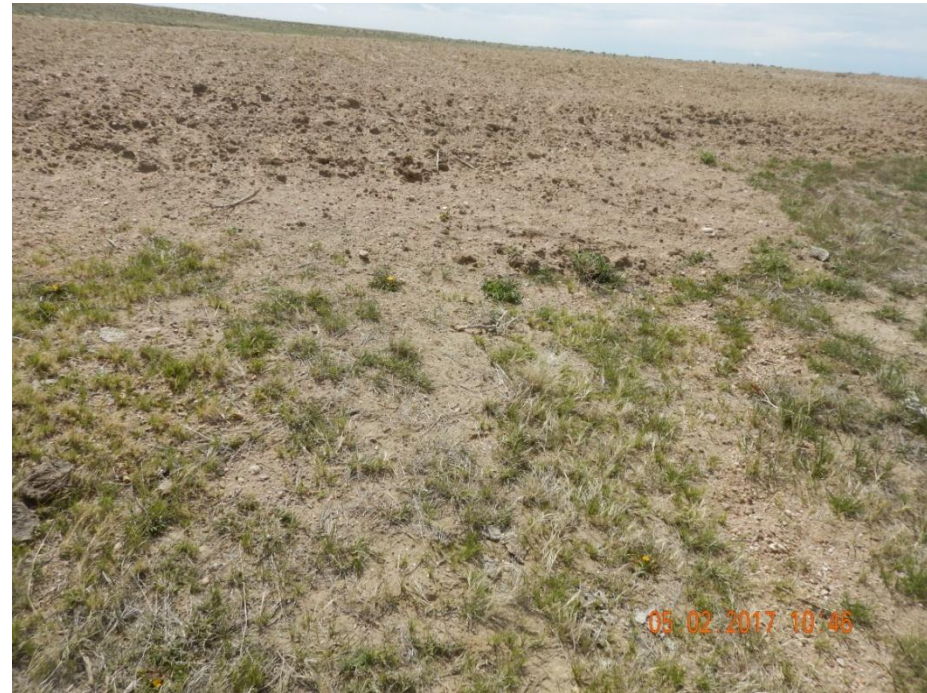
**Photo 12:** Photo taken from the northwest corner of the pad, facing southeast. Photo shows areas of the pad that previous inspections had identified erosion concerns. Photo shows erosion has been repaired, however, it does not appear that BMPs have been implemented per the CA. Area appears to be stabilized at time of inspection; continue to perform stormwater management and maintenance until final reclamation passes.

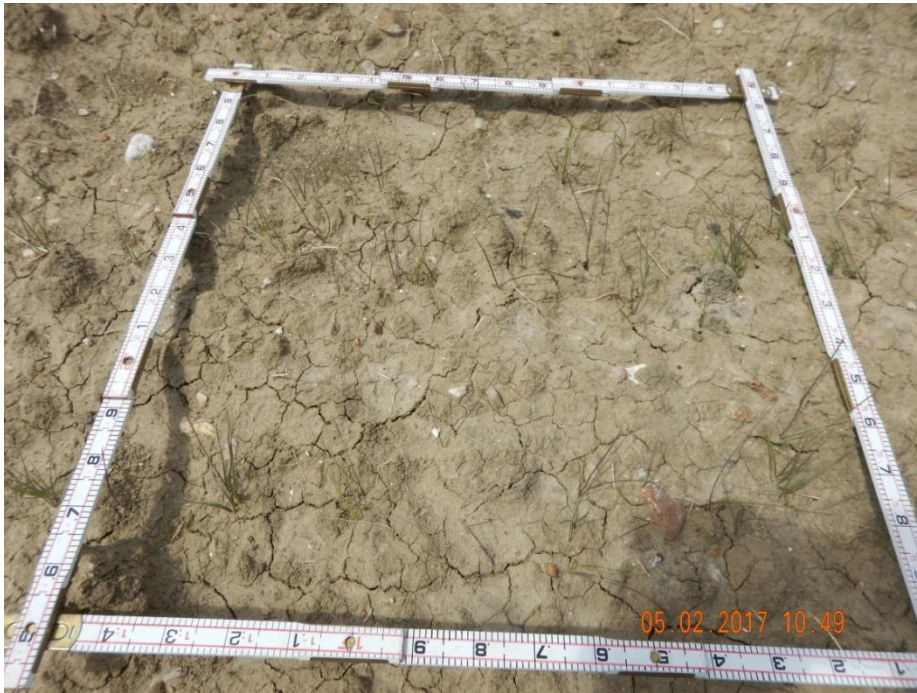
**Photo 13:** Photo taken from the north end of the location. Photo shows germination evident likely from reclamation re-seeding activities. Quadrat is ~1.5 feet x 1.5 feet.

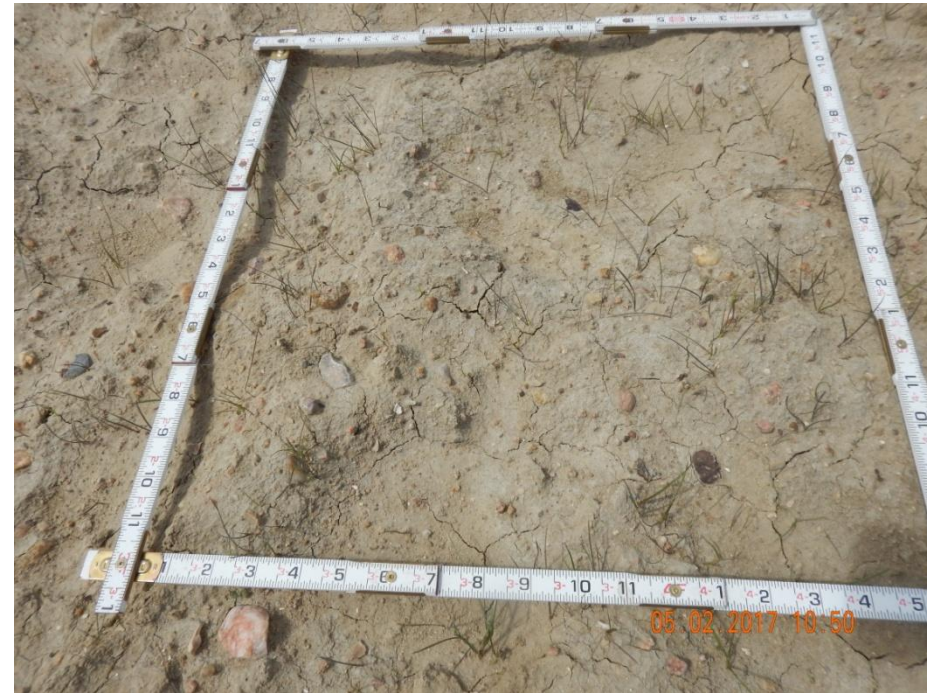
**Photo 14:** Photo taken from the center of the location. Photo shows germination evident likely from reclamation re-seeding activities. Quadrat is ~1.5 feet x 1.5 feet.

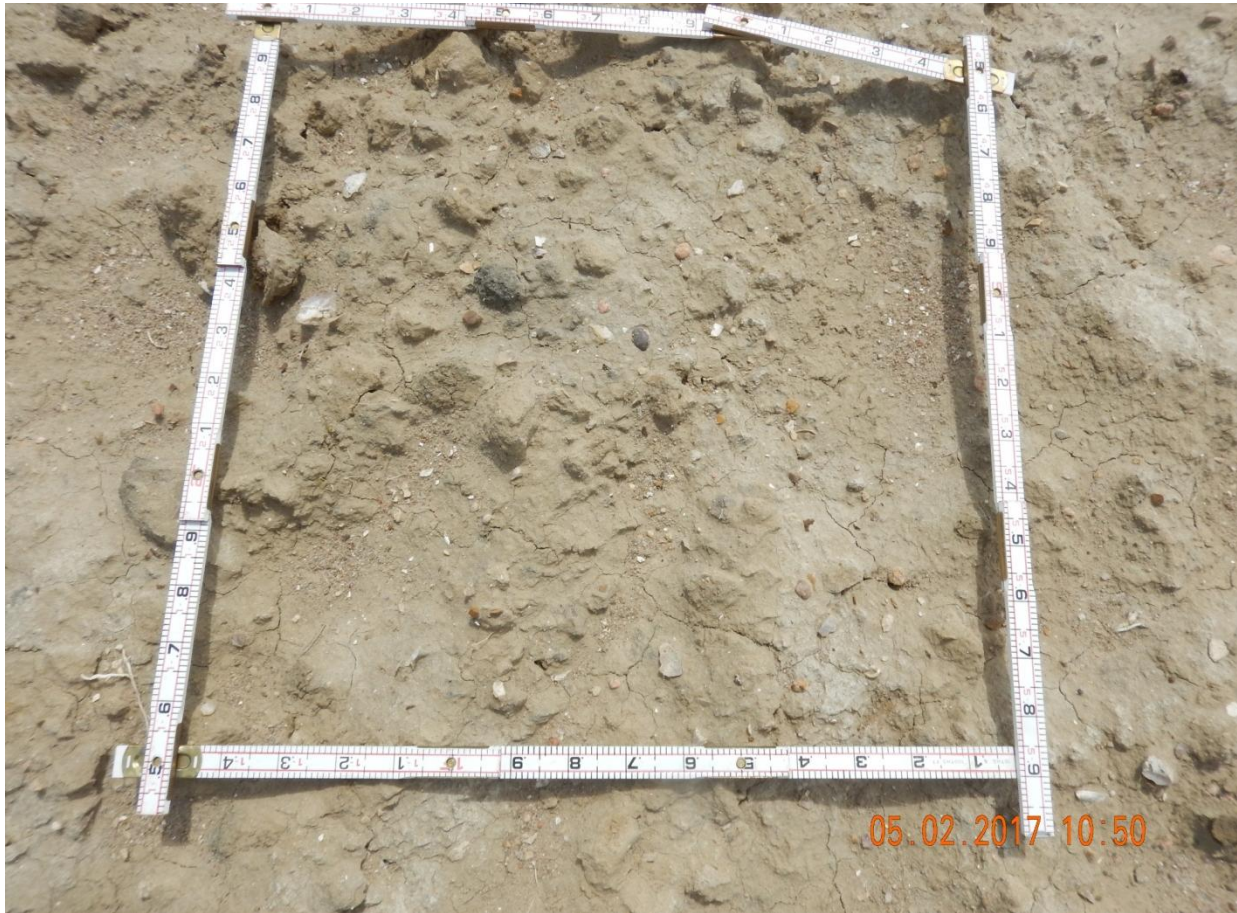
**Photo 15:** Photo taken from the southwest end of the location. Photo shows area of the location where vegetative germination is not evident. Continue to monitor this portion of the location and reseed if reclamation does not progress. . Quadrat is ~1.5 feet x 1.5 feet.
