# Stormwater Inspection

May 5, 2017

Operator: HIGHLANDS NATURAL RESOURCES CORPORATION- #10625

Location ID: 449920

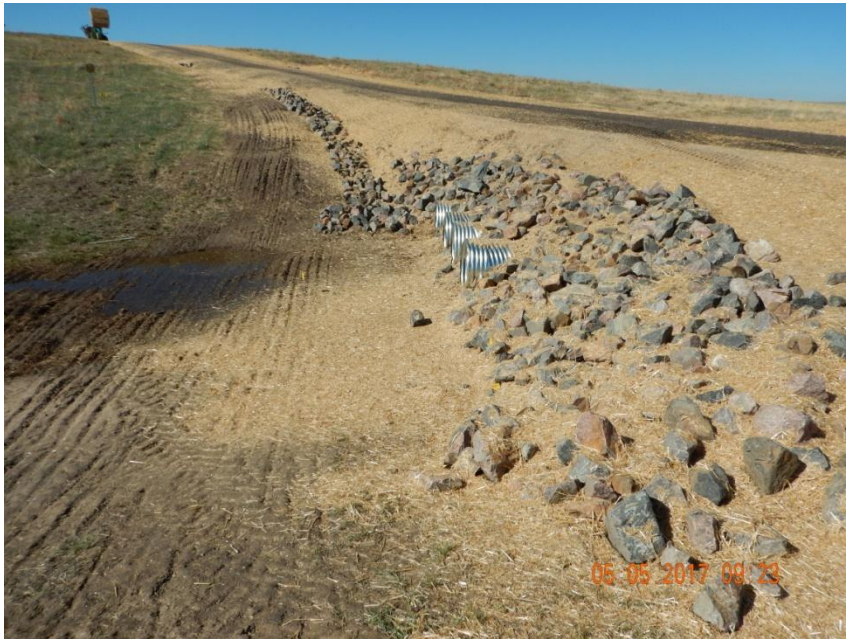
**Photo 1.** Photo taken along a drainage area on the east side, facing South. Rip rap has been installed around the fill slopes of the culverts; rip rap has been installed along the ditch area leading to the drainage area; road ditch areas have been seeded and mulching IN-PROCESS.

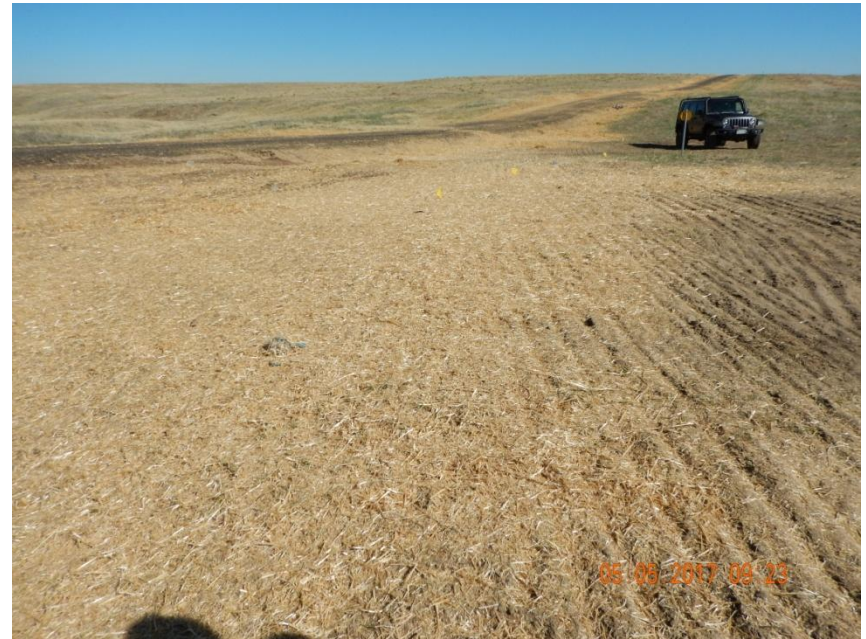
**Photo 2.** Photo taken from the previous photo location, facing North. All disturbance areas will be seeded, straw mulched and crimped.

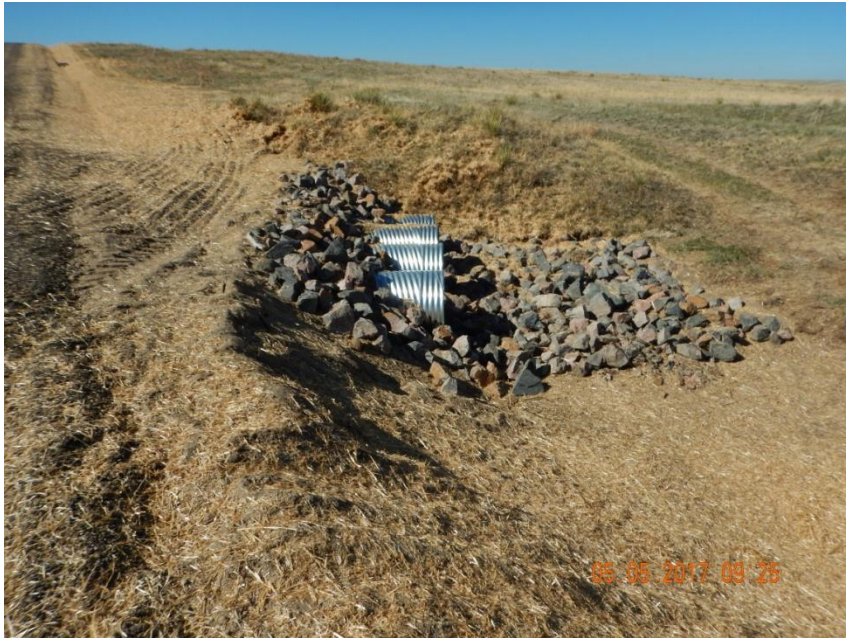
**Photo 3.** Photo taken along a drainage area on the west side, facing South. Rip rap has been installed around the fill slopes of the culverts; rip rap has been installed along the outlet area; road ditch areas have been seeded and mulching IN-PROCESS.

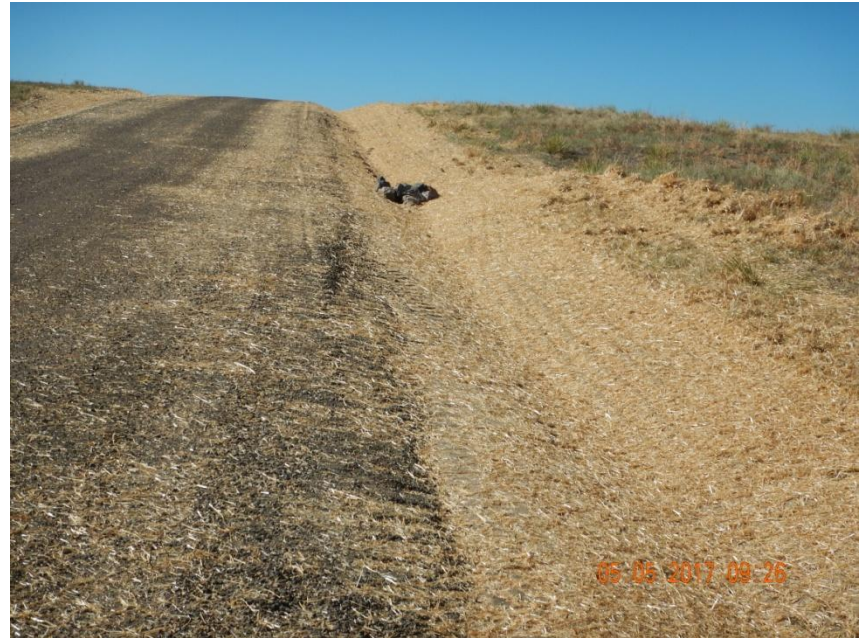
**Photo 4.** Photo taken from the approximate previous photo location, facing South. All disturbance areas will be seeded, straw mulched and crimped. Check dam material has been placed along portions of the ditch and will be installed so that it is not just a pile of rocks.

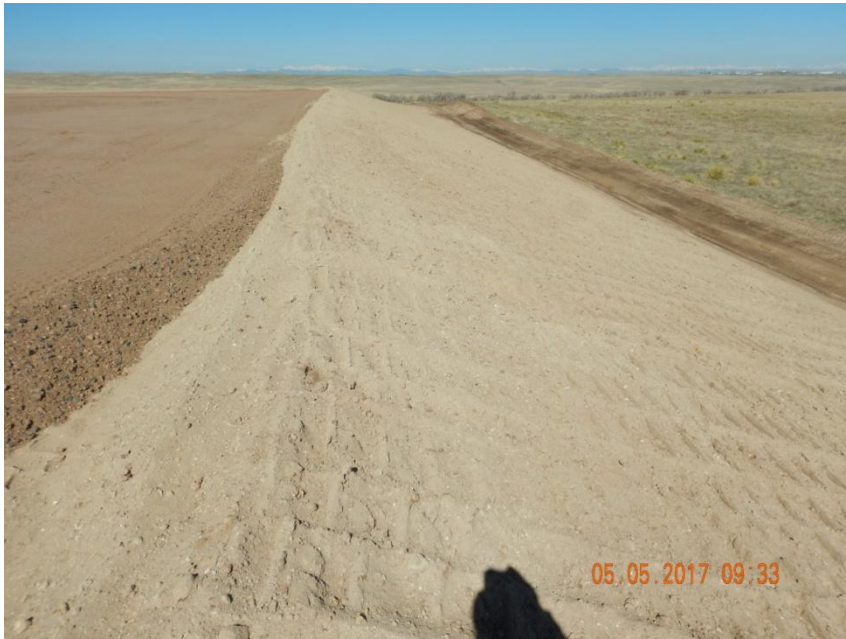
**Photo 5.** Photo taken from the northern fill slope, facing West. Photo illustrates tracking with equipment up and down the slope to reduce runoff erosion potential.

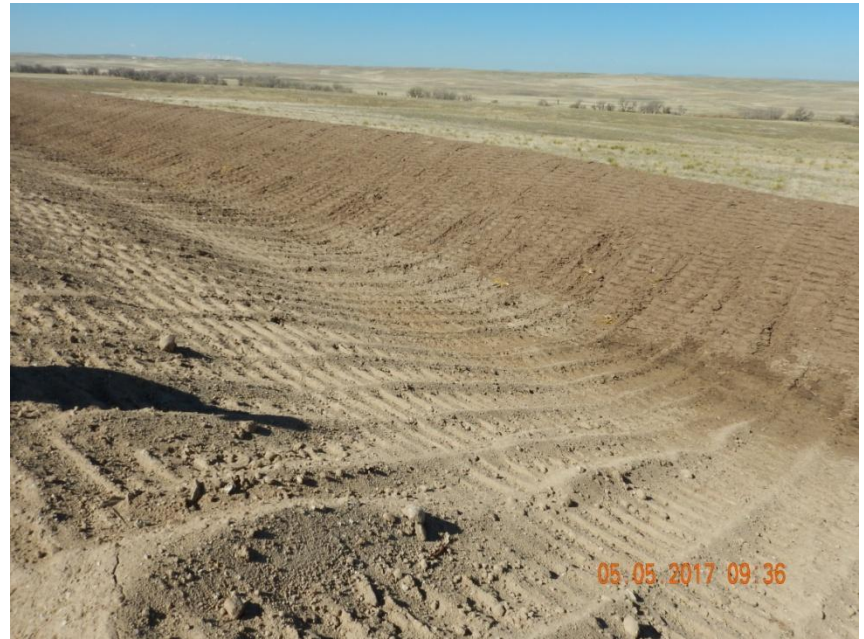
**Photo 6.** Photo taken from the western fill slope and topsoil stockpile, facing Southwest. Photo illustrates tracking with equipment up and down the slope to reduce runoff erosion potential.

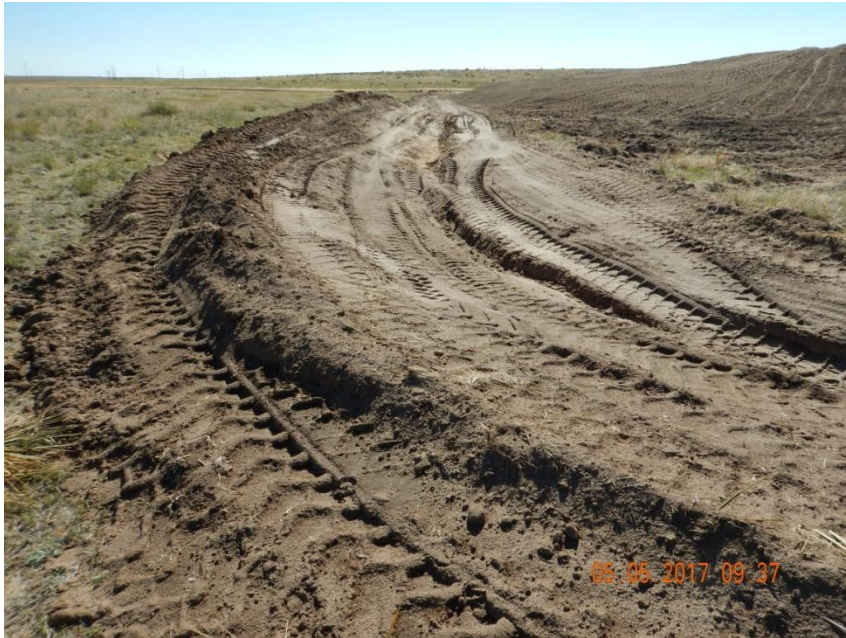
**Photo 7.** Photo taken from the northwest location, facing East. Berm BMP material does not appear to be sufficiently compacted to ensure unconsolidated soil material does not discharge from location.

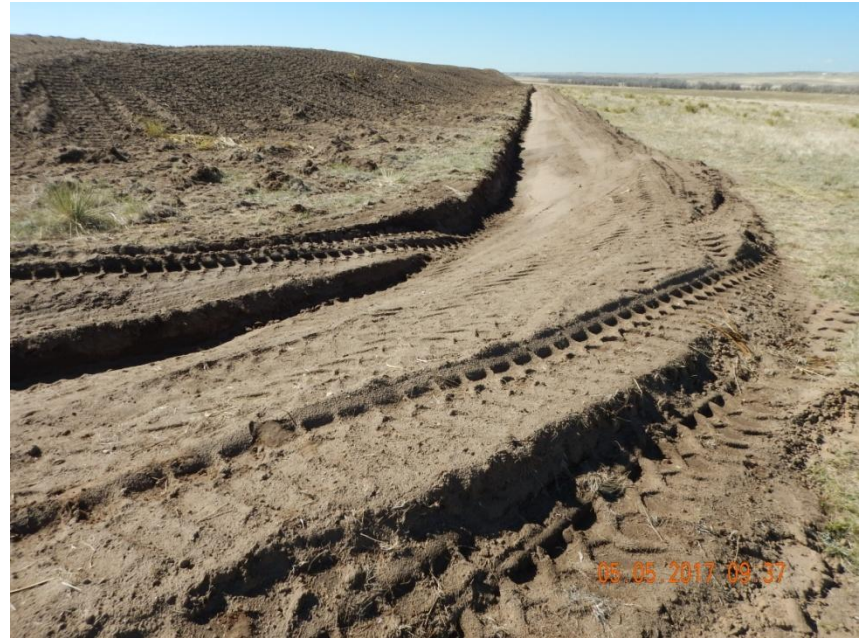
**Photo 8.** Photo taken from the northwest location, facing South. Berm BMP material does not appear to be sufficiently compacted to ensure unconsolidated soil material does not discharge from location.

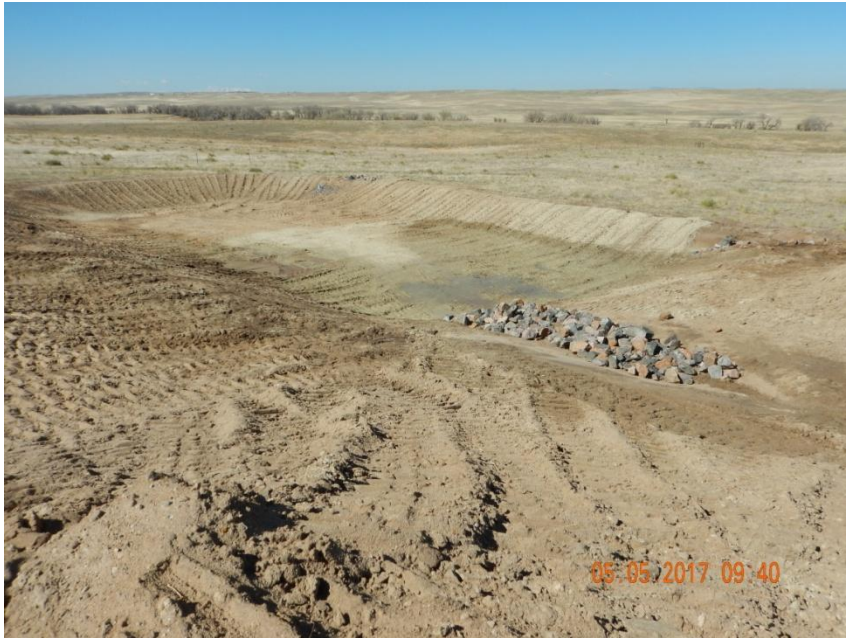
**Photo 9.** Photo taken from the southwest perimeter of the location, facing Southwest. A sediment basin has been installed in conjunction with inlet and outlet protection devices.

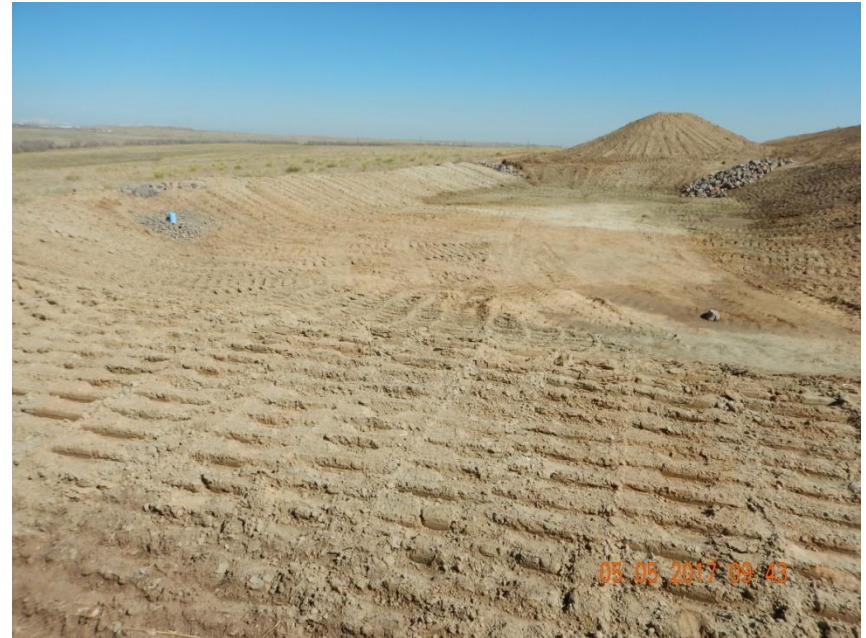
**Photo 10.** Photo taken from the southern sediment basin, facing North. All slopes have been tracked up and down to reduce runoff erosion potential.

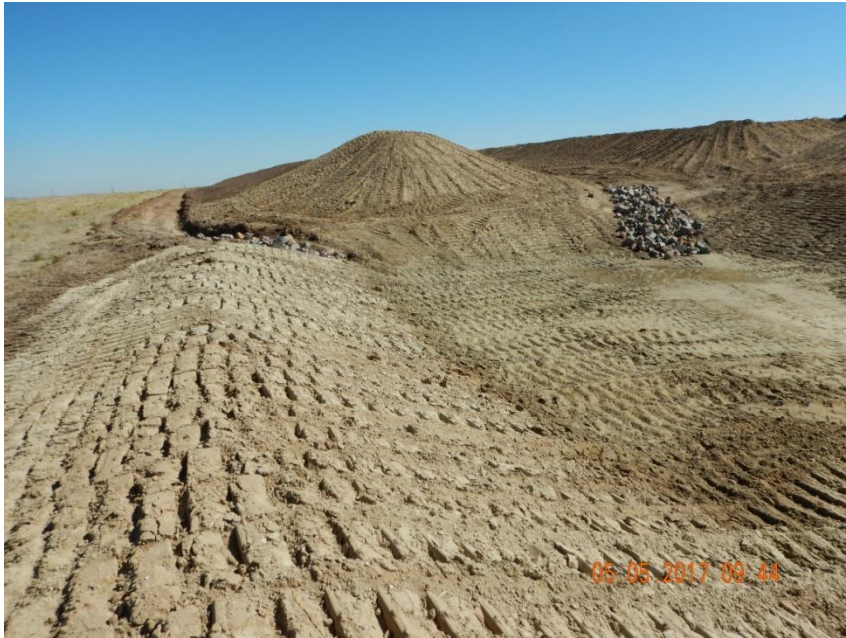
**Photo 11.** Photo taken from the western sediment basin, facing North. All slopes have been tracked up and down to reduce runoff erosion potential. Photo illustrates inlet protection to the sediment basin.

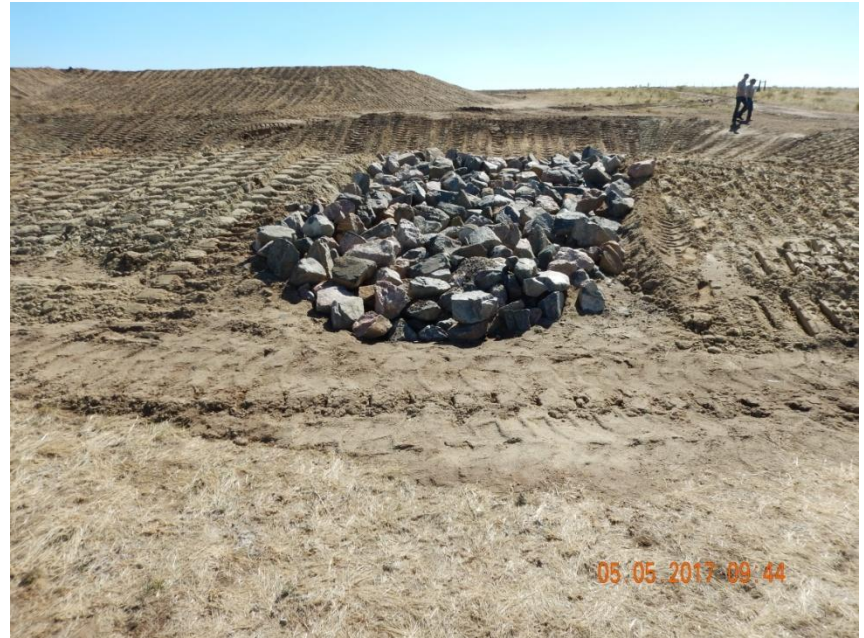
**Photo 12.** Photo taken from the western sediment basin, facing South. Photo illustrates outlet protection for the sediment basin.
