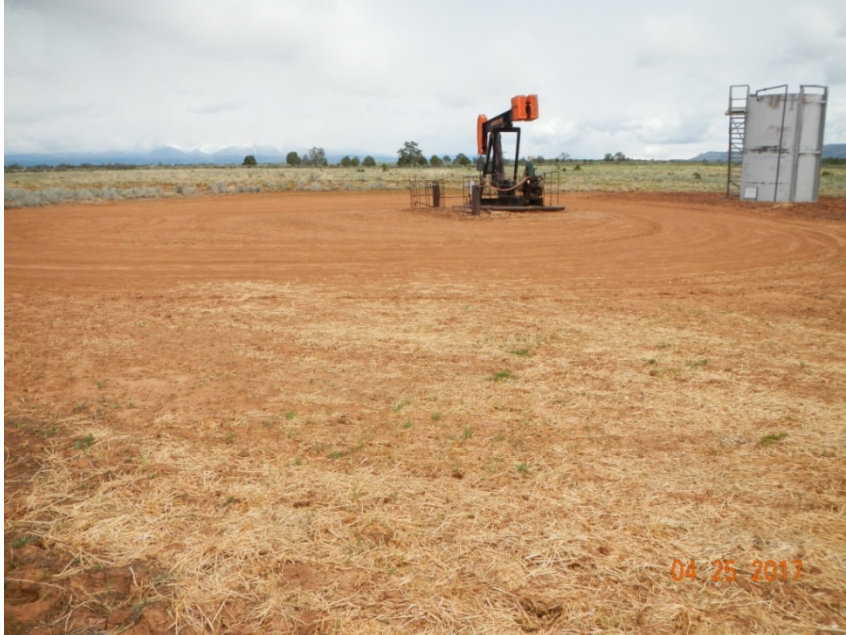
Photo 1: View of the project area from the southwestern corner facing center.

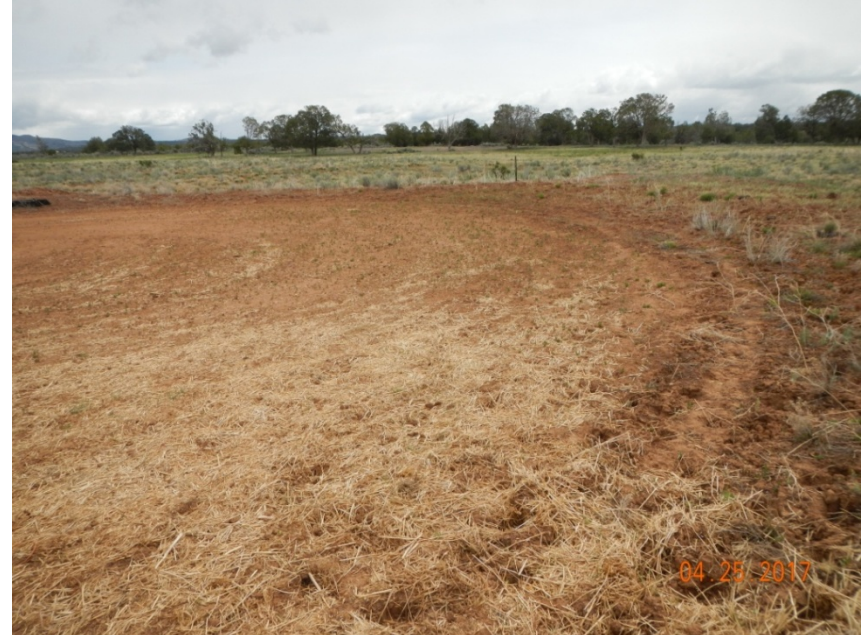
Photo 2: View of the southern portion of the project area from the southwestern corner facing eastward. It appears southern area was recently seeded and mulched. Some germination was observed.

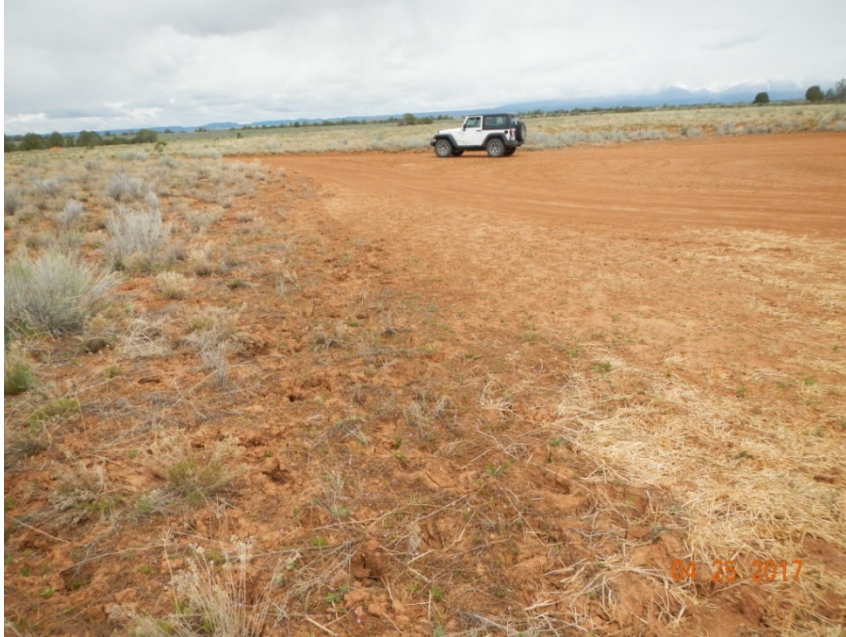
Photo 3: View of the western portion of the project area from the southwestern corner facing northward.

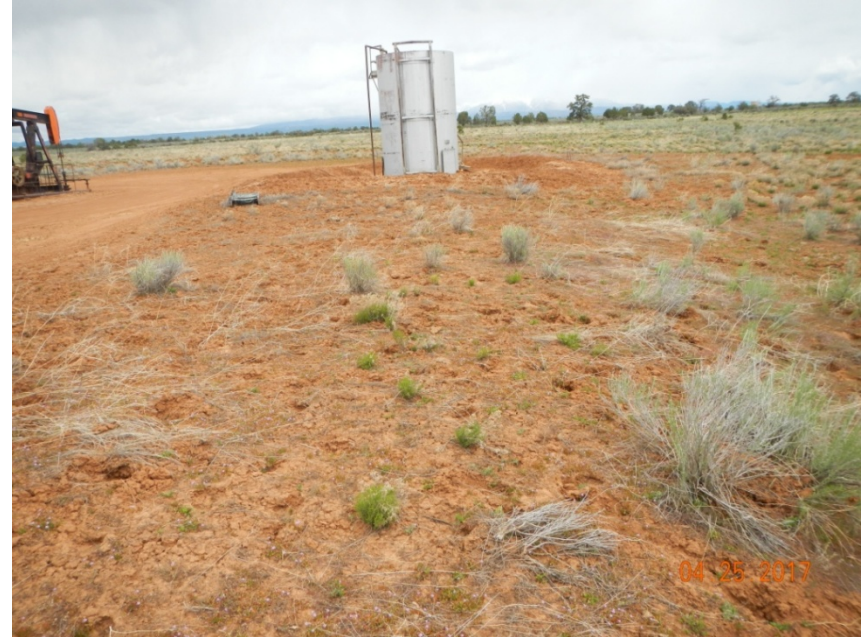
Photo 4: View of the eastern portion of the project area from the southeastern corner facing northward. Two unused ladders are present around the tanks.
