Construction and Stormwater Inspection

May 5, 2017

Operator: BURLINGTON RESOURCES OIL & GAS LP- #26580

Inspection Photos
Location Name: Prosper Farms 4-65 2-1 /4AH
Location ID: 443722

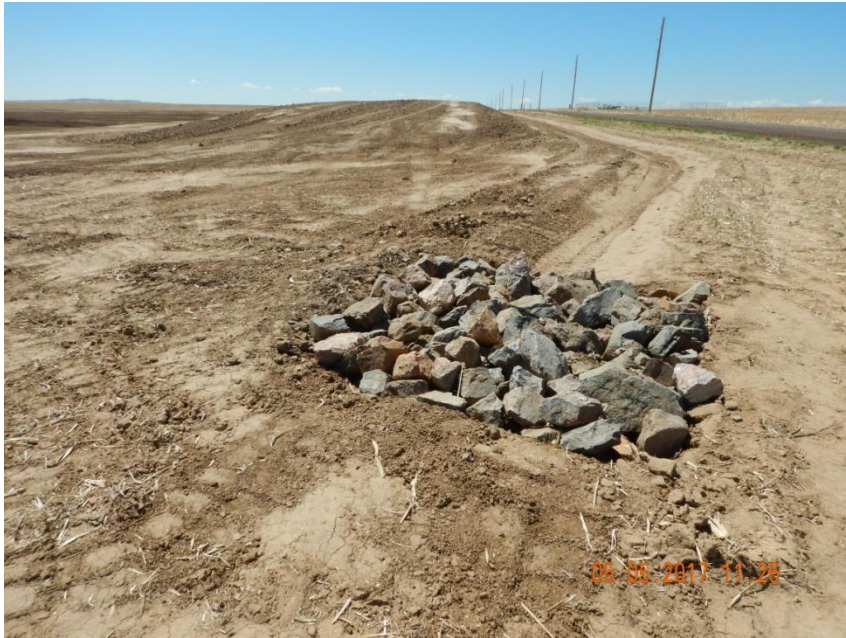
Photo 1. Photo taken north of the topsoil stockpile, facing South. A ditch and berm BMP has been installed around the western location of the stockpile which is directed to a stabilized pit. Per conversations with the Operator, this will be directed to the sediment basin upon completion of the location.

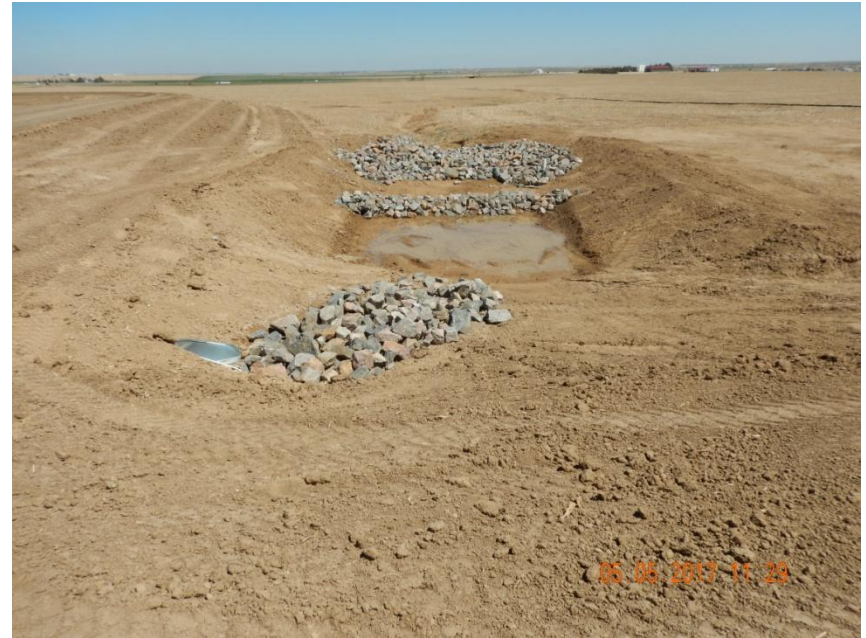
Photo 2. Photo taken from the northeastern location, facing North. Sediment basin has been installed with both inlet and outlet protection devices.

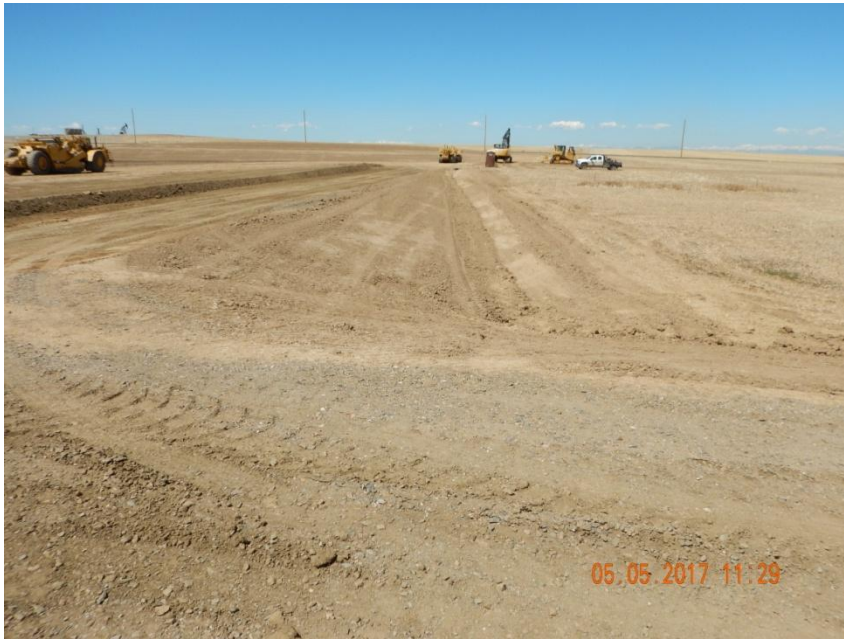
Photo 3. Photo taken from the previous photo location, facing West. A ditch and berm BMP has been installed around the perimeter of the location where stormwater runoff is directed through a culvert to the sediment basin.

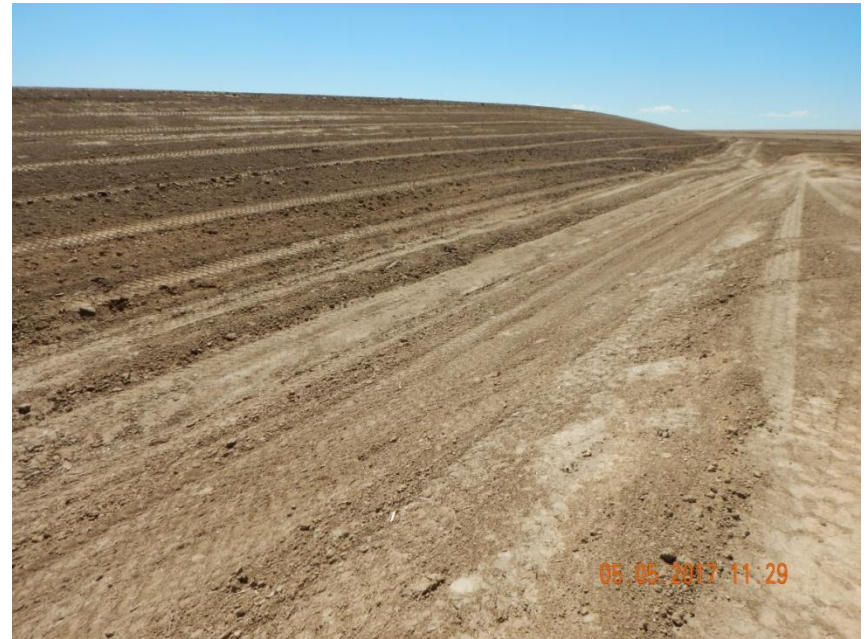
Photo 4. Photo taken from the eastern perimeter of the location, facing Southeast. A spoil stockpile has been stored along the eastern perimeter of the location. Per conversations with the Operator, all stockpiles will be seeded, straw mulched and crimped upon completion of the location.

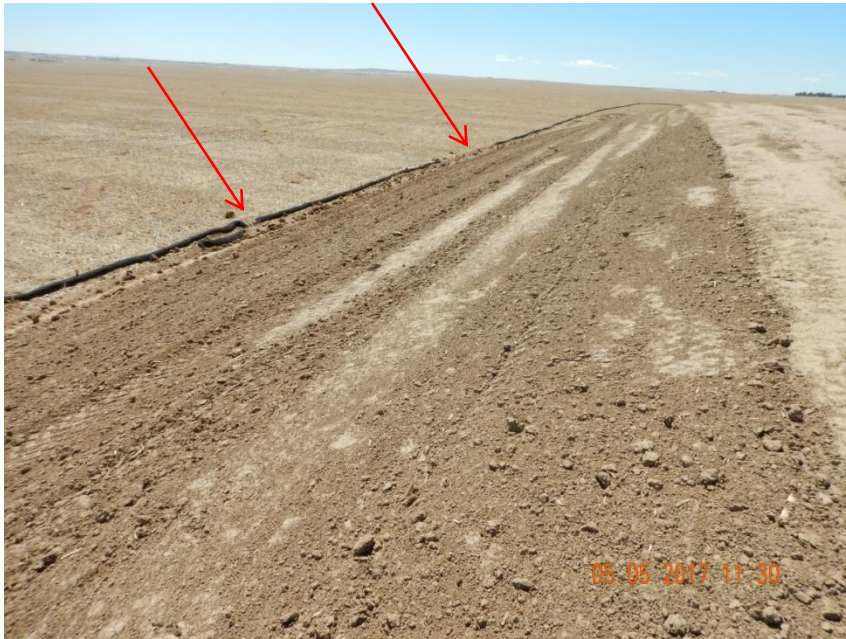
Photo 5. Photo taken from the top of the spoil stockpile, facing South. Filtrexx wattles have been installed around the outer perimeter of the stockpile. Portions of the filtrex are in need of repair/maintenance. Per conversations with the Operator, all stockpiles will be seeded, straw mulched and crimped upon completion of the location.

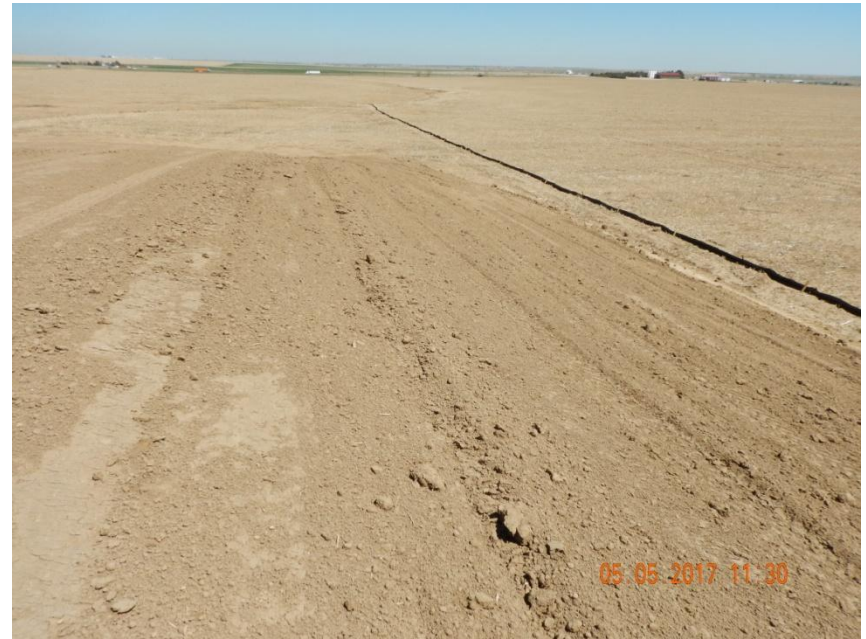
Photo 6. Photo taken from the top of the spoil stockpile, facing North. Filtrexx wattles have been installed around the outer perimeter of the stockpile and portions are in need of repair/maintenance. Per conversations with the Operator, all stockpiles will be seeded, straw mulched and crimped upon completion of the location.

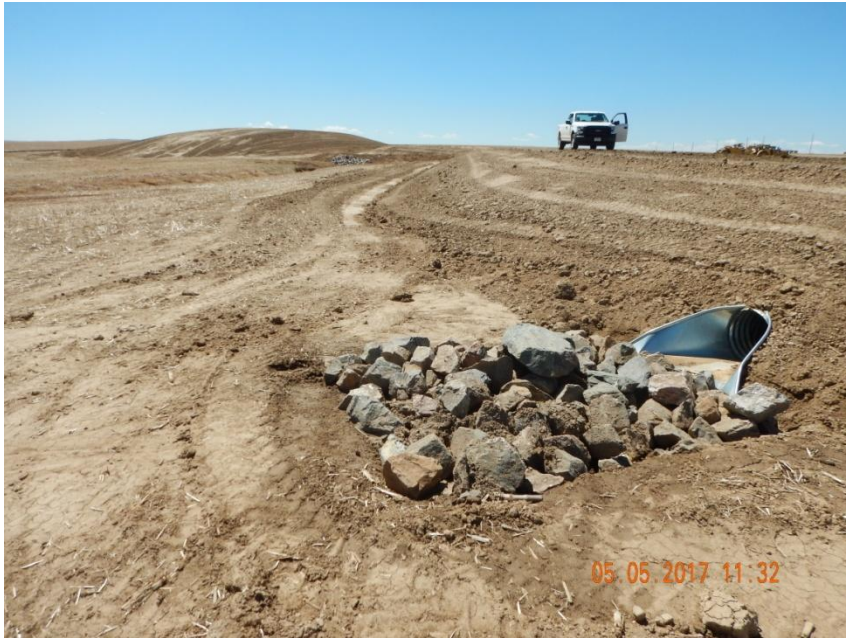
Photo 7. Photo taken from an outlet of a culvert along the east-facing side of the access road, facing South. A stabilized outlet has been installed in conjunction with the culvert.

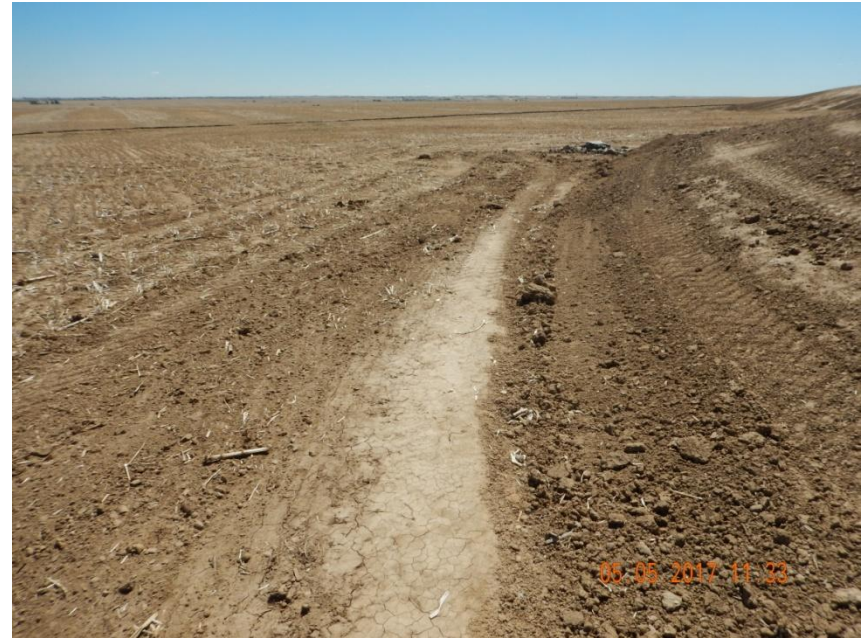
Photo 8. Photo taken along the north-facing side of the same access road in the previous photo, facing East. A shallow ditch has been constructed and appears to be directed to the stabilized outlet used for the culvert.

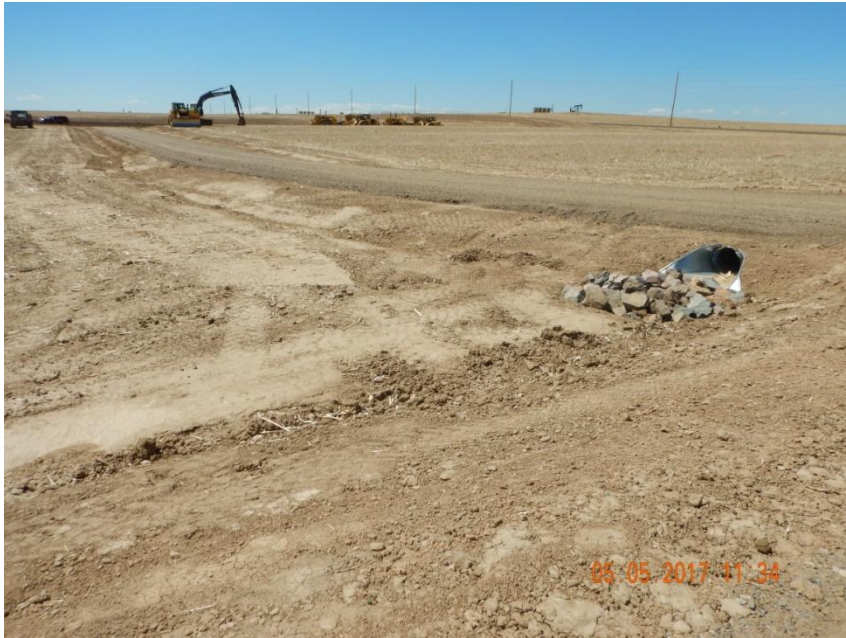
Photo 9. Photo taken from the western access road, facing South. A stabilized outlet has been installed in conjunction with the culvert.

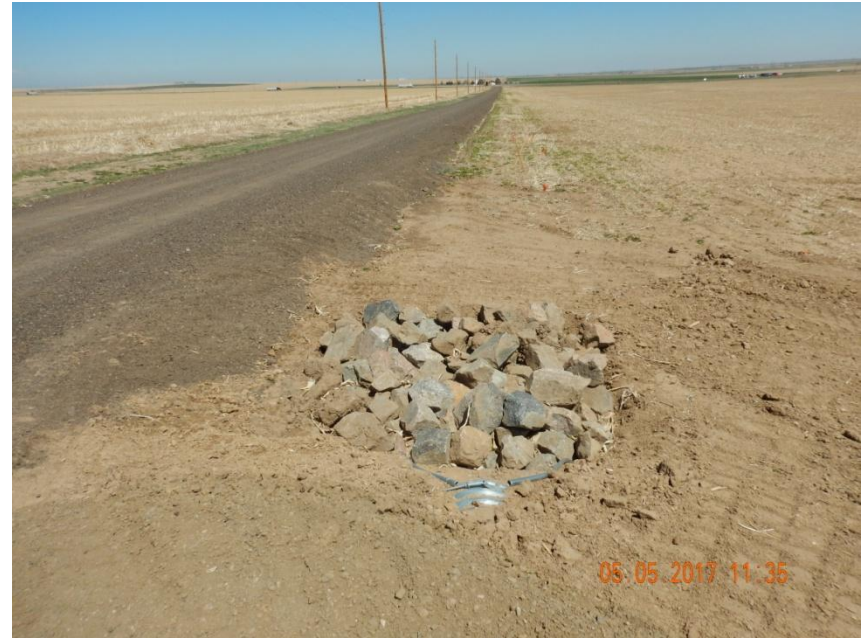
Photo 10. Photo taken from the entrance of location, facing North. A stabilized outlet has been installed in conjunction with the culvert.
