**Inspection Photos**  
**Location Name: Elkhorn Company B#6**  
**API: 05-123-09488**

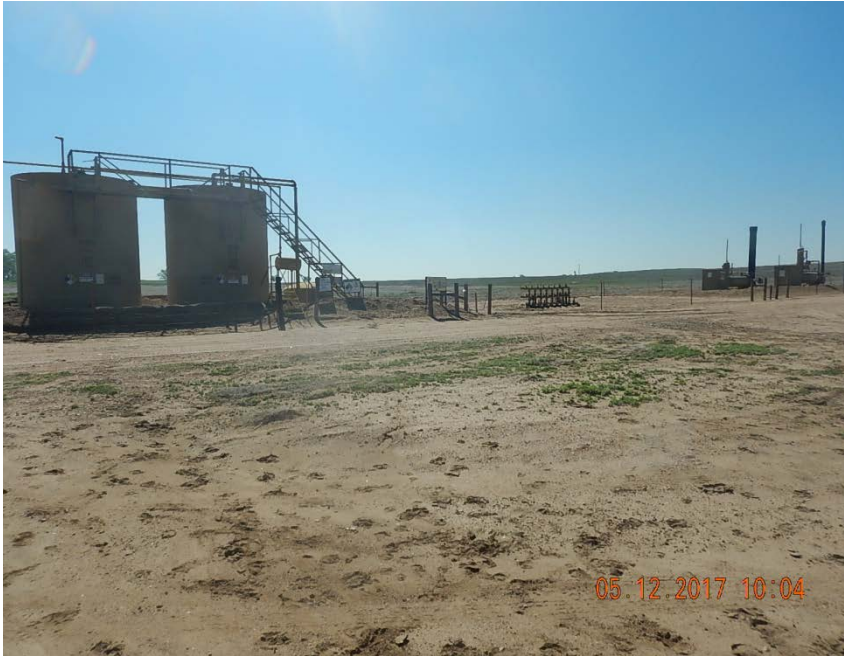
**Photo 1: Location, looking SE**

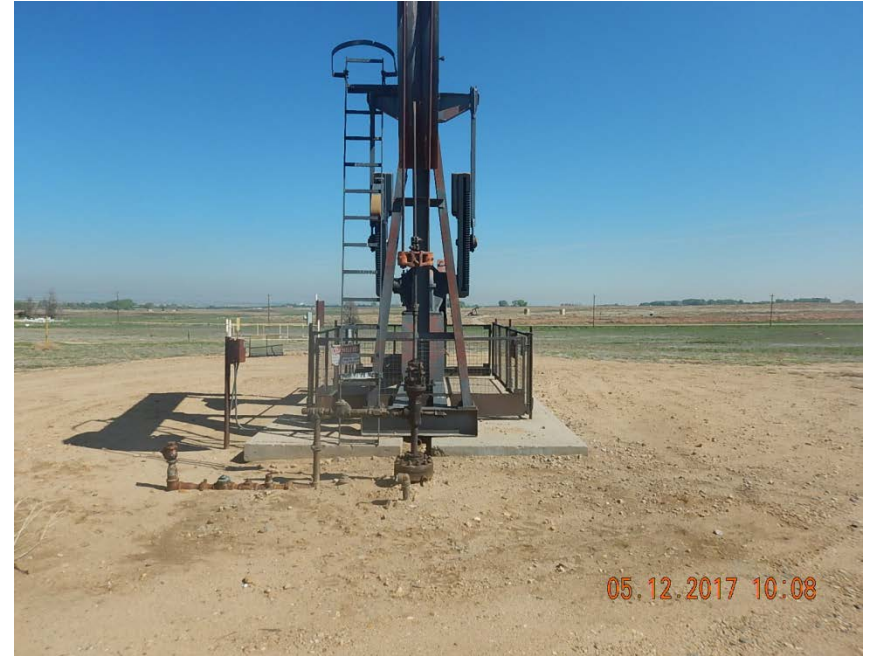
**Photo 2: Wellhead, looking N**

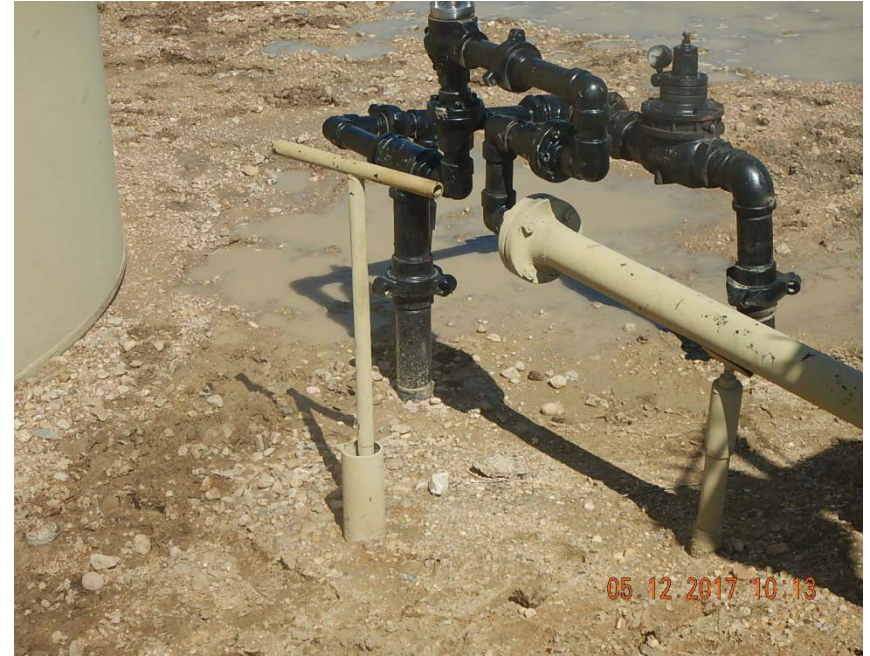
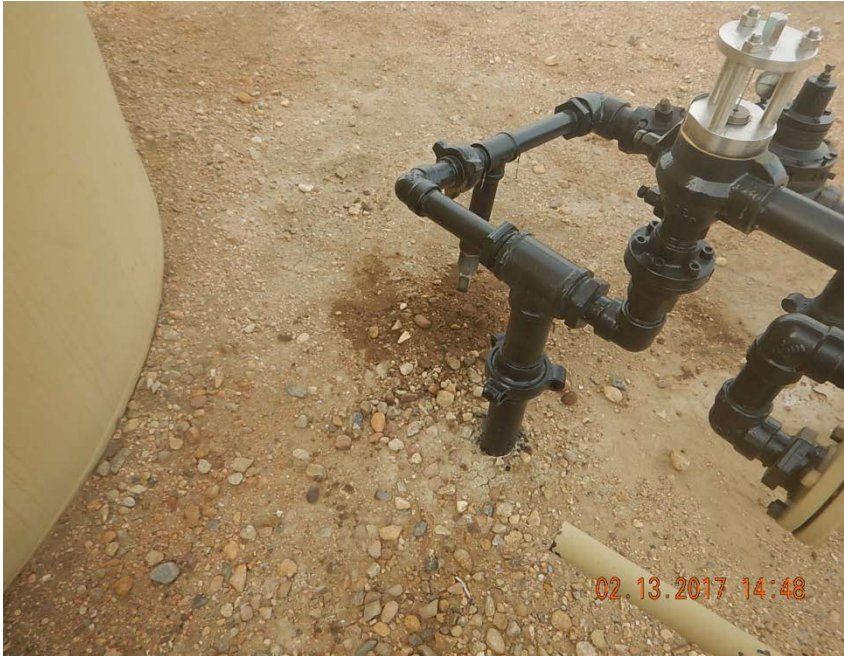
**Photo 3: Stained soil removed/remediated**

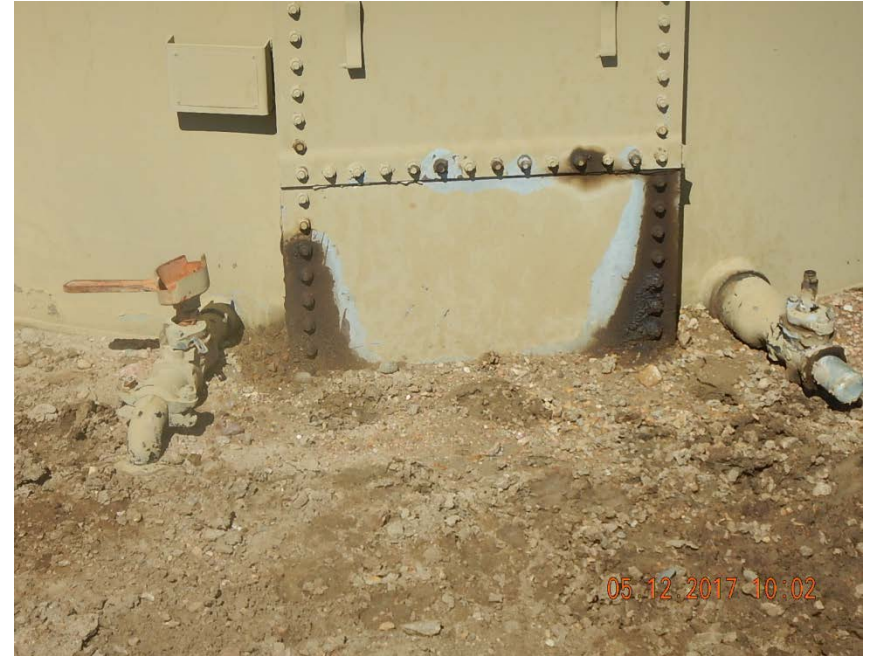
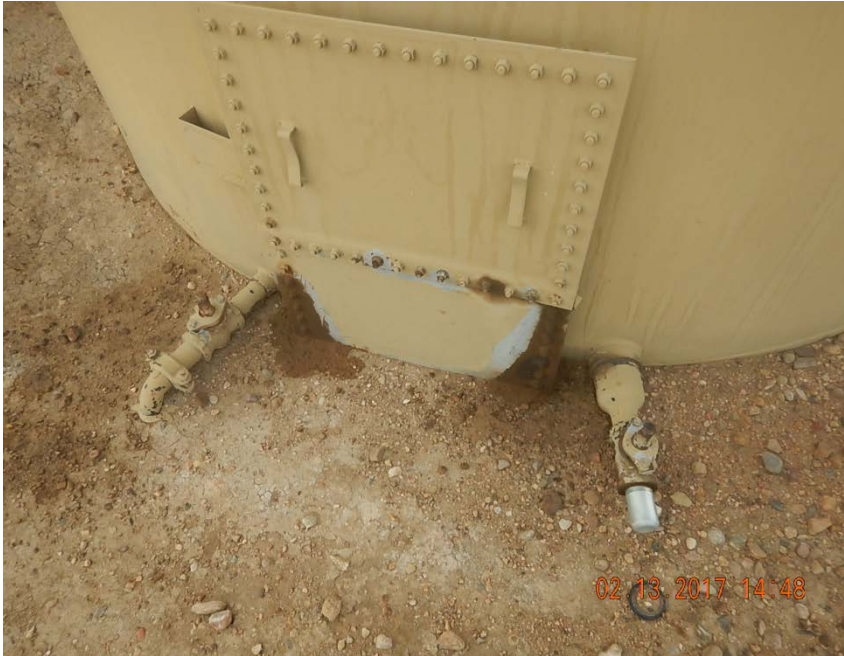
**Photo 4: Stained soil removed/remediated**

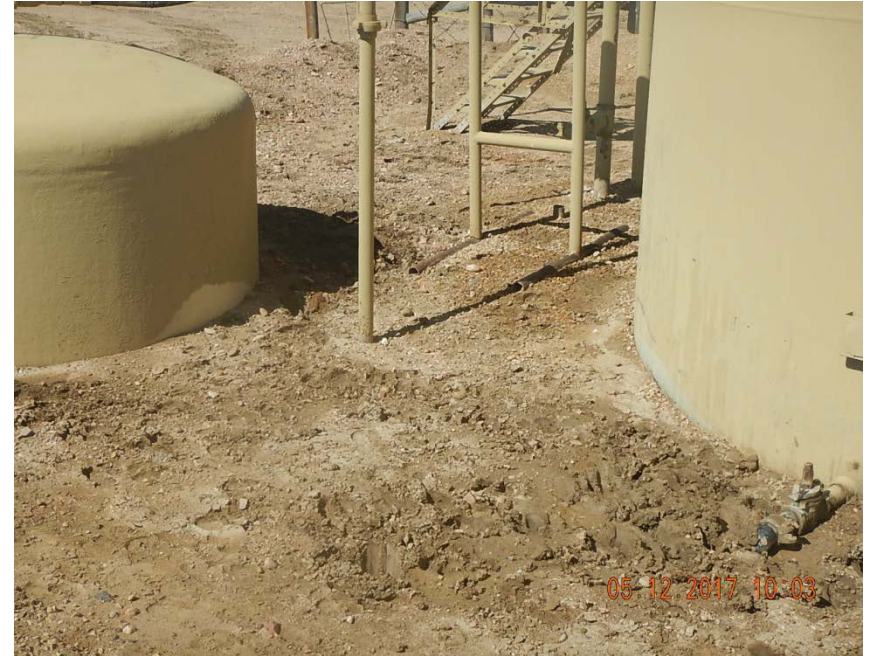
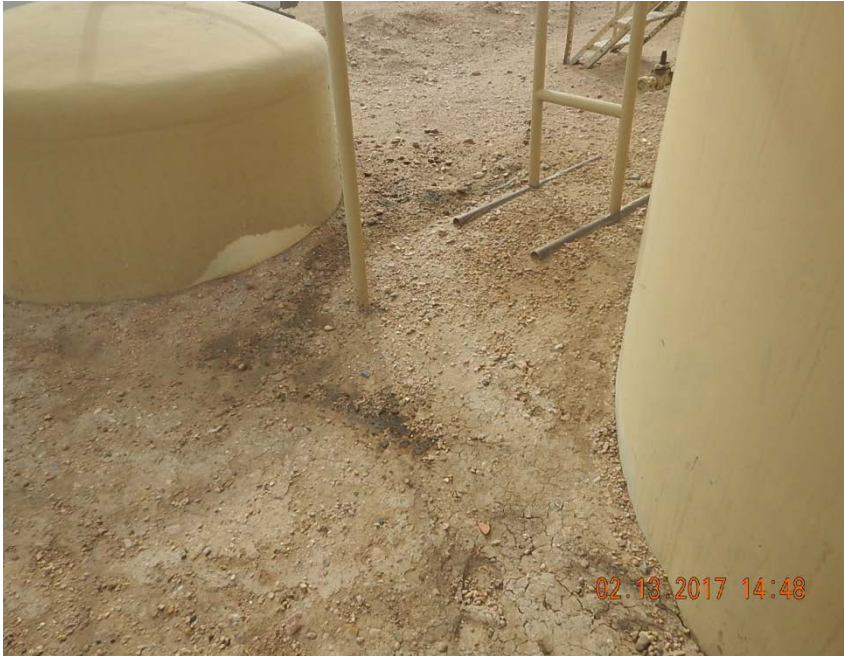
**Photo 5: Stained soil removed/remediated**

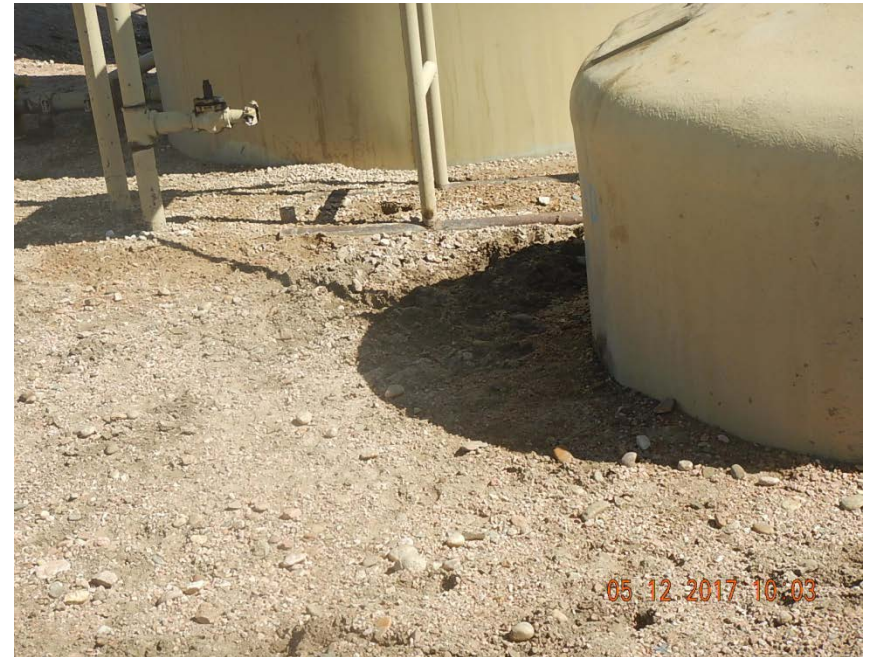
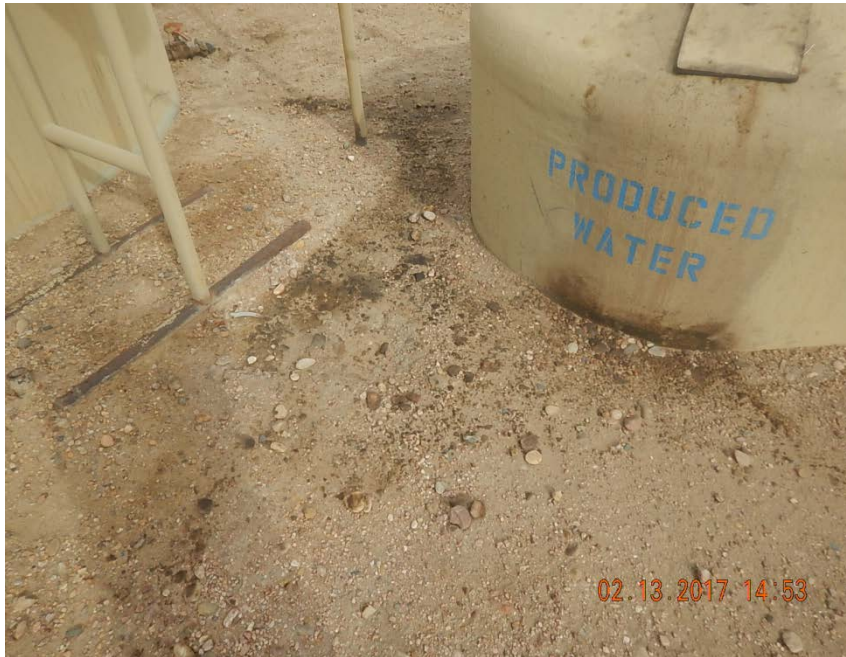
**Photo 6: Stained soil removed remediated**

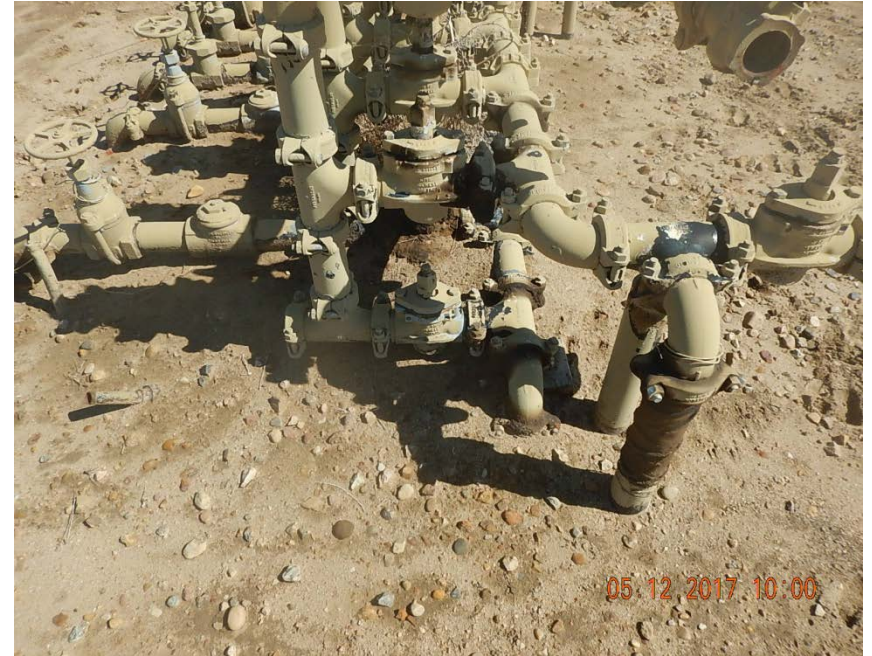
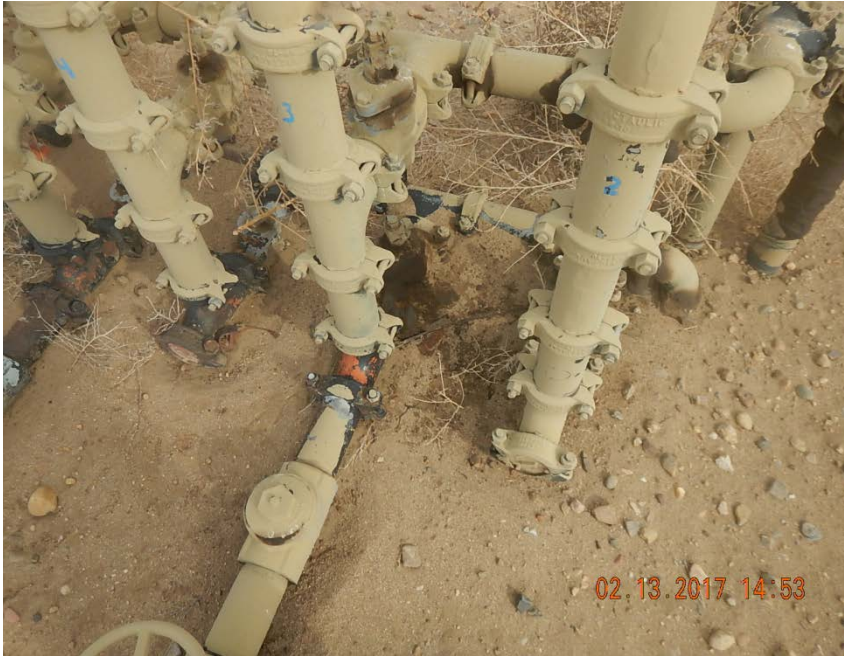
**Photo 7: Stained soil at manifold**

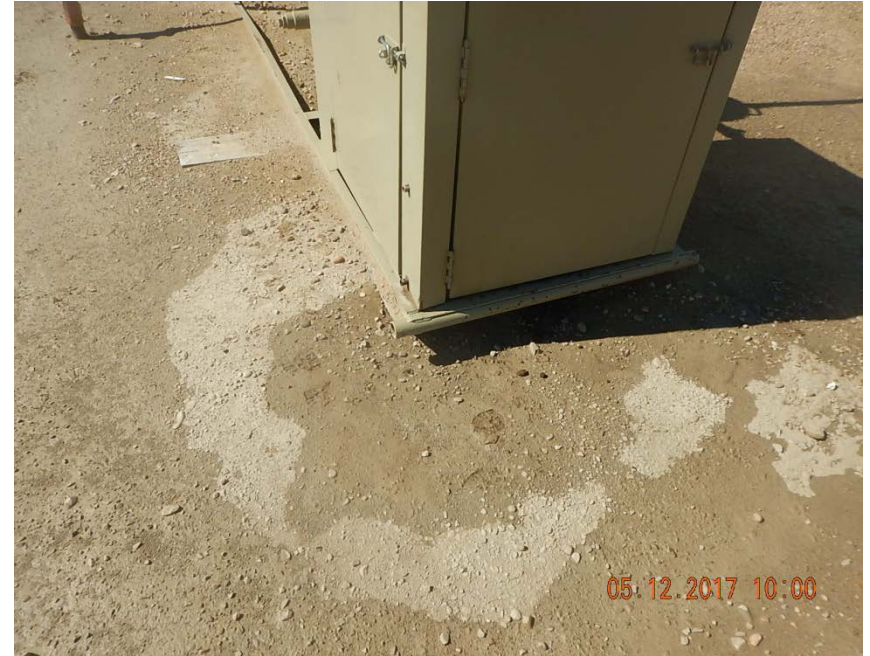
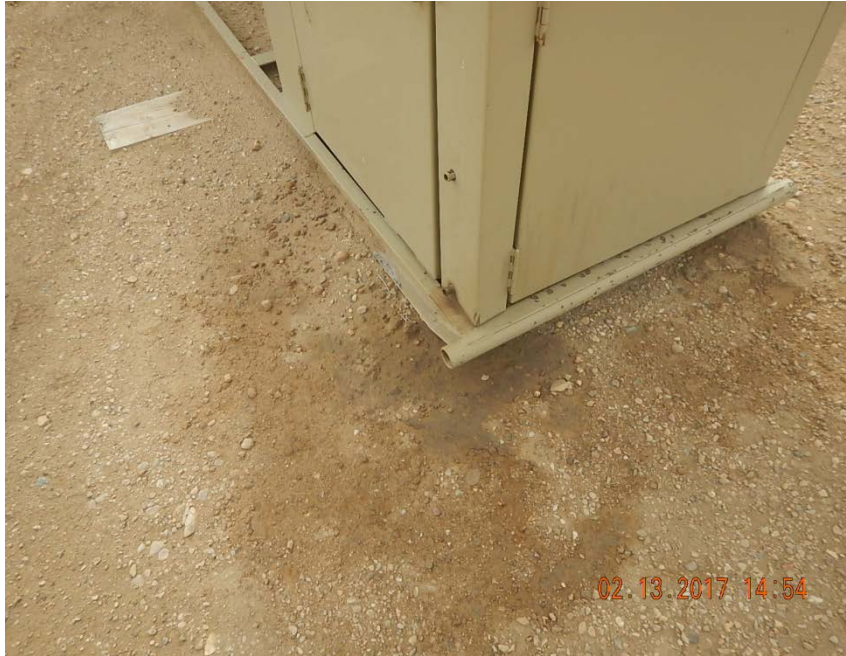
**Photo 8: Stained soil removed/remediated**

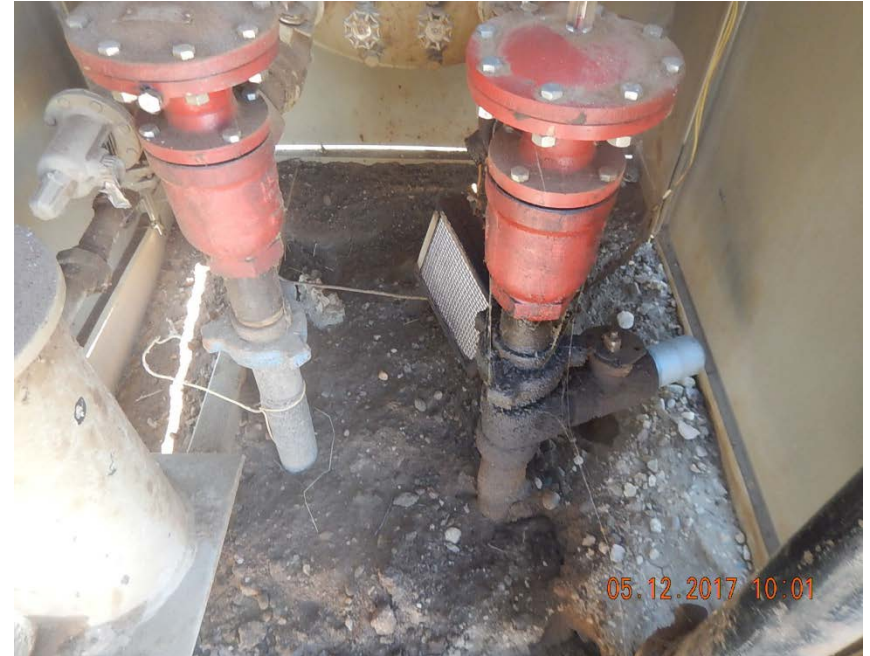
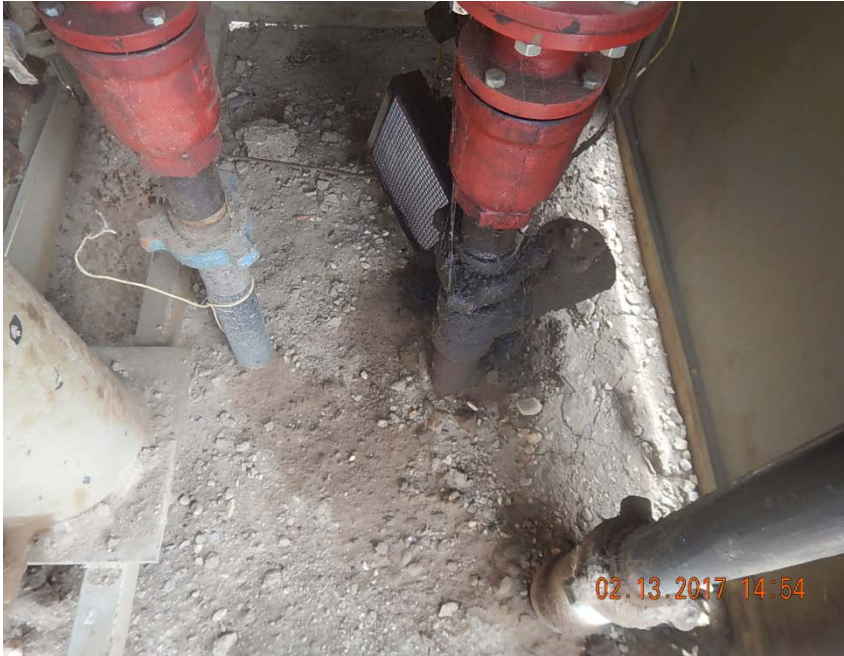
**Photo 9: Stained soil removed/remediated**

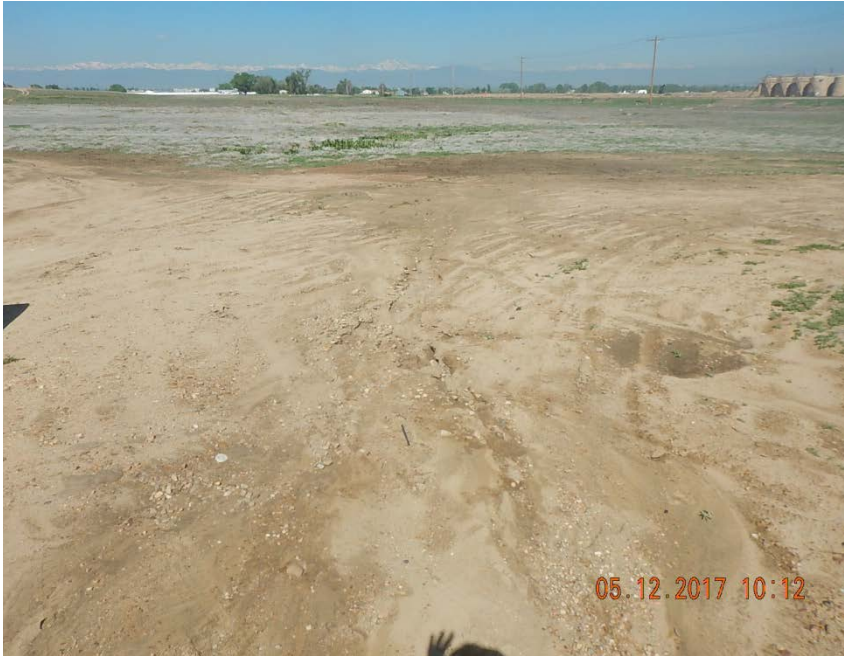
**Photo 10: Stormwater erosion on W side of location, looking W**

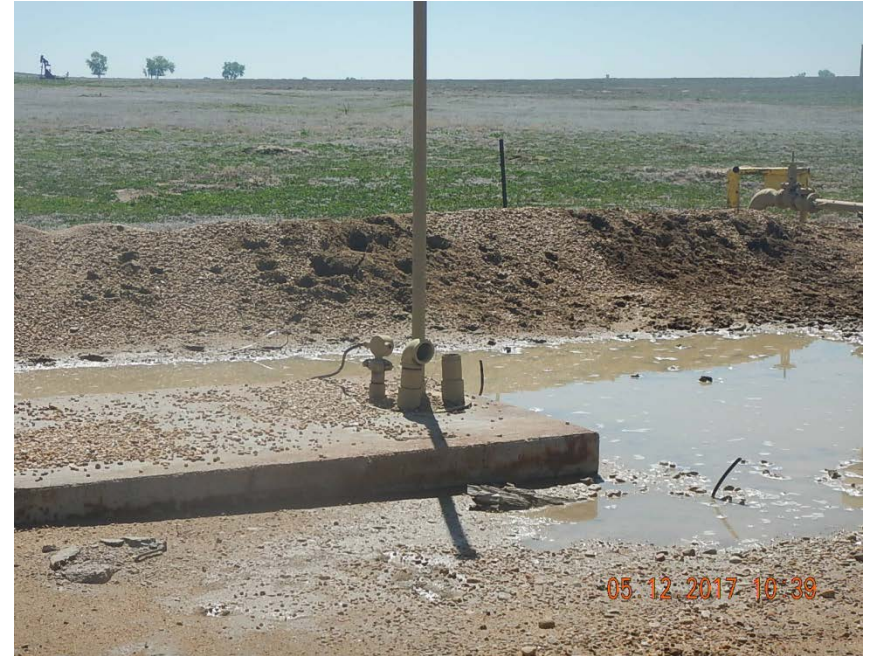
**Photo 11: Berms trampled by livestock**
