Inspection Photos

Operator: Bonanza Creek #8960

Location ID: 332428

Inspection Doc. Number: 682501987

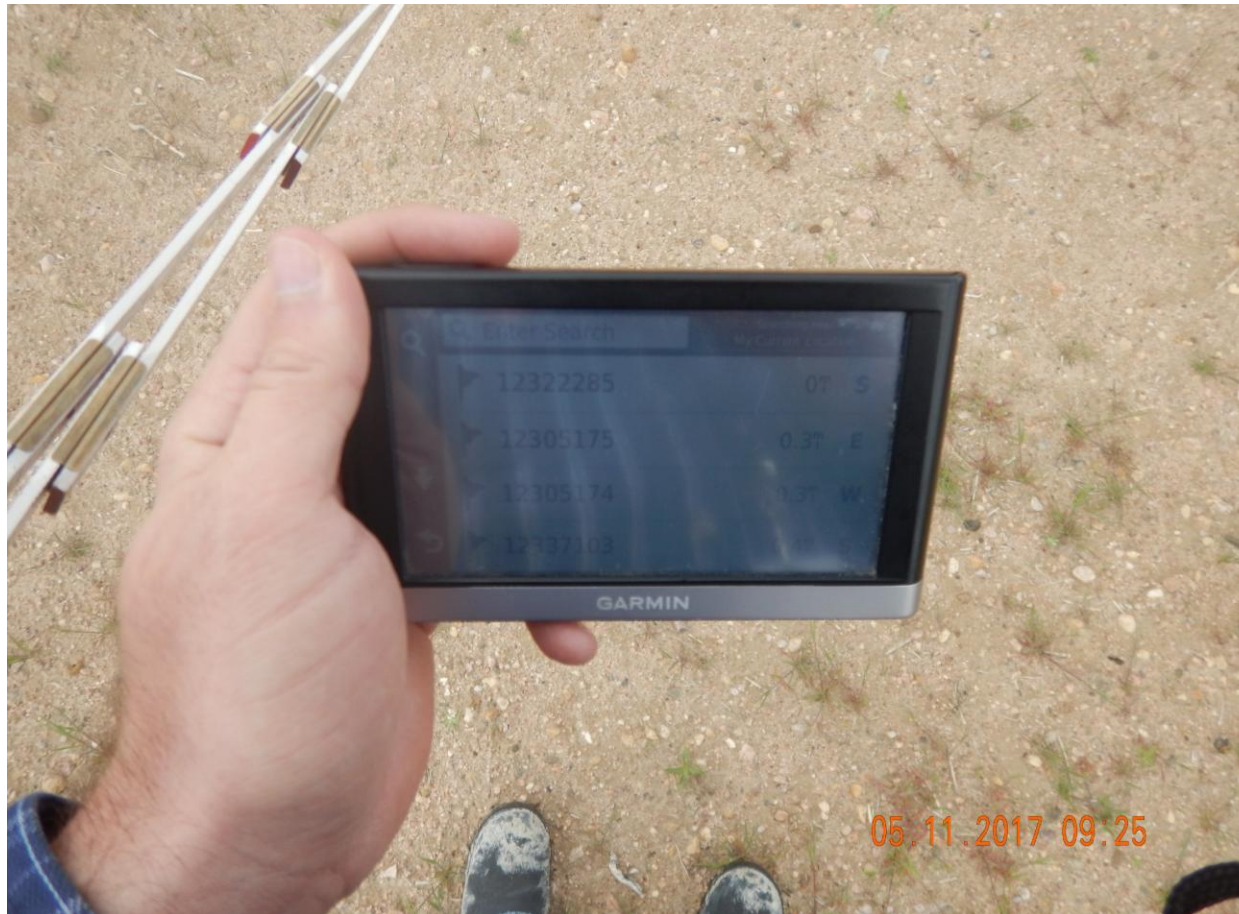
Photo 1: Photo of GPS verifying location.

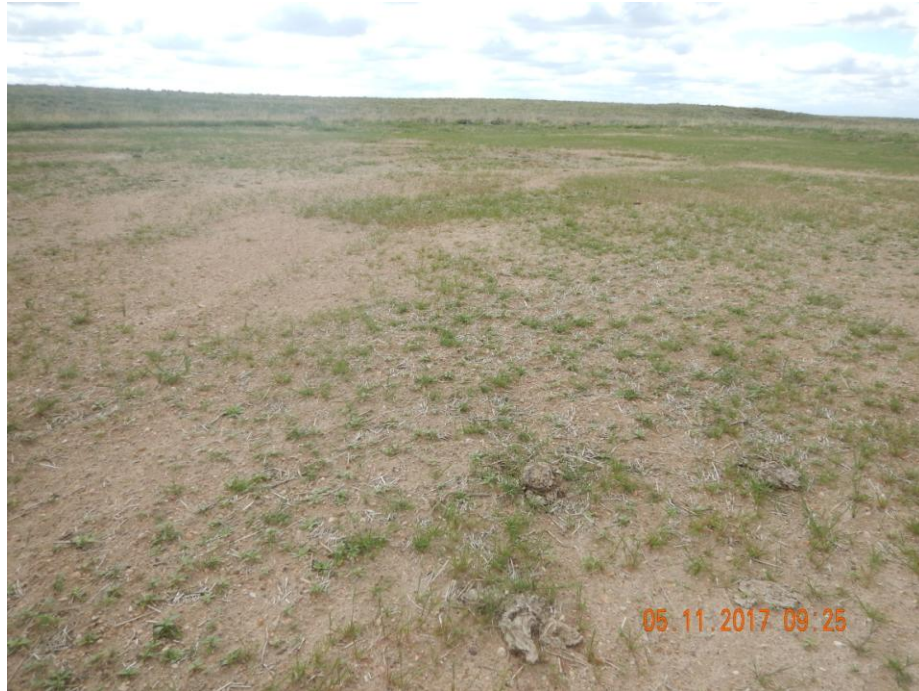
Photo 2: Photo taken from the north end of the location, facing southeast. Photo shows reclamation area. Note location does not appear to be progressing. Gravel / road base still remaining on location and road. Green vegetation seen on pad cheat grass.

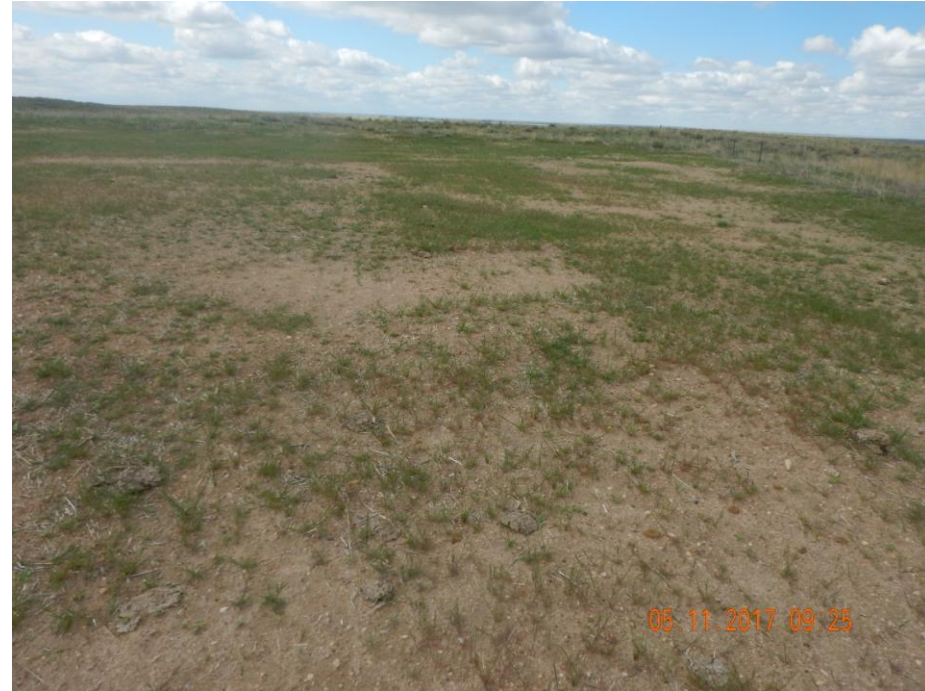
Photo 3: Photo taken from the north end of the location, facing southwest. Photo shows reclamation area. Note location does not appear to be progressing. Gravel / road base still remaining on location and road. Green vegetation seen on pad cheat grass.

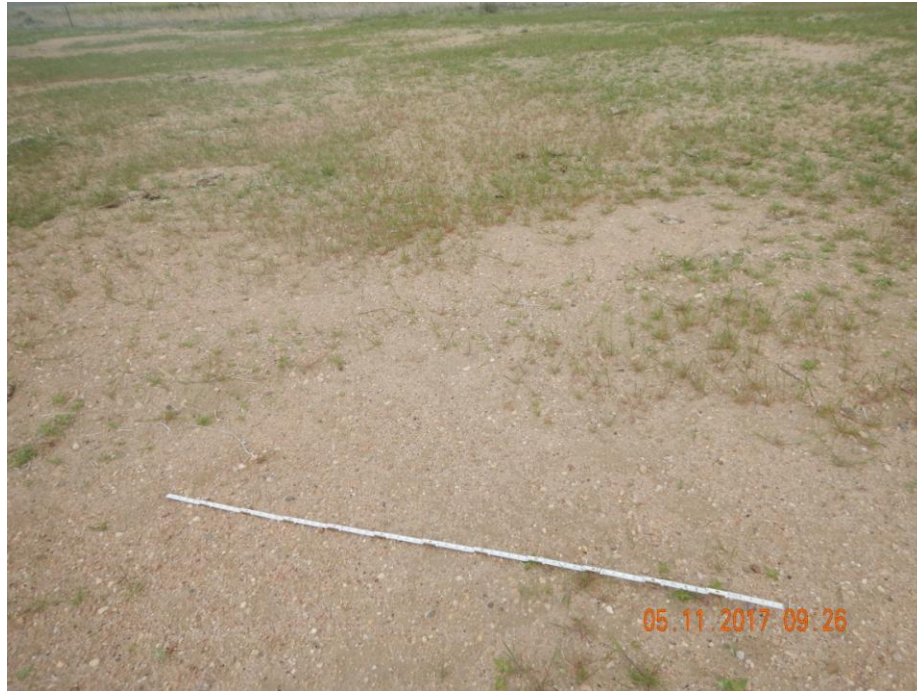
Photo 4: Photo taken from the location, facing. Photo shows gravel / road base still remaining on location. Green vegetation seen on pad cheat grass. 6 foot measuring stick for reference.

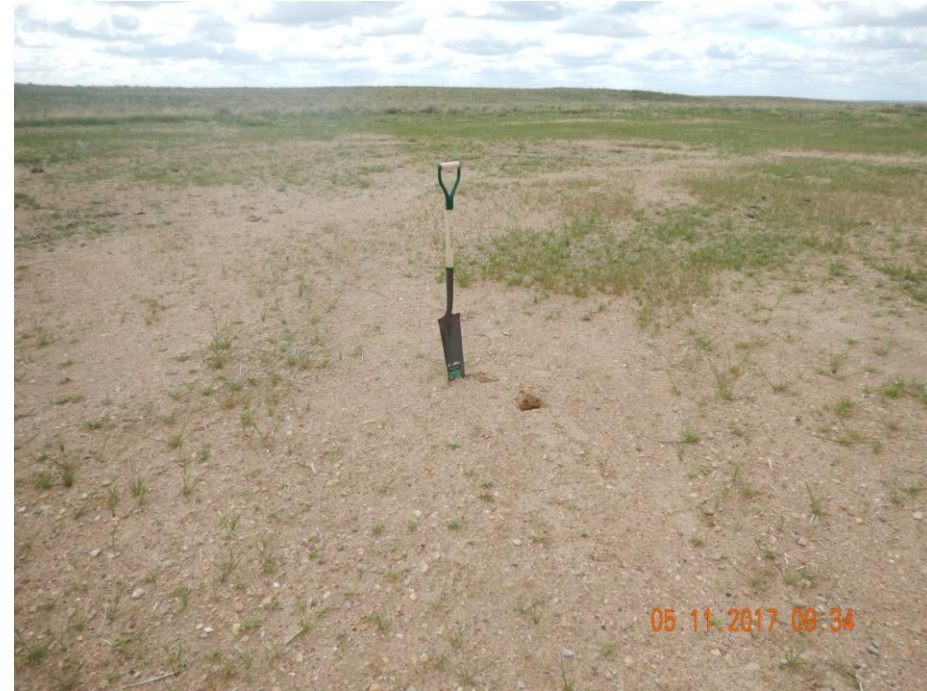
Photo 5: Photo taken from the location. Reclamation specialist tested location to see if compaction alleviation had been performed. Photo shows shovel was only able to penetrate soil ~2-3 inches before hitting a compaction zone.

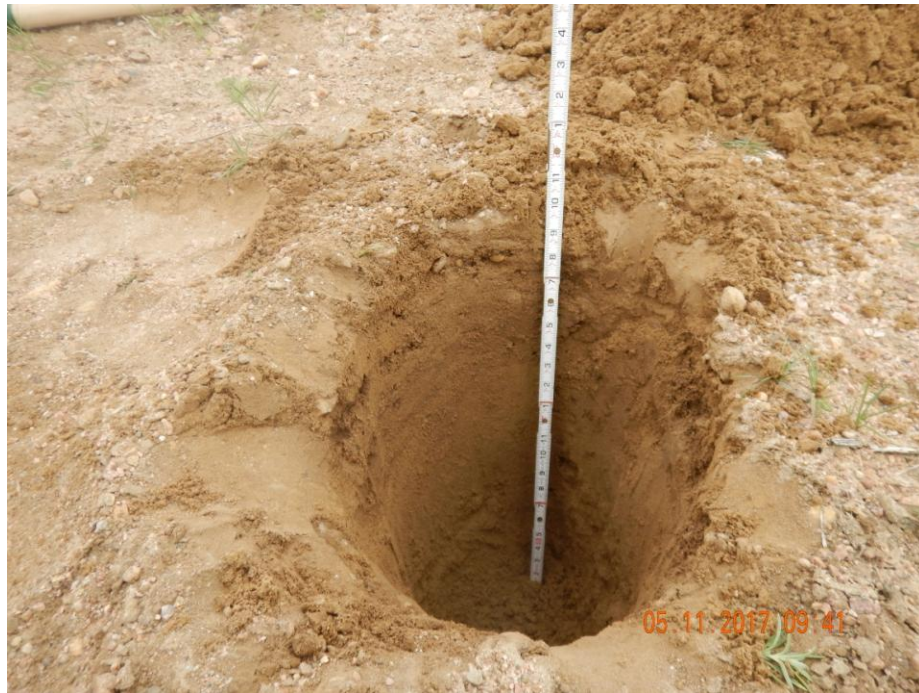
Photo 6: Photo taken from the location. Photo shows test pit dug by reclamation specialist to determine if compaction alleviation had been performed. Photo shows pit is ~20 inches deep.

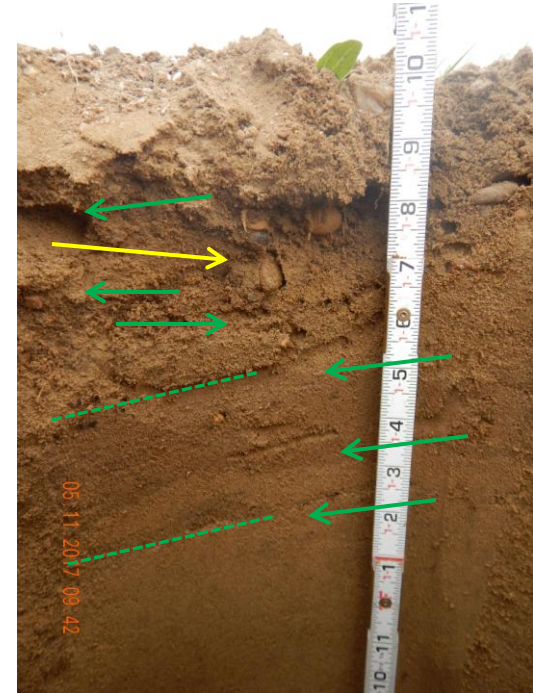
Photo 7: Photo shows test pit dug by reclamation specialist to determine if compaction alleviation had been performed. Photo shows road base can be found ~3-4 inches deep sub-surface (yellow arrow). Green line shows layer of subsoil where compaction has hindered water infiltration. Green arrows show multiple “platy” compaction layers

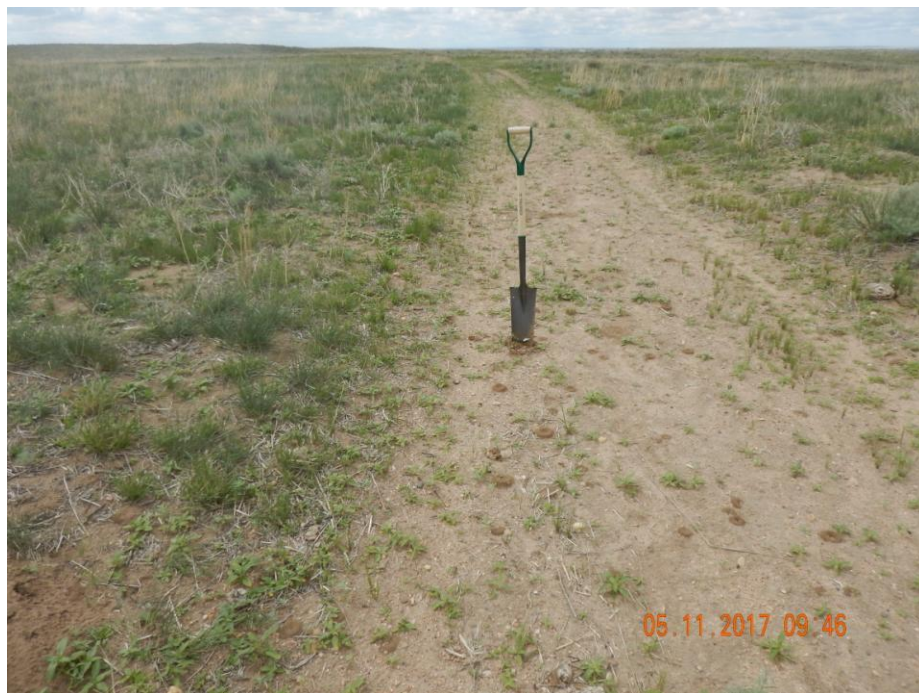
Photo 8: Photo taken from the location. Reclamation specialist tested location to see if compaction alleviation had been performed. Photo shows shovel was only able to penetrate soil ~2-3 inches before hitting a compaction zone.

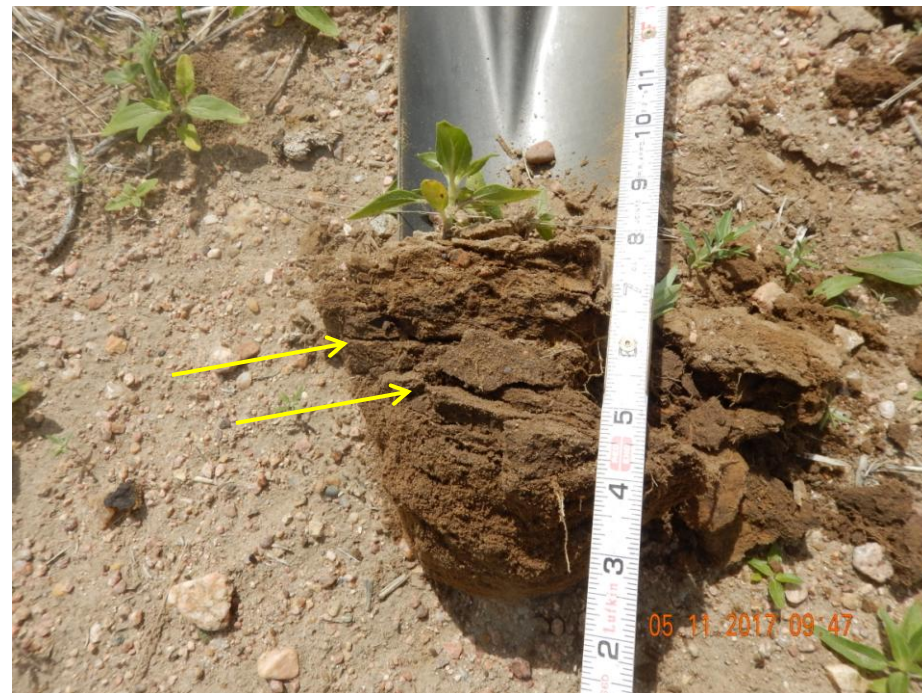
Photo 9: Photo shows a soil clod removed from the top 6-8 inches of the soil from the road. Photo shows "Platy" soil structures. Platy structures are thin, flat plates of soil that lie horizontally and are usually found in compacted soils. Yellow arrow seen points out some of the platy structures found.

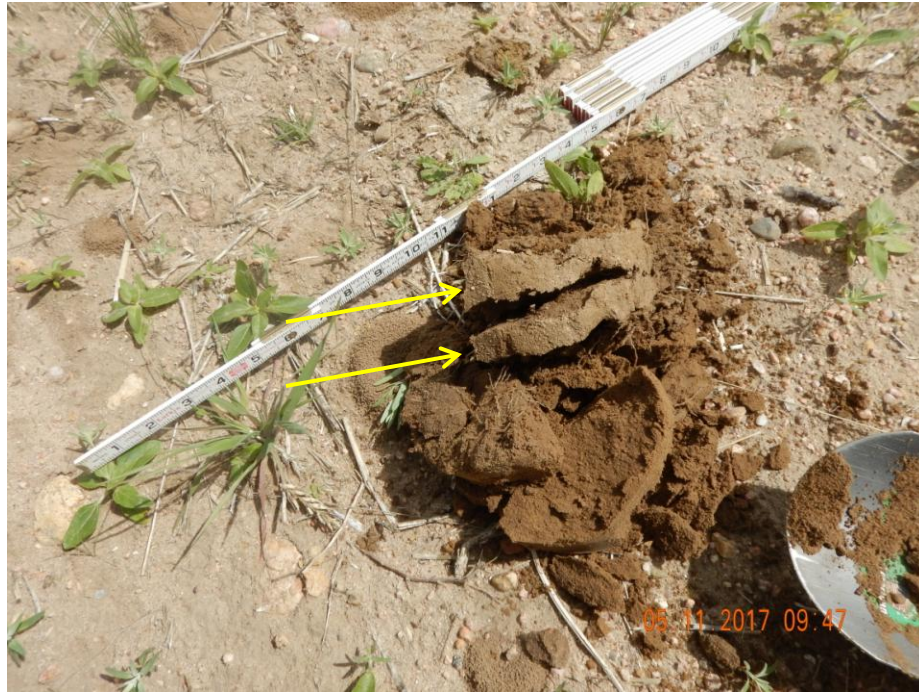
Photo 10: Photo shows a soil clod removed from the top 6-8 inches of the soil from the road. Photo shows “Platy” soil structures. Platy structures are thin, flat plates of soil that lie horizontally and are usually found in compacted soils. Yellow arrow seen points out some of the platy structures found.

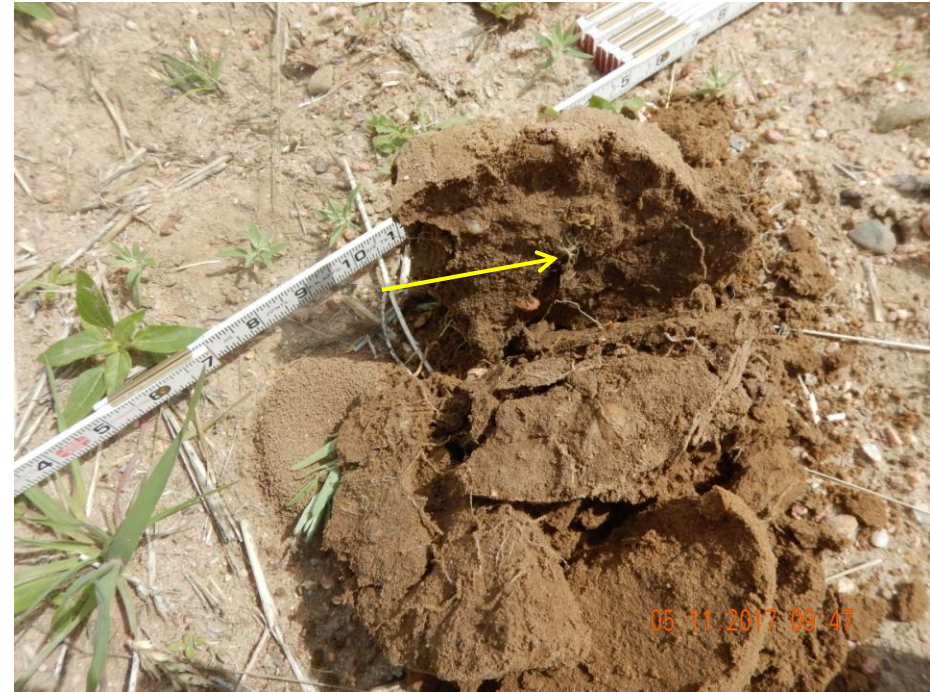
Photo 11: Photo shows a soil clod removed from the top 6-8 inches of the soil from the road. Photo shows “Platy” soil structures. Platy structures are thin, flat plates of soil that lie horizontally and are usually found in compacted soils. Arrow shows a layer of compaction that has hindered root penetration.
