April 7, 2017

## **Chevron – Mid Continent San Juan Basin Unit**

### **Crader 3-3 (API # 05-067-09614) Ignacio - Blanco Field: Rule 1004 Waiver Request**

#### **Sundry Notice Form 4 Attachment**

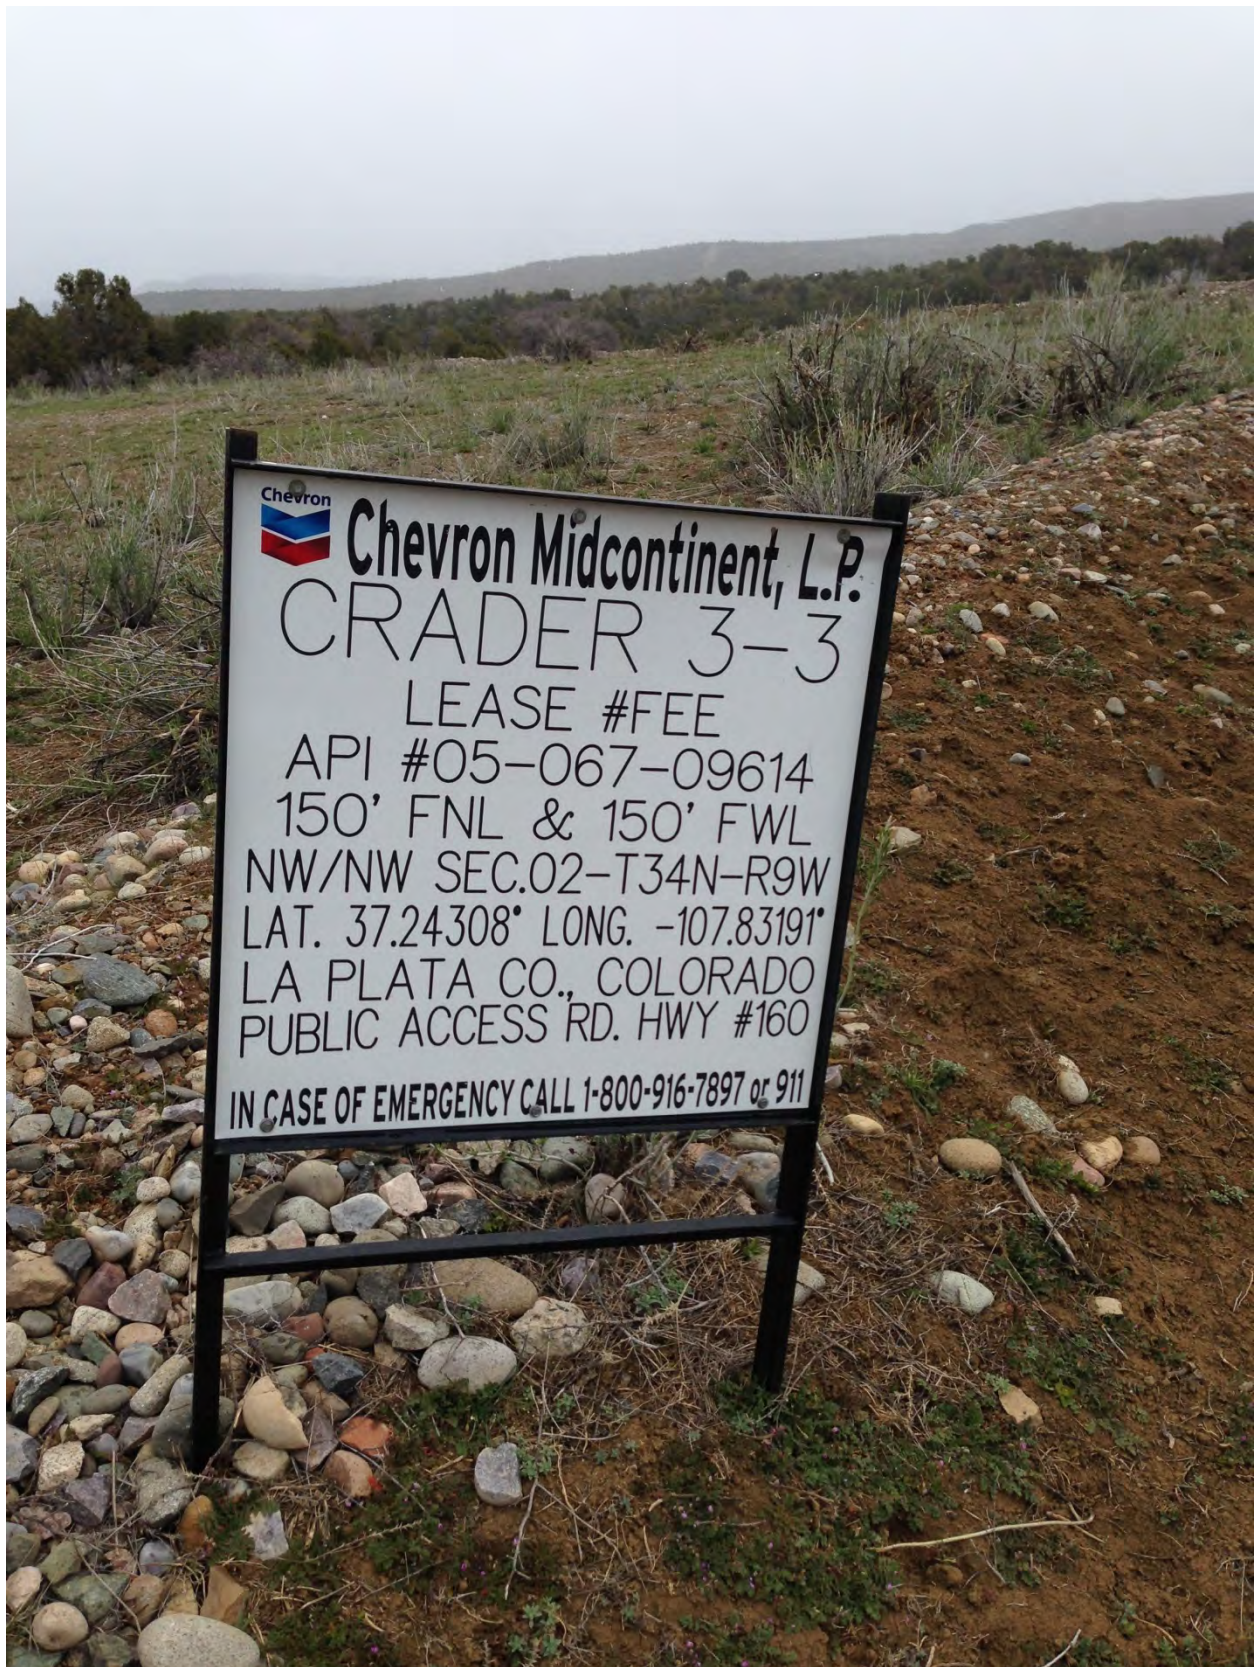
Photo 1 - Chevron Crader 3-3 Well Sign. View across pad to northeast.

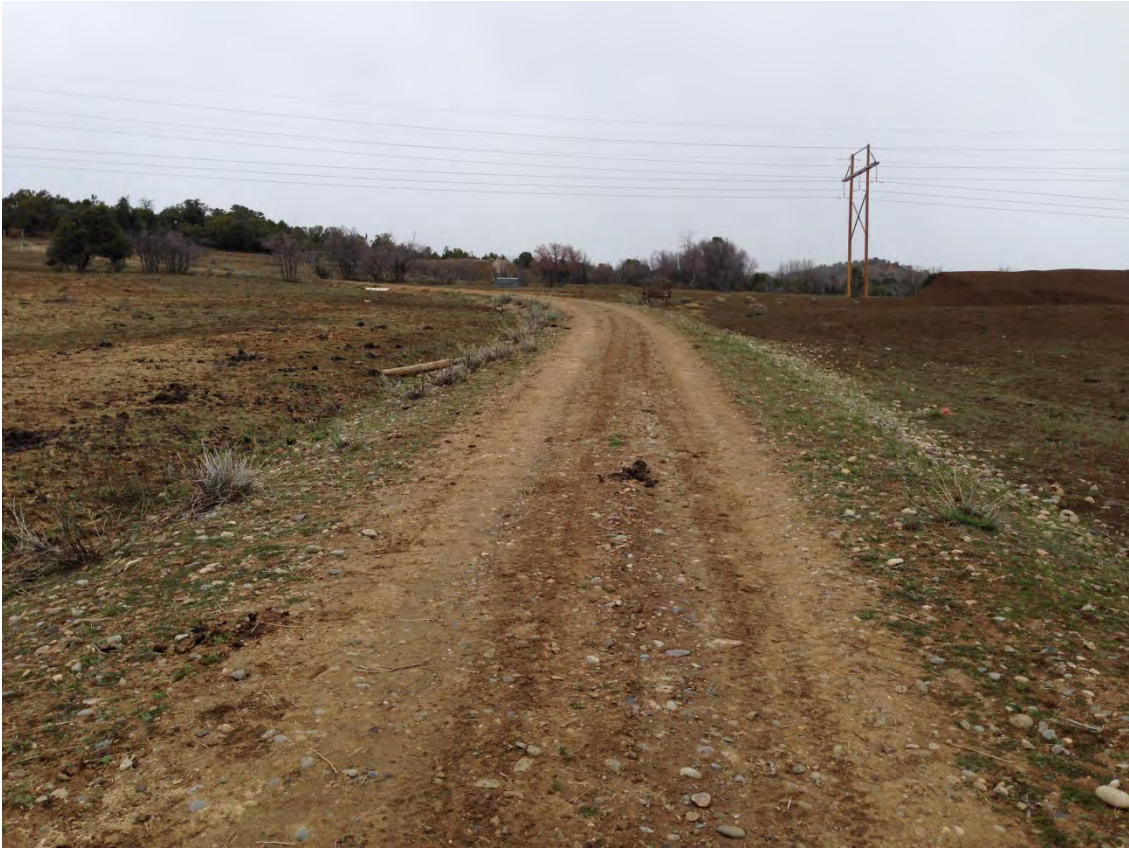
Photo 2 – Crader 3-3 Access Road. To remain. View to north.

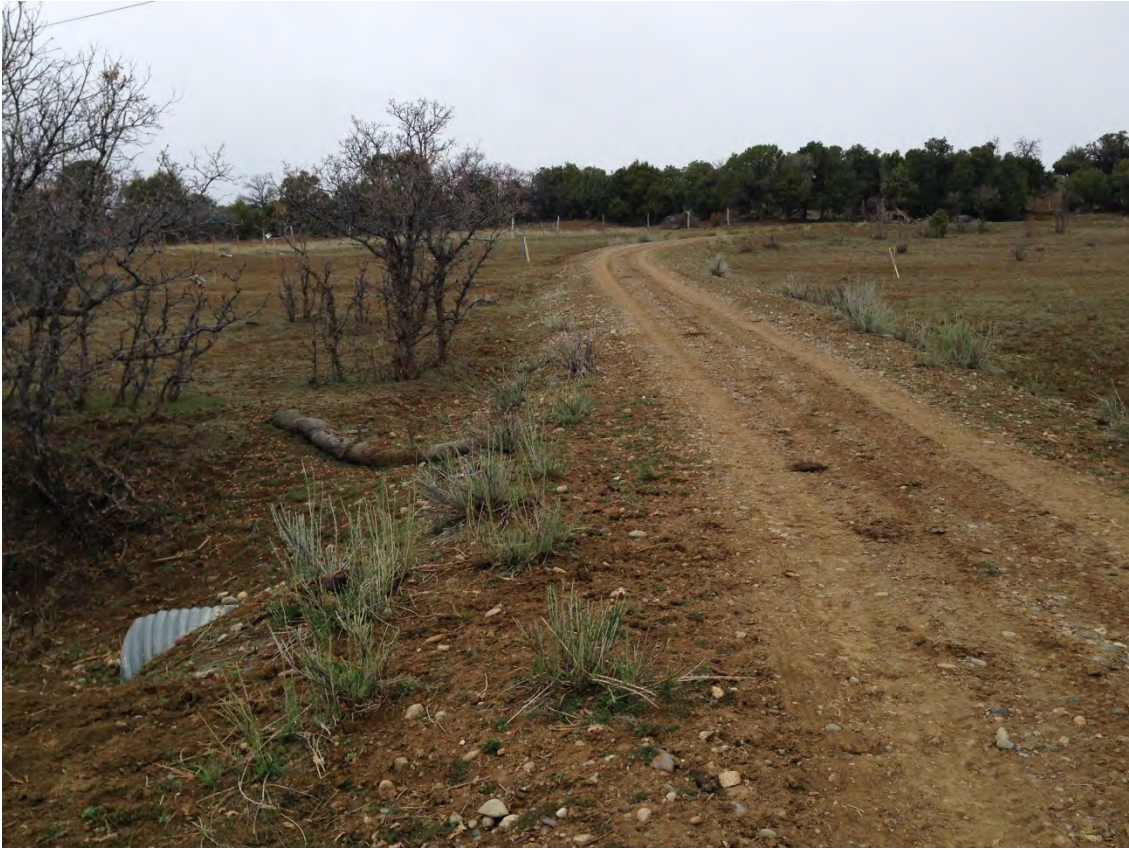
Photo 3 – Crader 3-3 Access Rd crossing irrigation ditch. To remain.

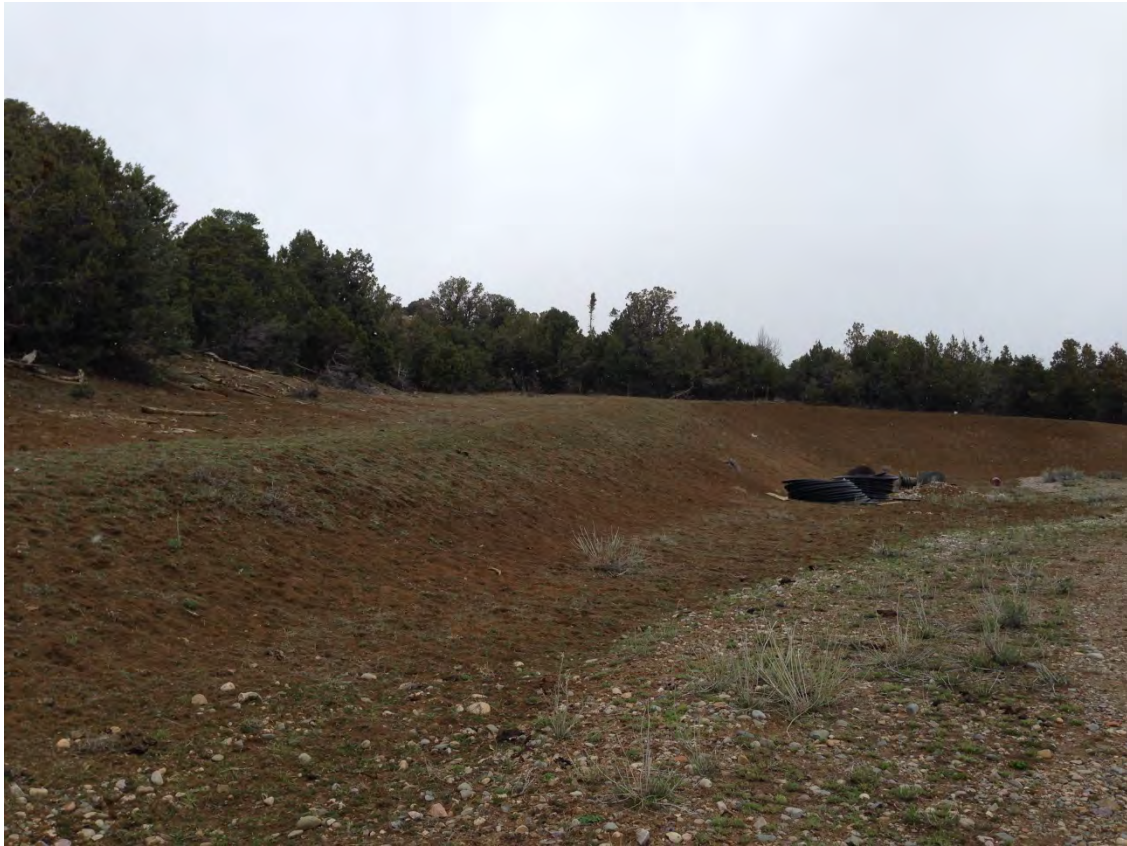
Photo 4 - Crader 3-3 cut wall and upper diversion ditch. Materials to be removed. View to north.

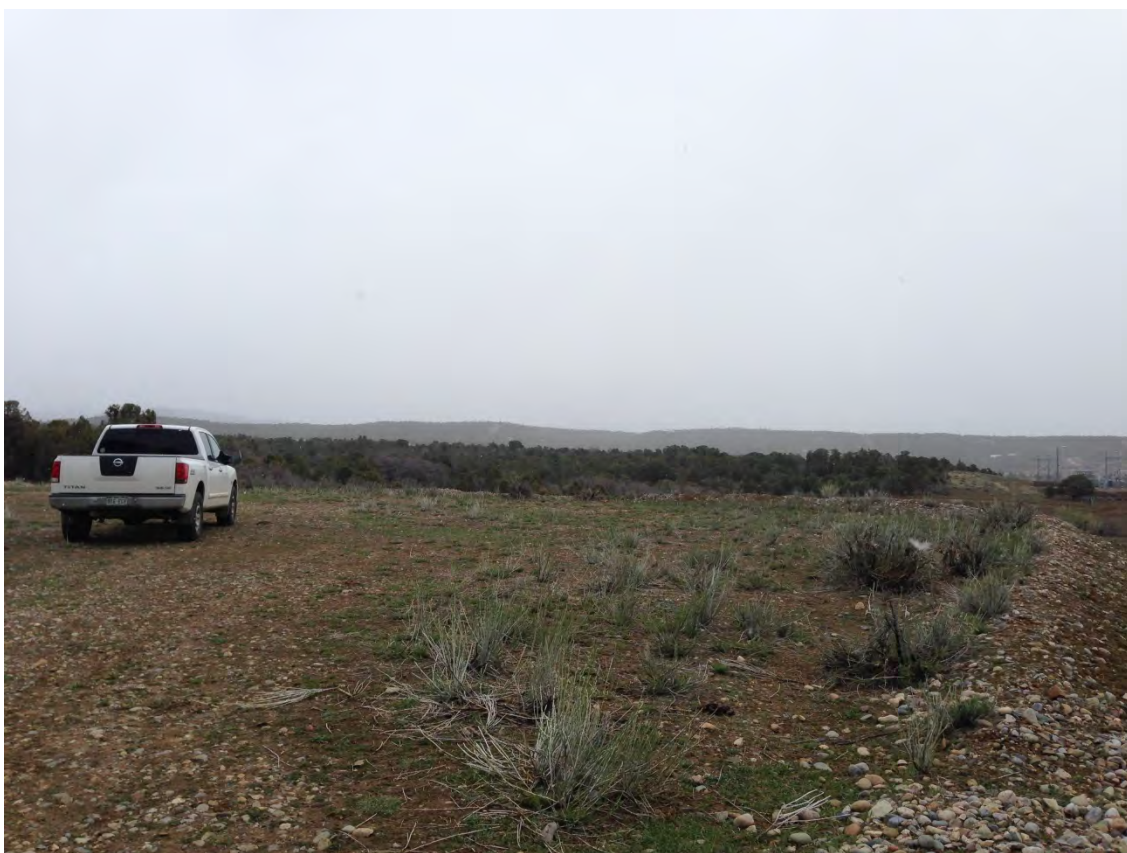
Photo 5 – Crader 3-3 graveled pad. To remain. View to northeast.

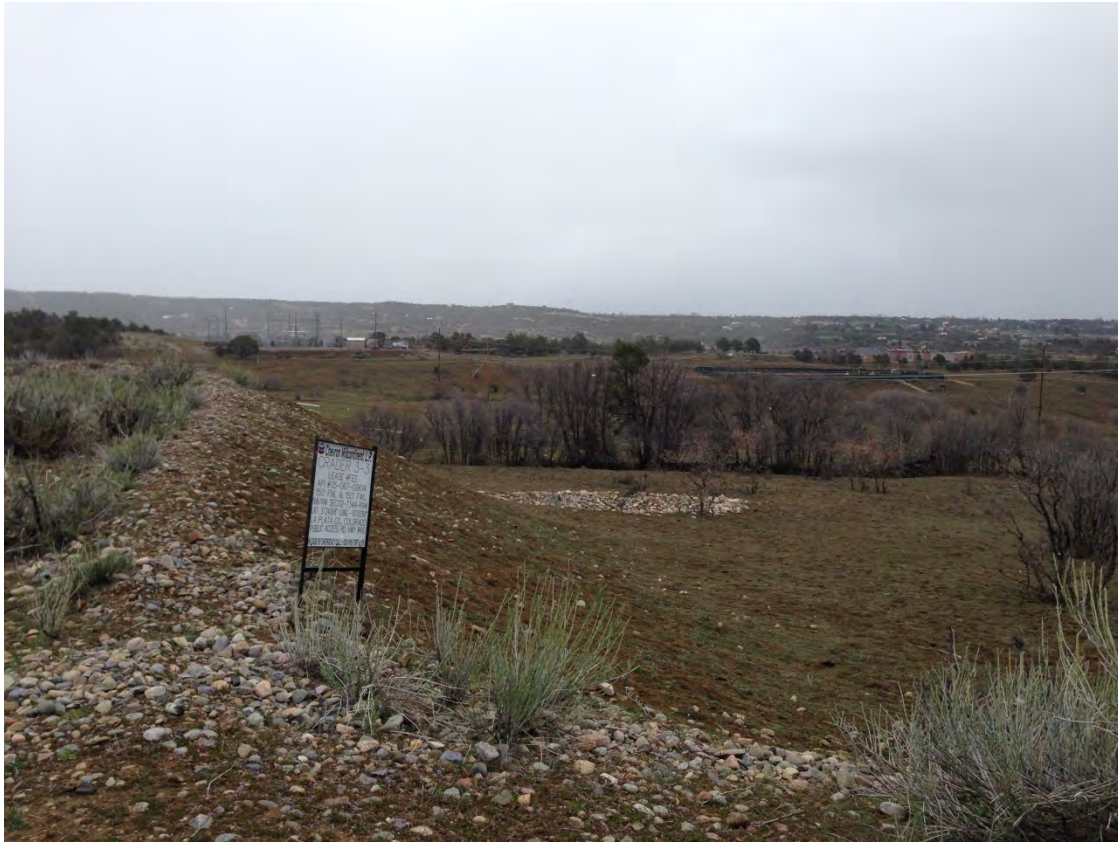
Photo 6 – Crader 3-3 south fill wall and stormwater pond. View to east.

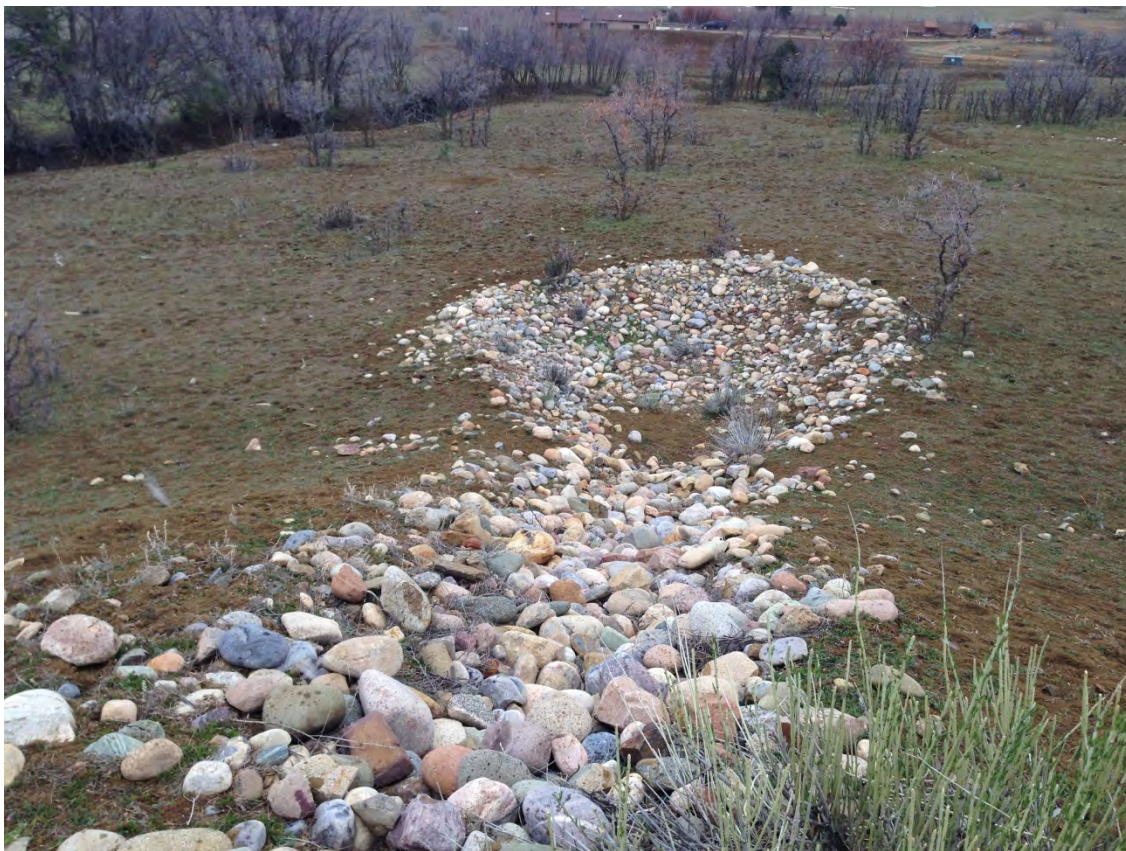
The Crader 3-3 has an active stormwater management system consisting of an upslope stormwater intercept ditch and a stormwater detention pond that collects and manages flow from the well location. These features are functional and will remain in place if the Rule 1004 waiver is granted. The discharge points for the upslope ditch currently exhibit some minor rilling. Several erosion control wattles are currently in place to slow sediment movement. These discharge points will be maintained by Chevron prior to the final reclamation inspection. Work will include

Photo 7 – Crader 3-3 stormwater detention pond. Functional and to remain. View to east.

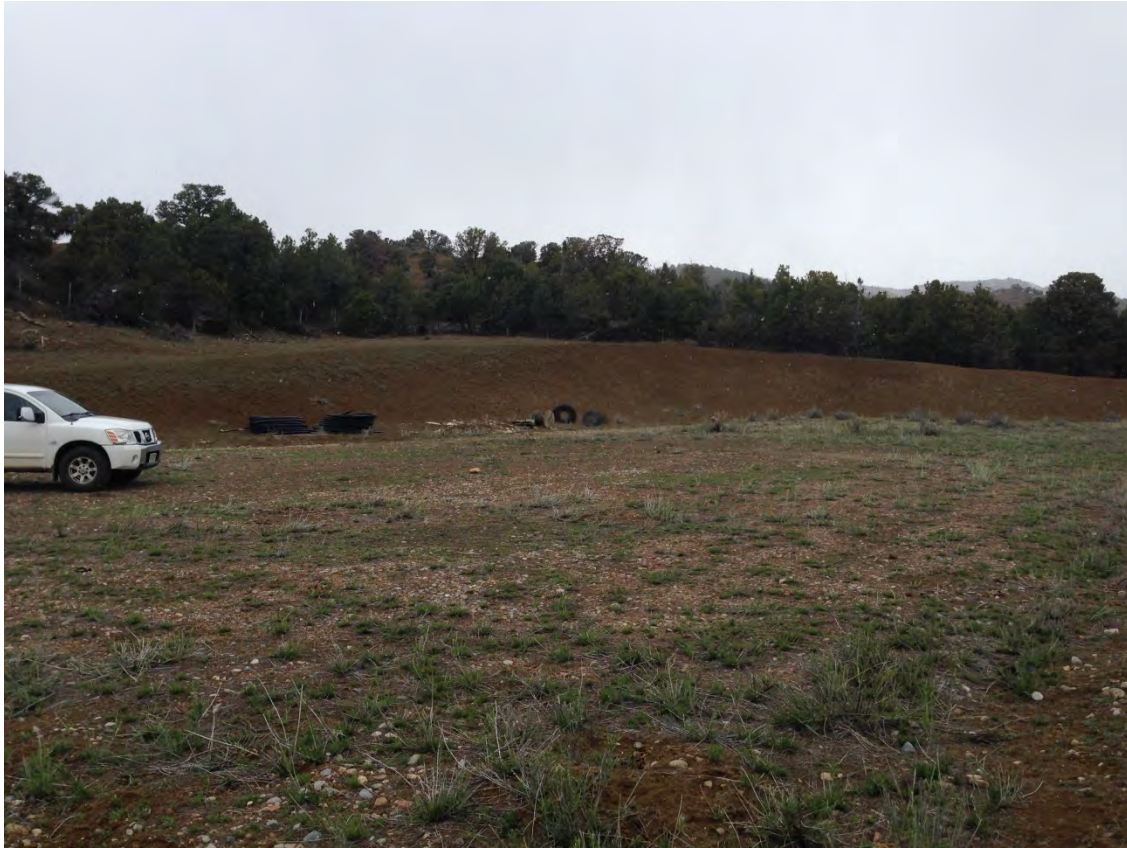
Photo 8 – Crader 3-3 pad and cut wall. Stored materials to be removed. View to northwest.

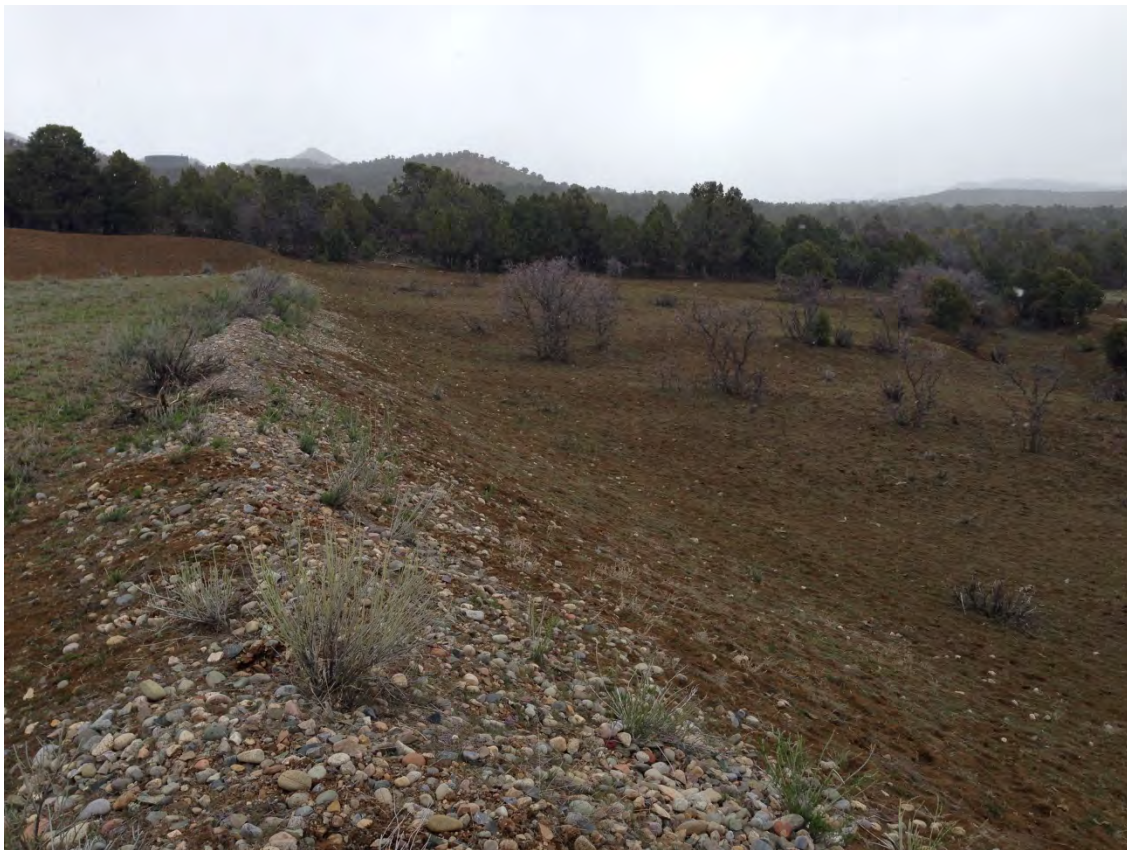
Photo 9 - Crader 3-3 east fill wall. To remain. View to north. Note grazing condition.

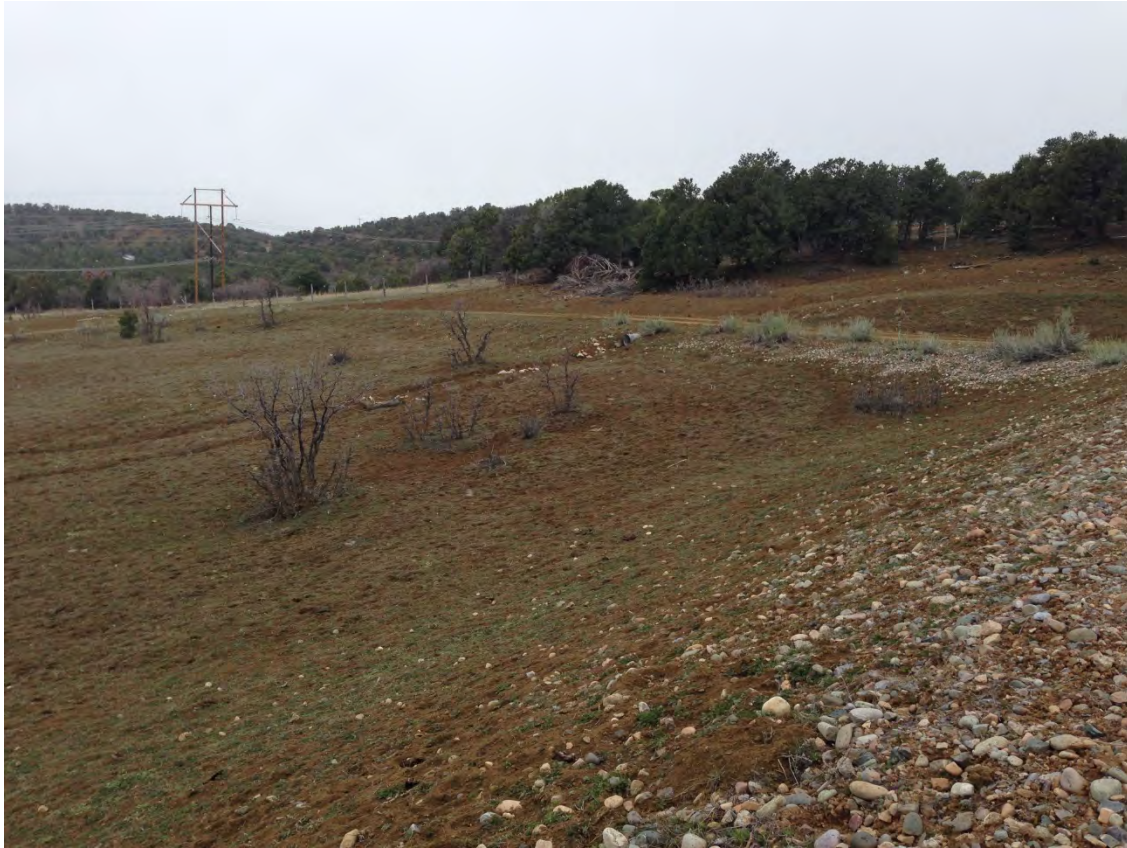
Photo 10 – Upper diversion ditch discharge south end. Note rills (to be mitigated) and grazing condition. View to south.

- Regrading rills,
- Placement of energy dissipation rock spreader at the discharge points,
- Seeding of repaired area,
- Placement of biodegradable erosion matting and erosion wattles in the repaired areas.
- Future maintenance of these areas will be the responsibility of the landowner.

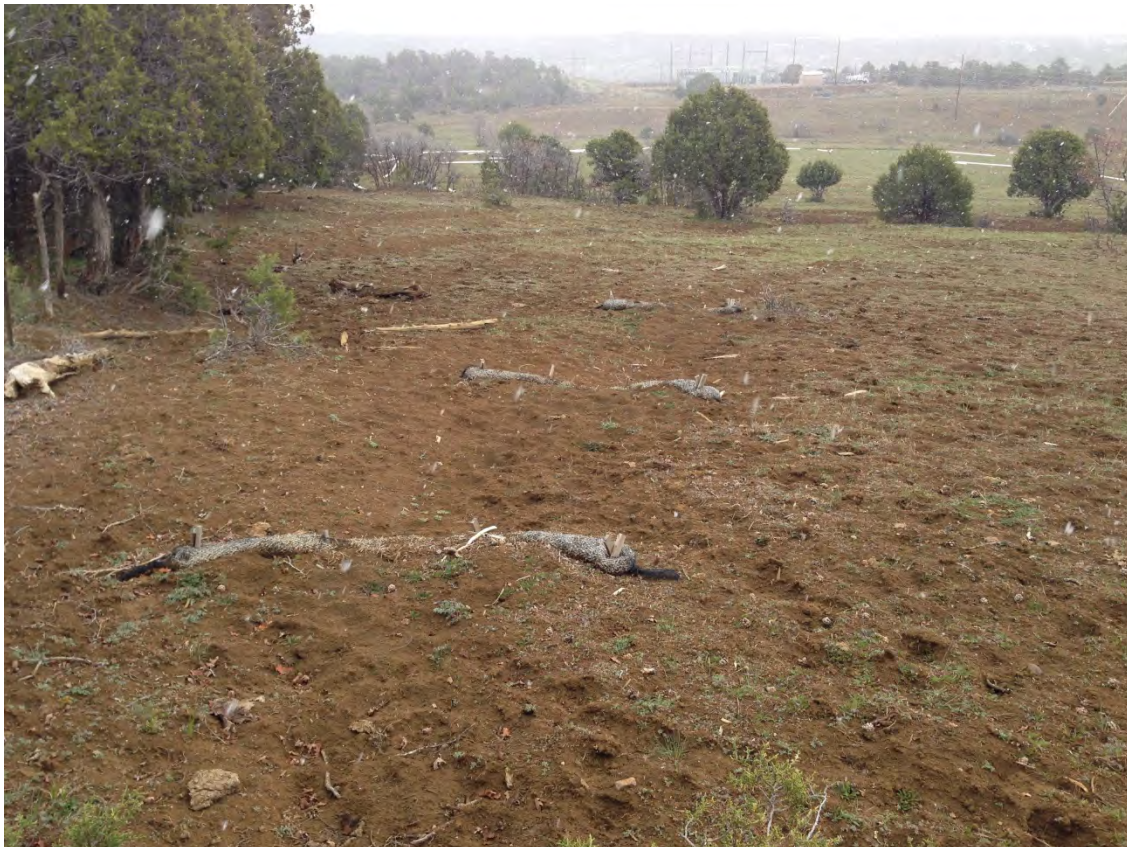
Photo 11 - Upper diversion ditch discharge north end. Note minor rill (to be mitigated). View to east.
