Reclamation Inspection

May 15, 2017

Operator: LONGS PEAK RESOURCES LLC- #10611

Location ID: 440192

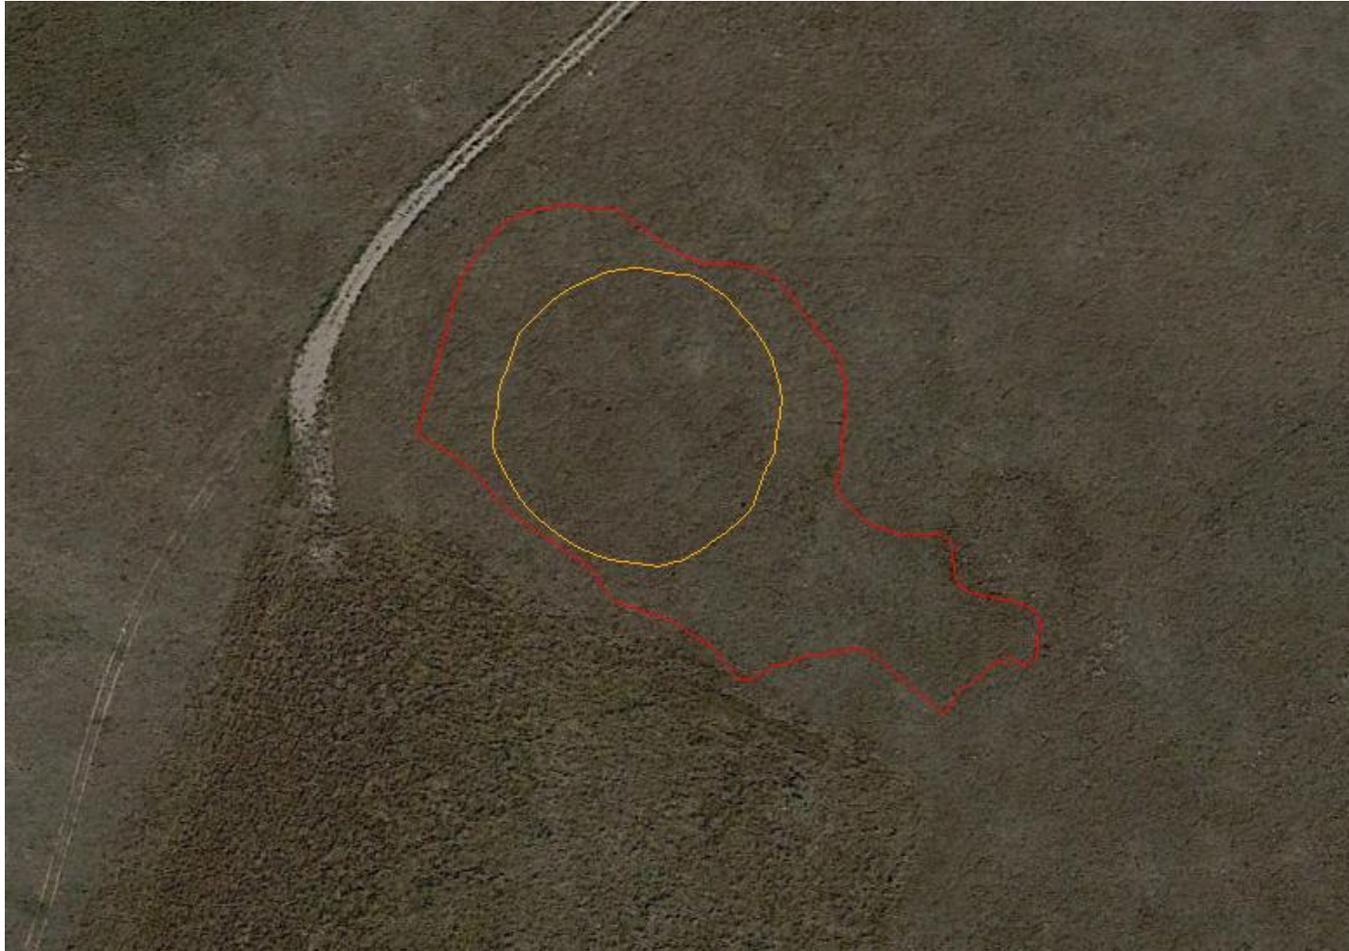
Google Earth aerial imagery taken September 7, 2016 of the MLVT location overlaid with field collected data using a Trimble handheld GPS from the May 15, 2017 inspection. Aerial imagery illustrates the approximate total disturbance area of the MLVT location highlighted in red and the actual tank location highlighted in orange.

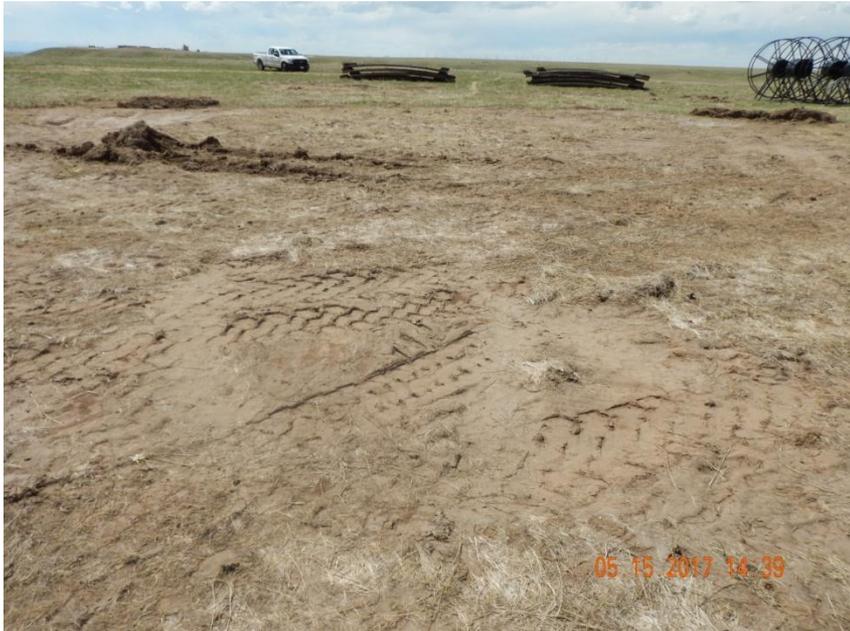
Photo 1. Photo taken from the center of the tank location, facing West. All disturbance associated with the MLVT location will have to be reclaimed per Rule 1004 standards.

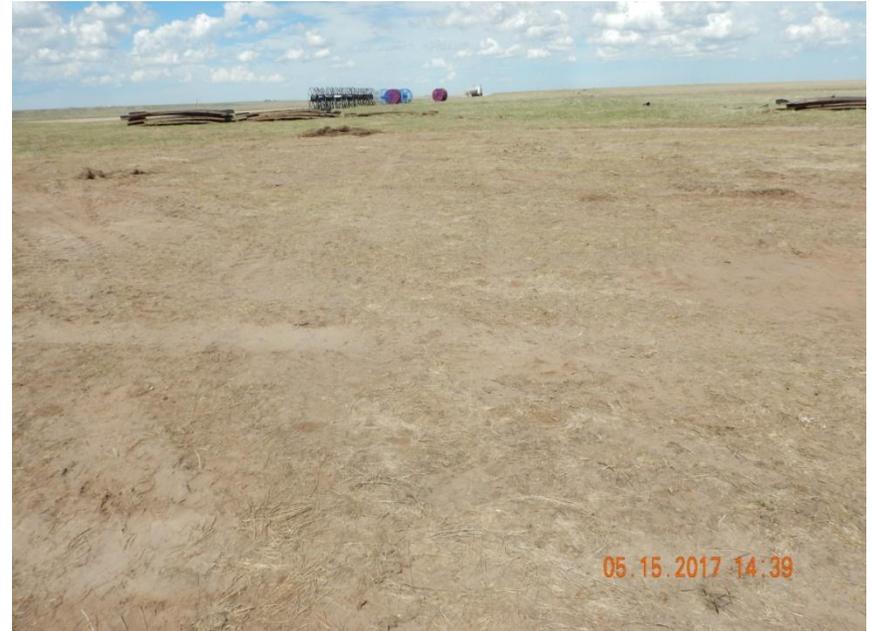
Photo 2. Photo taken from the center of the tank location, facing North. All disturbance associated with the MLVT location will have to be reclaimed per Rule 1004 standards.

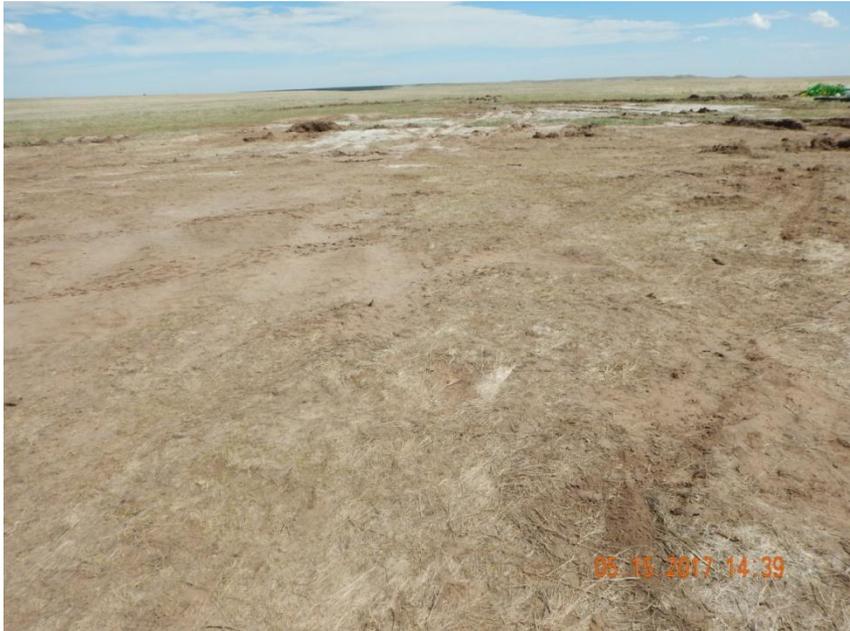
Photo 3. Photo taken from the center of the tank location, facing East. All disturbance associated with the MLVT location will have to be reclaimed per Rule 1004 standards.

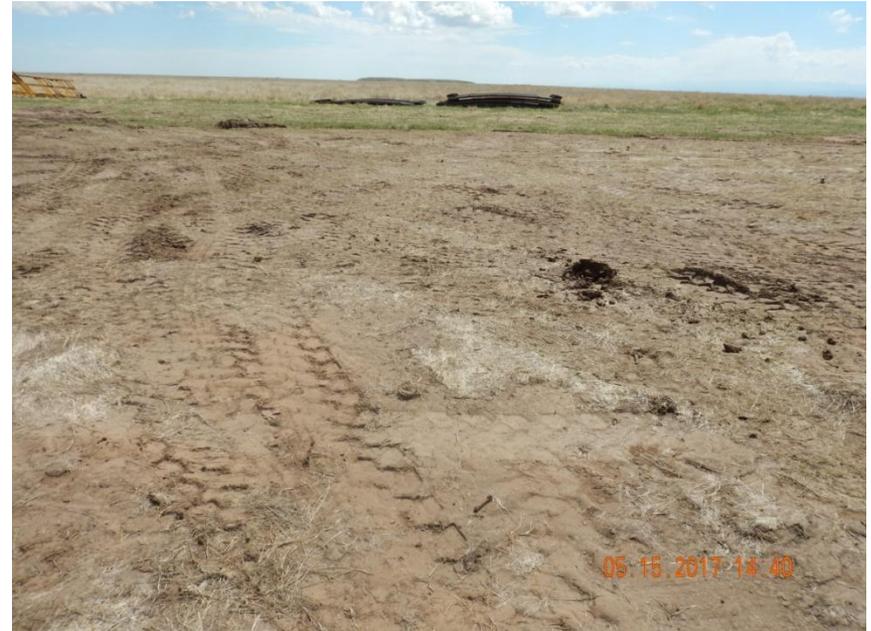
Photo 4. Photo taken from the center of the tank location, facing South. All disturbance associated with the MLVT location will have to be reclaimed per Rule 1004 standards.

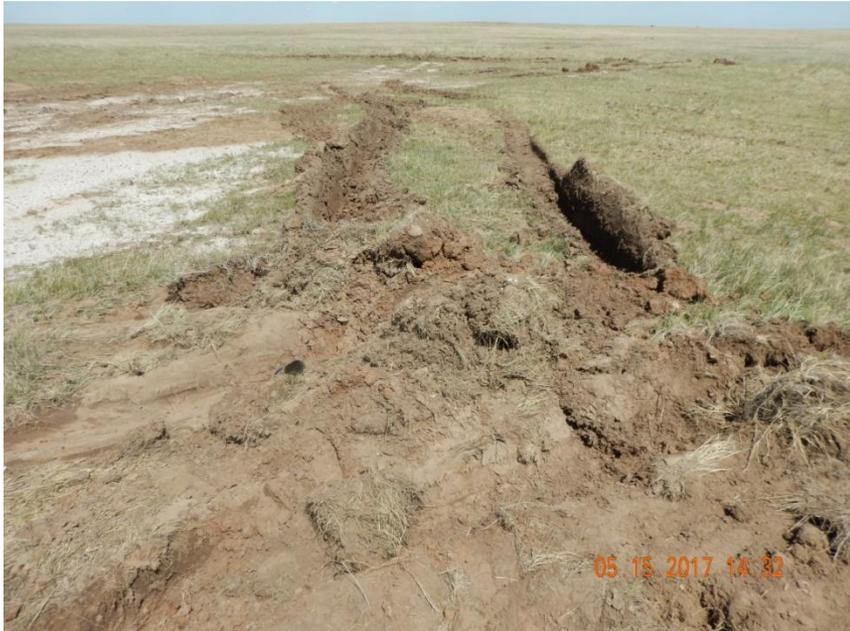
Photo 5. Photo taken from the southern disturbance area of the MLVT location, facing East. All disturbance associated with the MLVT location will have to be reclaimed per Rule 1004 standards.

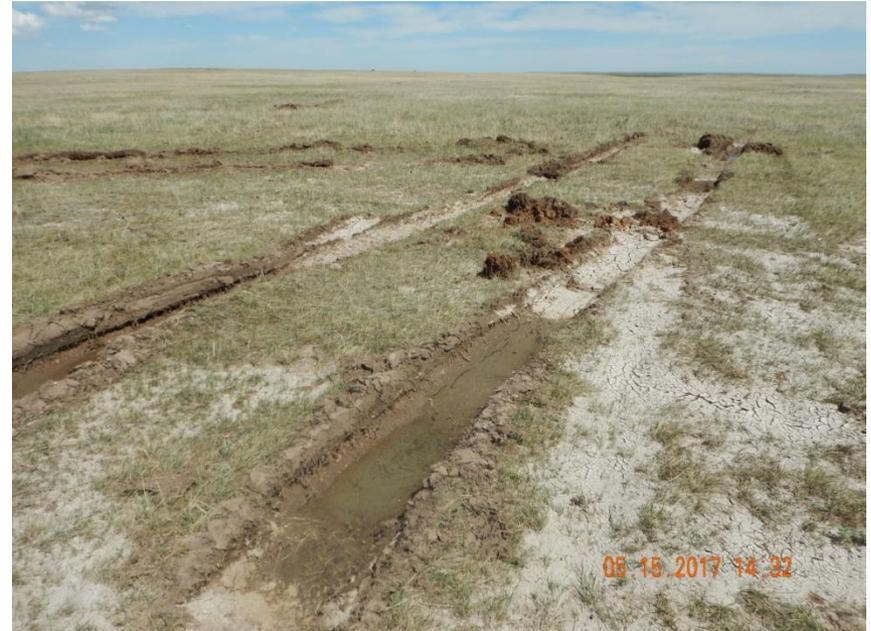
Photo 6. Photo taken from the eastern disturbance area of the MLVT location, facing East. All disturbance associated with the MLVT location will have to be reclaimed per Rule 1004 standards.

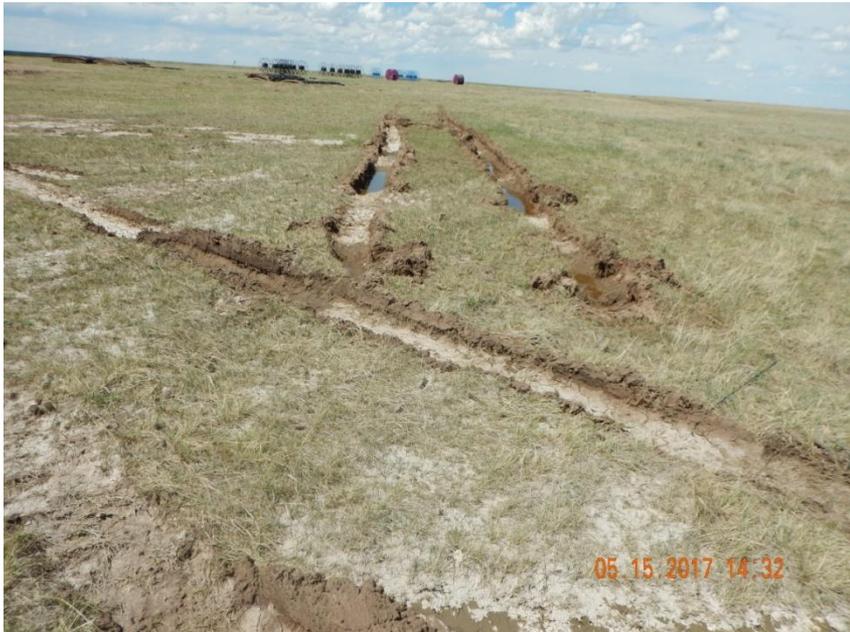
Photo 7. Photo taken from the eastern disturbance area of the MLVT location, facing West. All disturbance associated with the MLVT location will have to be reclaimed per Rule 1004 standards.

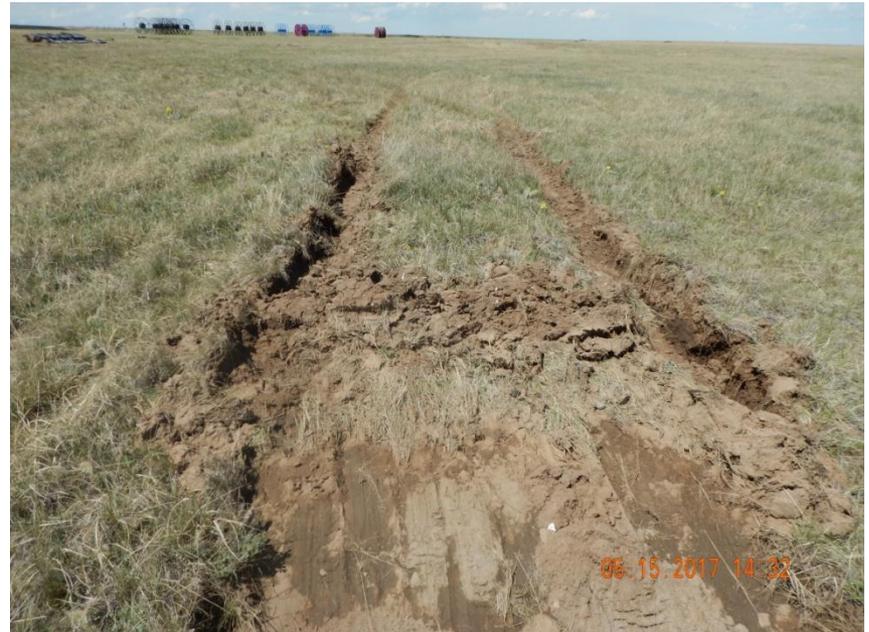
Photo 8. Photo taken from the eastern disturbance area of the MLVT location, facing West. All disturbance associated with the MLVT location will have to be reclaimed per Rule 1004 standards.
