Stormwater Inspection

May 15, 2017

Operator: LONGS PEAK RESOURCES LLC- #10611

Inspection Photos
Location Name: RAILAY #28-3-1CH
API: 05-123-39863

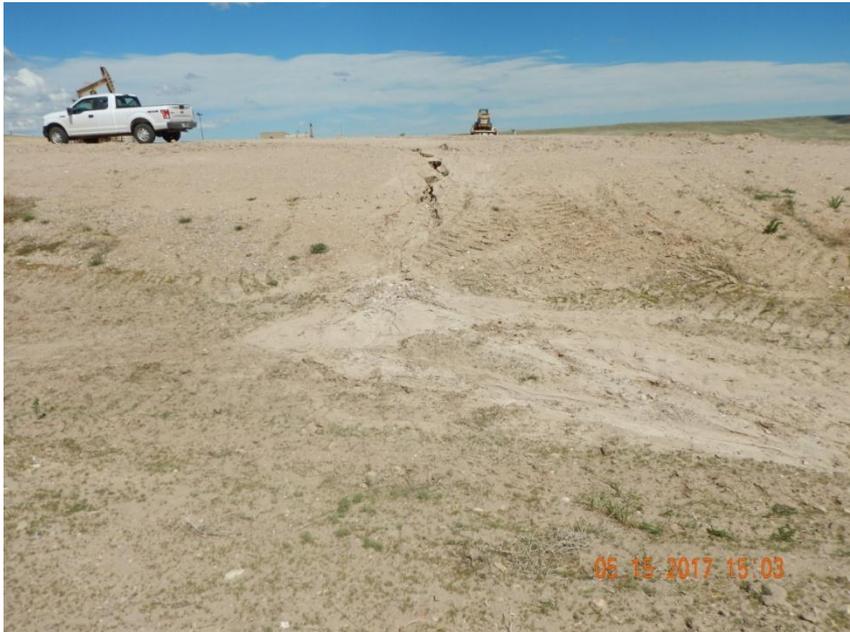
Photo 1. Photo taken of the southwest well pad along the west-facing side, facing East. Gully erosion observed along the well pad perimeter. Sediment appears to be contained within the stormwater BMP areas of the location.

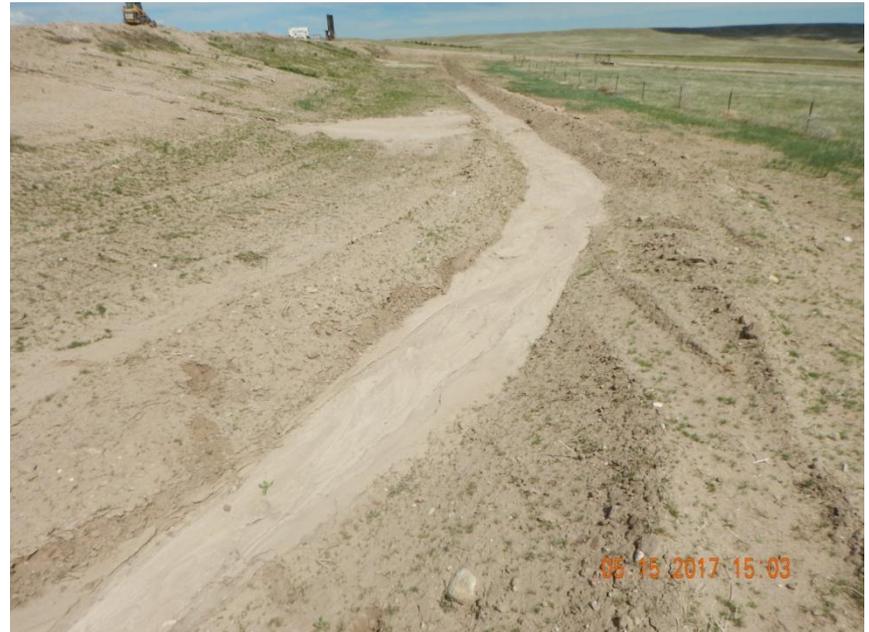
Photo 2. Photo taken from the approximate previous photo location, facing East. Sediment appears to be contained within the stormwater BMP areas of the location.

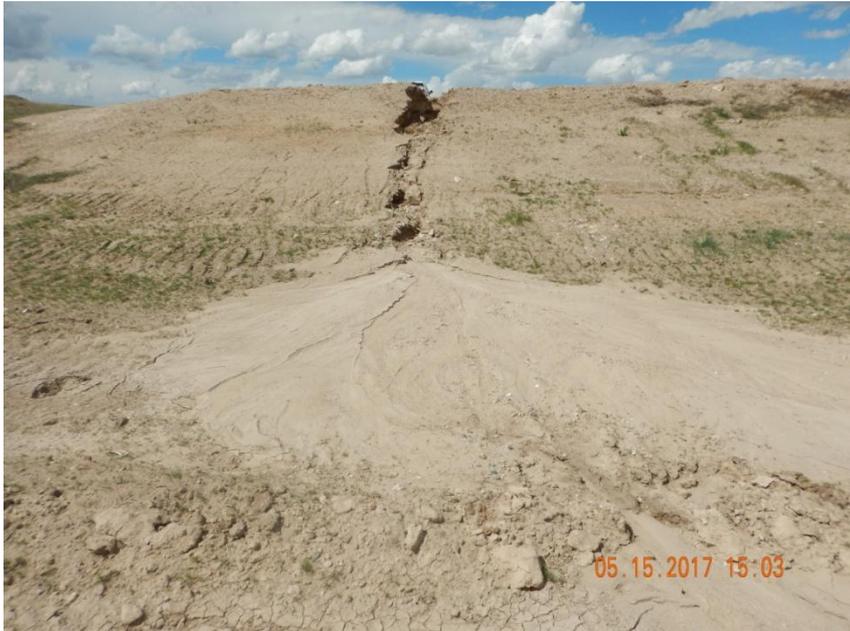
Photo 3. Photo taken of the southwest well pad along the south-facing side, facing North. Gully erosion observed along the well pad perimeter. Sediment appears to be contained within the stormwater BMP areas of the location.

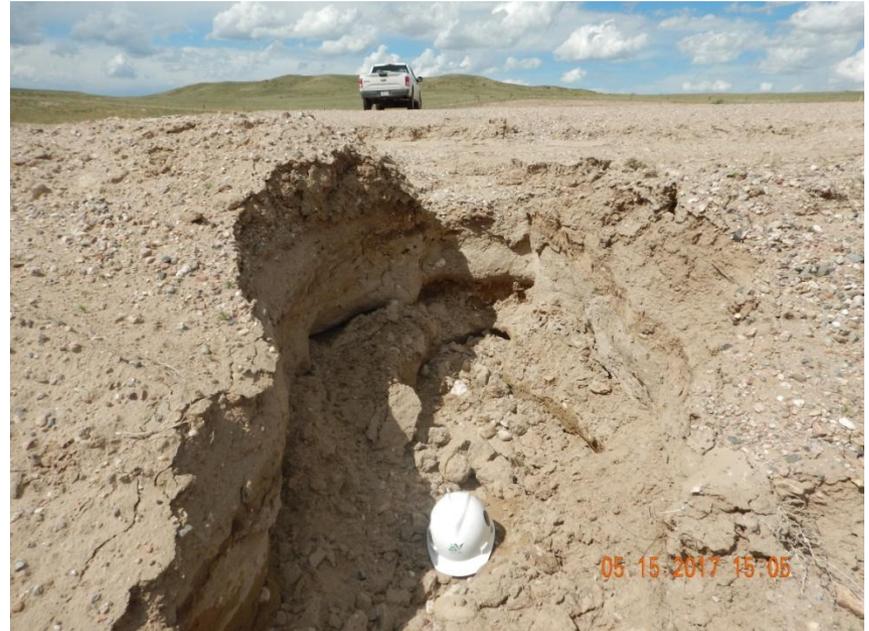
Photo 4. Close-up photo of the gully erosion from the previous photo.

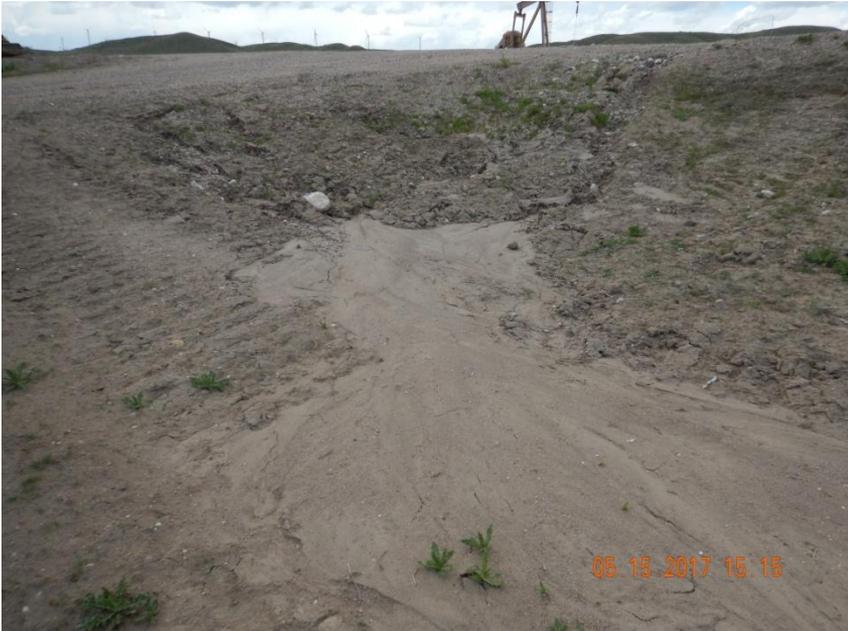
Photo 5. Photo taken along the east entrance of location, facing Northwest. Rill erosion observed along the entrance. Sediment appears to be contained within the stormwater BMP areas of the location.

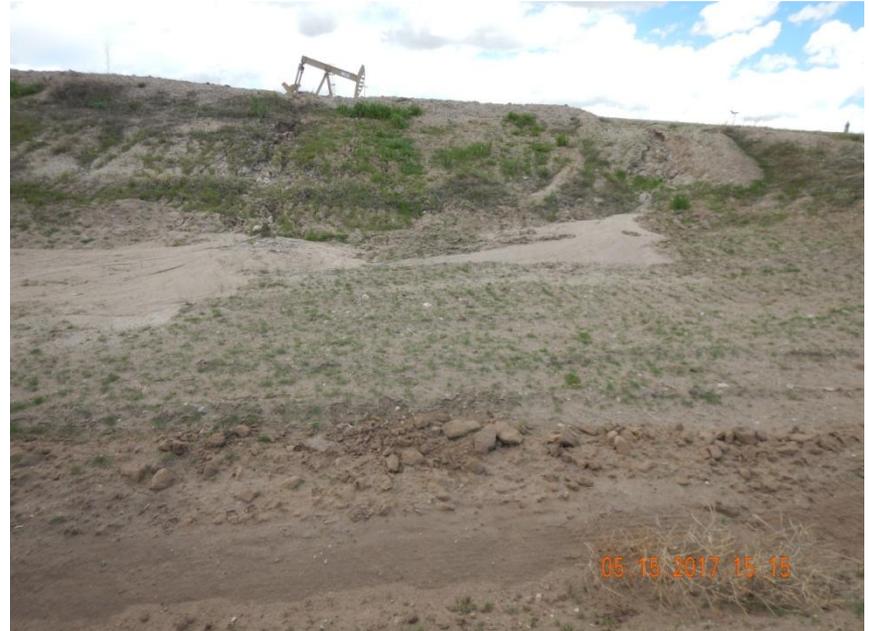
Photo 6. Photo taken along the west entrance of location, facing North. Rill erosion observed along the entrance. Sediment appears to be contained within the stormwater BMP areas of the location.

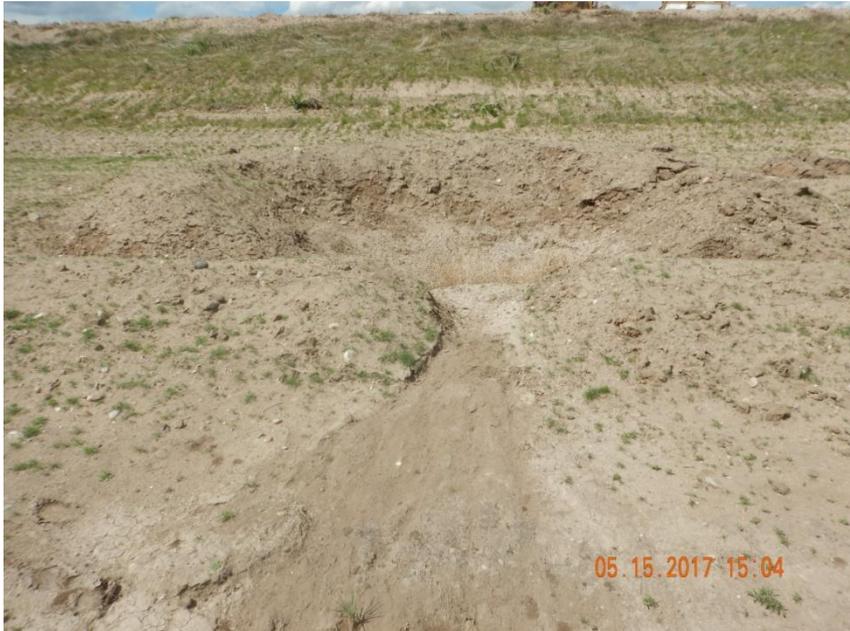
Photo 7. Photo taken from the western sediment trap, facing North. Sediment trap does not have any stabilized outlet protection to prevent sediment laden stormwater from discharging if the sediment trap reaches to capacity.

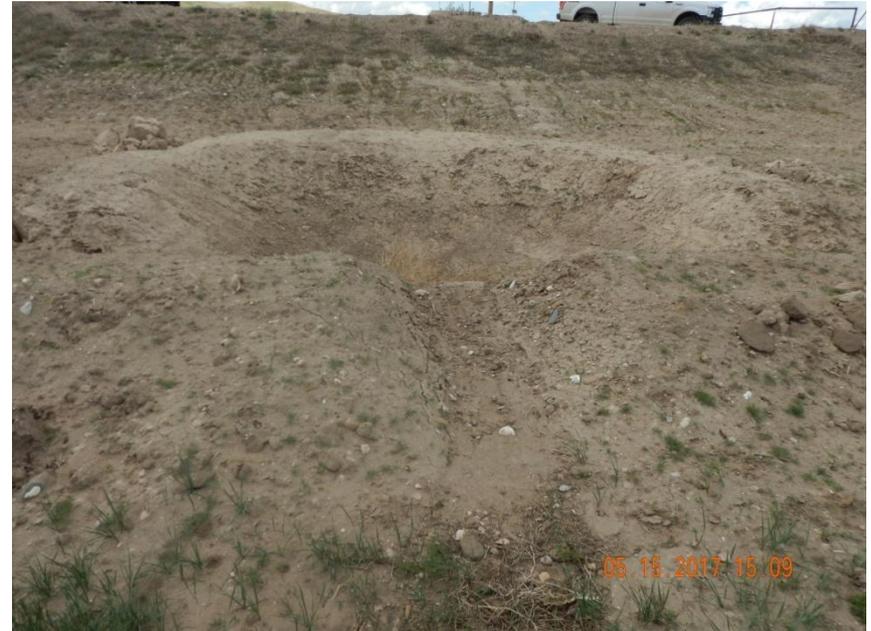
Photo 8. Photo taken from the eastern sediment trap, facing North. Sediment trap does not have any stabilized outlet protection to prevent sediment laden stormwater from discharging if the sediment trap reaches to capacity.

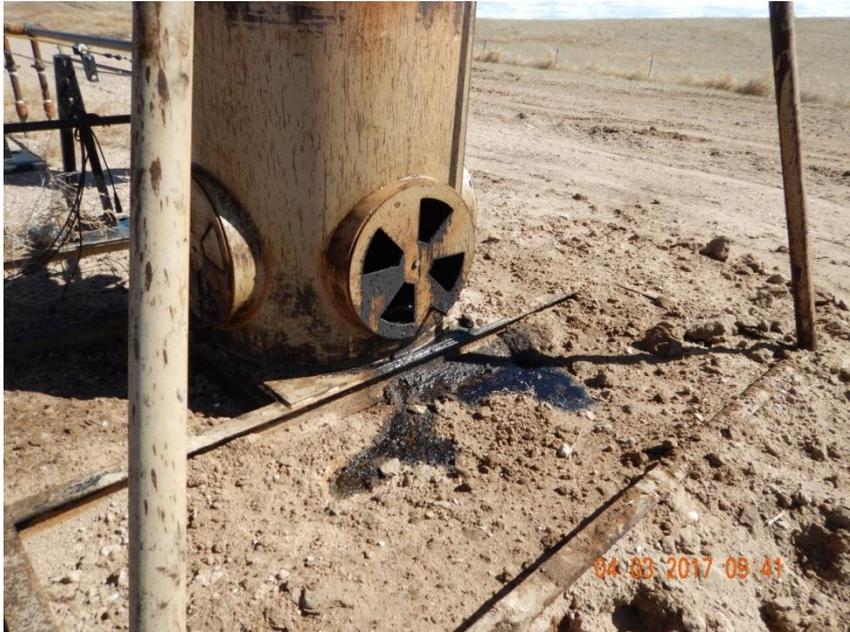
Photo 9. Photo taken on April 3, 2017 from the southeast production area, facing East. Equipment leaking hydrocarbon like odor.

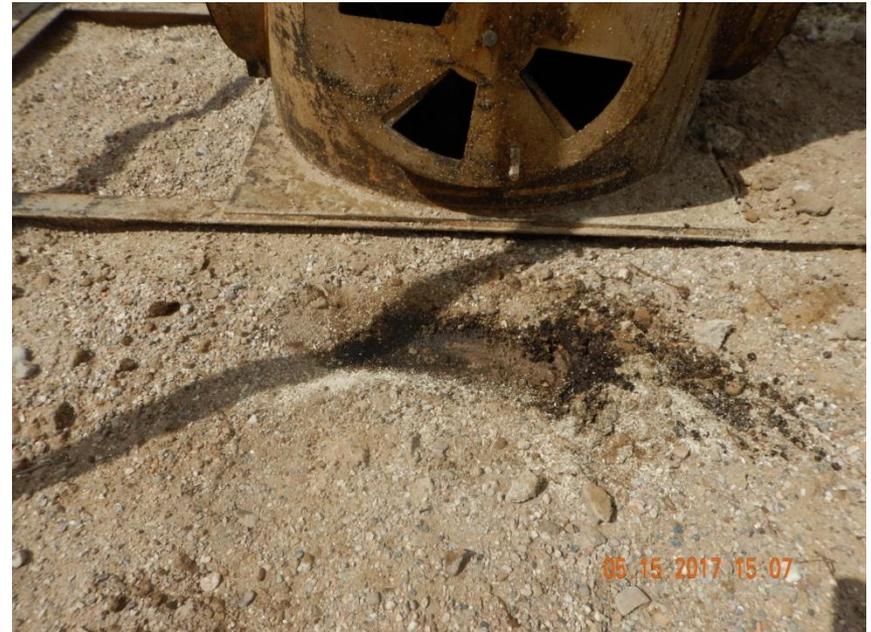
Photo 10. Photo taken on May 15, 2017 from the southeast production area. It appears the impacted soil around the equipment has not been removed. Removal of 1"-2" of gravel on top reveals stained soil with a hydrocarbon like odor.
