# Interim Reclamation and Stormwater Inspection

May 16, 2017

Operator: BURLINGTON RESOURCES OIL & GAS LP- #26580

API: 05-001-09805

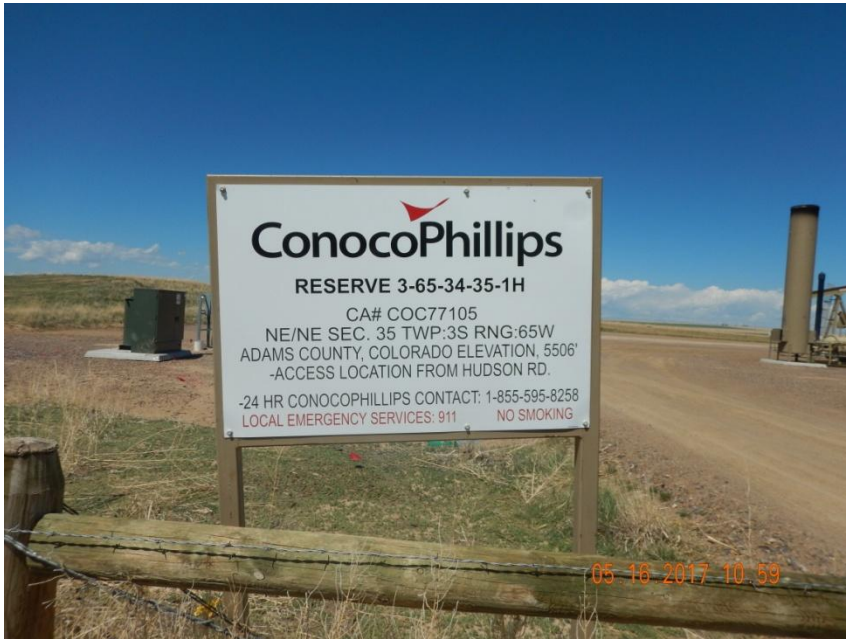
**Photo 1.** Well sign at location entrance.

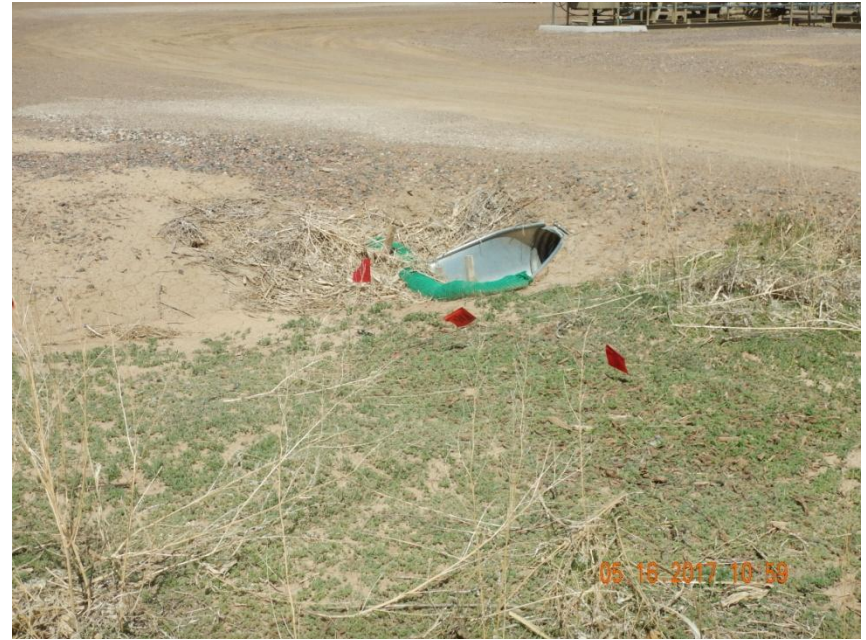
**Photo 2.** Photo taken from the entrance of location, facing Northwest. Inlet protection installed in conjunction with the culvert.

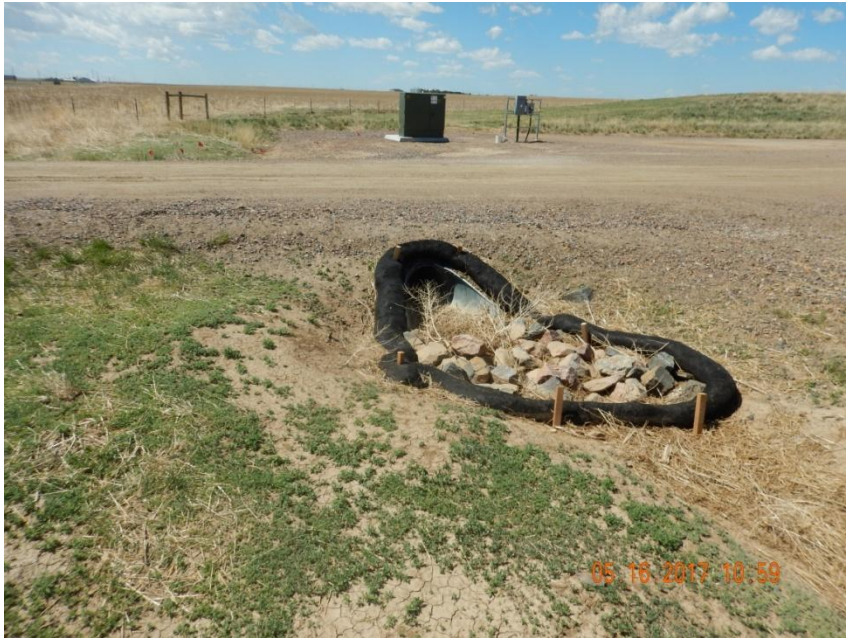
**Photo 3.** Photo taken from the entrance of location, facing South. Outlet protection installed in conjunction with the culvert.

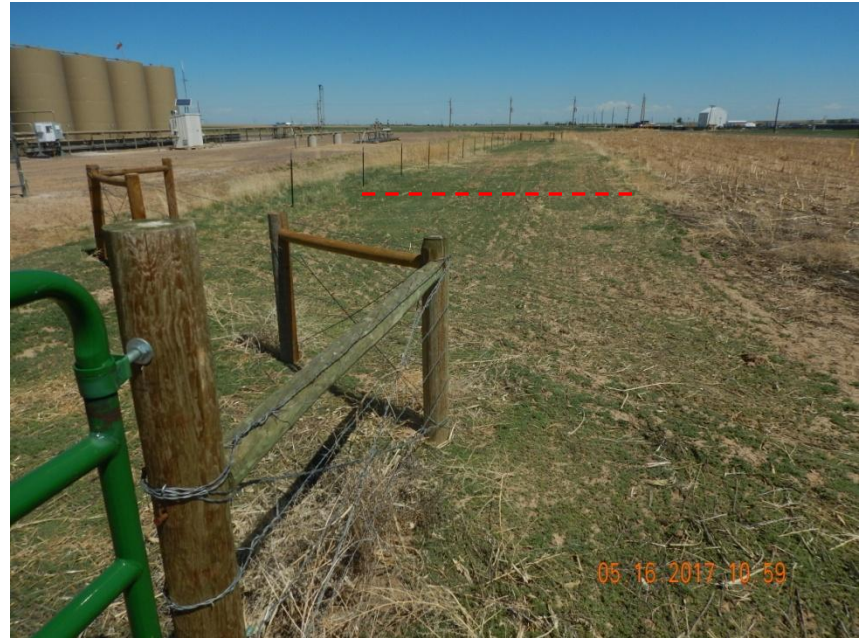
**Photo 4.** Photo taken from the entrance of location, facing North. Perimeter fence has been adjusted to reduce the disturbance area (red-dashed line) and make more land available to farm.

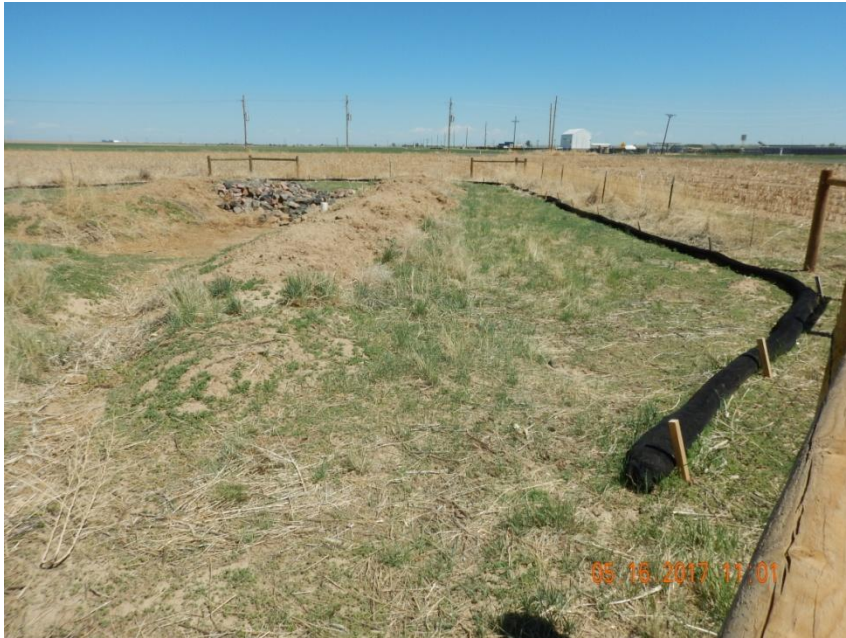
**Photo 5.** Photo taken from the northeastern perimeter of the location, facing North. Wattle BMPs have been repaired/replaced around the sediment trap BMP.

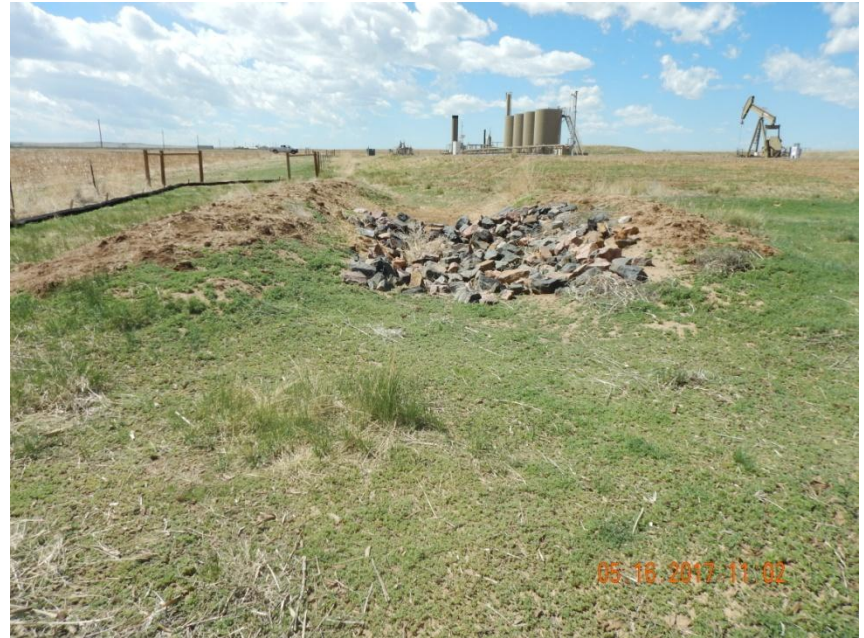
**Photo 6.** Photo taken from the northeastern perimeter of the location, facing South. Sediment trap BMP installed with outlet protection device BMPs.

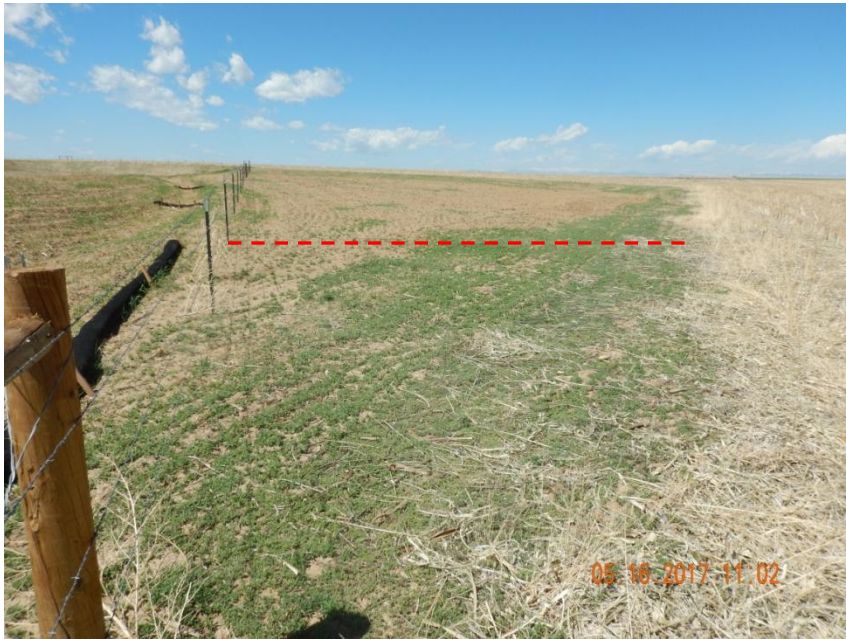
**Photo 7.** Photo taken from the northern perimeter of the location, facing West. Perimeter fence has been adjusted to reduce the disturbance area (red-dashed line) and make more land available to farm.

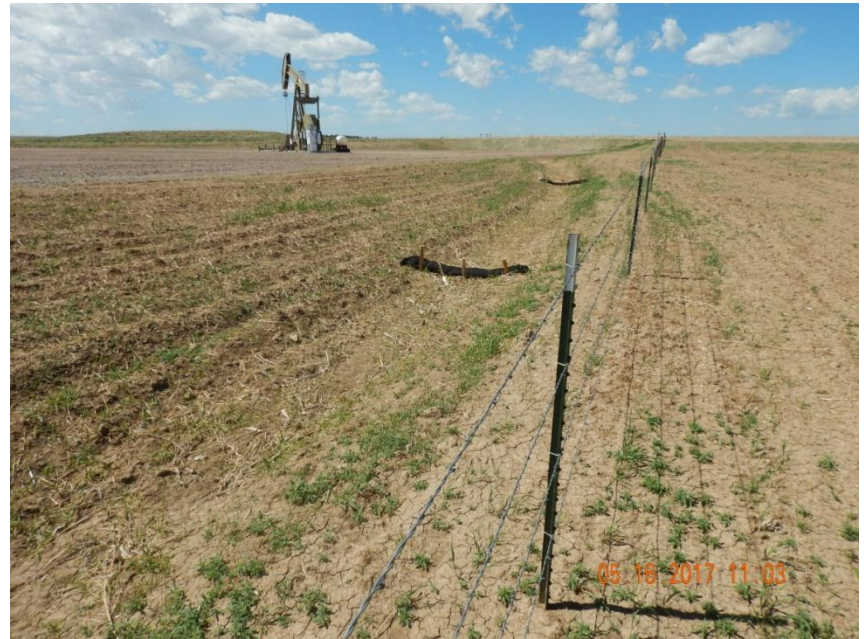
**Photo 8.** Photo taken from the northwestern perimeter of the location, facing Southwest. Wattle BMPs along the perimeter of the location have been repaired/replaced.

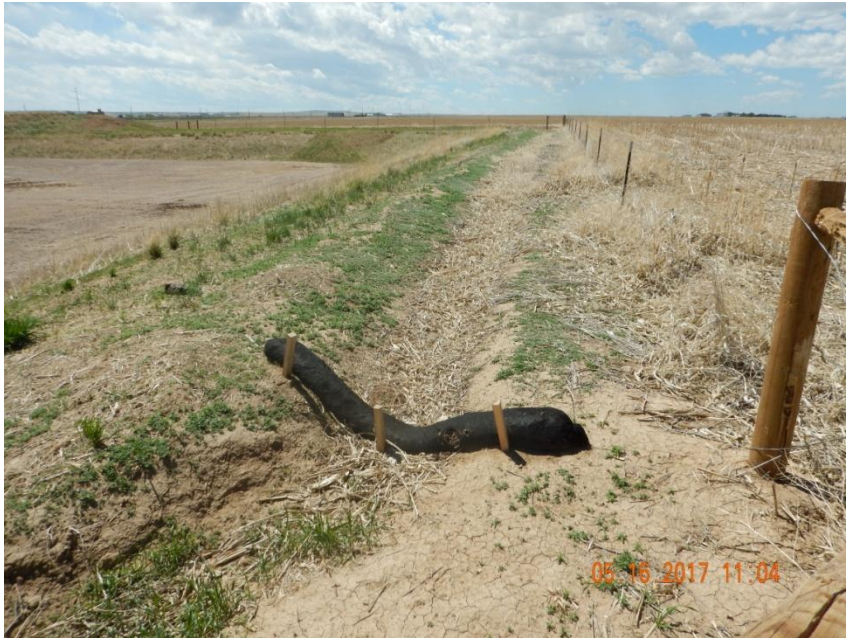
**Photo 9.** Photo taken from the western perimeter of the location, facing South. Wattle BMPs along the perimeter of the location have been repaired/replaced.

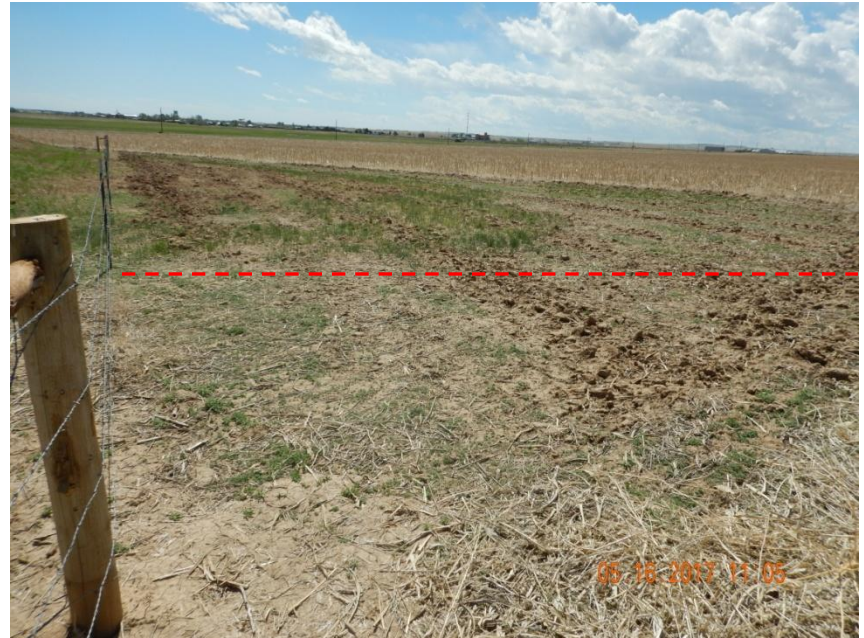
**Photo 10.** Photo taken from the southwest perimeter of the location, facing Southeast. Perimeter fence has been adjusted to reduce the disturbance area (red-dashed line) and make more land available to farm. Appears this portion of the location was where topsoil was previously. Topsoil was used during the interim reclamation work.

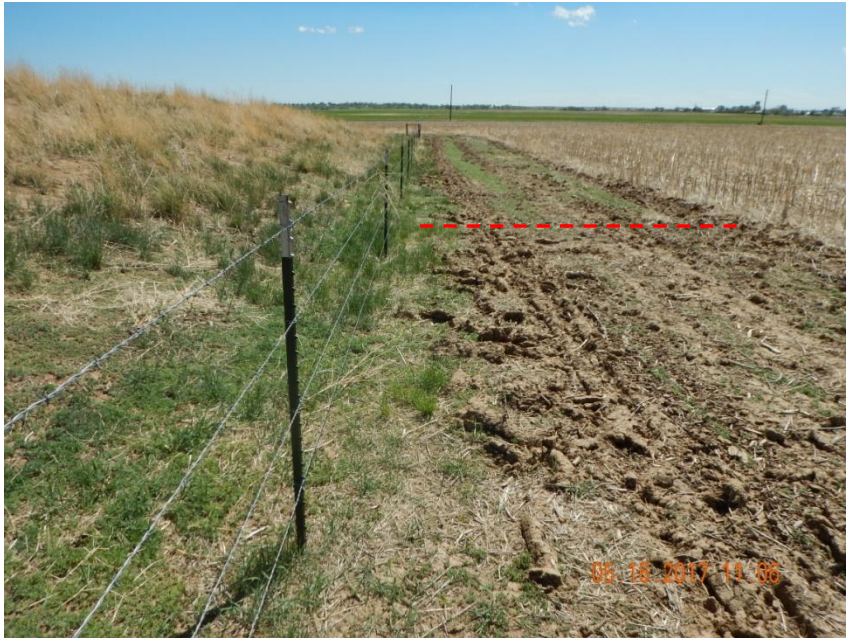
**Photo 11.** Photo taken from the southern perimeter of the location, facing East. Perimeter fence has been adjusted to reduce the disturbance area (red-dashed line) and make more land available to farm.

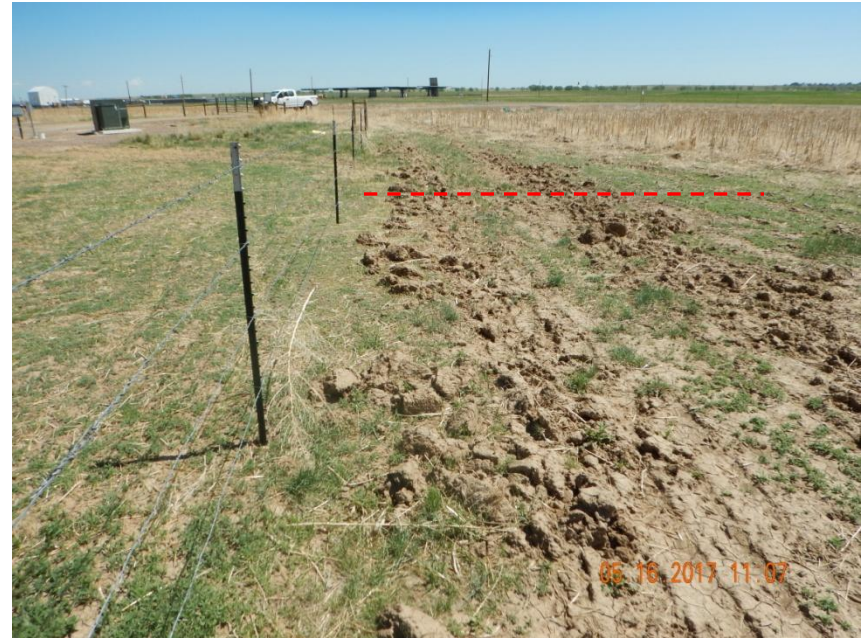
**Photo 12.** Photo taken from the southeastern perimeter of the location, facing Northeast. Perimeter fence has been adjusted to reduce the disturbance area (red-dashed line) and make more land available to farm.

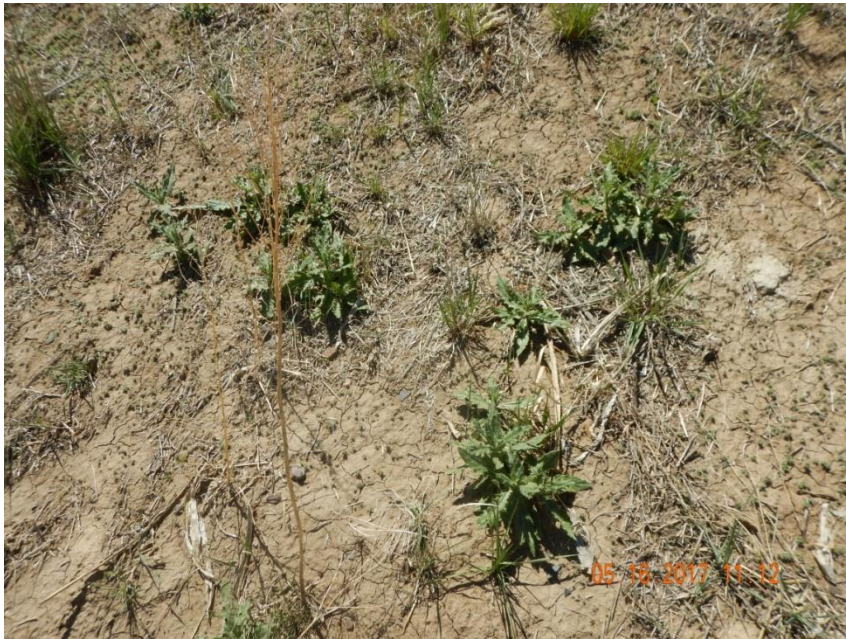
**Photo 13.** Photo taken from the north-facing topsoil stockpile. Canada thistle (*Cirsium arvense*) was observed in small amounts.

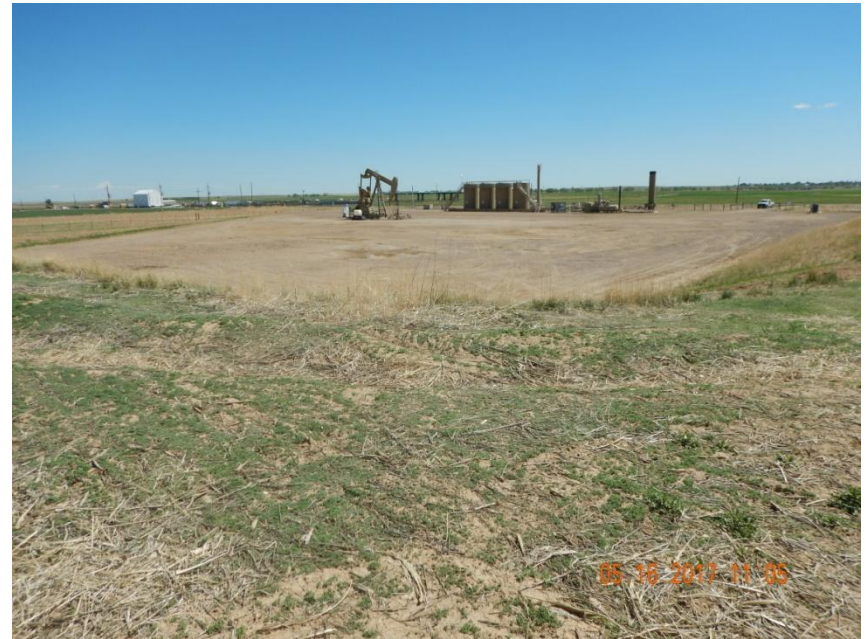
**Photo 14.** Photo taken from the southwestern perimeter of the location, facing Northeast. It appears portions of the production area could have been further reduced in size- see following photos.

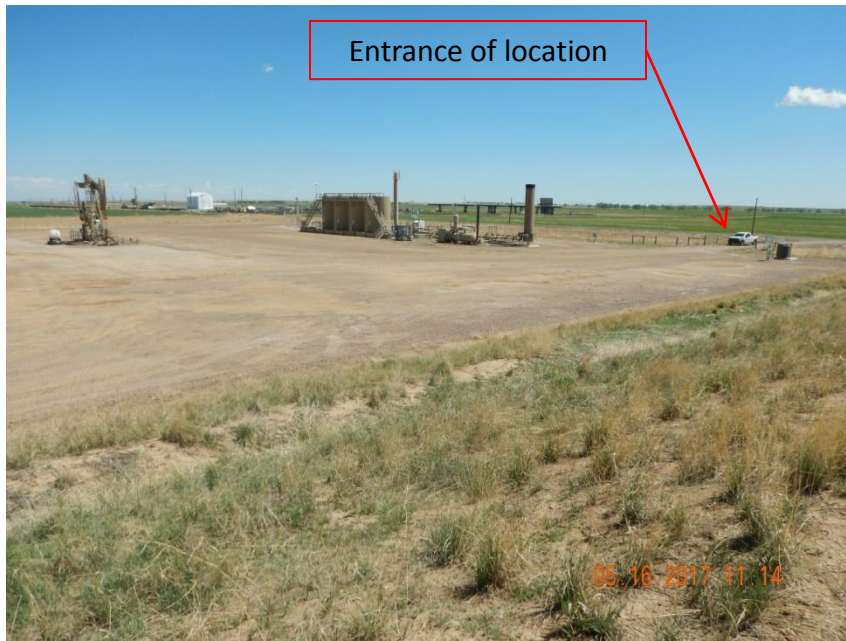
**Photo 15.** Photo taken from the topsoil stockpile, facing Northeast. Photo illustrates the equipment and facilities on along the production areas.

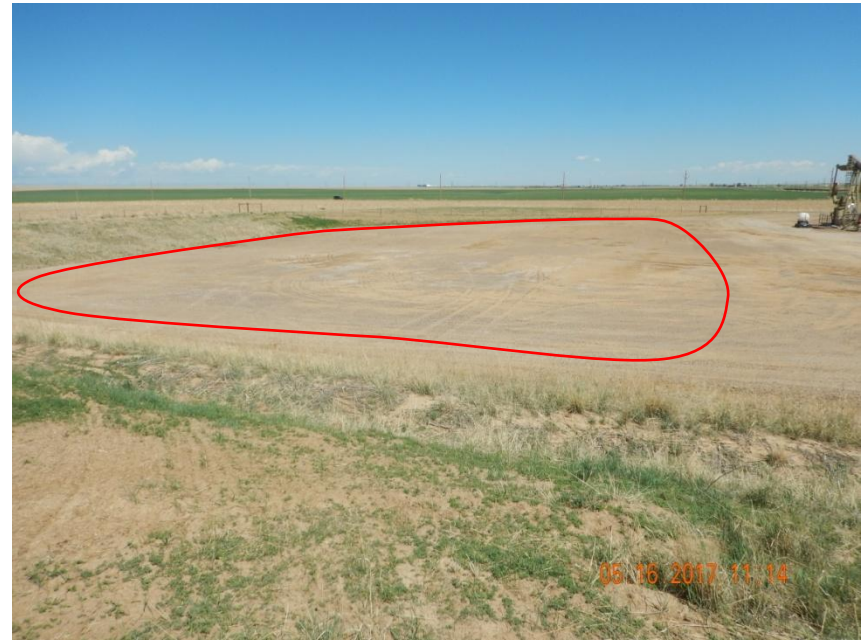
**Photo 16.** Photo taken from the topsoil stockpile, facing North. Photo illustrates areas along the western production area that do not appear to be necessary for production activity (highlighted in red). If this area is not needed for production activities, the area should comply under Rule 1003.b.
