# Interim Reclamation and Stormwater Inspection

May 16, 2017

Operator: BURLINGTON RESOURCES OIL & GAS LP- #26580

API: 05-005-07180

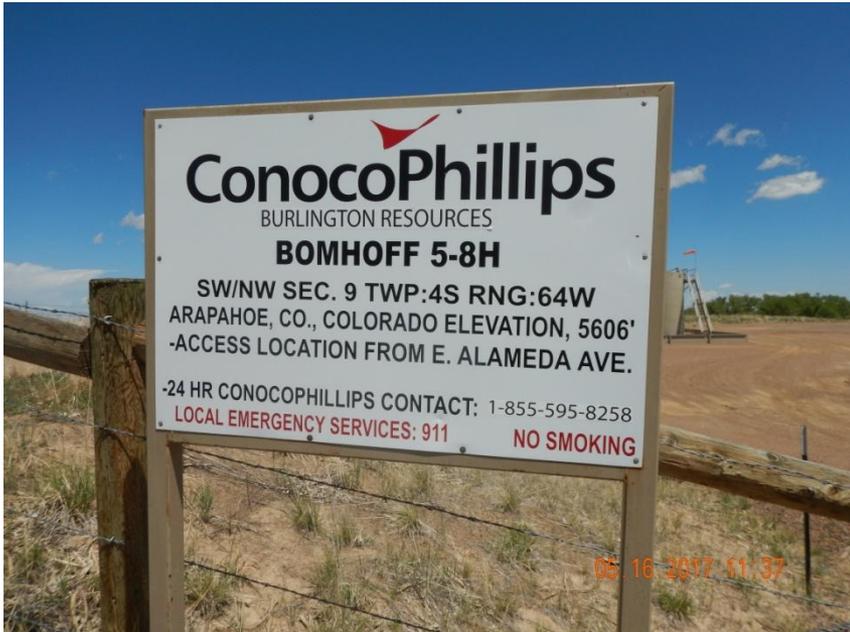
**Photo 1.** Well sign at location entrance.

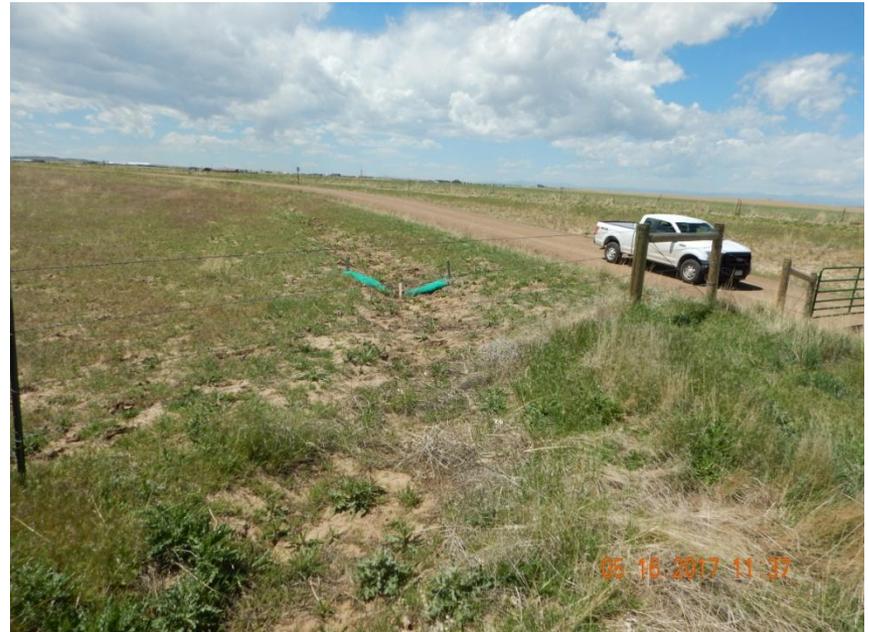
**Photo 2.** Photo taken from the entrance of location, facing Southwest. Appears a diversion ditch has been installed to control run-on onto location. Wattle BMPs are in need of repair.

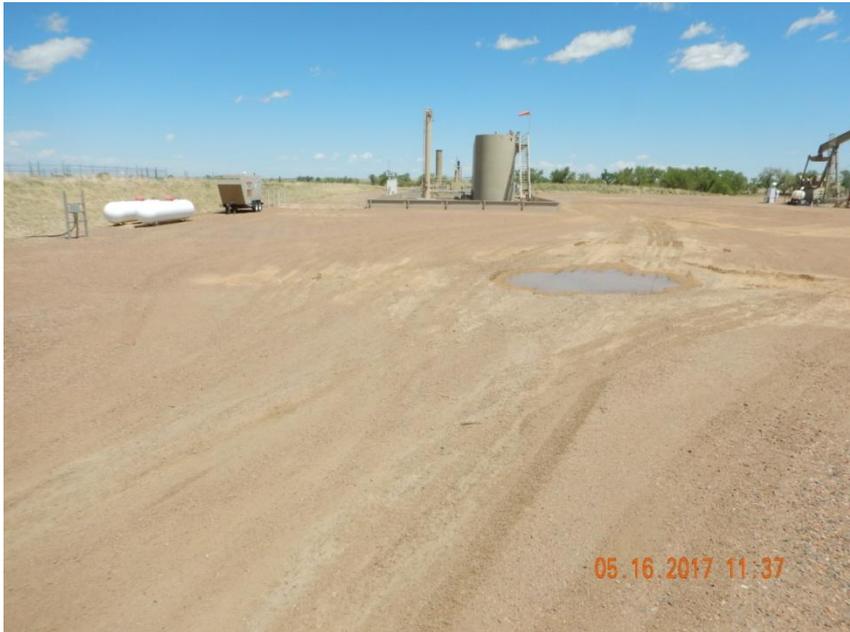
**Photo 3.** Photo taken from the entrance of location, facing North. Photo illustrates the equipment and facilities on along the production areas.

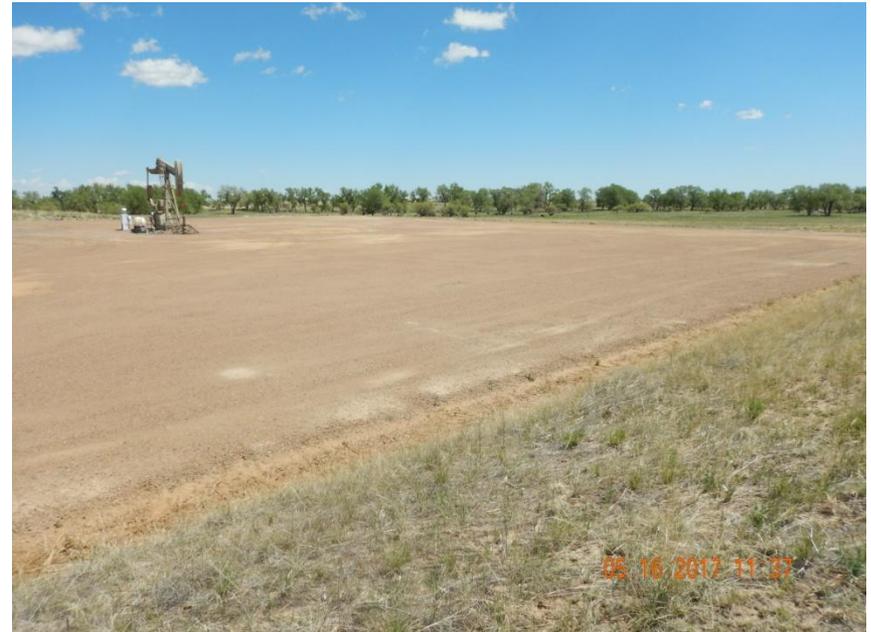
**Photo 4.** Photo taken from the entrance of location, facing Northeast. Photo illustrates areas along the eastern production area that do not appear to be necessary for production activity and shall comply under Rule 1003.b.

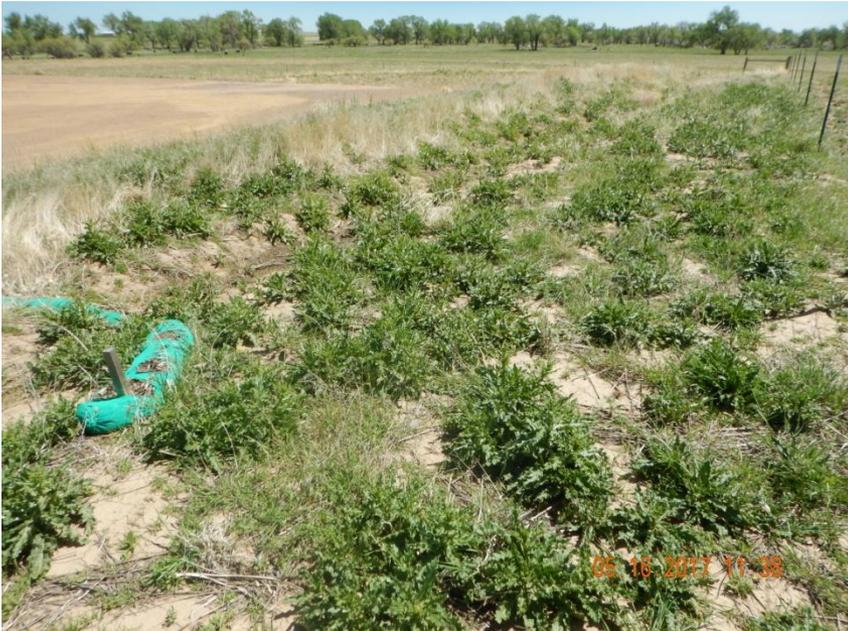
**Photo 5.** Photo taken from the southern perimeter of the location, facing East. Appears a diversion ditch has been installed to control run-on onto location. Wattle BMPs are in need of repair. Canada thistle (*Cirsium arvense*) was observed throughout the perimeter of the location.

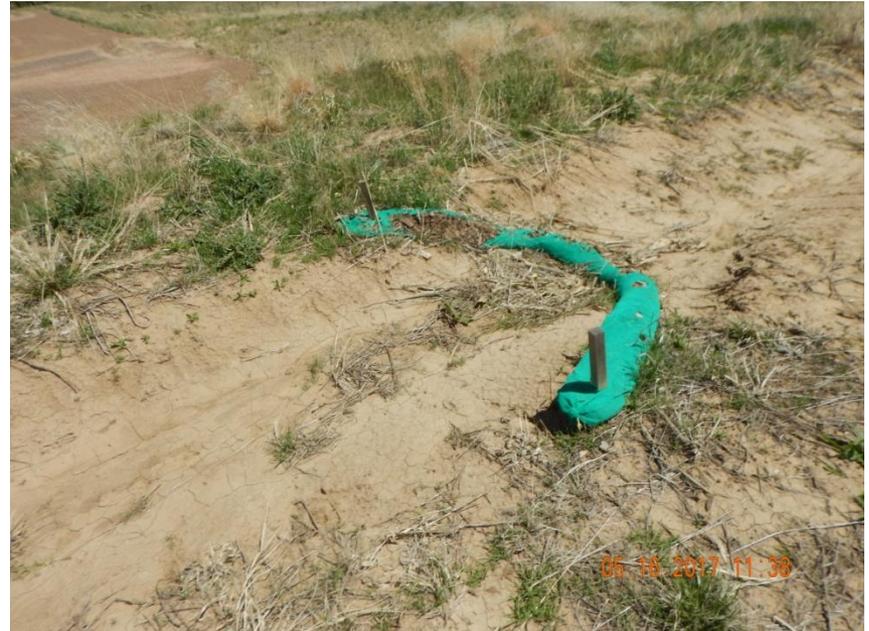
**Photo 6.** Photo taken along the southern diversion ditch illustrating a wattle BMP in need of repair.

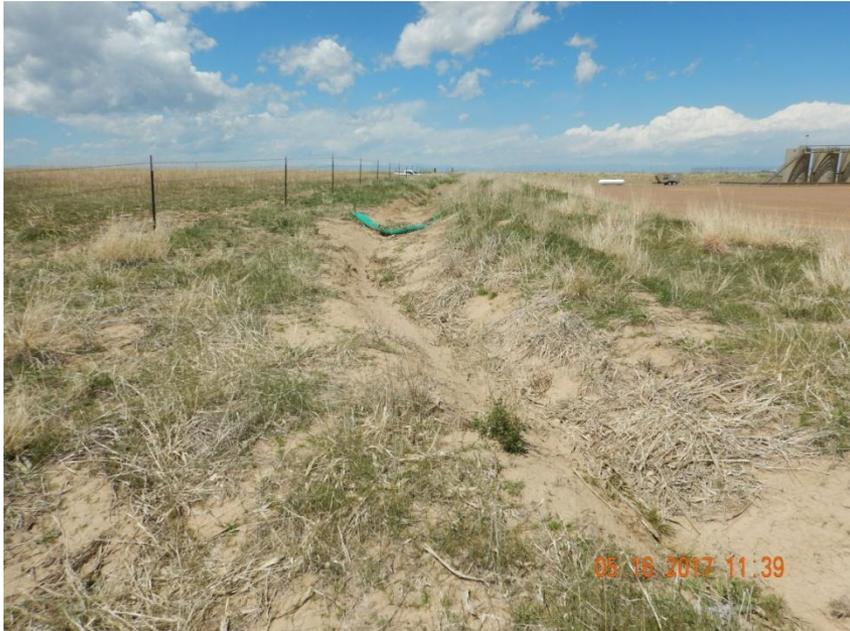
**Photo 7.** Photo taken from the southeast perimeter of the location, facing West. Photo illustrates the diversion ditch BMP that has been installed to control run-on onto location.

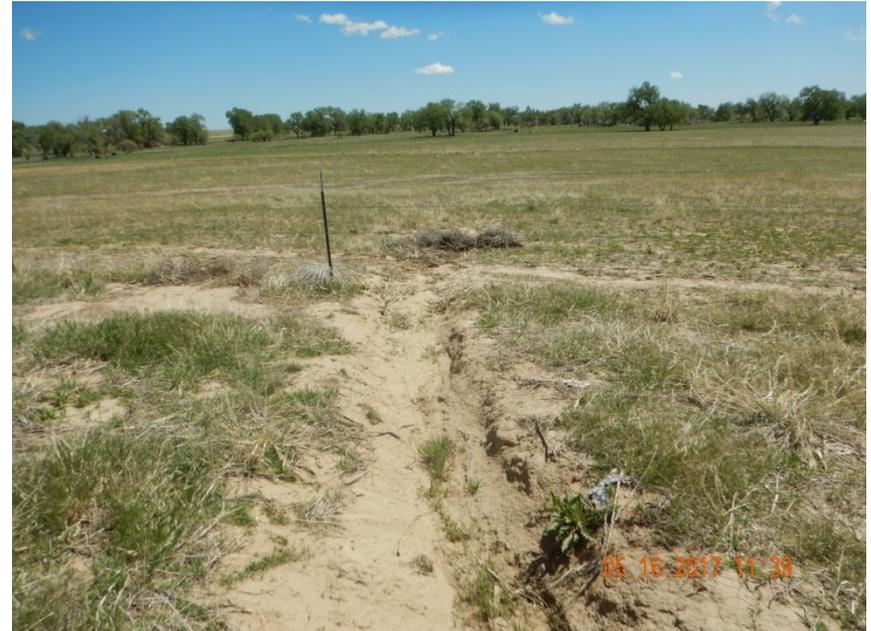
**Photo 8.** Photo taken from the previous photo location, facing East. The diversion ditch BMP does not have any form of a stabilized outlet structure to prevent sediment laden stormwater from leaving location. It appears sediment is being discharged off location and shall comply under Rule 1002.f.

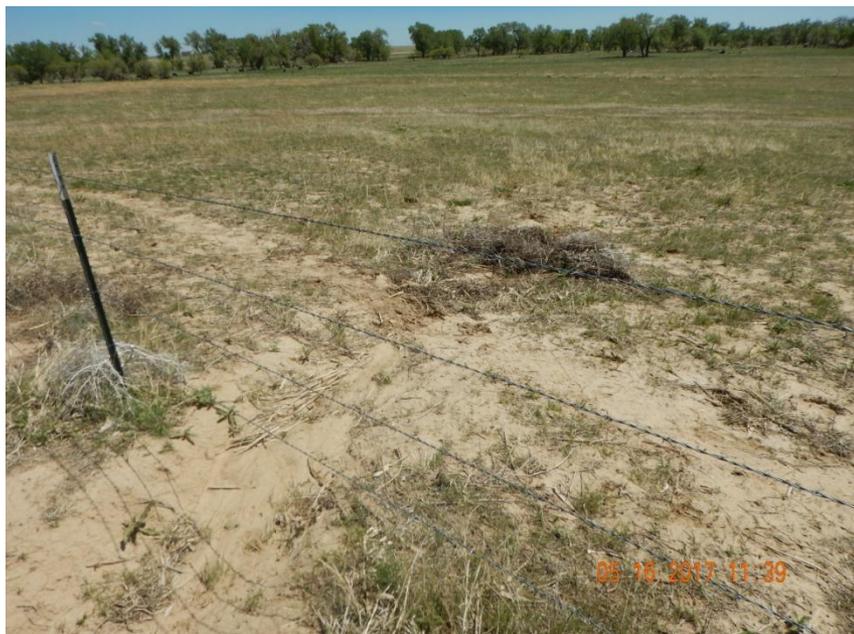
**Photo 9.** Photo taken along the perimeter of the location and the adjacent land, facing East. The diversion ditch BMP does not have any form of a stabilized outlet structure to prevent sediment laden stormwater from leaving location. It appears sediment is being discharged off location and shall comply under Rule 1002.f.

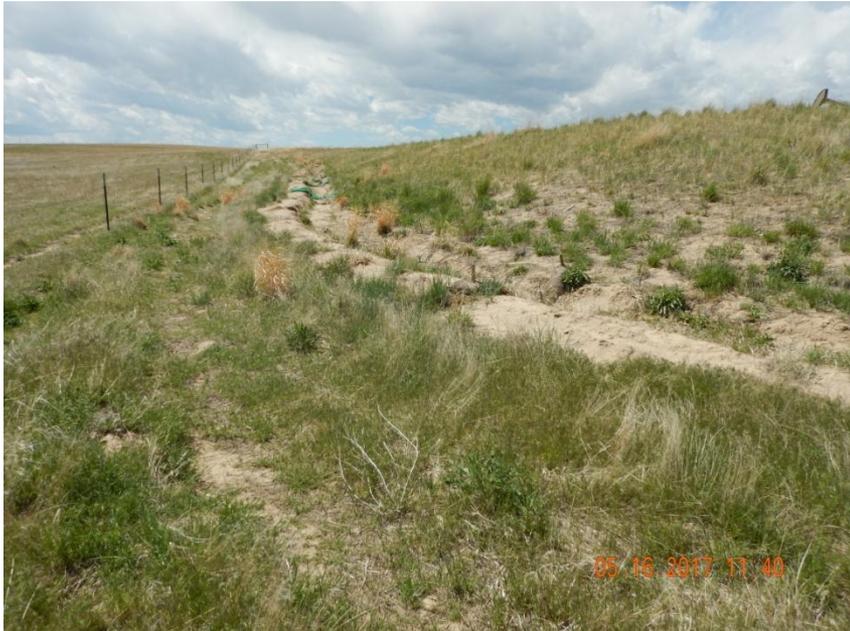
**Photo 11.** Photo taken along the northeast perimeter of the location, facing South. Diversion ditch BMP installed in conjunction with wattle BMPs which is directed to a sediment trap. Wattle BMPs are in need or repair.

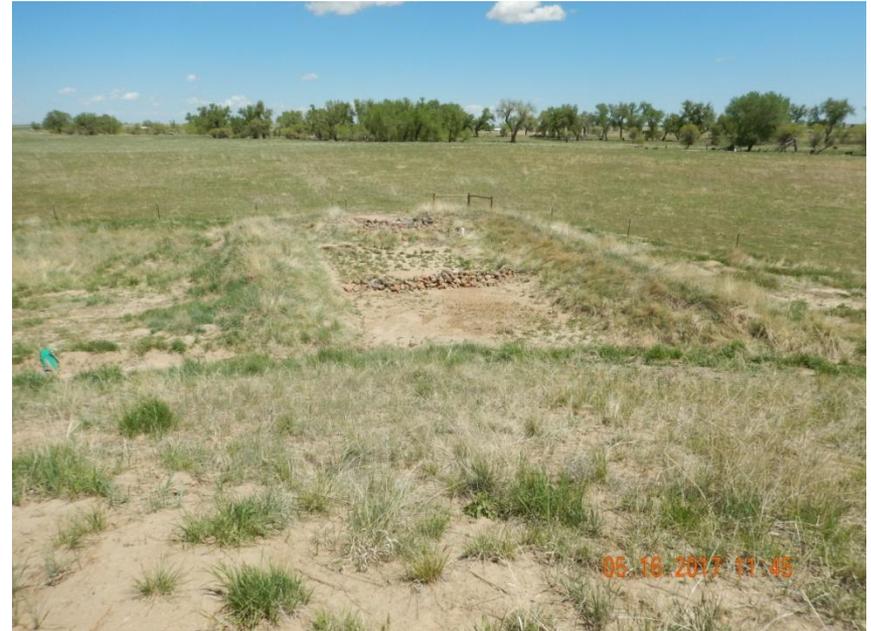
**Photo 12.** Photo taken from the northeast production area, facing North. Photo illustrates the sediment trap BMP that has been installed.

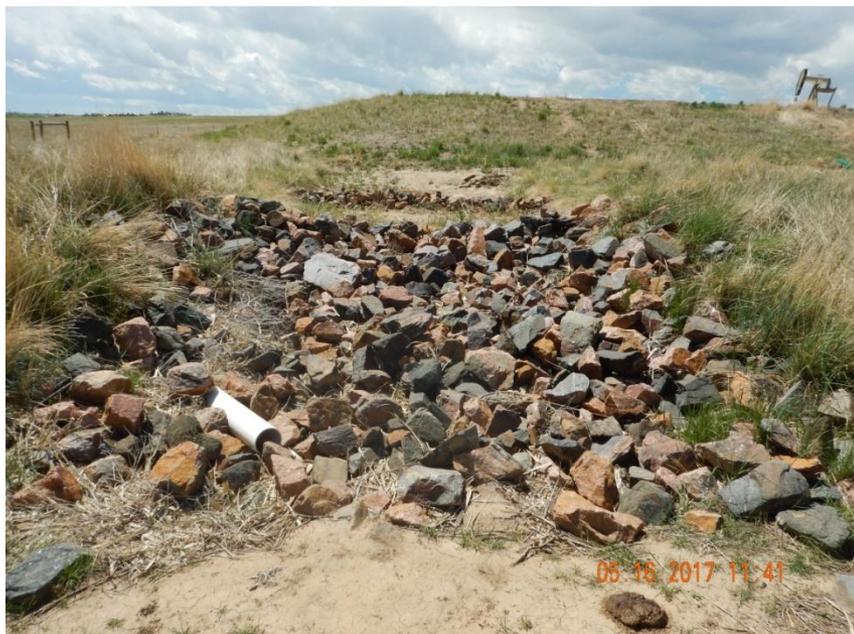
**Photo 13.** Photo taken along outlet area of the sediment trap, facing South. Outlet protection device BMPs have been installed in conjunction with the sediment trap.

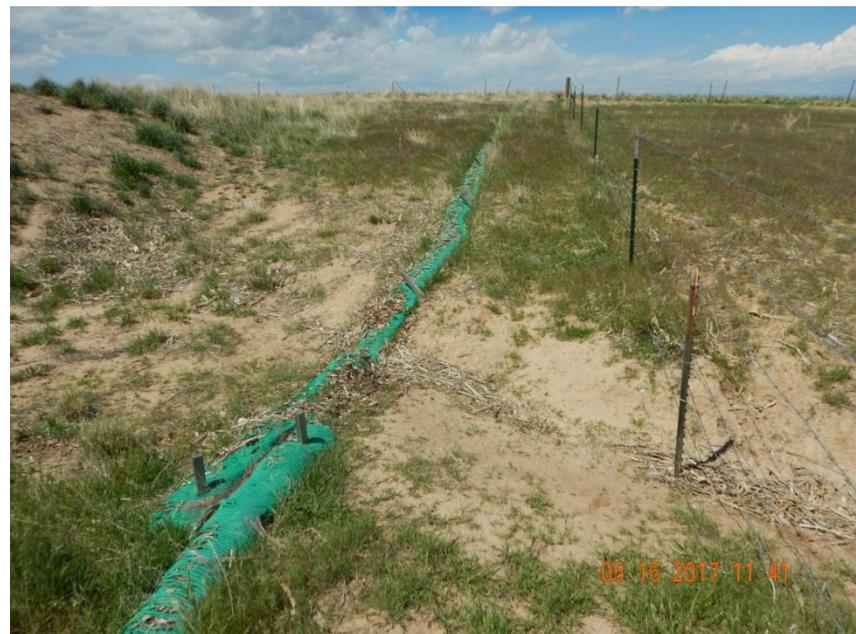
**Photo 14.** Photo taken along the northwestern perimeter of the location, facing West. Wattle BMPs are in need or repair. It is unclear whether erosion from the oil and gas location has caused a gully formation or whether that was previously existing. Wattle BMPs might be an insufficient BMP by itself to ensure sediment laden stormwater from leaving location.

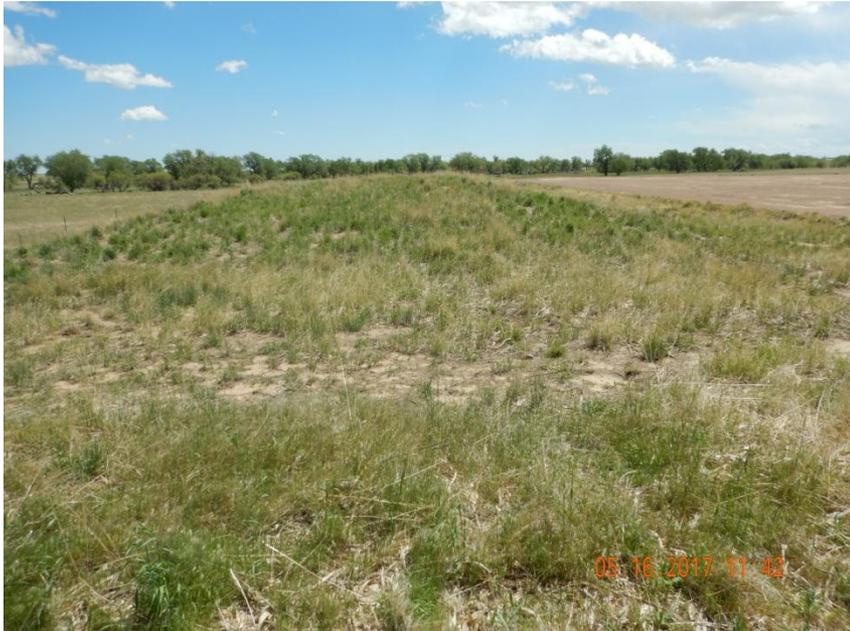
**Photo 15.** Photo taken along the northwest perimeter of the location, facing East. Soil stockpile, likely topsoil, has been stored along the northern perimeter of the location.
