# Stormwater Inspection

May 22, 2017

Operator: EXTRACTION OIL & GAS LLC - #10459

Location ID: 439079

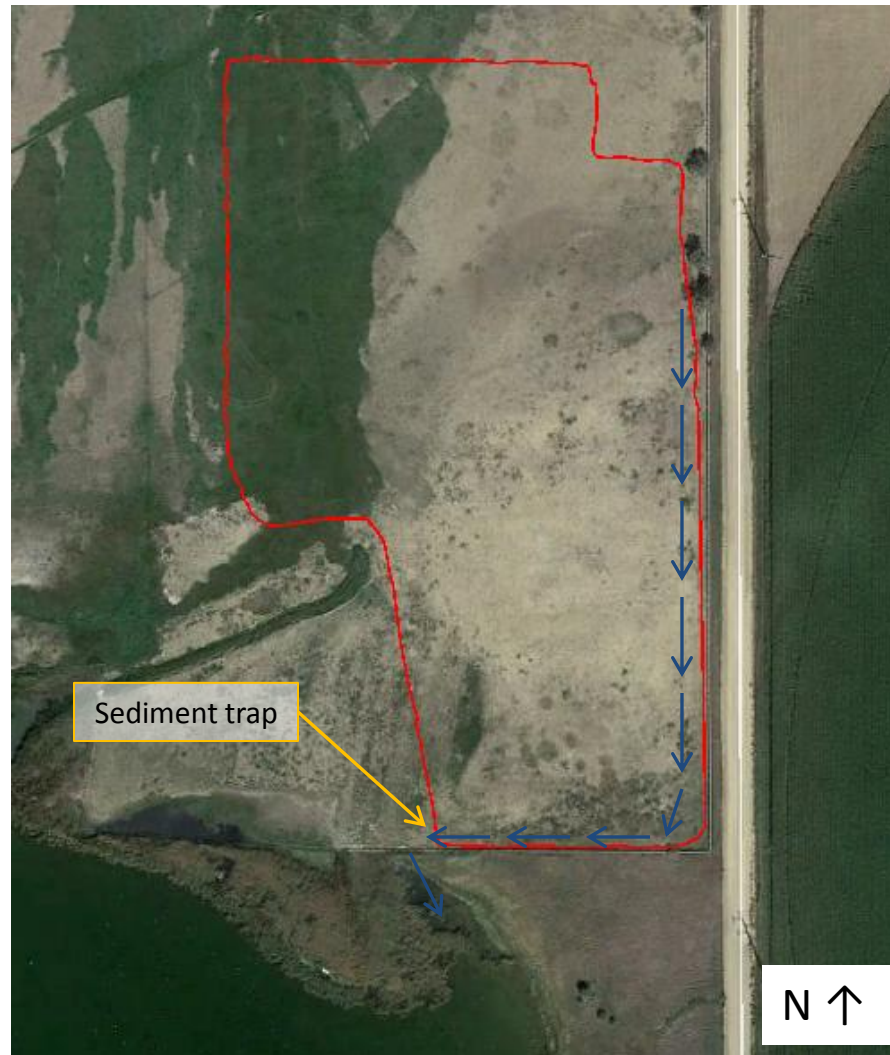
Google Earth aerial photo taken 9/7/2016 illustrating the Kennedy location in relation to Newell Lake to the southwest. The Kennedy location construction started on January 30, 2017 (Form 42 Document #401196319). The perimeter of the Kennedy location, red line, was mapped on February 22, 2017 using a handheld Trimble device. Blue arrows illustrate the direction standing stormwater was being pumped from the location into the perimeter ditch BMP which was directed to a sediment trap, on May 22, 2017. See the following photos for more details.

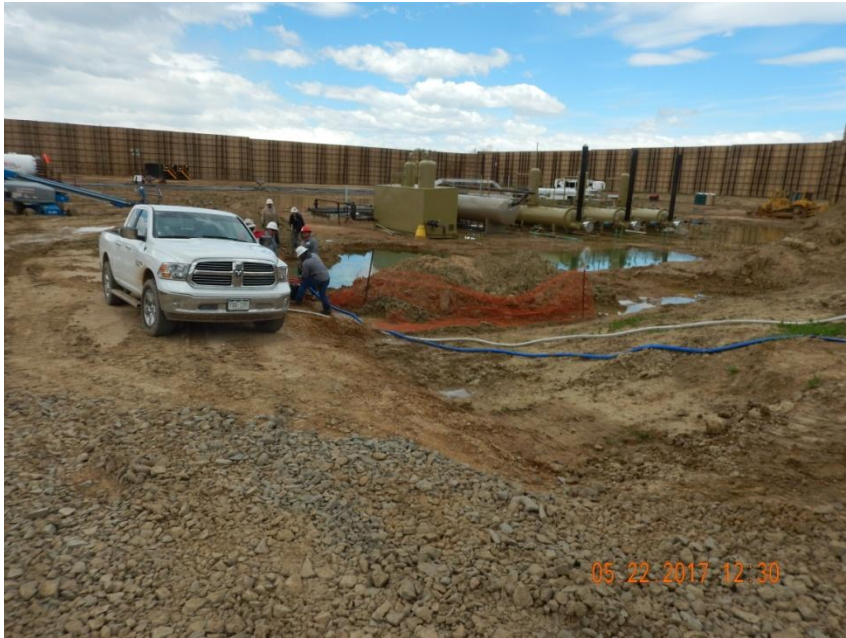
**Photo 1.** Photo taken from the entrance of the location, facing West. Photo illustrates the Operator pumping standing stormwater from location into the perimeter ditch BMP.

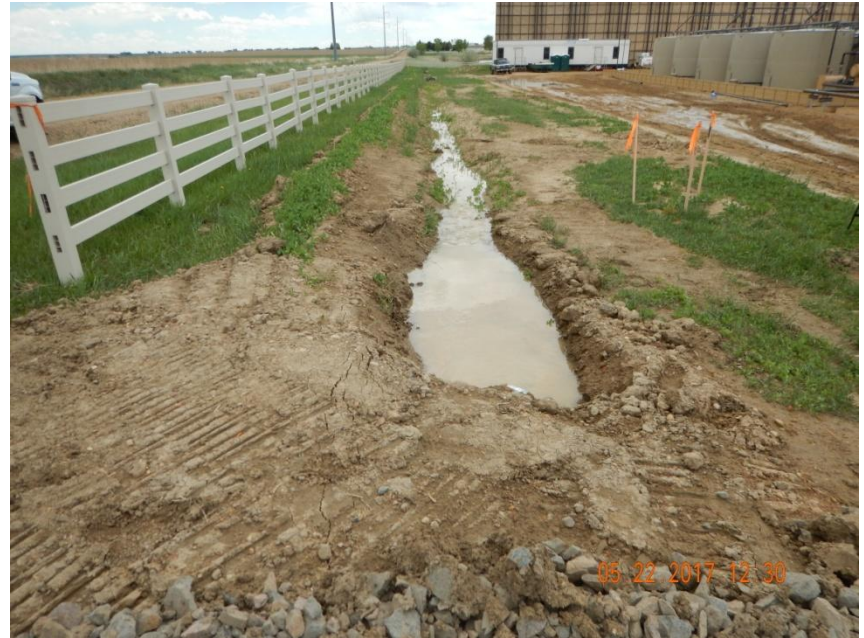
**Photo 2.** Photo taken from the entrance of the location, facing South along the perimeter ditch BMP. Photo illustrates standing stormwater from location being pumped into the perimeter ditch BMP.

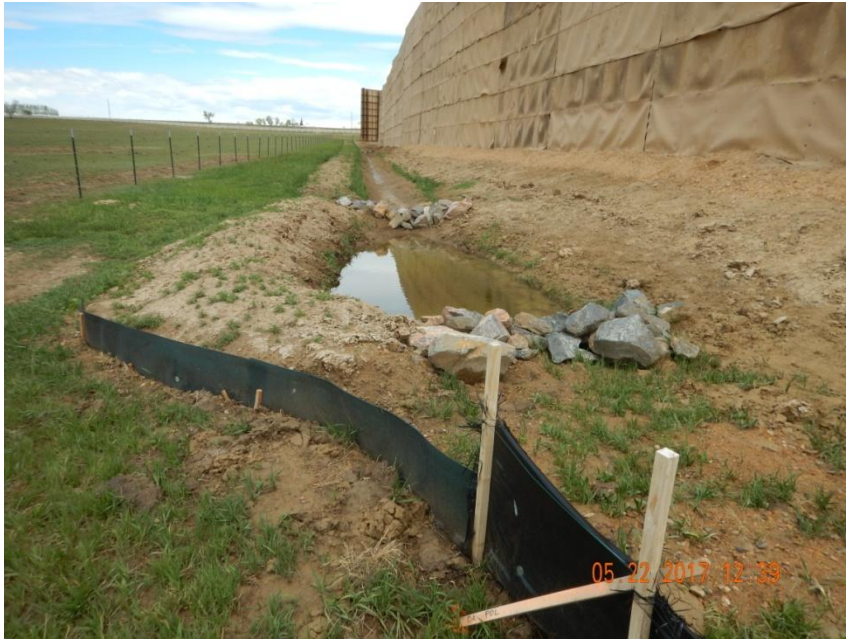
**Photo 3.** Photo taken from the western sediment trap, facing North. Sediment trap appears to be properly functioning. The Operator did not pump or direct stormwater from the location to this sediment trap.

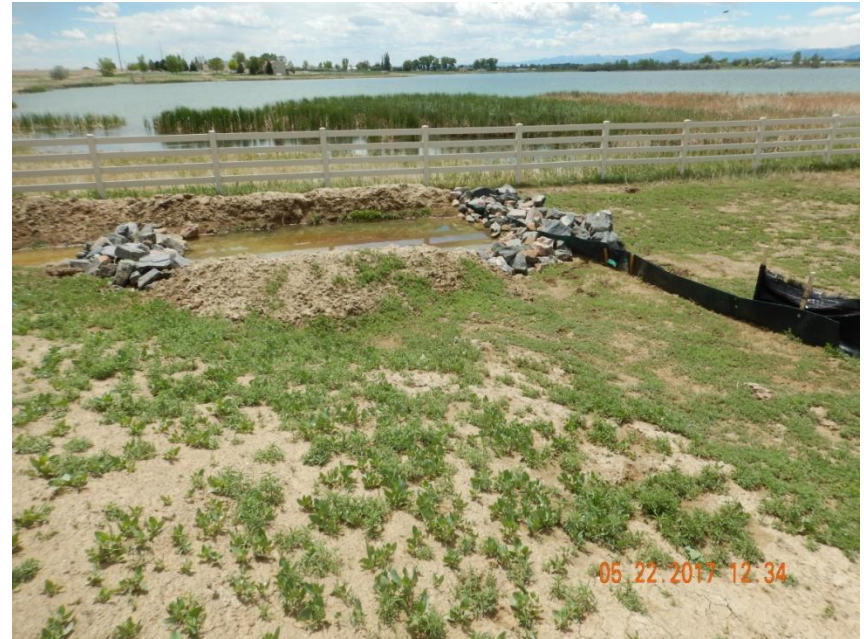
**Photo 4.** Photo taken from the southwestern sediment trap, facing South prior to the pumped stormwater from the location reaching the sediment trap. Sediment trap appears to be properly functioning at this time prior to pumping.

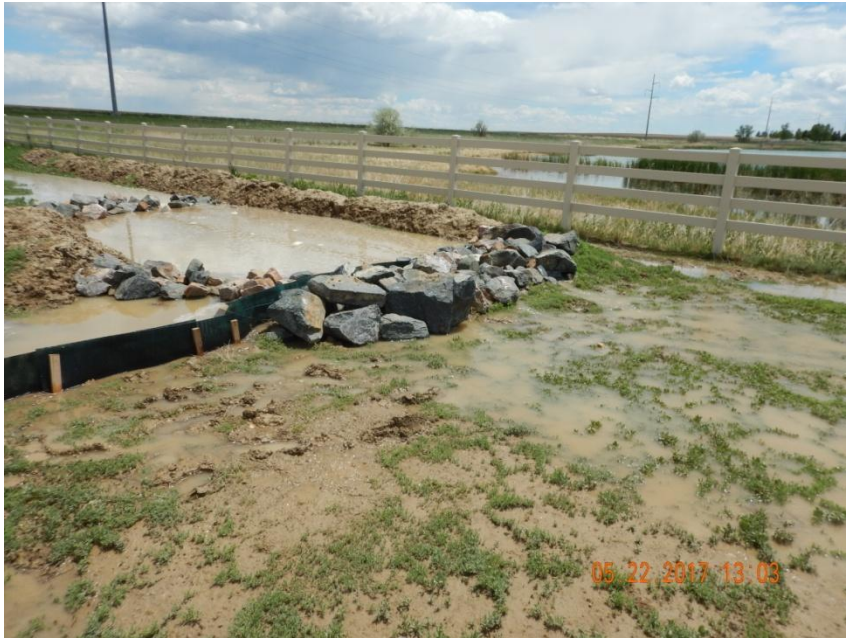
**Photo 5.** Photo taken from the southwest sediment trap, facing Southeast along the outfall area. Sediment laden stormwater is flowing through the sediment trap at an accelerated rate that is not allowing sediment to drop out prior to being discharged from location. S-Fence BMP does not appear to be an adequate BMP. In addition, discharged flows from the sediment trap are eroding the surface owners property off of the location west of the sediment trap which is contributing to additional sediment discharge into Newell Lake.

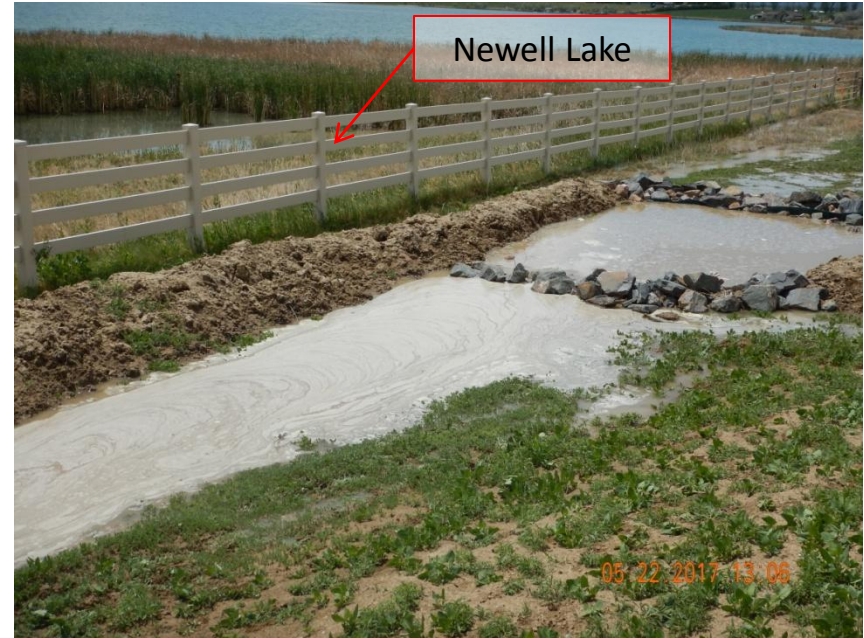
**Photo 6.** Photo taken from the southwest sediment trap, facing Southwest. Photo illustrates pumped sediment laden stormwater from the location being discharged from the sediment trap and its proximity to Newell Lake.

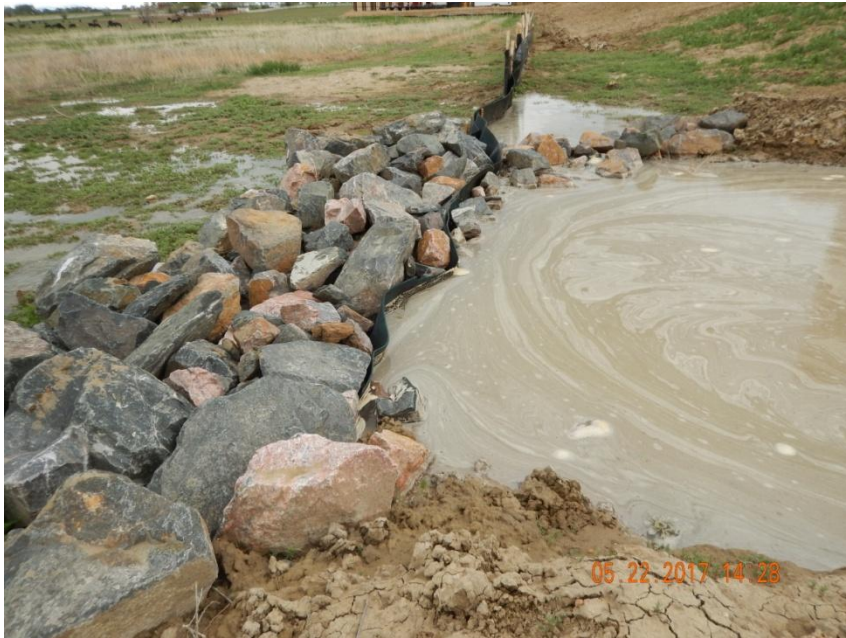
**Photo 7.** Photo taken from the southwest sediment trap, facing North. Photo illustrates pumped sediment laden stormwater from the location flowing through the sediment trap outfall at an accelerated rate that is not allowing sediment to drop out prior to being discharged from location, even with the S-Fence BMP.

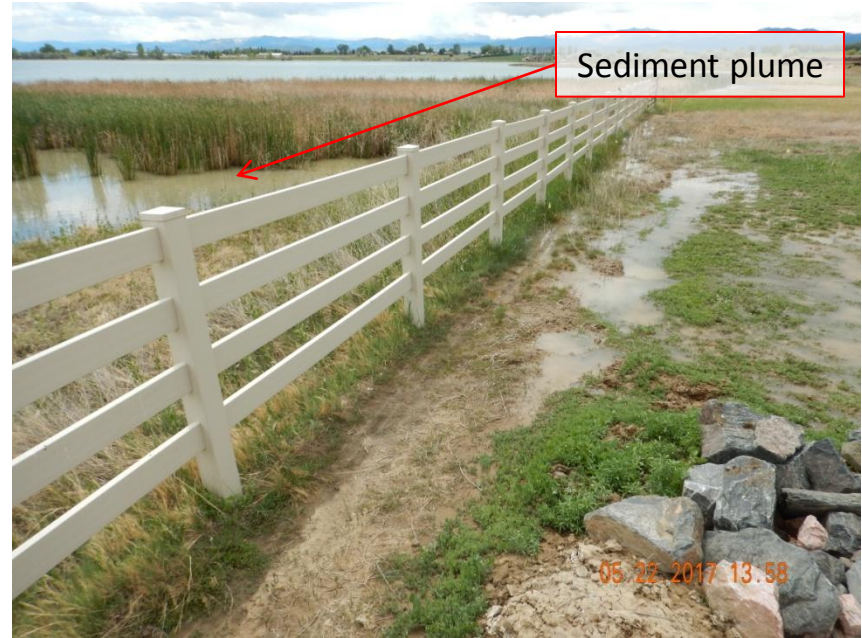
**Photo 8.** Photo taken from the southwest sediment trap, facing West. Photo illustrates pumped sediment laden stormwater from the location being discharged from location and areas west of the sediment trap that are contributing to additional sediment discharge into Newell Lake, ~20'-30' from the sediment trap. Photo also illustrates the sediment plume from sediment laden stormwater discharge flows from the location.

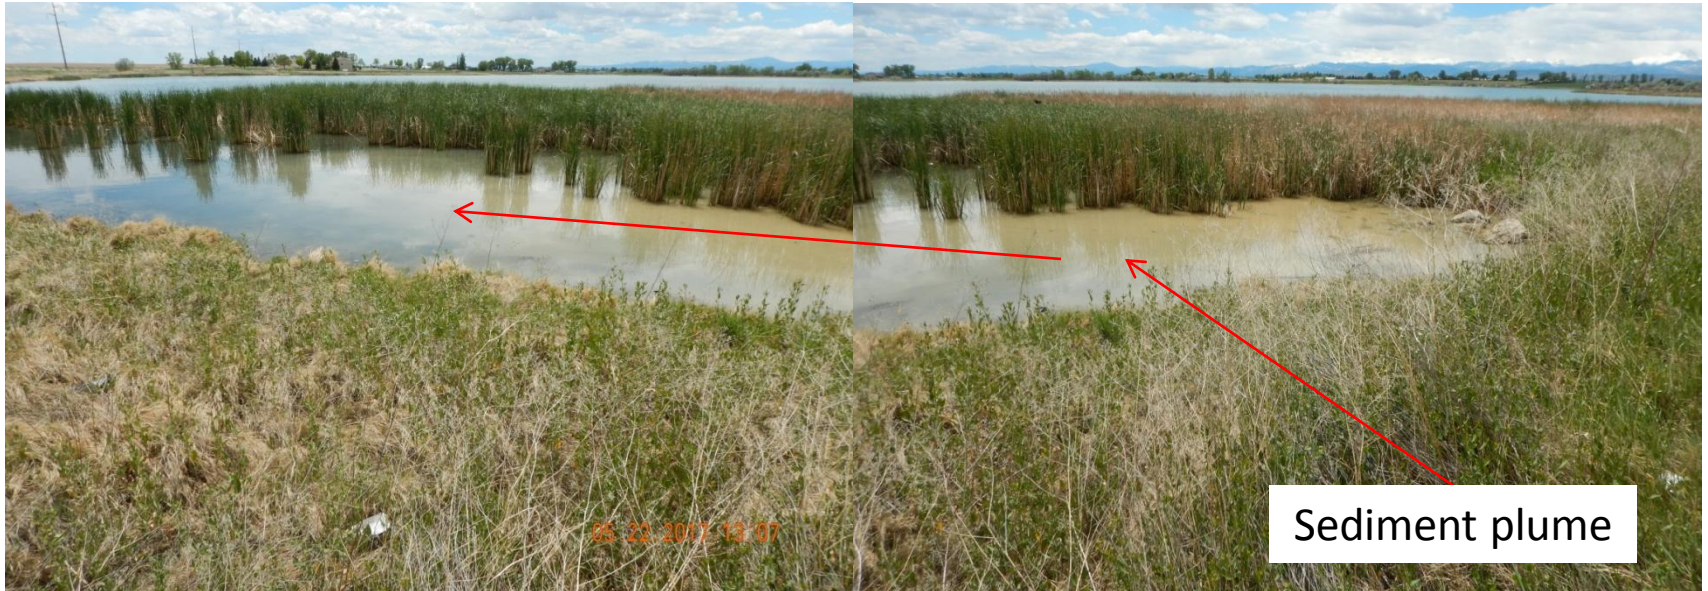
**Photo 9.** Photo taken from the northern Newell Lake area, facing South, adjacent to the Kennedy location illustrating the sediment plume from sediment laden stormwater discharge flows from the location.

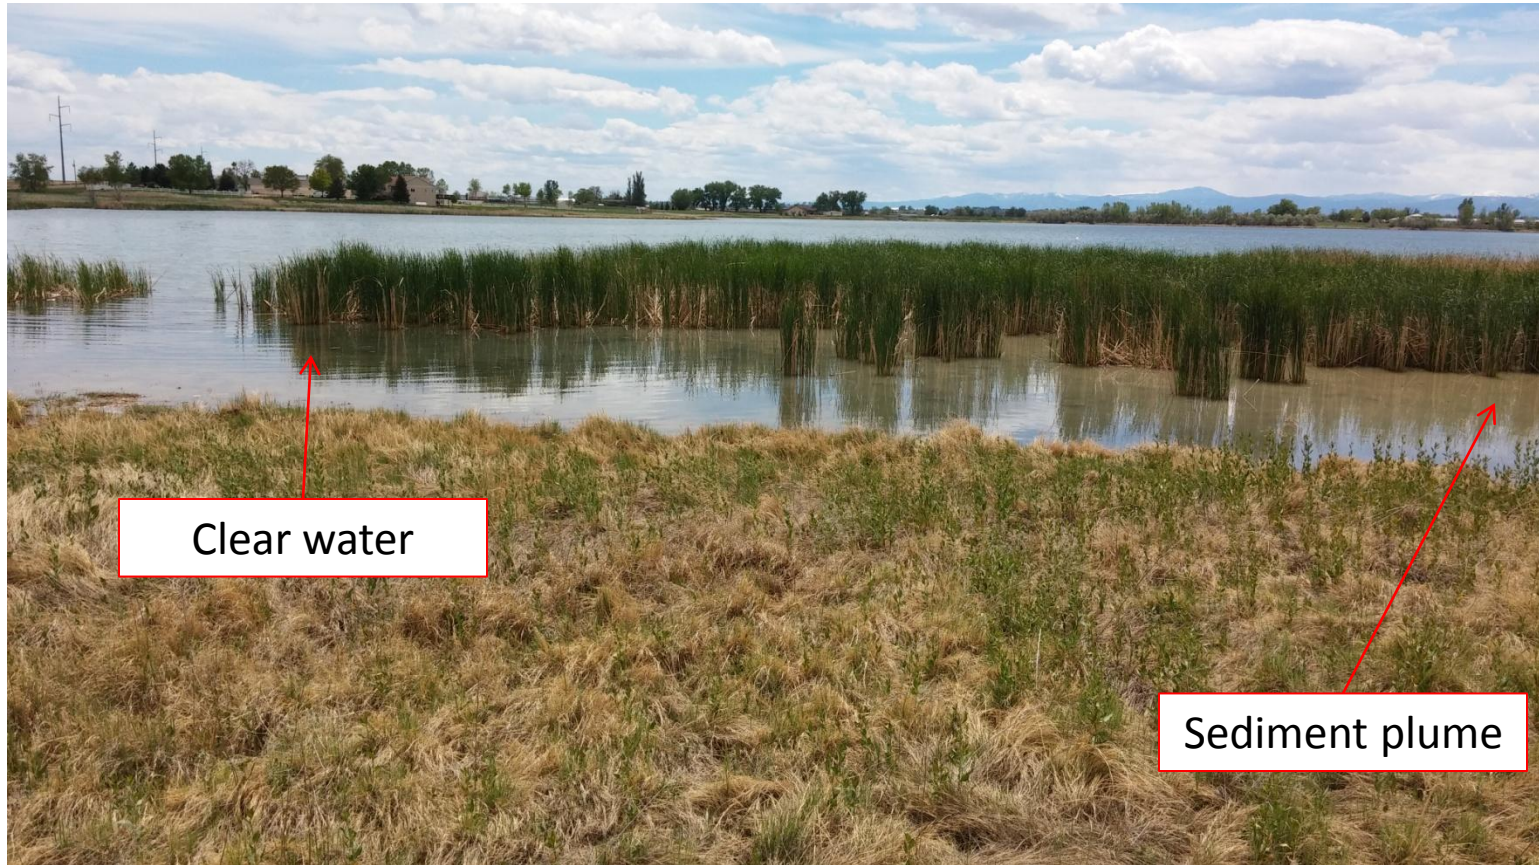
**Photo 10.** Photo taken from the northern Newell Lake area, facing South, adjacent to the Kennedy location approximately 20'-30' from the sediment trap. The photo illustrates the sediment plume, to the right of the screen, in relation to the clear, undisturbed water.
