Flowline Inspection Photos
Location Name: Orr #24-1
API: 05-123-14538

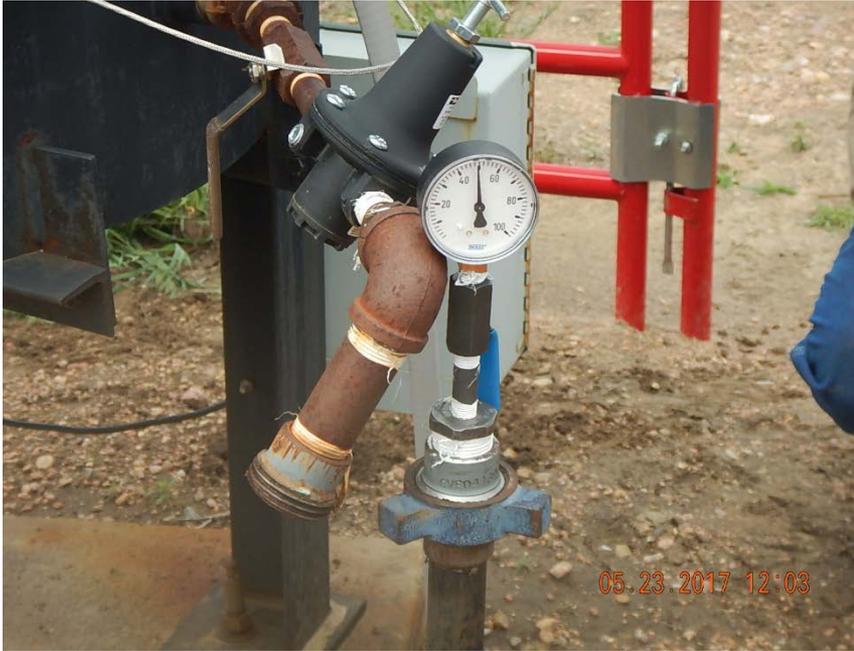
Photo 1: Pressure test on supply line for ECD

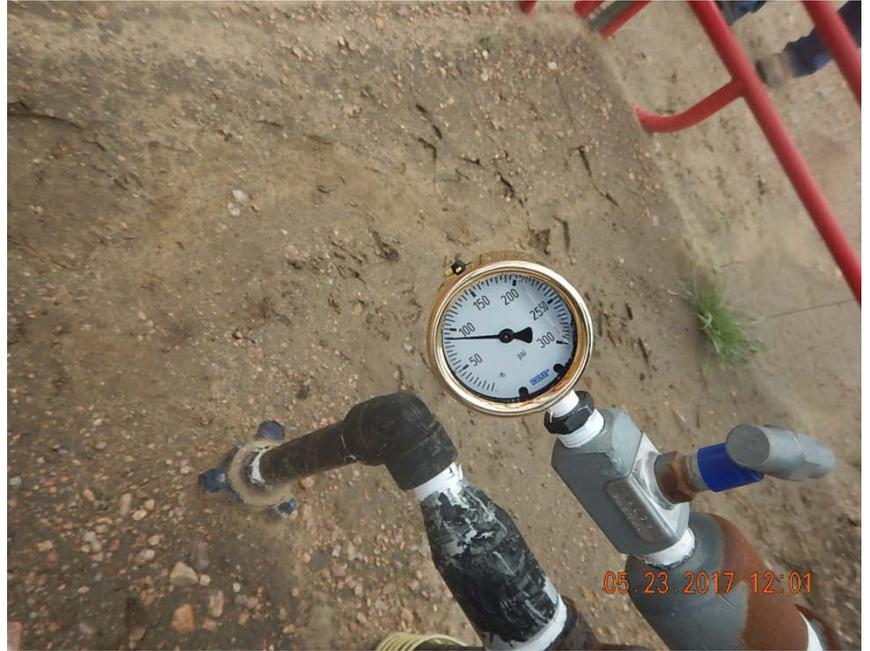
Photo 2: Pressure test for flare line on ECD

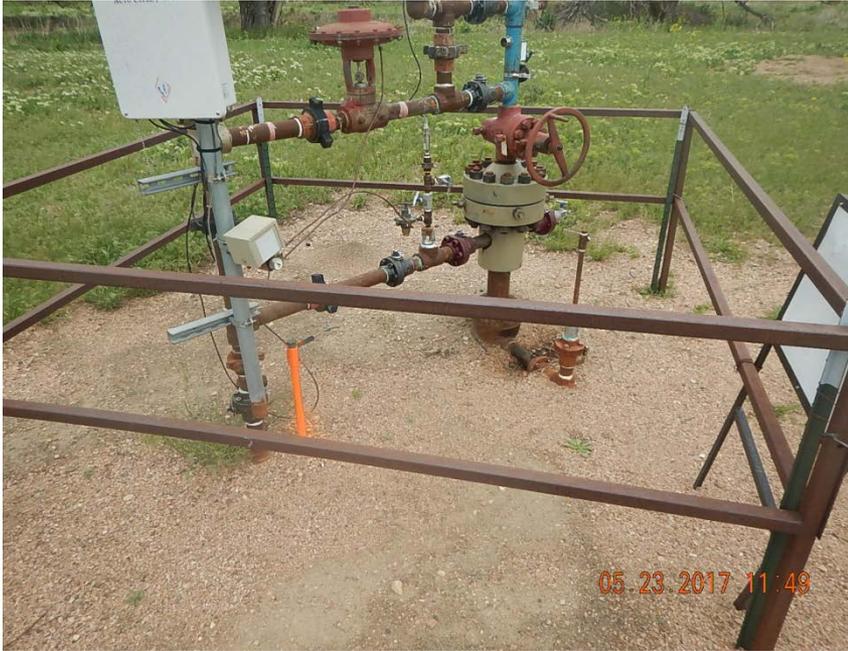
Photo 3: Risers at wellhead. Unused line marked for removal.

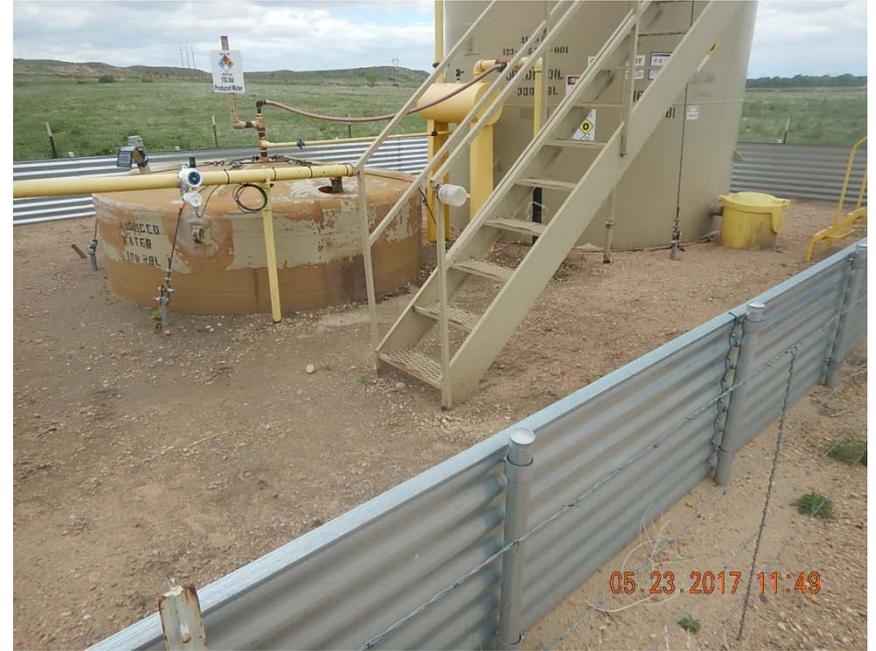
Photo 4: Risers at tank battery.

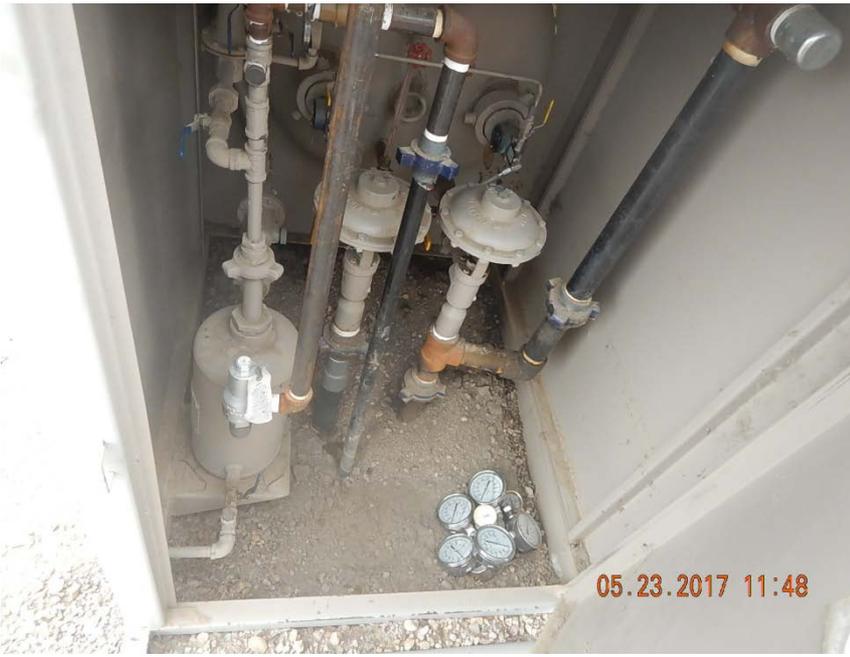
Photo 5: Risers in separator

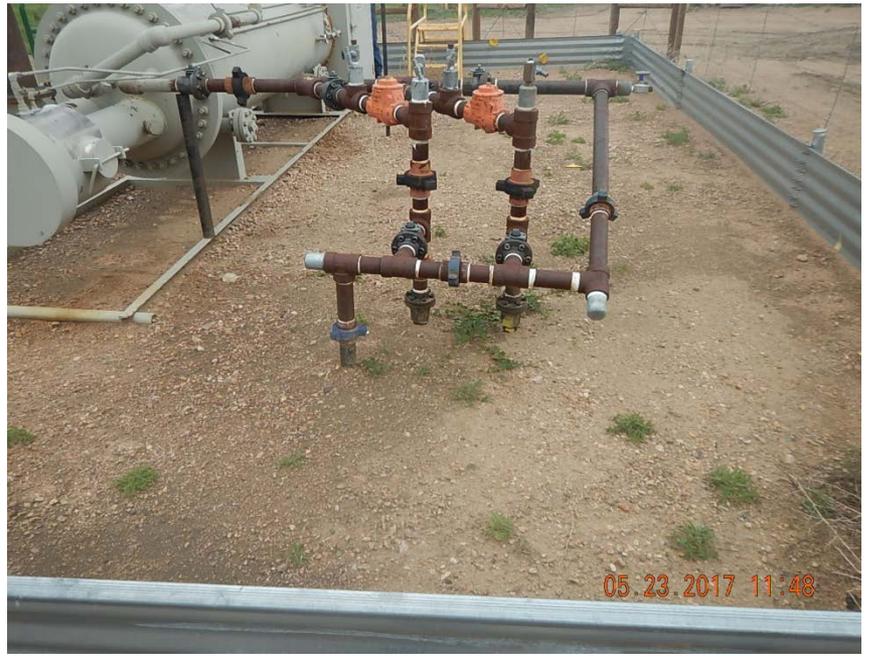
Photo 6: Risers at separator

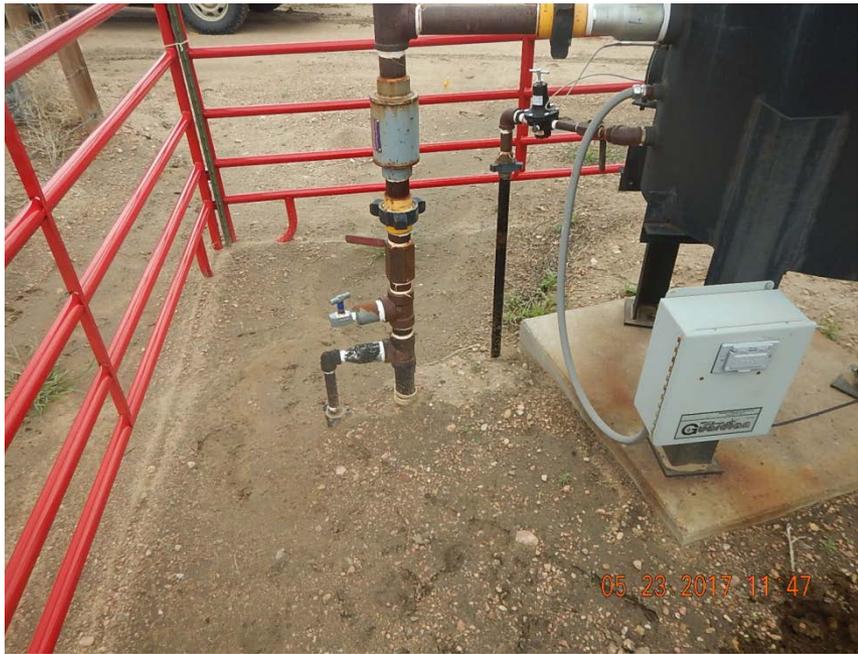
Photo 1: Risers at ECD
