Petroglyph Energy, Inc.
Well Pad Final Reclamation Evaluation

Well Name: State 36-05

Evaluation Date: July 15, 2015

Evaluated by: Lindsey Brandt; Senior Environmental Scientist; Habitat Management, Inc.

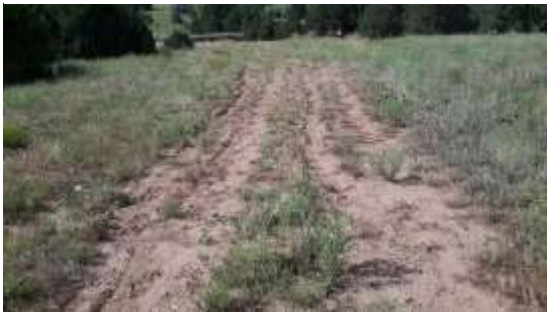
Tire ruts along the access road are causing water to channelize and erosion to occur. It appears that the road was driven on when wet which caused the tire ruts.

Erosion

The access road should be cross-rippled or harrowed to alleviate compaction, and BMPs should be installed to manage drainage. The access road and areas indicated on the attached map should be reseeded with the approved seed mix, and mulched with Woodstraw at a target rate of 60% cover.

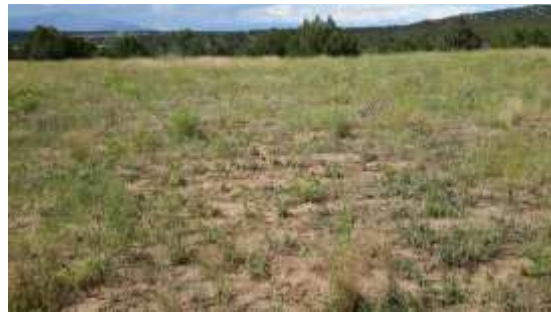
Good area

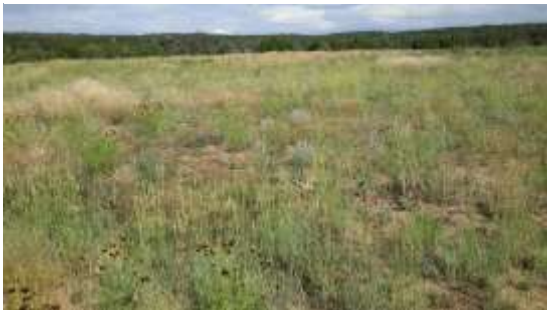
Good area

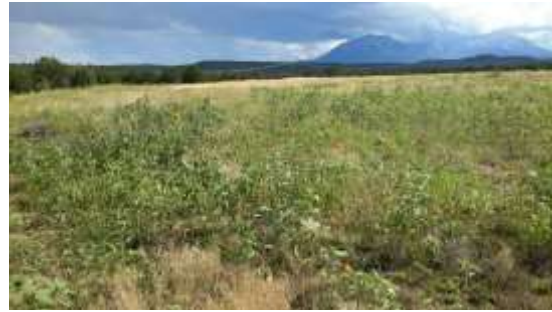
Low vegetation density

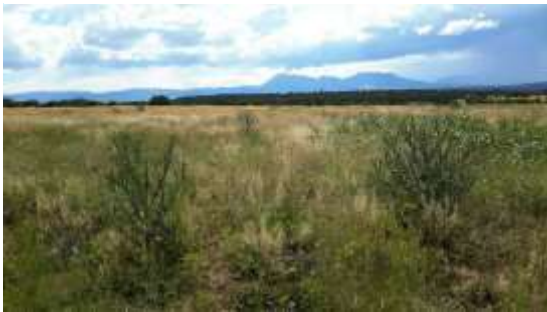
Portions of the State 36-05 well pad are establishing satisfactorily as shown in the attached photos and map. The rest of the pad is dominated by weedy annuals including tall tumblemustard (*Sisymbrium altissimum*), however, often desirable vegetation is establishing underneath. Cheatgrass (*Bromus tectorum*) is dispersed throughout the site, however currently not abundant. Scotch thistle (*Onopordum acanthoides*) is abundant throughout the pad and diffuse knapweed (*Centaurea diffusa*) occurs scattered along the access road, as well as one plant on the southeast corner of the pad.

Noxious weeds

Many years of noxious weed management are likely required to effectively control weed infestations on this site. The entire well pad should be treated in the fall of 2015 to minimize the cheatgrass infestation. Prior to herbicide application the site should be mowed to remove the standing dead annual vegetation and allow for effective soil contact of herbicides. A pre-emergent herbicide should be applied to prevent germination of this winter annual.

Thistle and knapweed rosettes should be spot-sprayed with appropriate broadleaf selective herbicides in fall 2015 and spring 2016 ideally before bolting occurs. Pre-emergent herbicide application around the thistle infestation may also be beneficial to reducing this species.

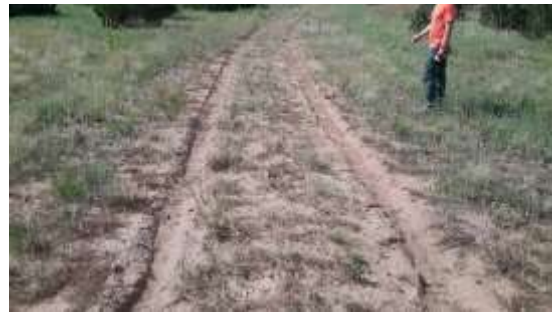
Ruts on road

After management activities are completed the access road should be blocked in order to prevent vehicle traffic on the site for several growing seasons. The site should be checked periodically to inspect for infestations of other noxious weeds, and identify other issues that may arise and potentially impact successful reclamation.

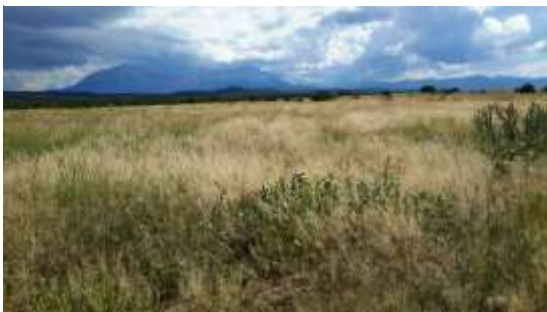
Weedy annual vegetation
