Inspection Photos
Location Name: McCarty #28-1
API: 05-123-12931

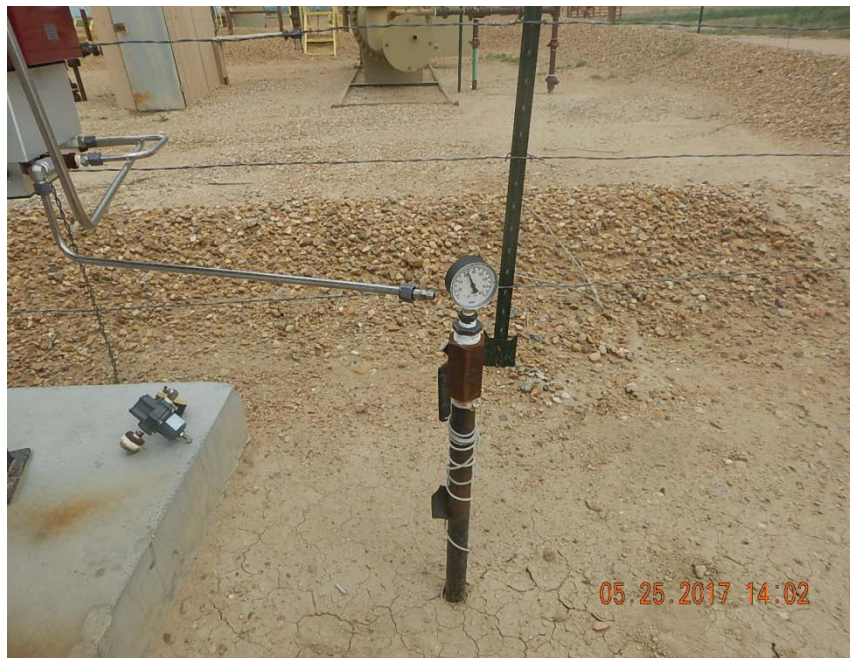
Photo 1: Pressure test of flowline

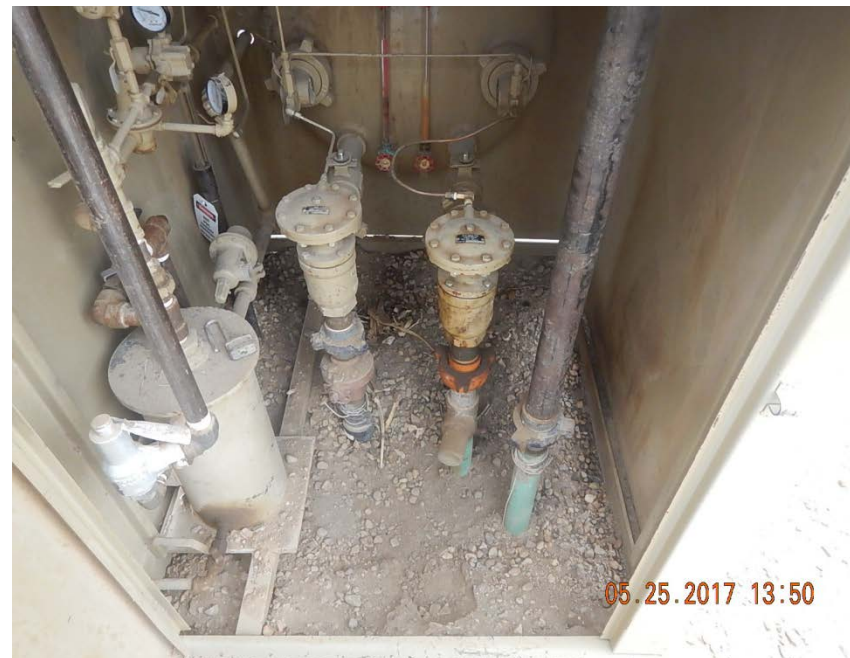
Photo 2: Risers in separator house

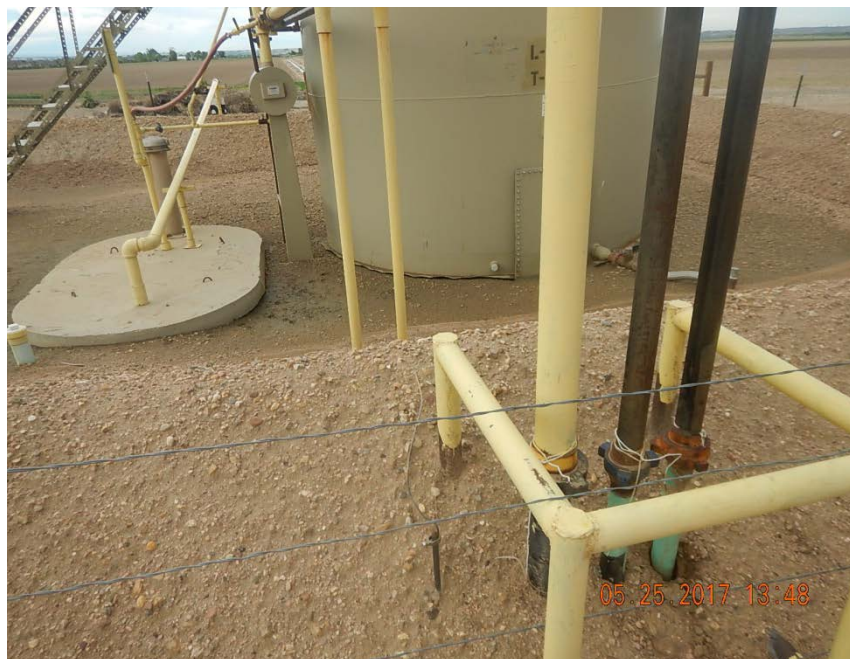
Photo 3: Risers at tank battery

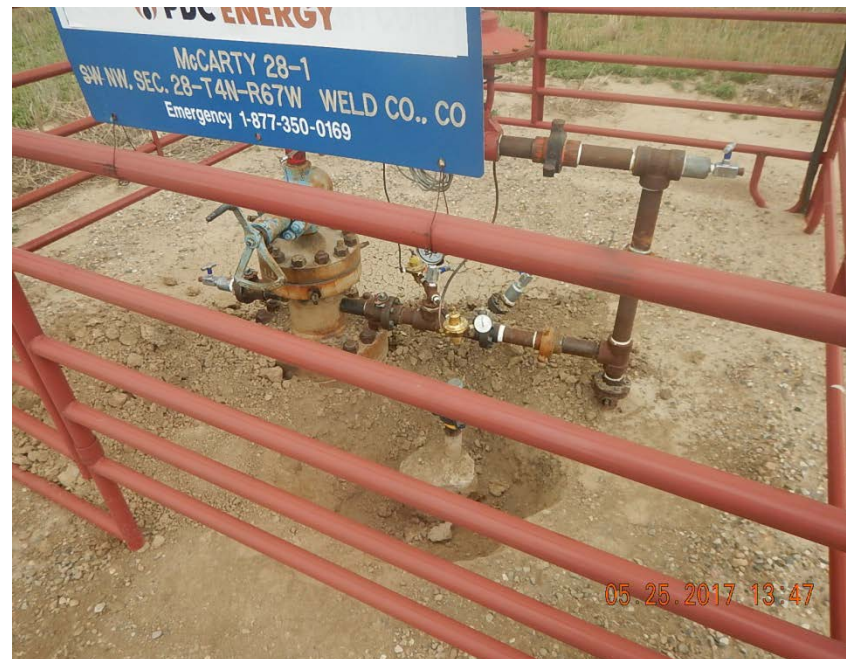
Photo 4: Risers at wellhead

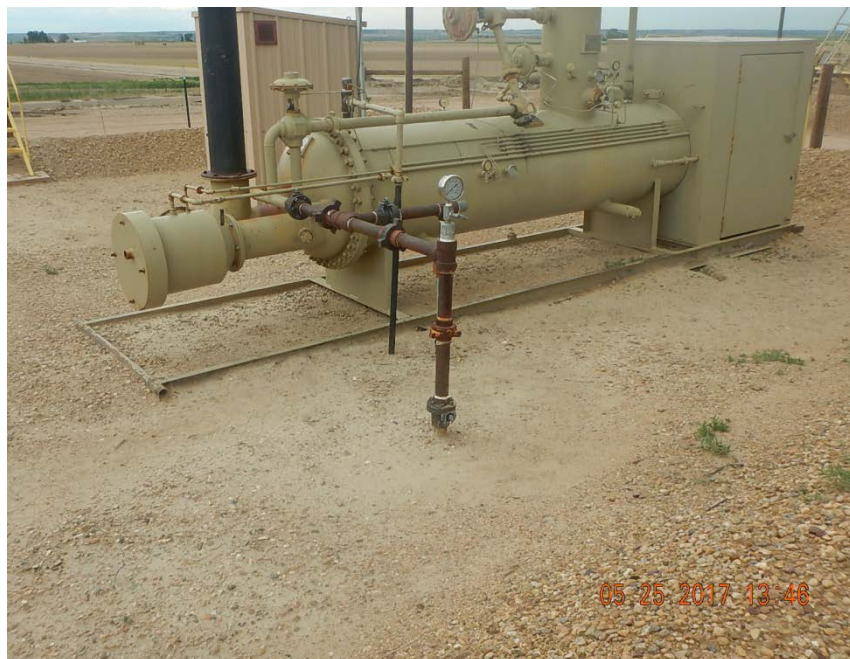
Photo 5: Risers at separator

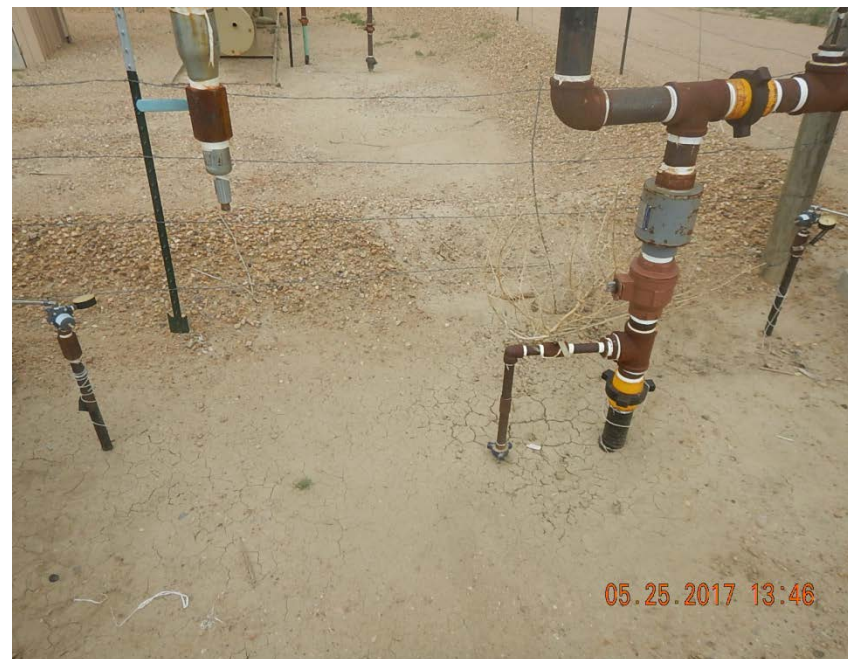
Photo 6: Risers at eCD

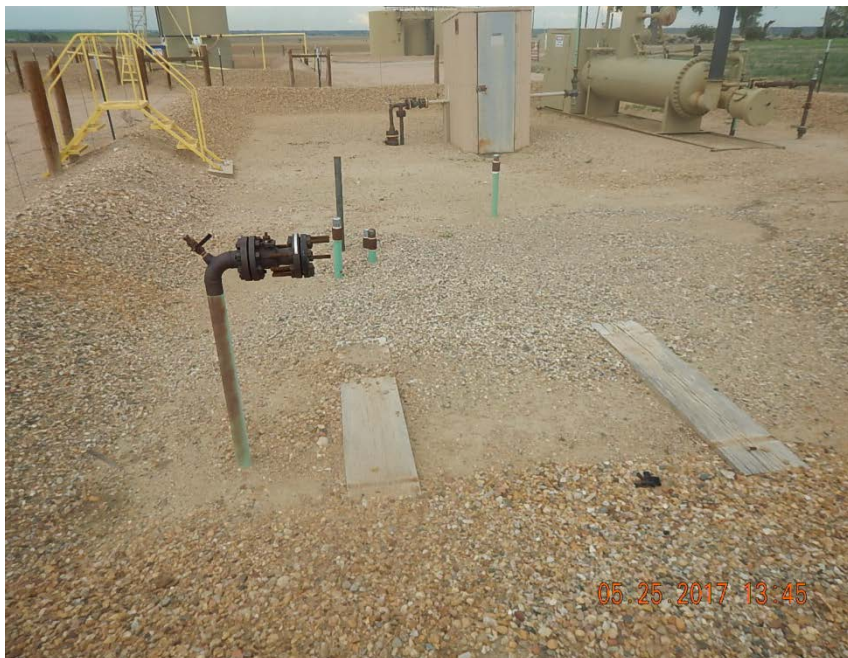
Photo 7: Risers from removed separator.
