Inspection Photos – 2017 Flowline NTO  
Inspection  
Location Name: Gooch 2-33  
API: 05-081-05366

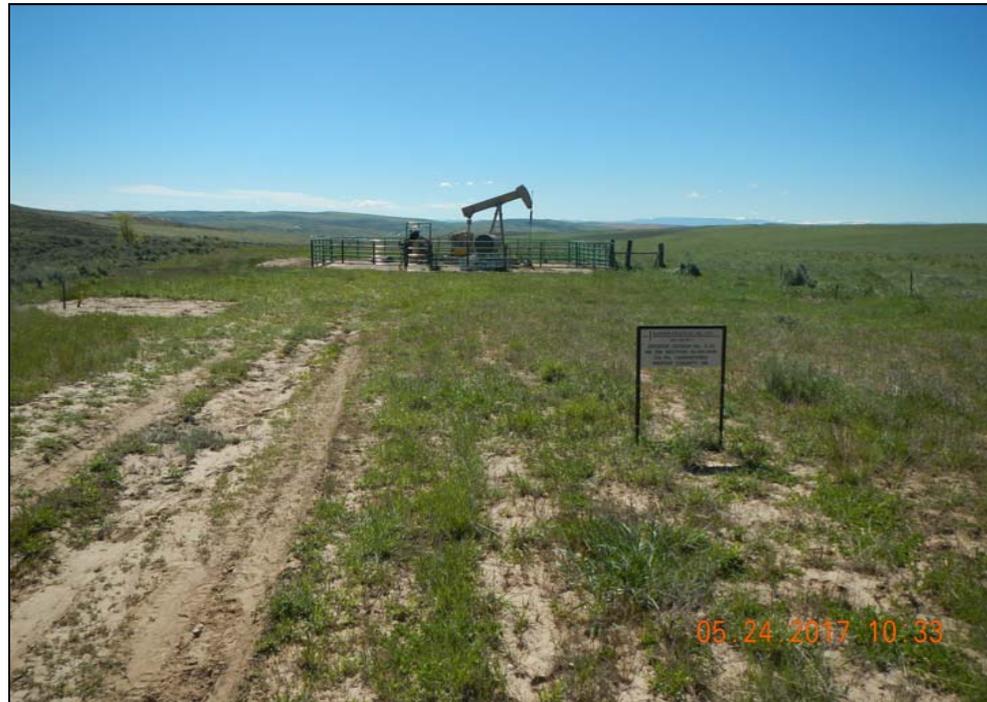
**Photo 1. Location overview taken at entrance facing southeast.**

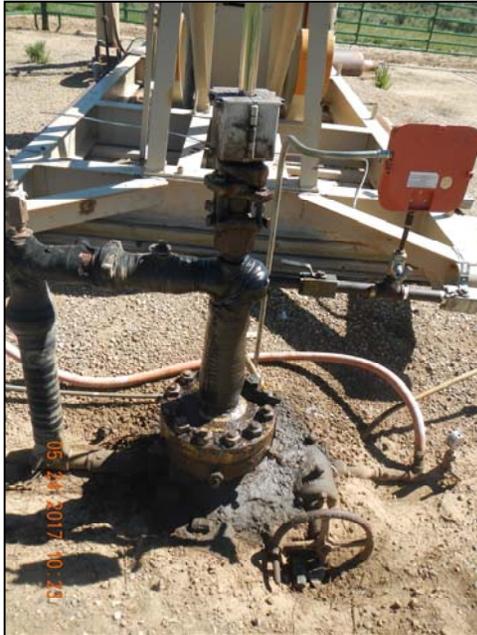
**Photo 2. Stained soil at wellhead.**

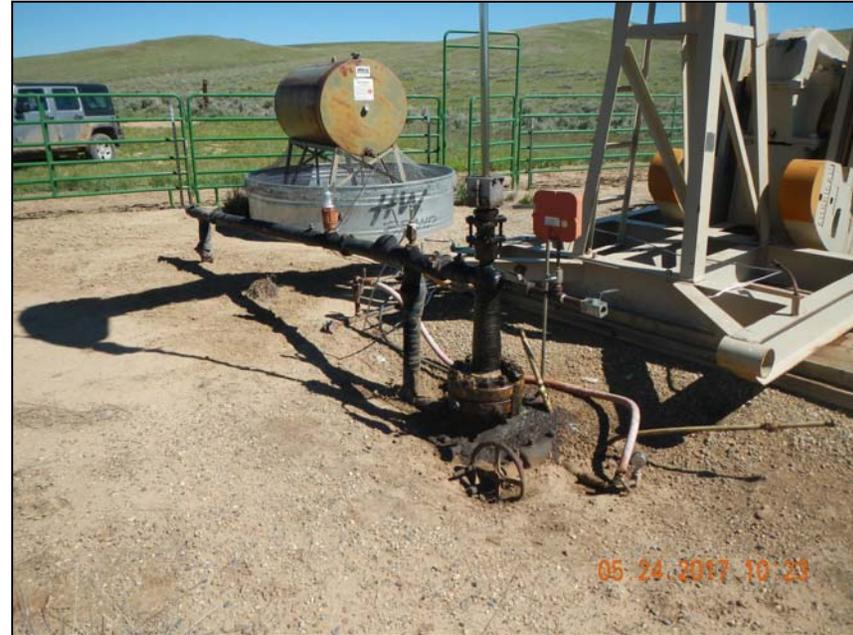
**Photo 3. Wellhead assembly showing 1 -2" insulated riser, 1 -1" poly line, methanol lines.**

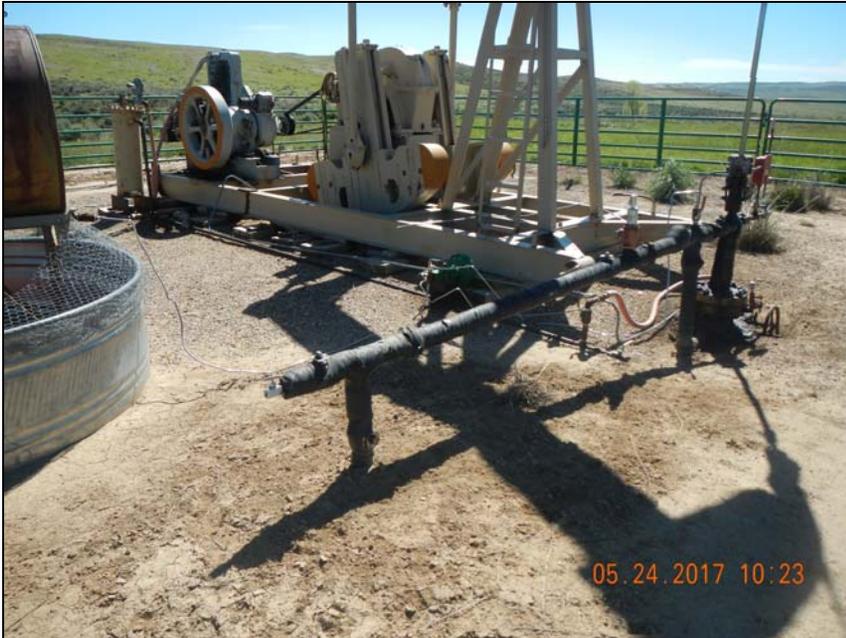
Photo 4. Wellhead assembly showing lines running to separator and motor.

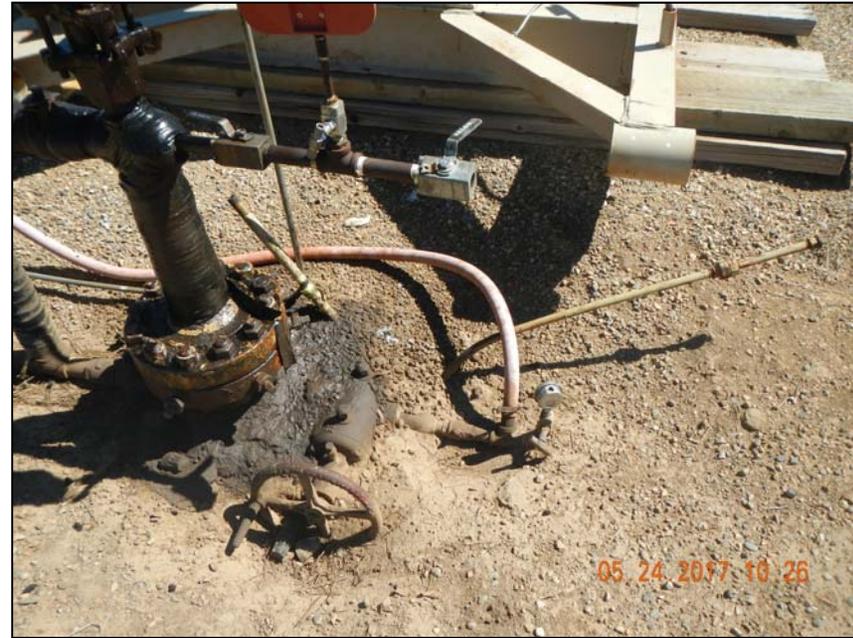
Photo 5. Close-up of 2 -1" risers not in use.
