Inspection Photos – 2017 Flowline NTO
Inspection
Location Name: Amoco-Federal 21-1
API: 05-081-06439

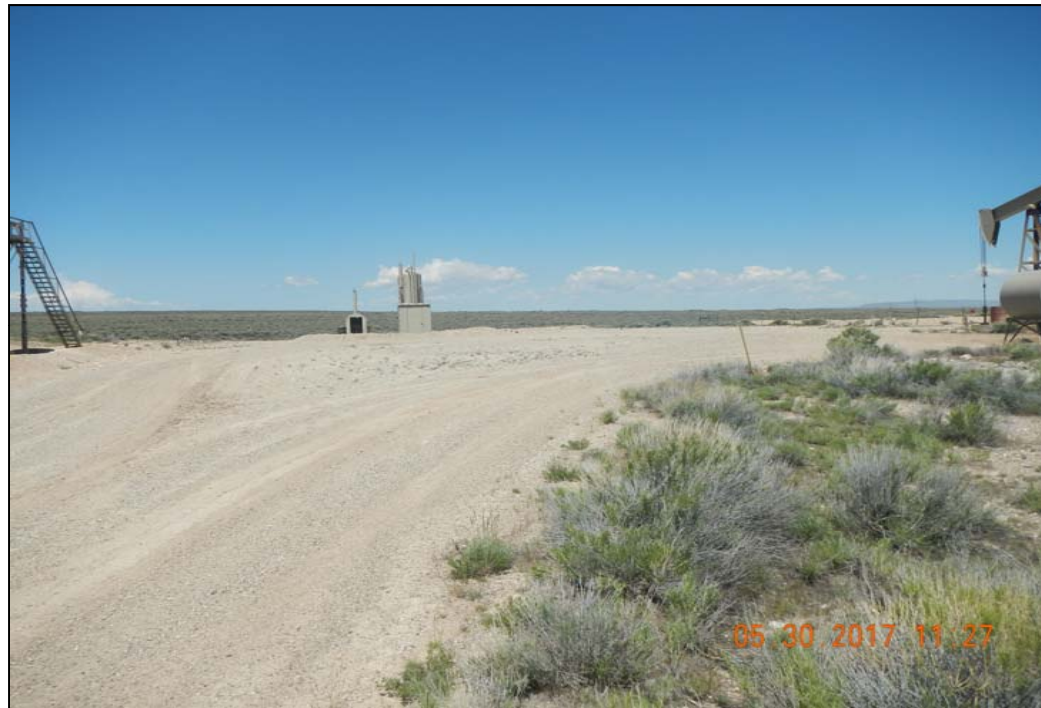
Photo 1. Overview of location taken at entrance to location facing west.

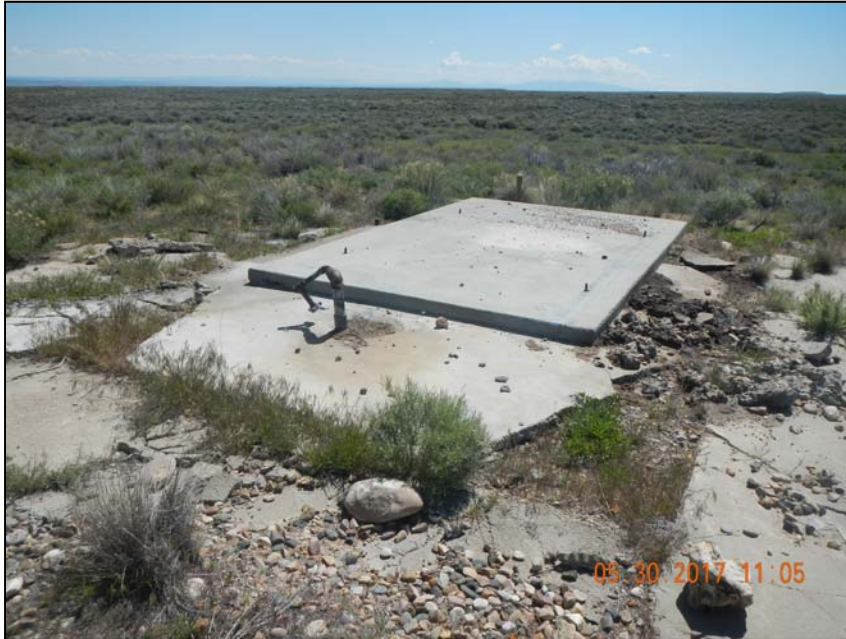
Photo 2. Concrete base at entrance with 4 – 2" steel risers not in use.

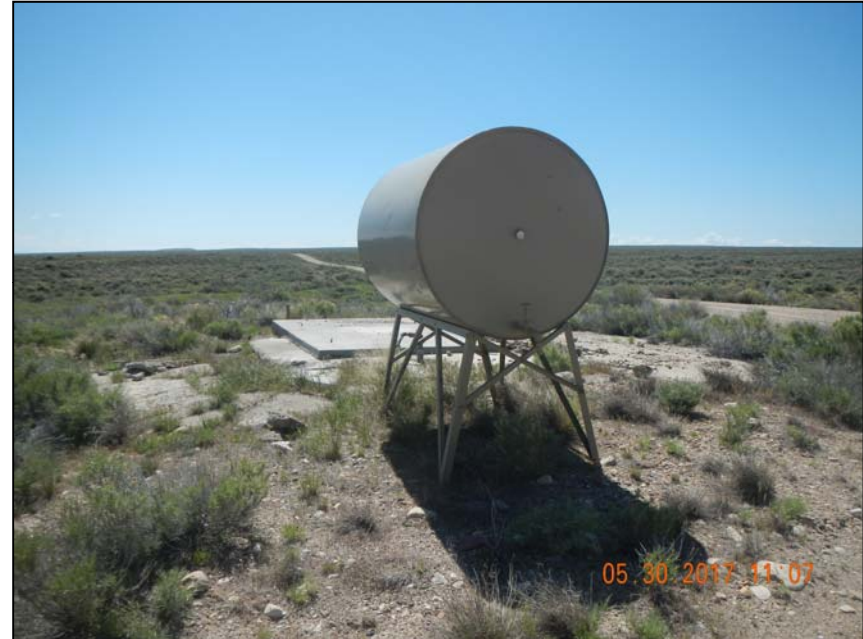
Photo 3. Unlabeled container.

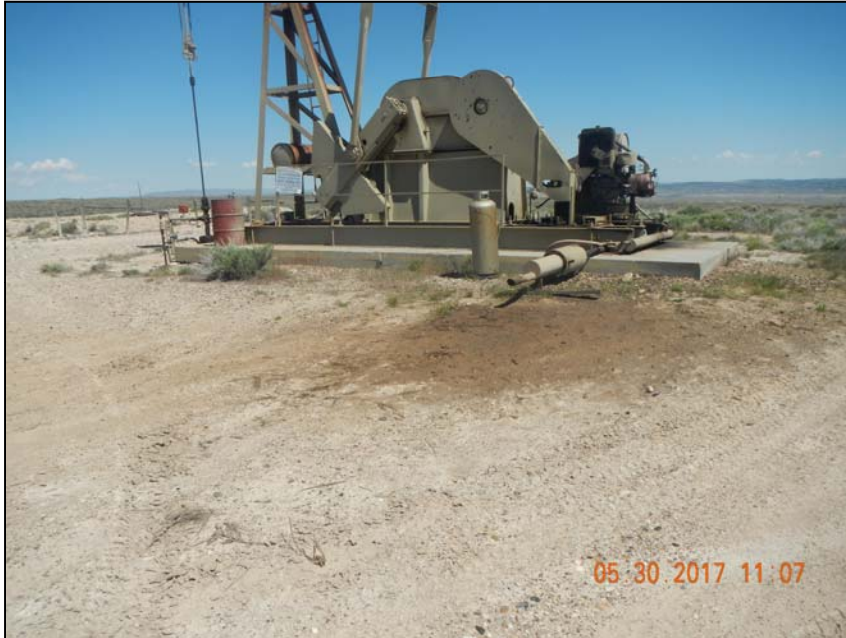
Photo 4. Stained soil at pump jack exhaust.

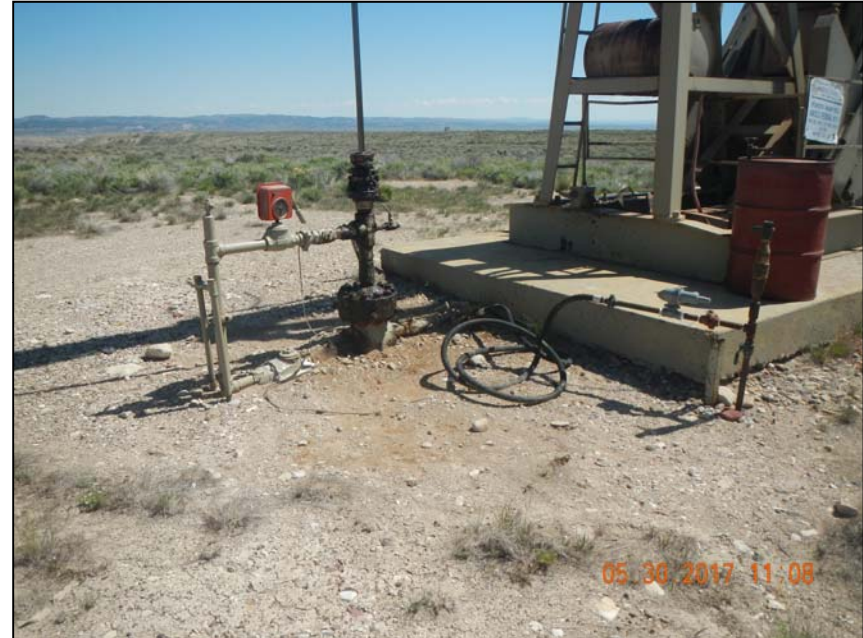
Photo 5. Wellhead. 2 – 1" steel risers, 1 – 2" steel riser, 1 – 2" steel to poly flowline to 1" steel riser.

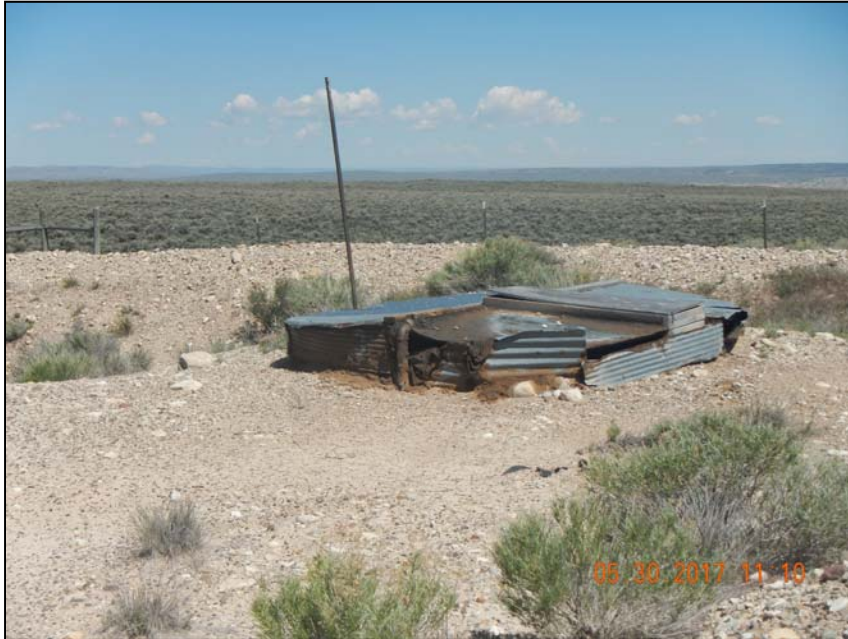
Photo 6. 1 – 2” steel riser at tank and pit.

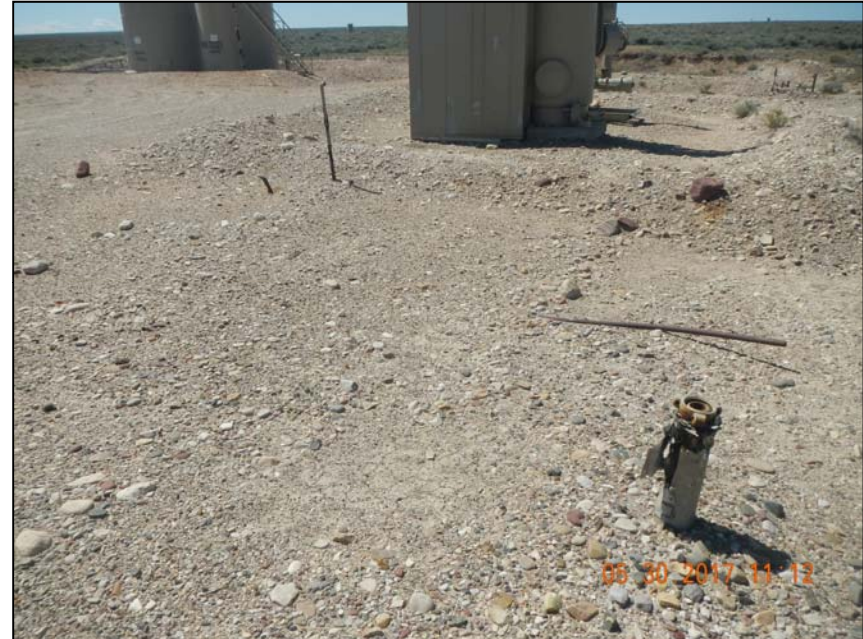
Photo 7. 1 – 2” and 1 -1” steel riser not in use.

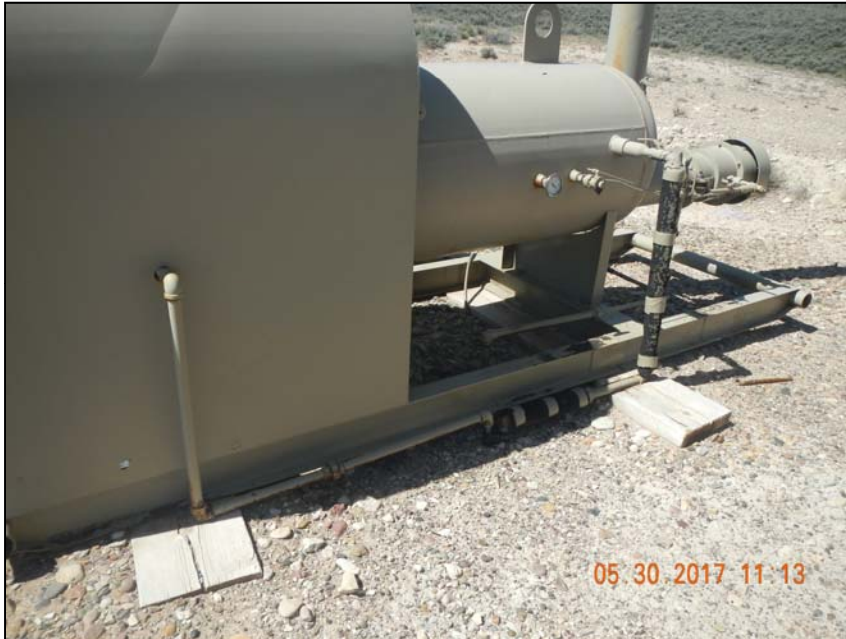
Photo 8. 3 – 1” steel risers at horizontal separator.

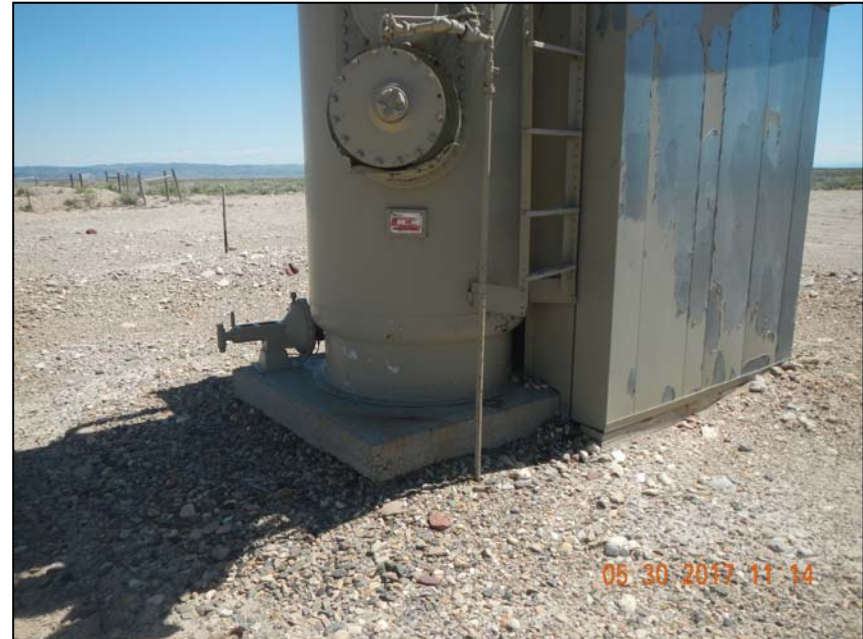
Photo 9. 5 -2” steel risers and 2 – 1” steel risers at vertical separator.

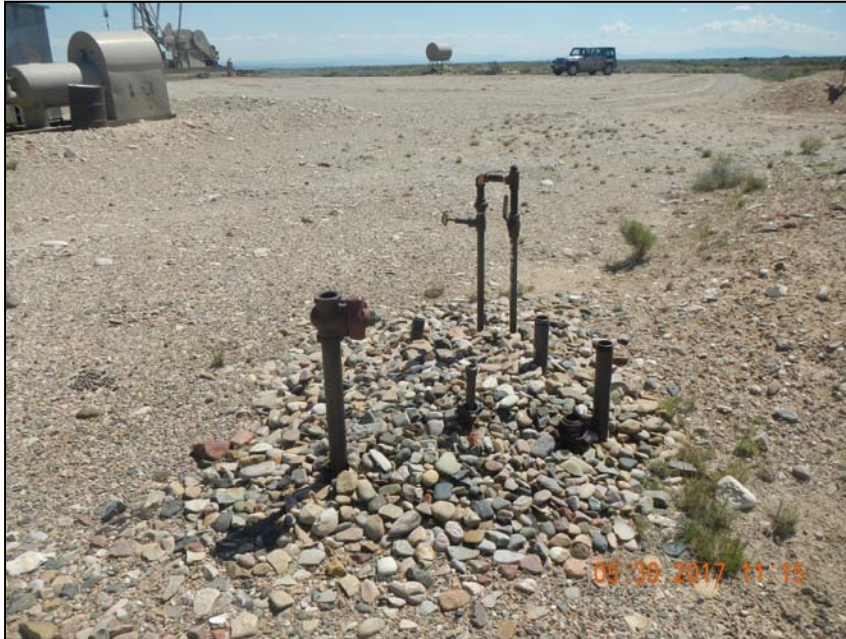
Photo 10. 5 – 2” steel risers and 3 – 1” steel risers not in use.

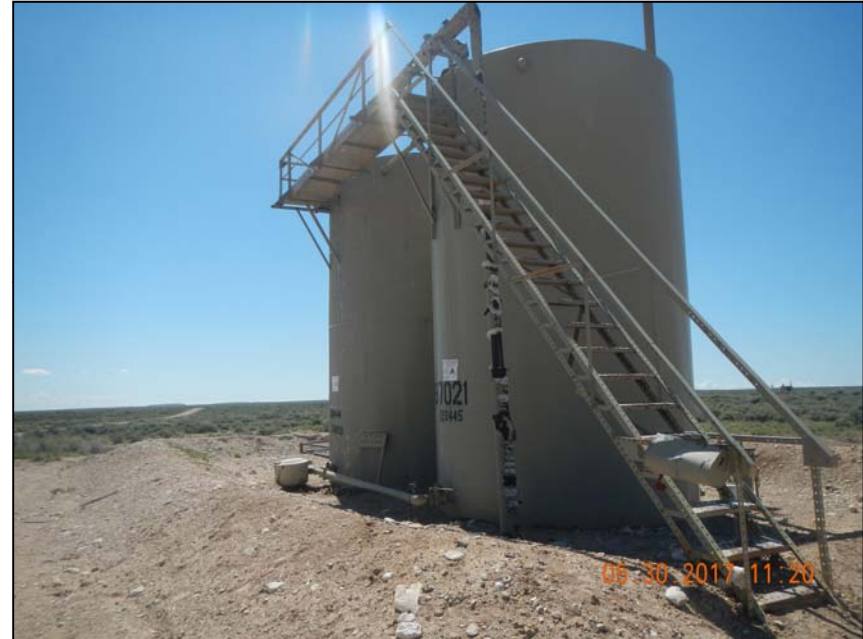
Photo 11. 2 – 1” and 1 – 2” steel insulated risers at tank.

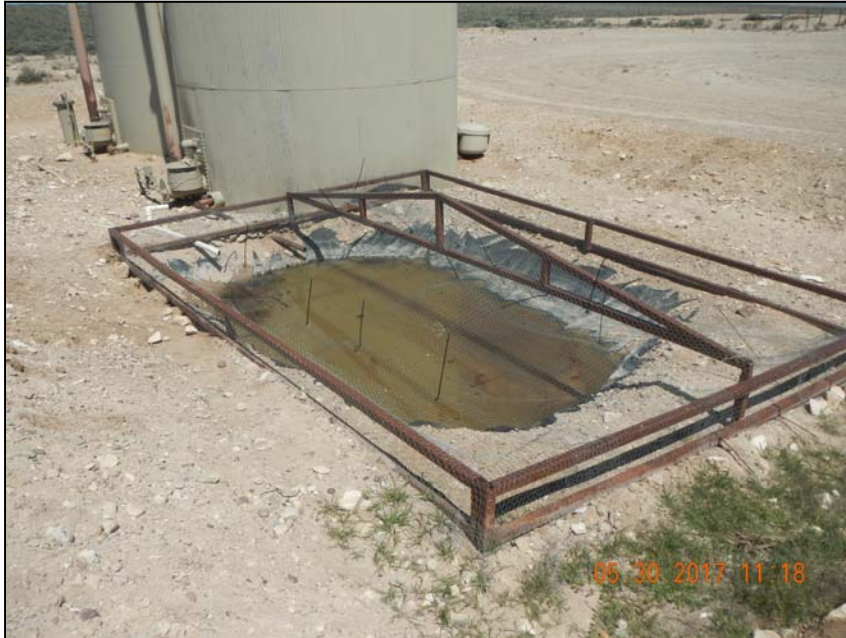
Photo 12. Pit in tank berm with sheen and oil and two flowlines entering from tank battery.

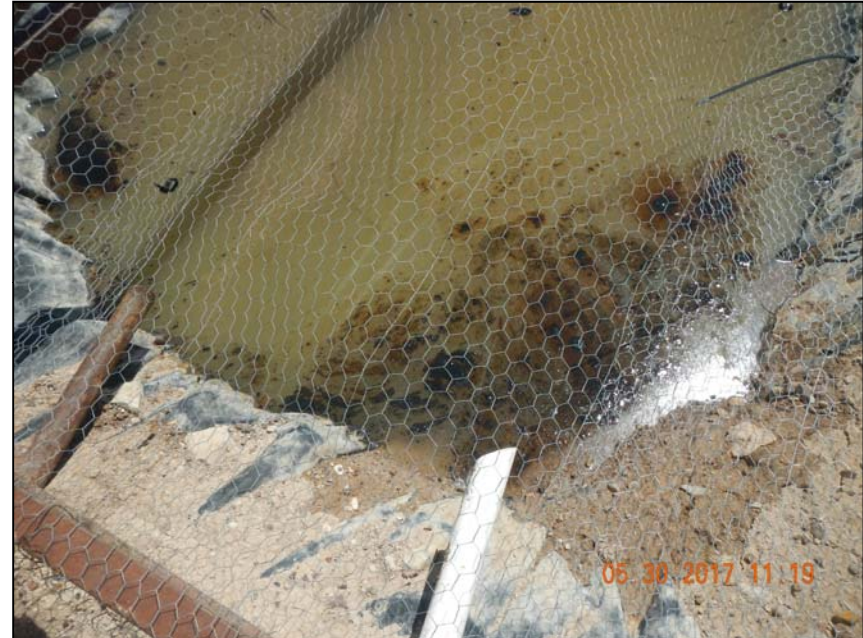
Photo 13. Close-up of flowlines and sheen and oil on pit.
