Flowline and Final Reclamation Inspection

Operator: MAGPIE OPERATING, INC- # 52530

API: 05-069-06112

Inspection Photos
Location Name: SAULCY #3
API: 05-069-06112

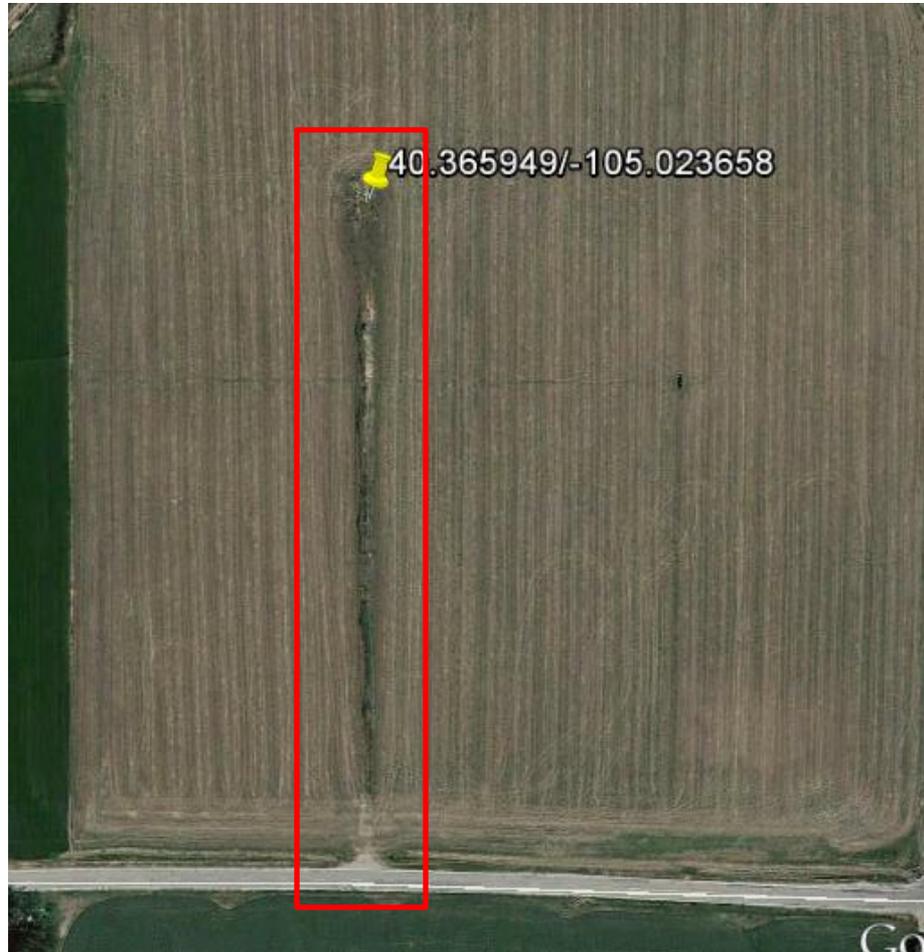
Google Earth aerial imagery taken June 19, 2014 illustrating an approximate 770' access road AND well location that has not been reclaimed per Rule 1004 standards.

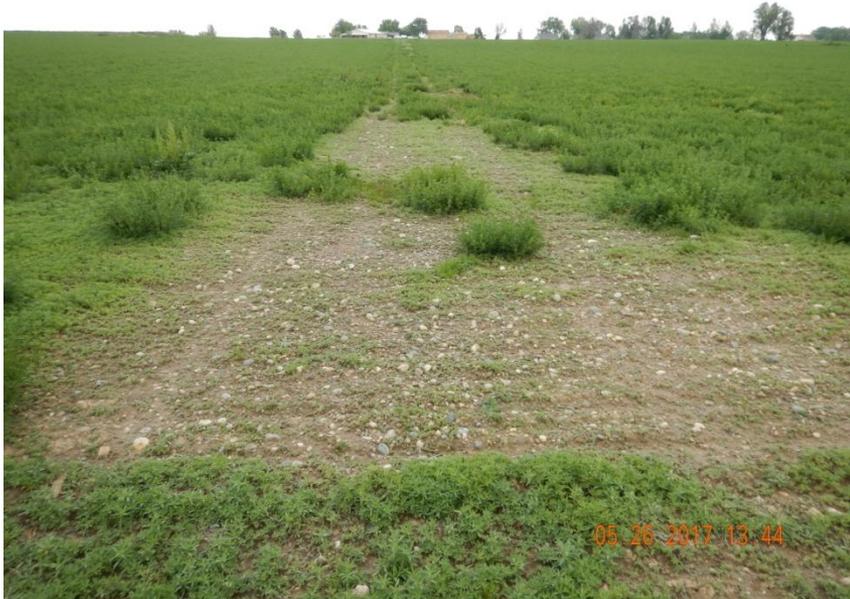
Photo 1. Photo taken from the access point off CO Rd. 16, facing North along the access road. Gravel has not been removed and access road has not been contoured.

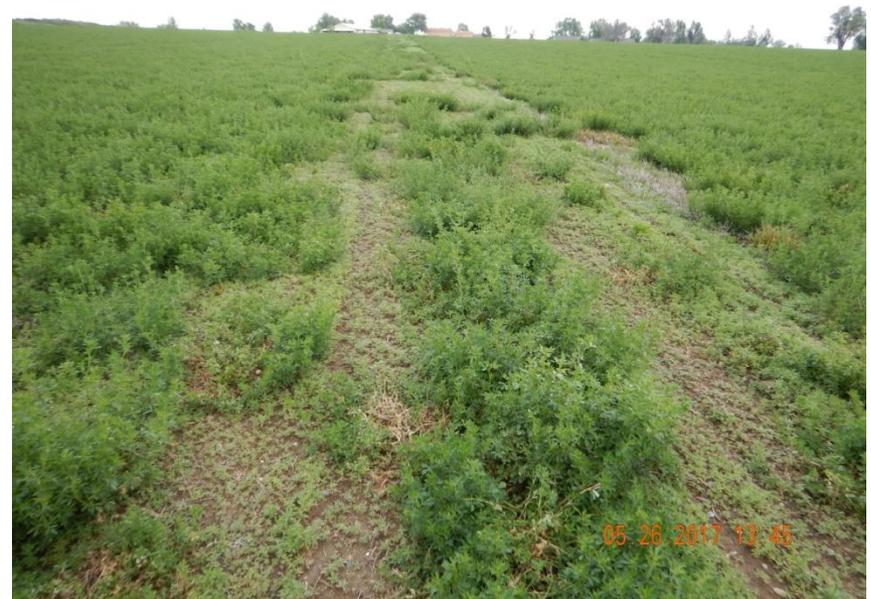
Photo 2. Photo taken north of the previous photo location, facing North along the access road. Gravel has not been removed and access road has not been contoured.

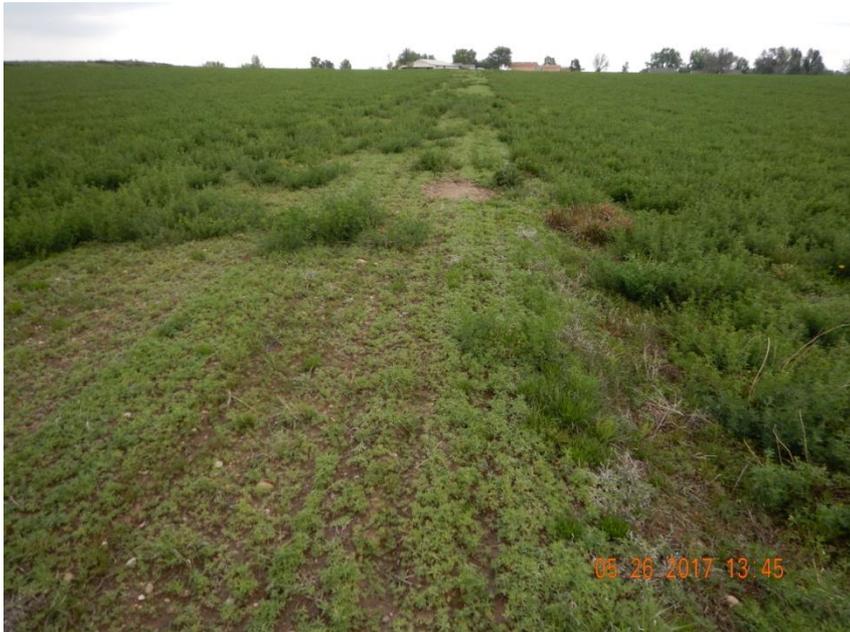
Photo 3. Photo taken north of the previous photo location, facing North along the access road. Gravel has not been removed and access road has not been contoured.

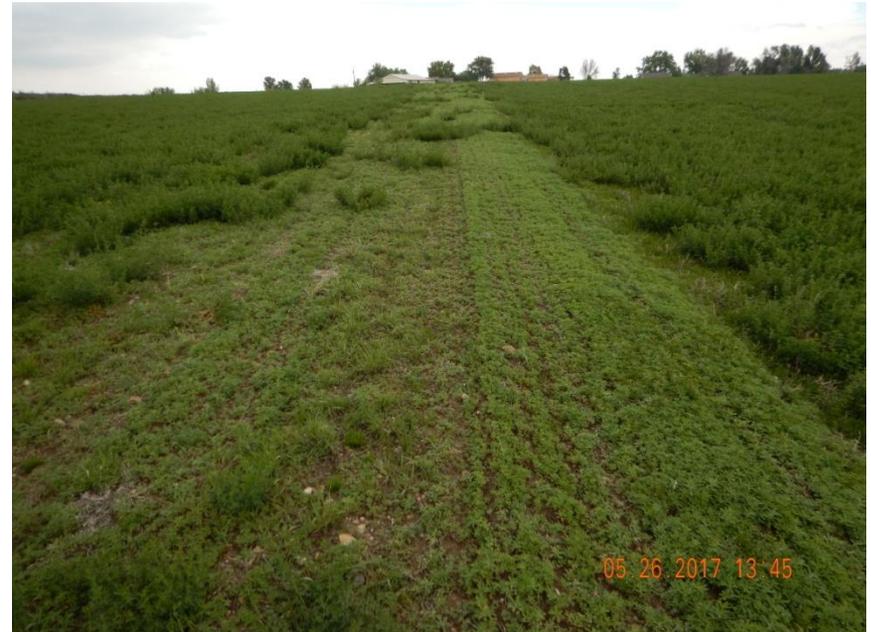
Photo 4. Photo taken north of the previous photo location, facing North along the access road. Gravel has not been removed and access road has not been contoured.

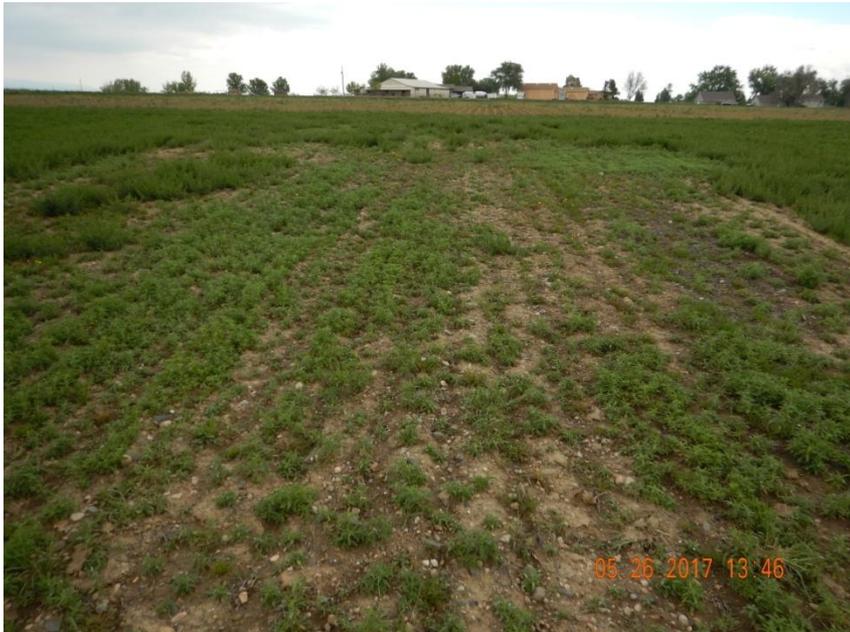
Photo 5. Photo taken from the well location, facing North. Gravel has not been removed and has not been contoured.

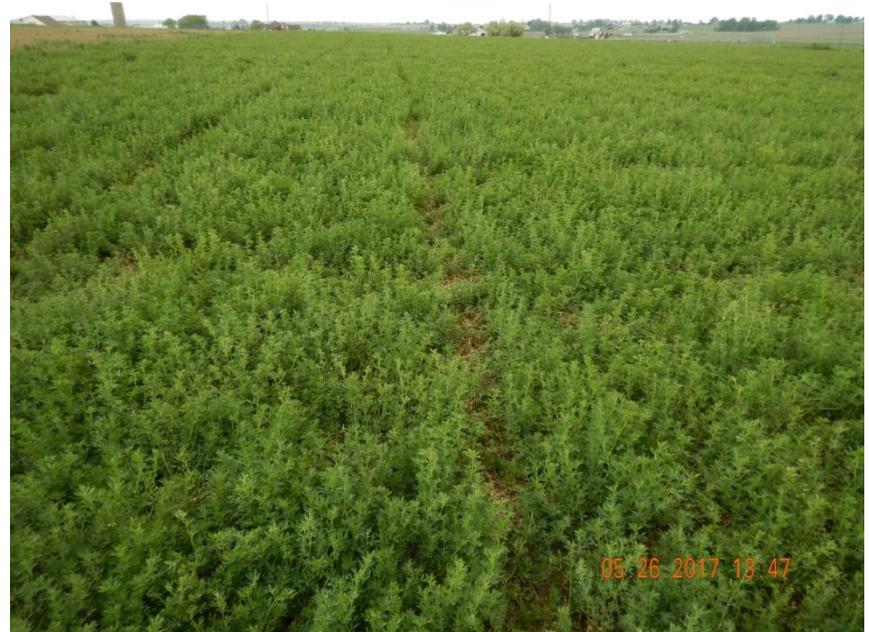
Photo 6. Reference photo taken east of the access road, facing East. Disturbance areas are not reflective of cropland reference areas.
