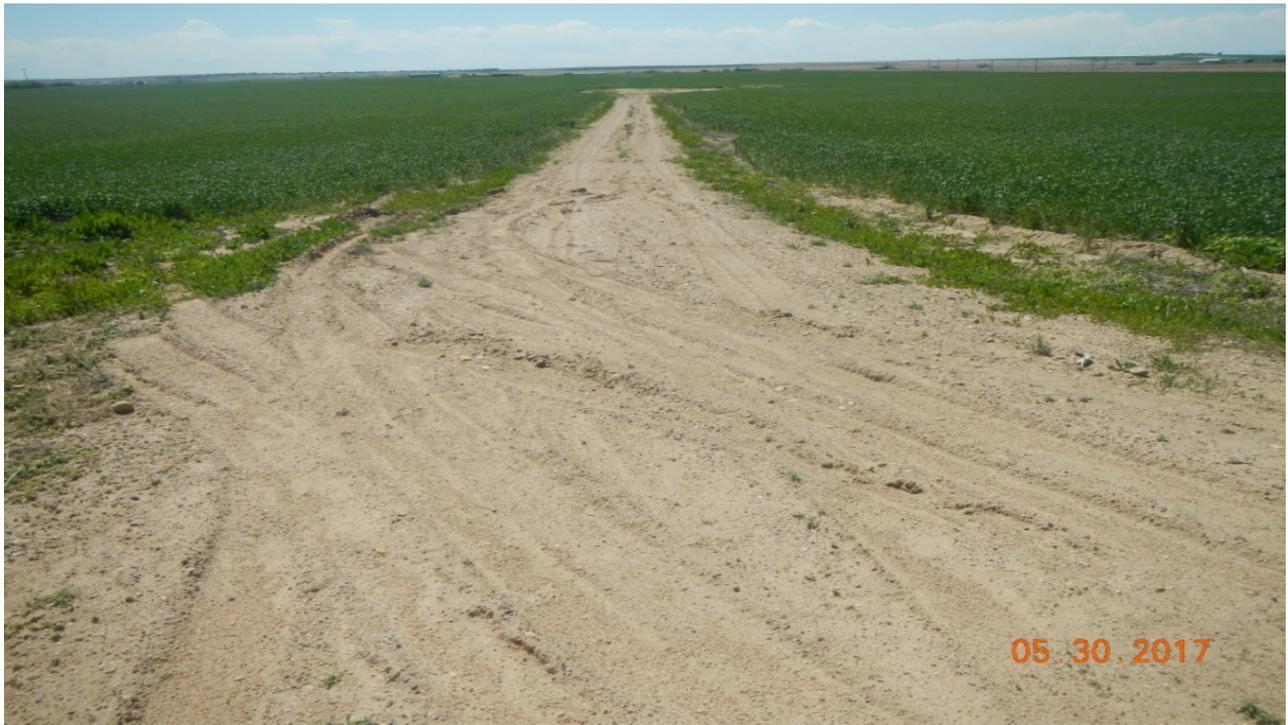
**photo 1:** Facing west toward the access road.

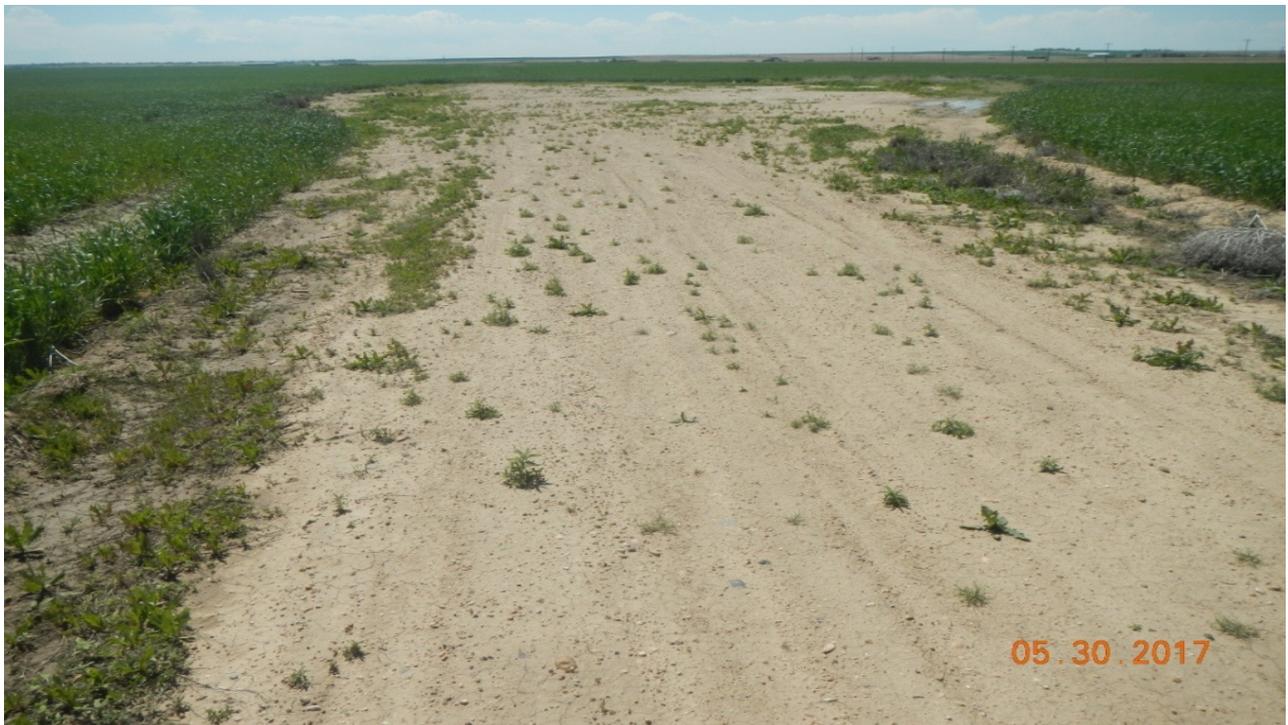
**photo 2:** Facing west toward the location.

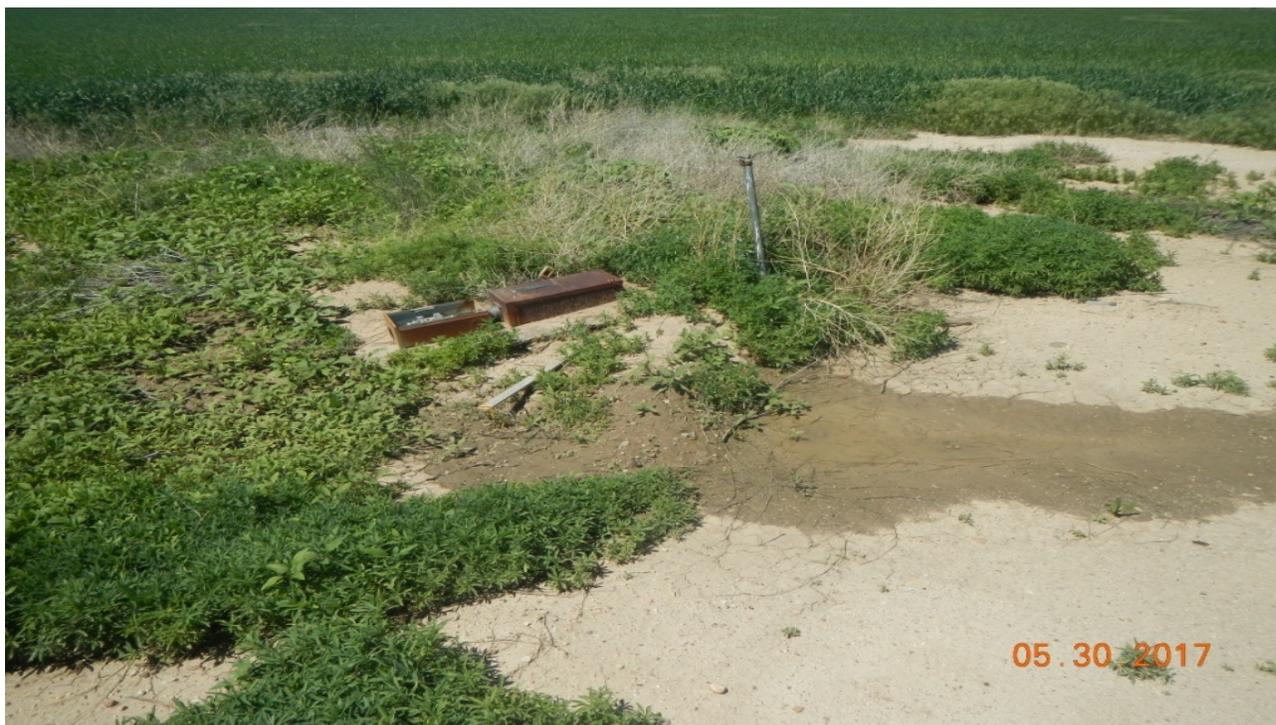
**photo 3:** There is an electric utility that remains at the location.

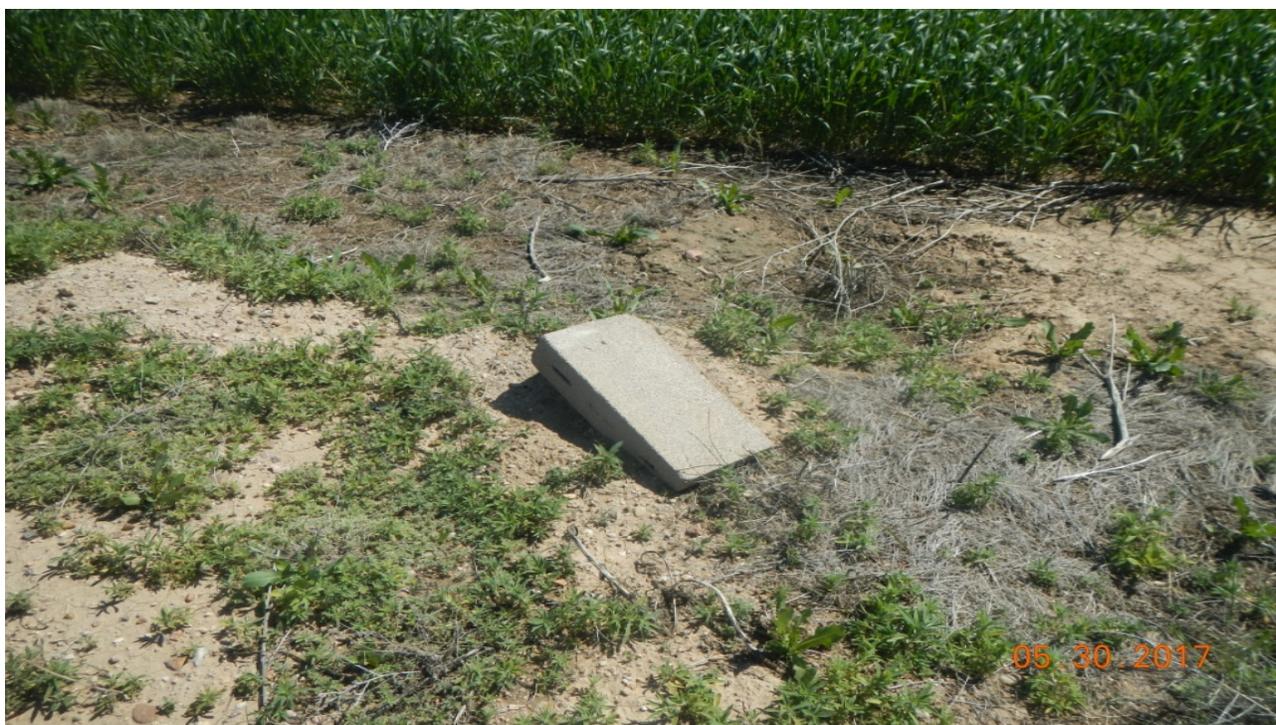
**photo 4:** A block remains which can interfere with ag activities.

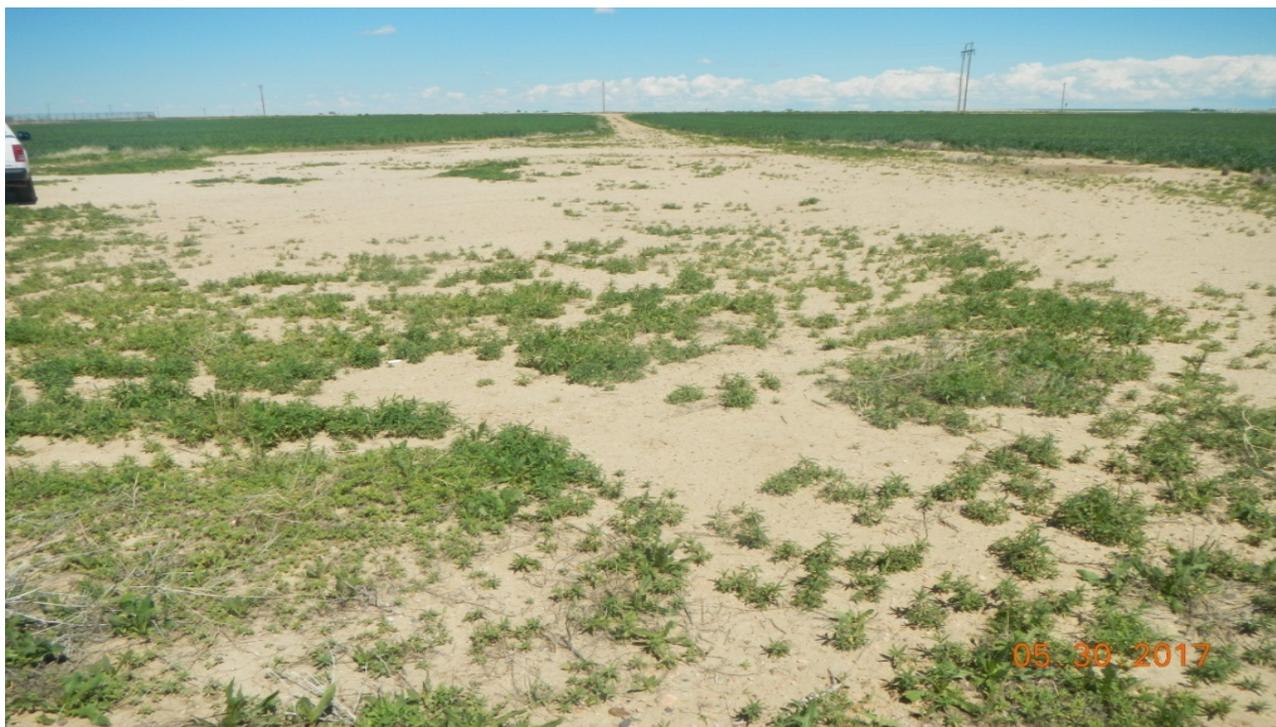
**photo 5:** West side of the location facing east.

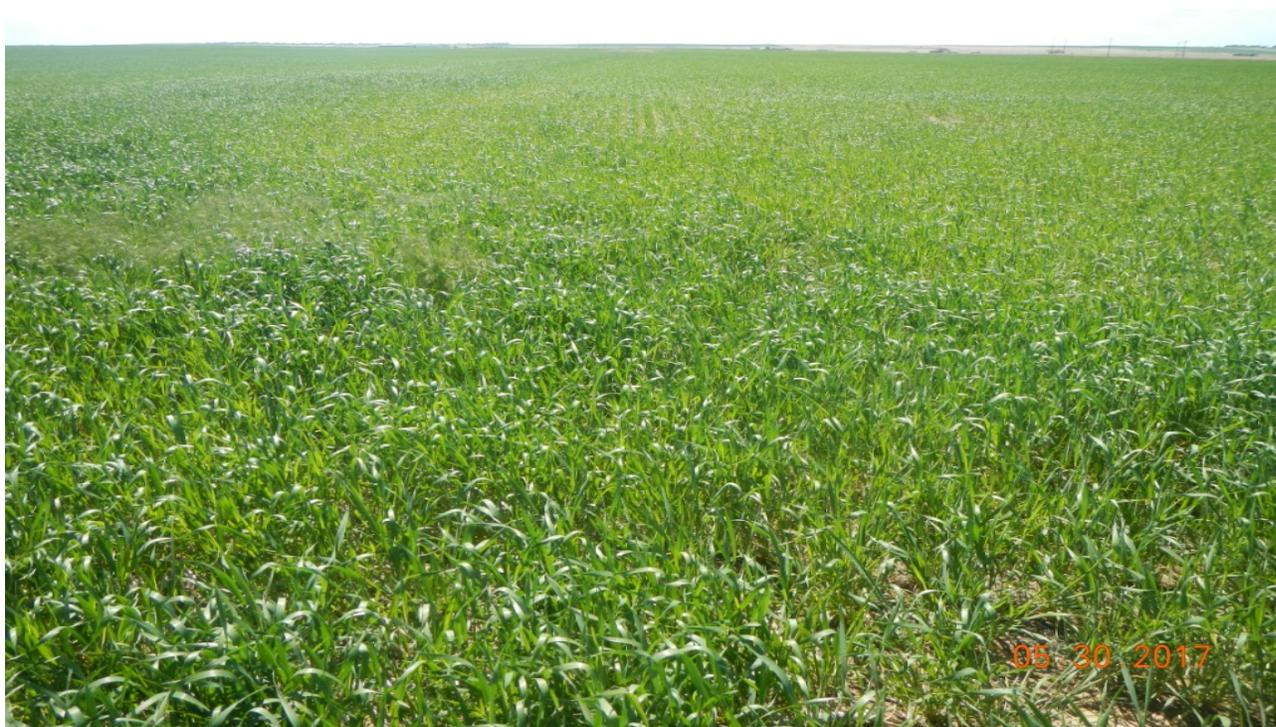
**photo 6:** Facing west at the surrounding crop.
