Inspection Photos – 2017 Flowline NTO
Inspection
Location Name: Powder Wash Federal 28-
7
API: 05-081-06605

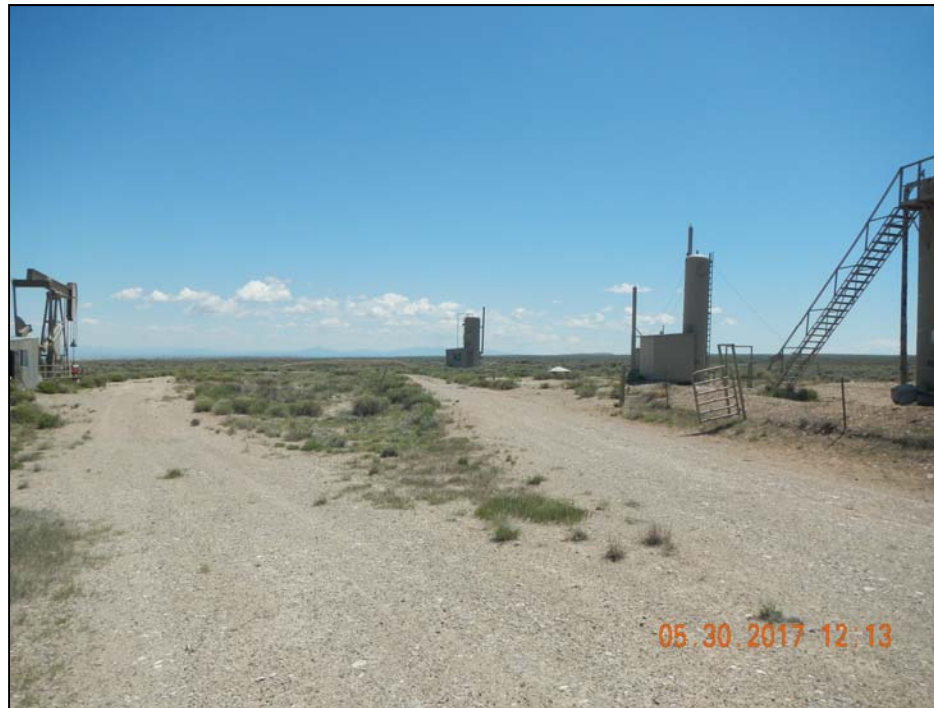
Photo 1. Overview of location taken at entrance to location facing east.

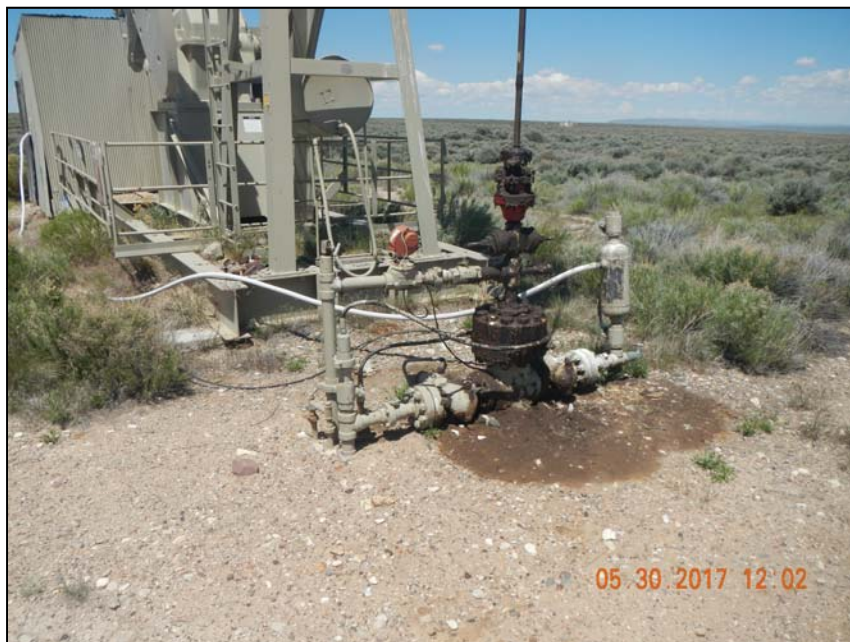
Photo 2. Risers at wellhead. Stained soil at wellhead.

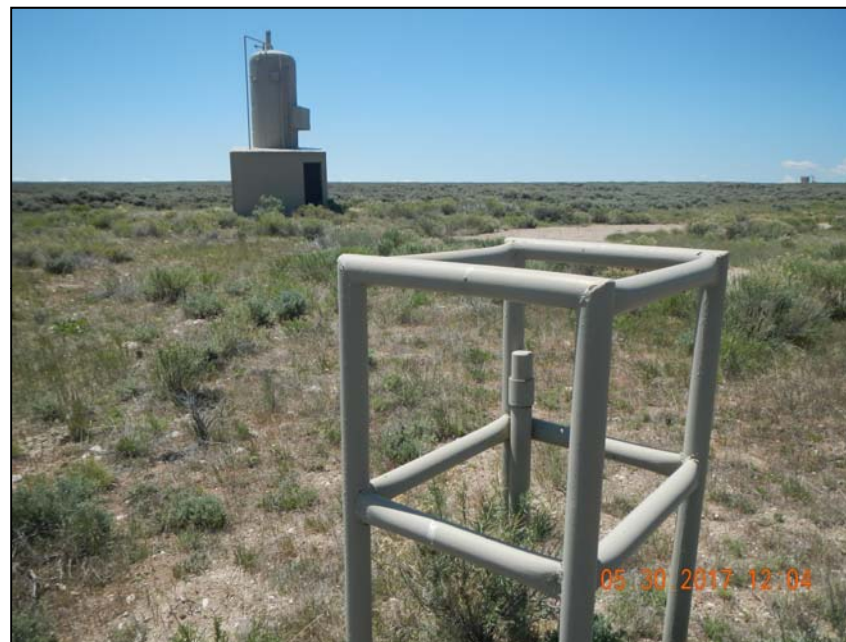
Photo 3. 1 – 2" steel riser at 40.88615, -108.29376

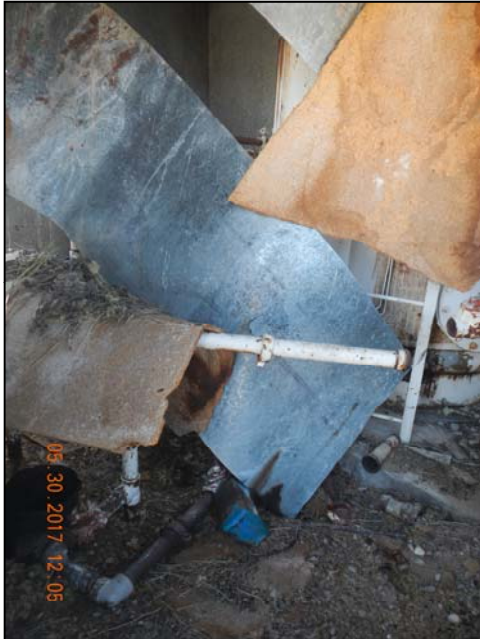
Photo 4. Risers inside stand alone vertical separator.

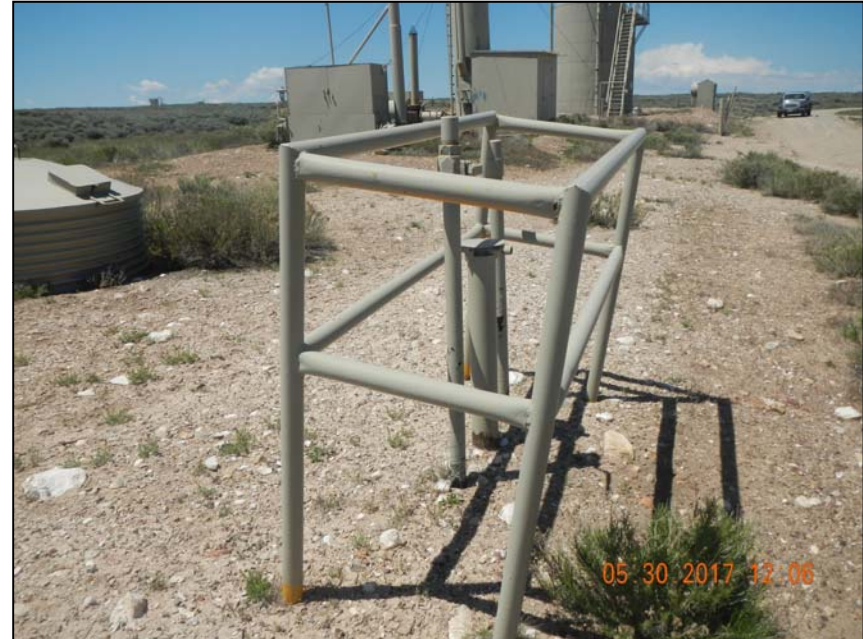
Photo 5. 3 – 2" steel risers at 40.88588, -108.29424

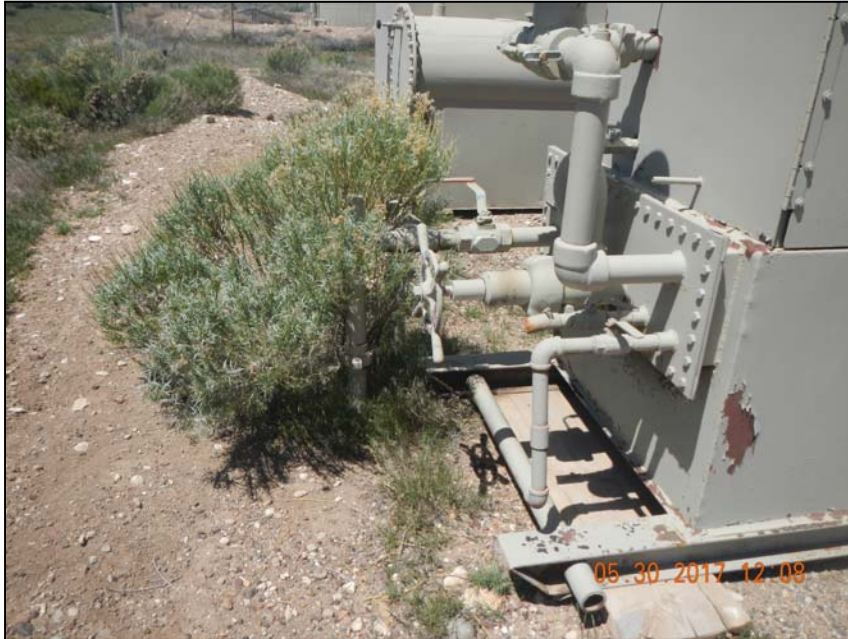
Photo 6. Risers at horizontal separator on east end.

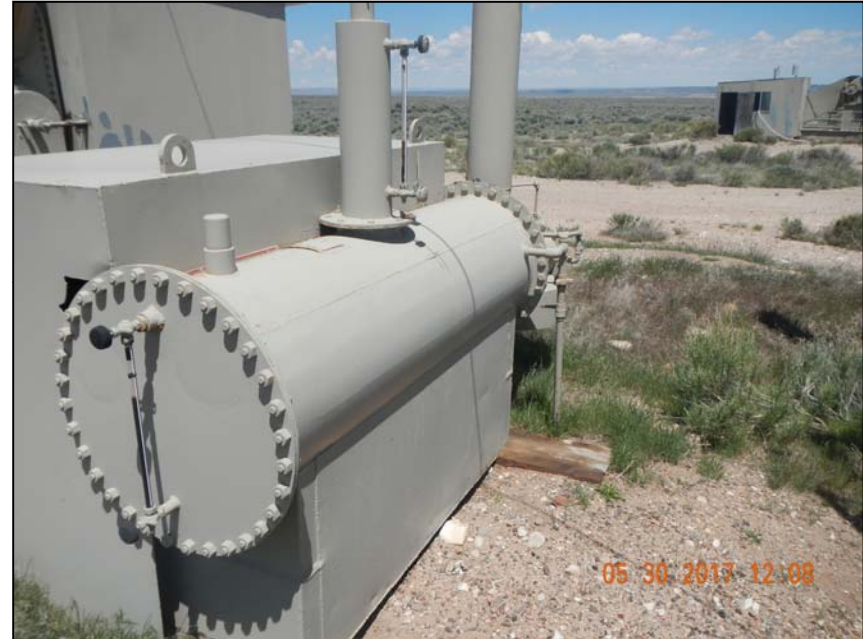
Photo 7. Risers at middle separator.

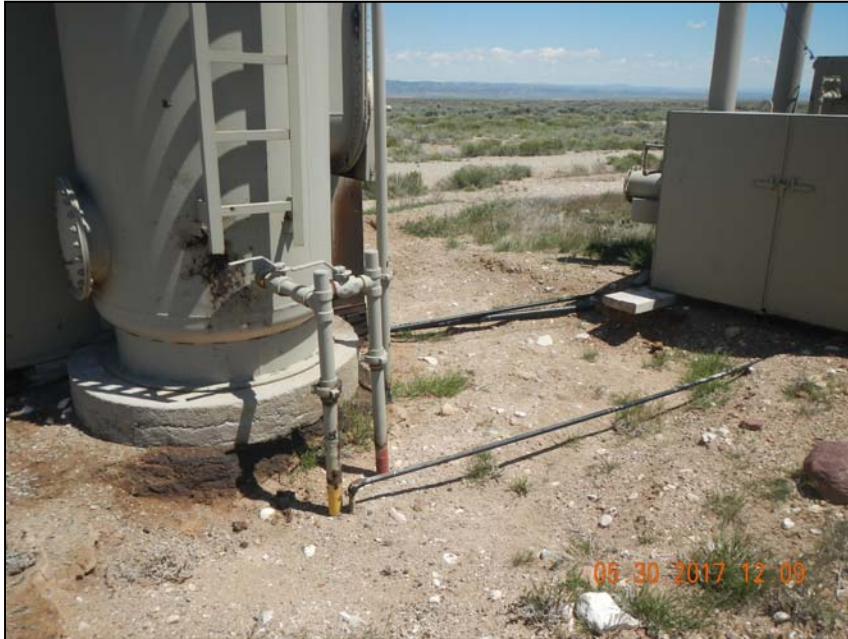
Photo 8. Risers and flowlines at vertical and middle horizontal separators.

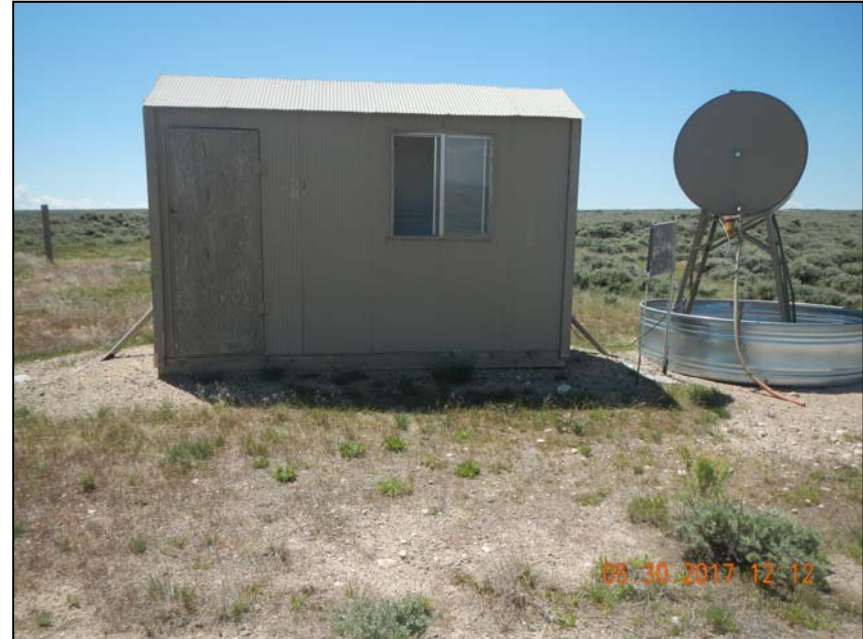
Photo 9. 2 – 2" steel risers at meter run. Unlabeled container on right.
