Inspection Photos – 2017 Flowline NTO
Inspection
Location Name: Powder Wash Federal 28-
11
API: 05-081-06425

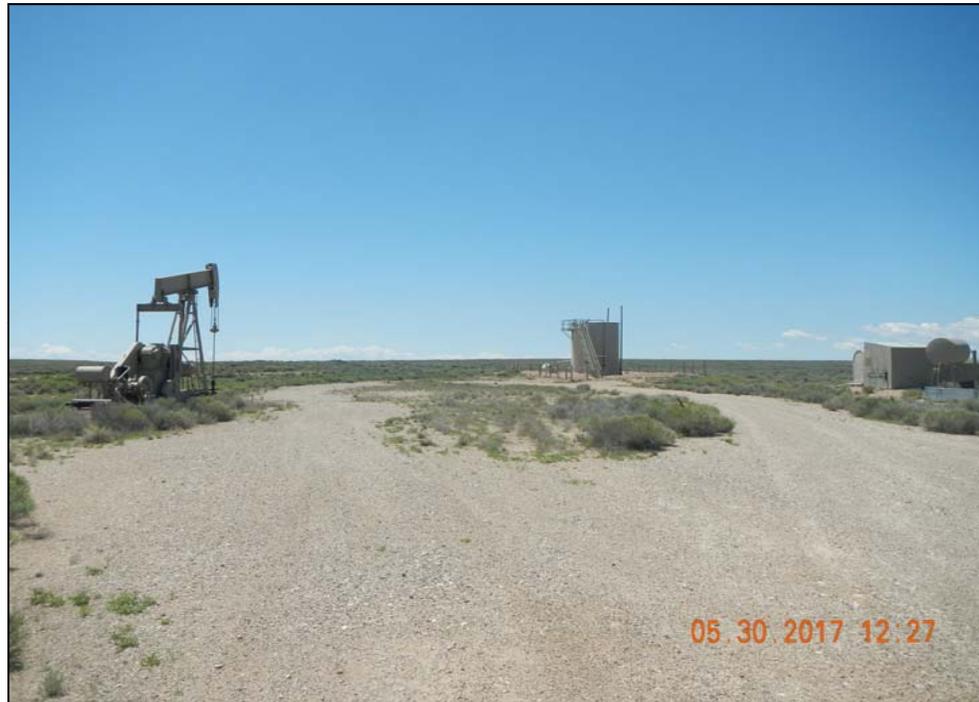
Photo 1. Overview of location taken at entrance to location facing south.

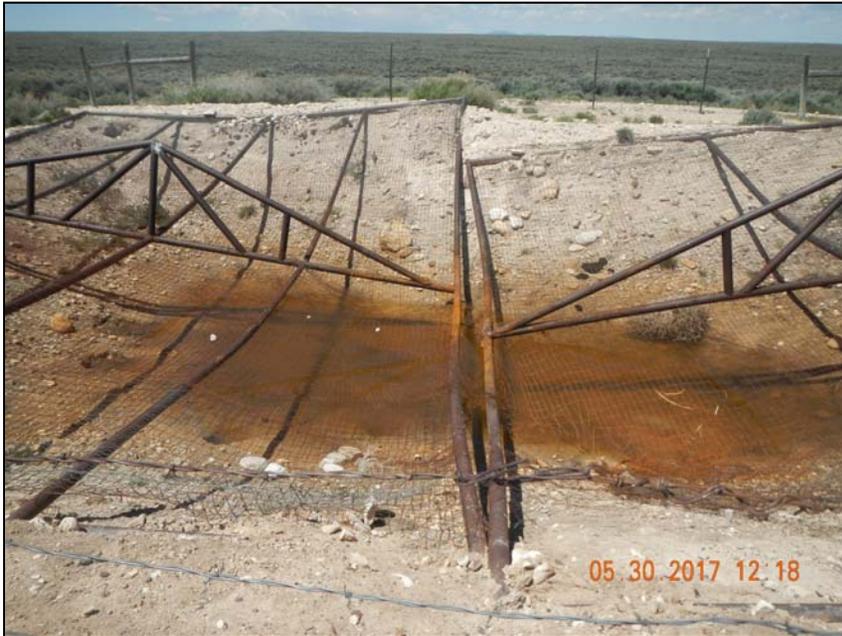
Photo 2. Pit at 40.882770, -108.299100.

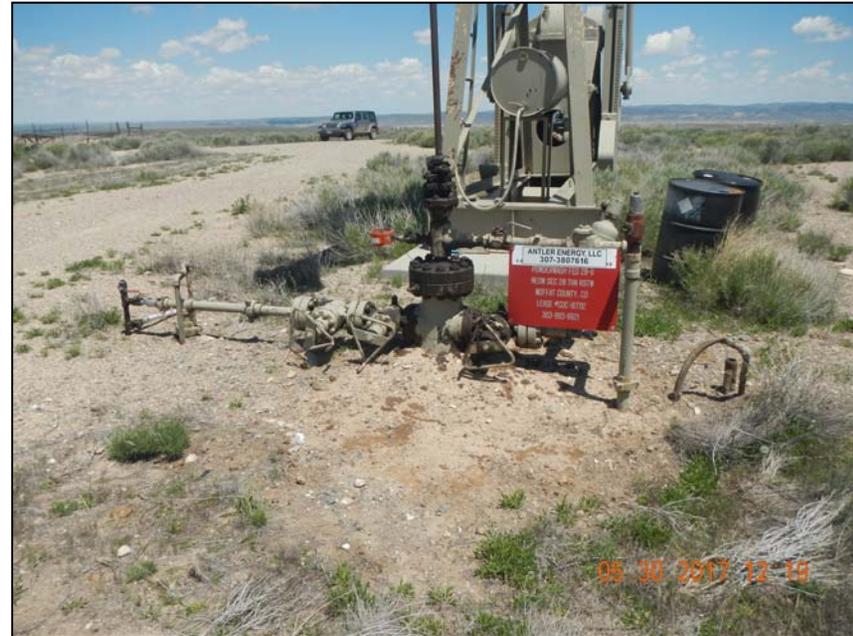
Photo 3. Risers at wellhead. Lube oil containers stored without secondary containment in background.

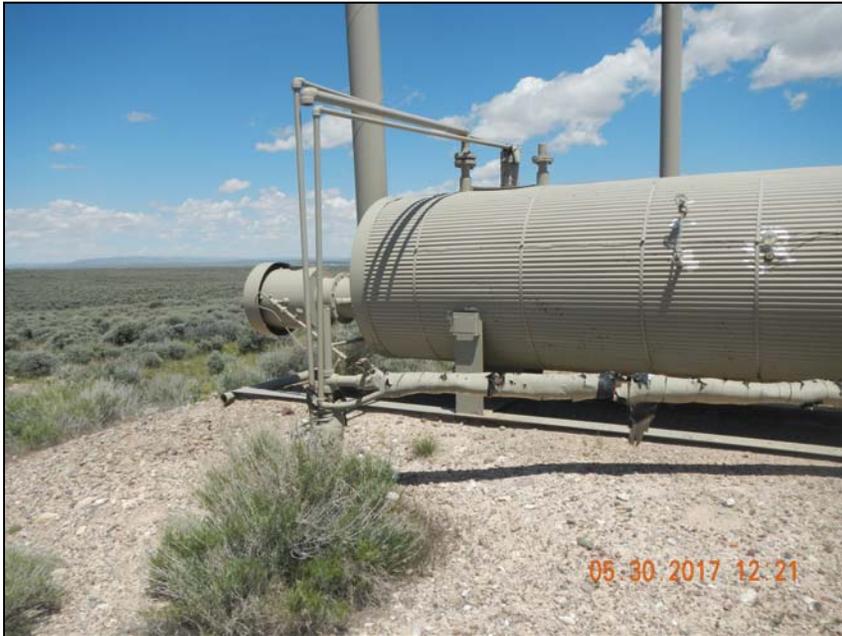
Photo 4. Risers at separator.

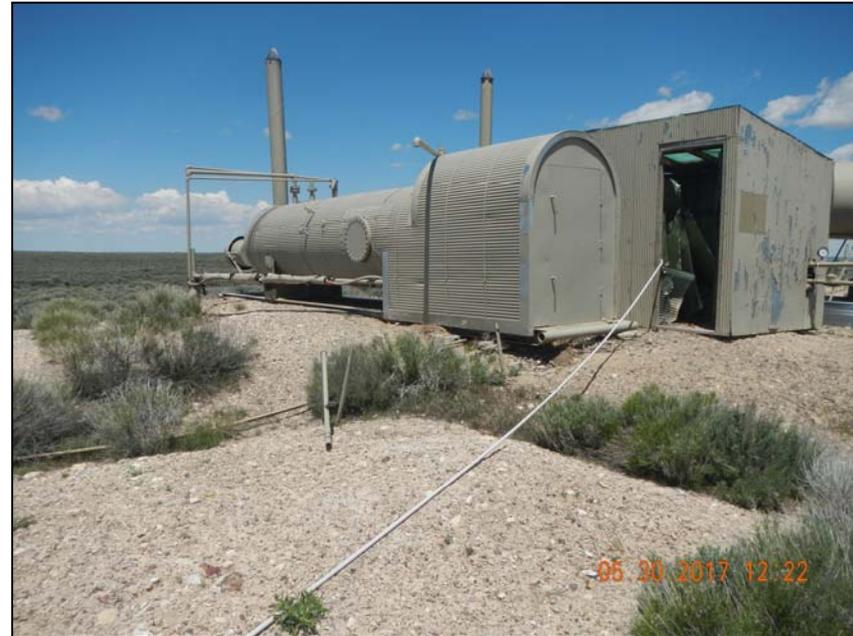
Photo 5. Risers at separator with poly flowline in foreground.

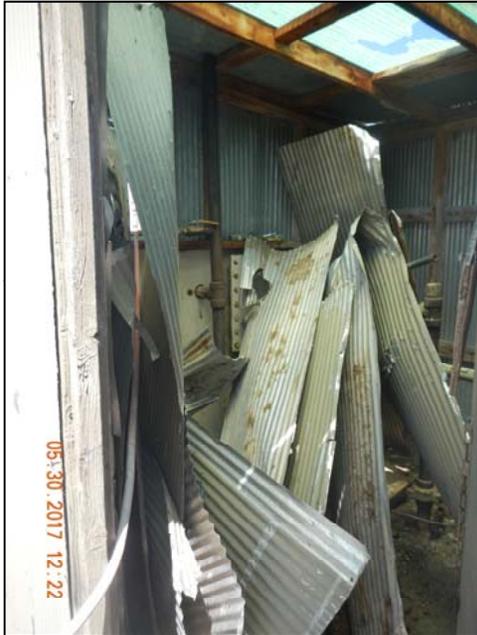
Photo 6. Risers inside separator.

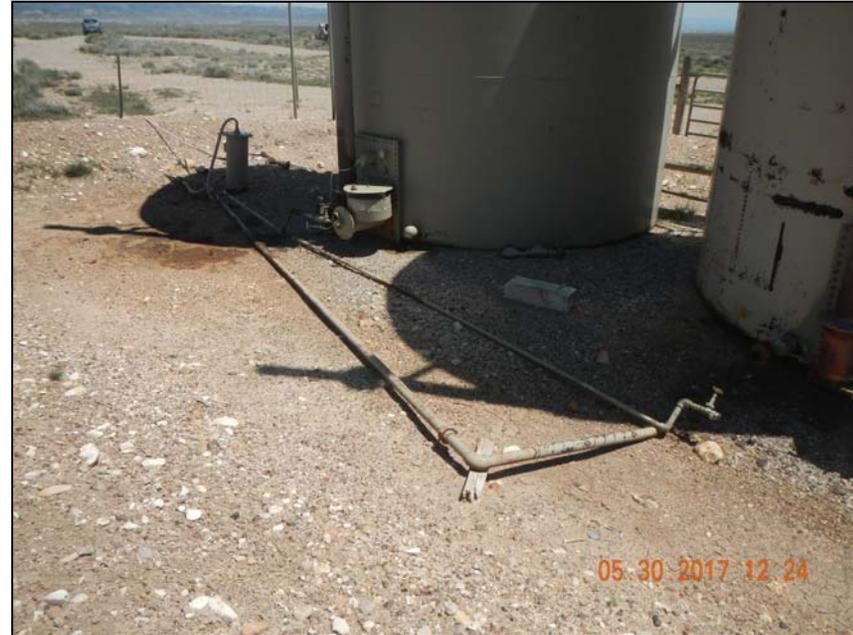
Photo 7. Risers at tank battery.

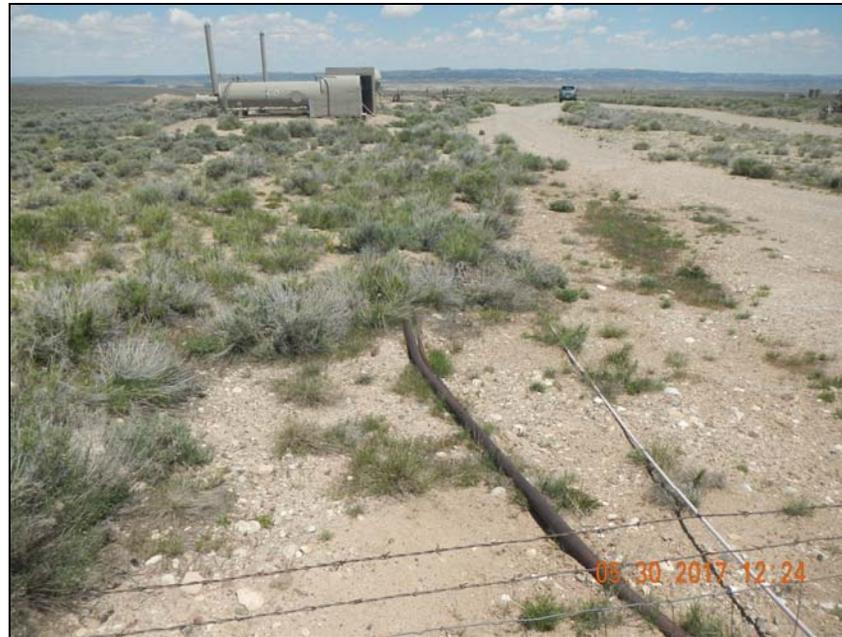
Photo 8. Flowlines from tank battery to separator and pit.
