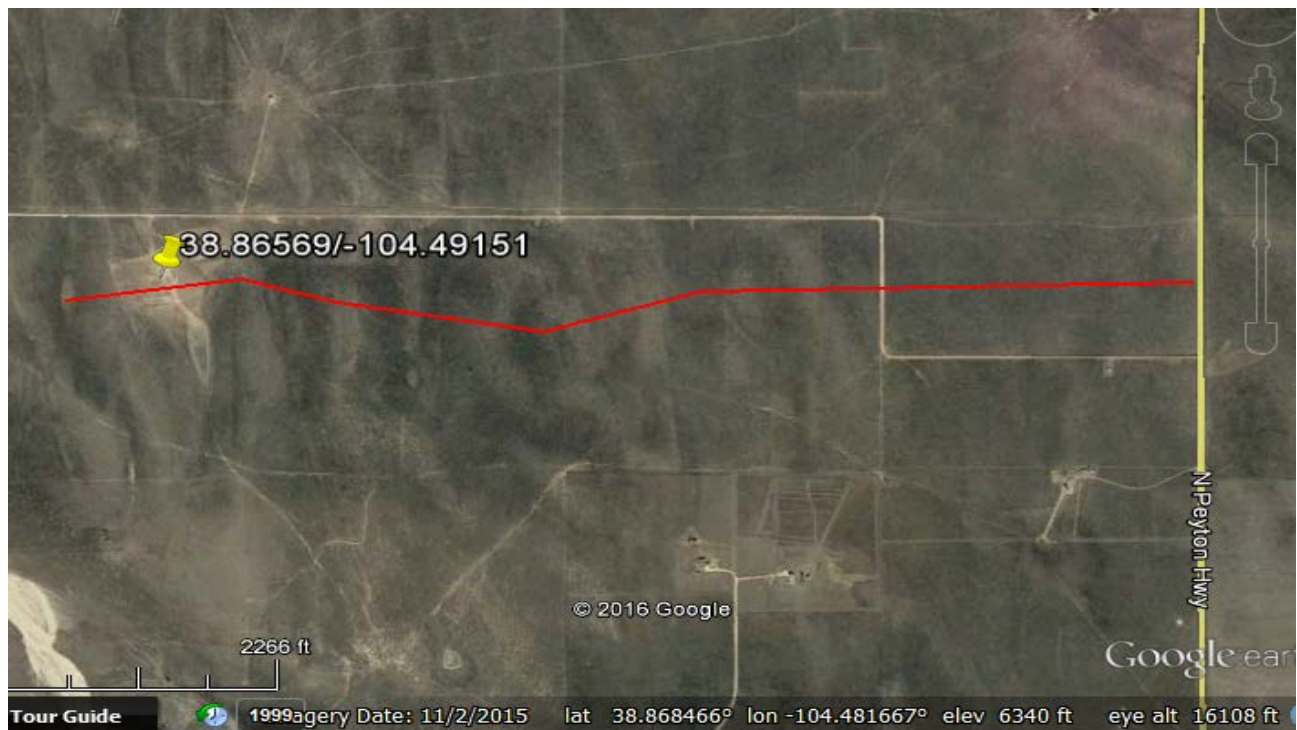
photo 1: Red line indicates newly constructed road which intersect the access road and the location.

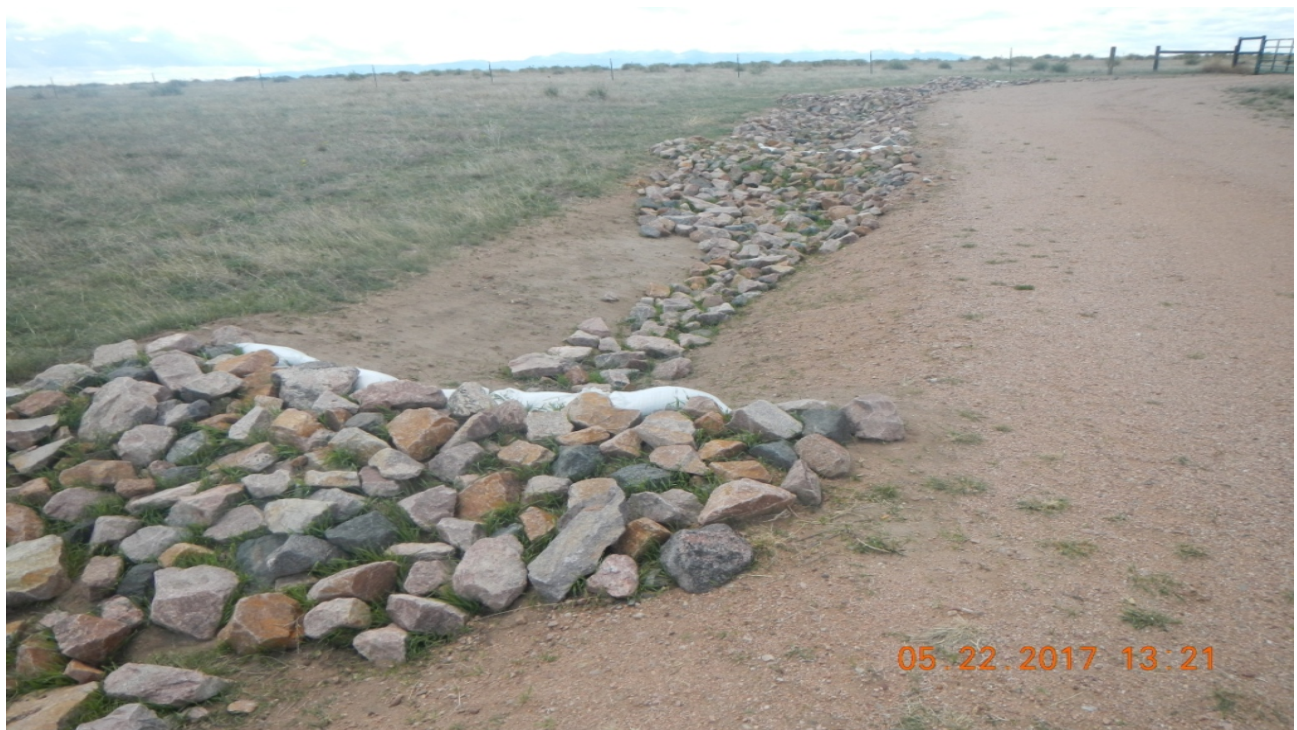
photo 2: Facing west along the access road. Rock rip/rap has been placed along the road where erosion channel was documented in the previous inspection.

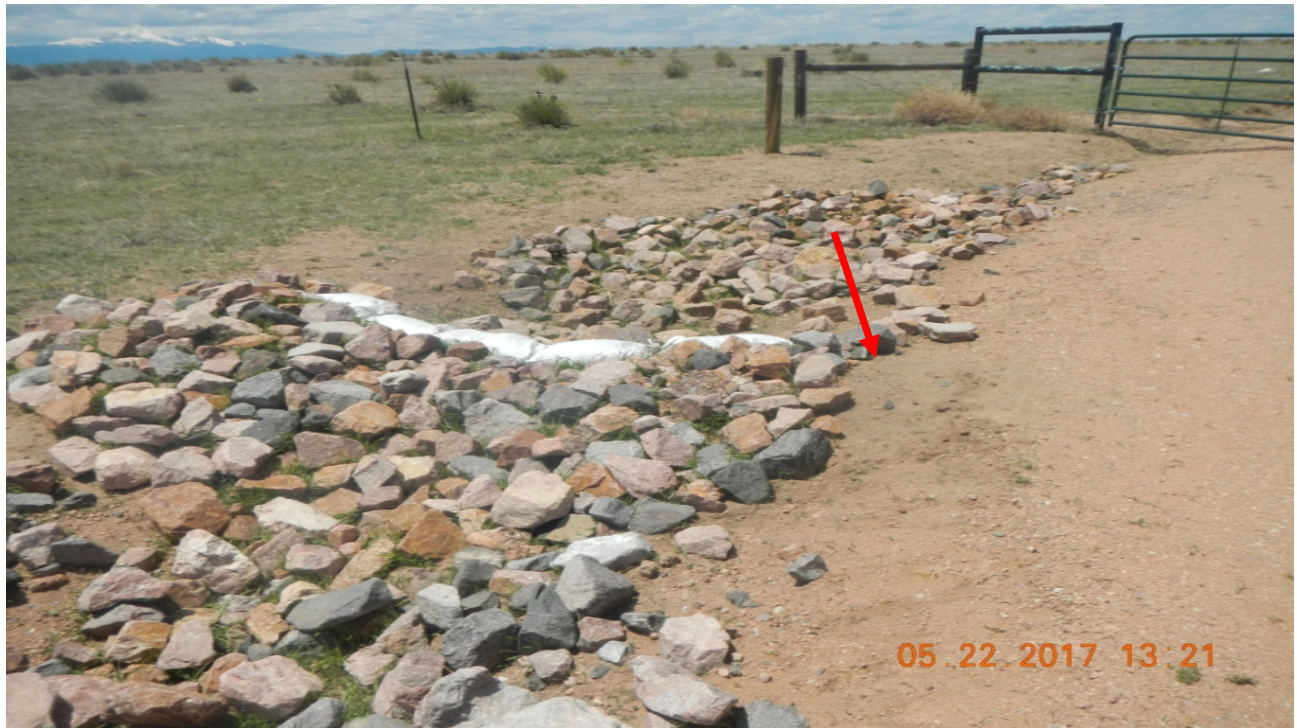
photo 3: There are rock rip/rap check dams with sandbags however they don't appear to be constructed correctly. Stormwater could flow around the low area as shown by the arrow.

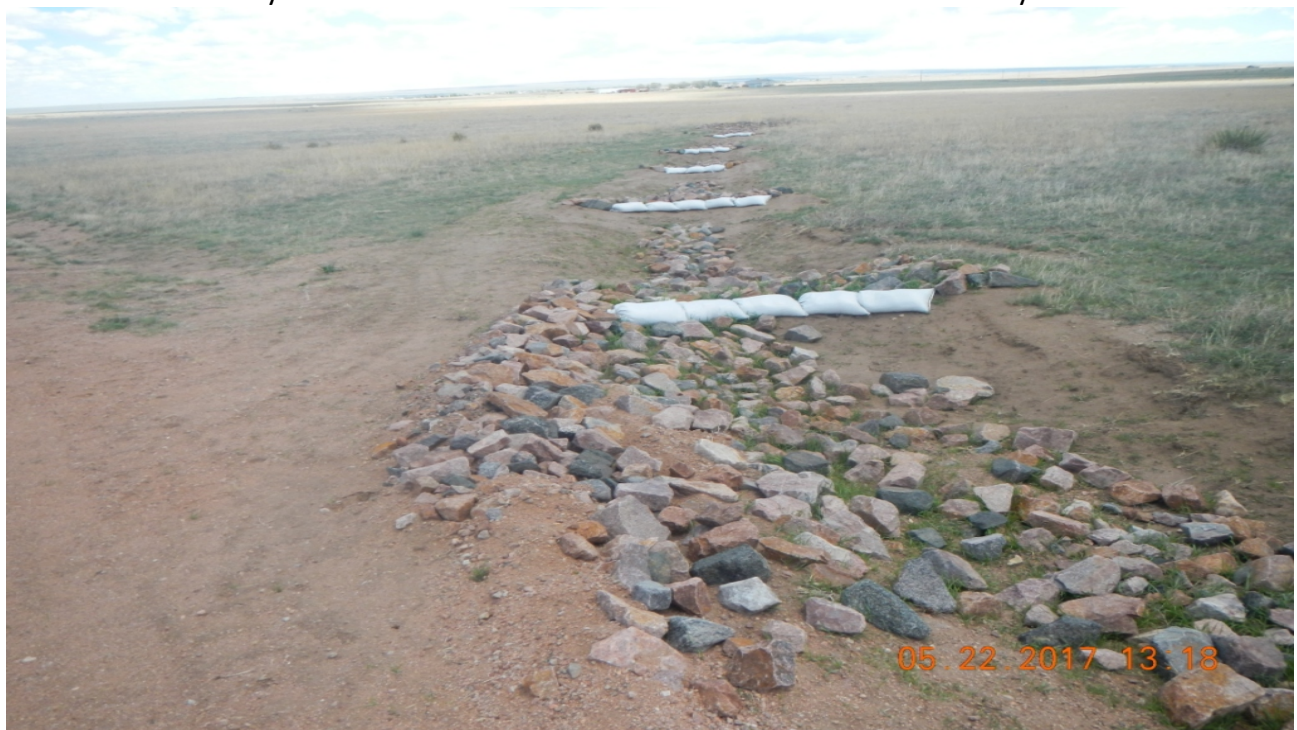
photo 4: The erosion channel directed out toward the pasture has rock rip/rap and sandbags installed.

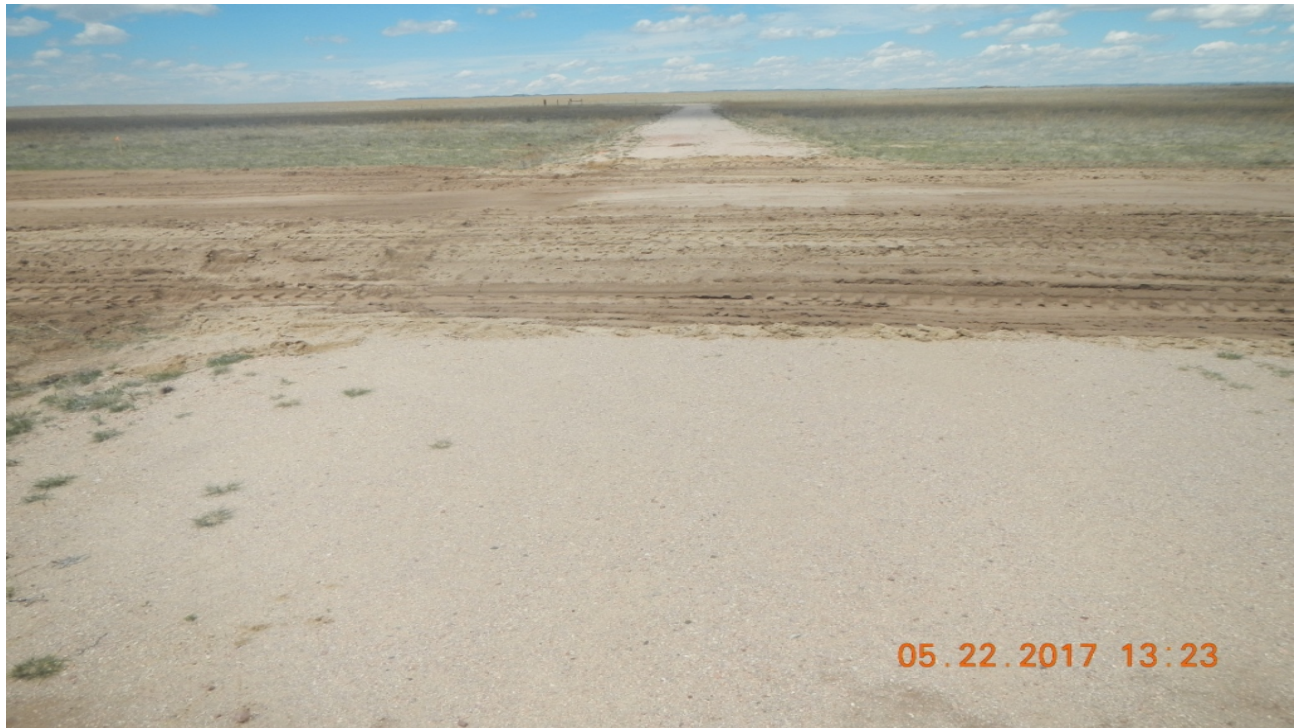
photo 5: Facing north along the access road. A new road is being constructed which intersects the access road at this point.

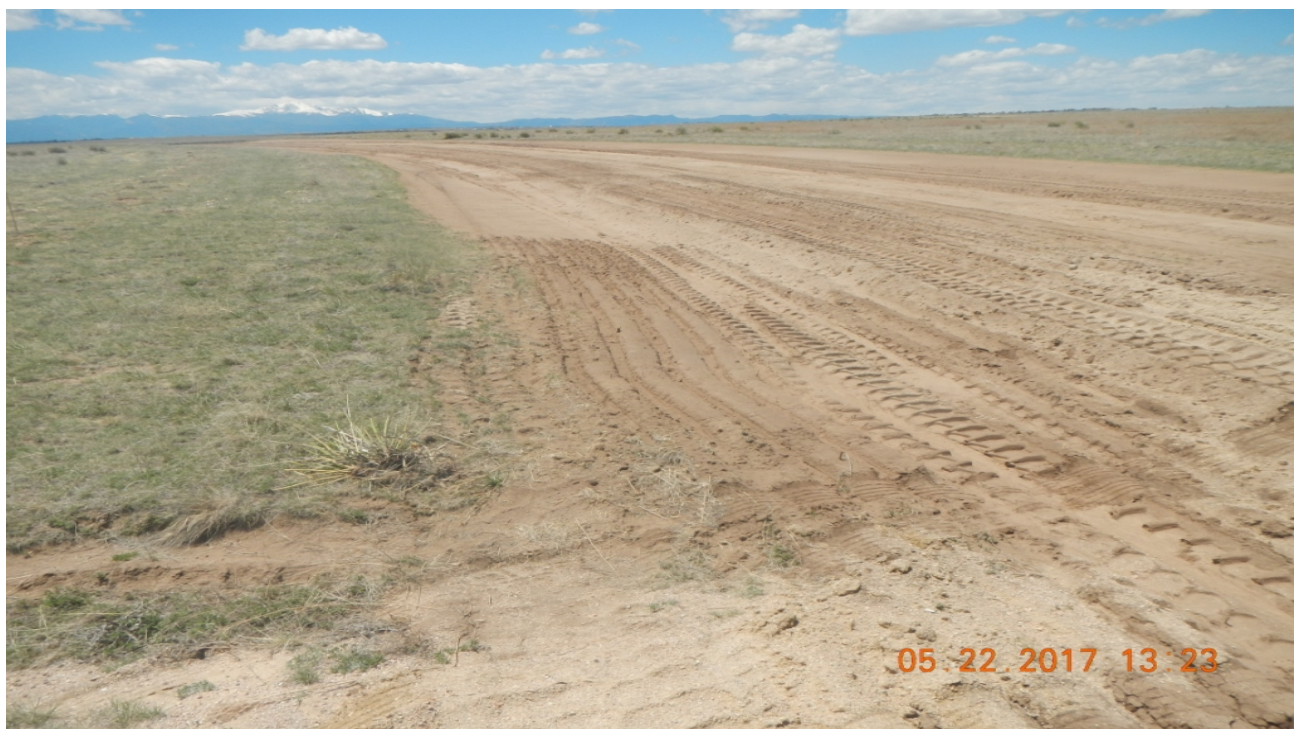
photo 6: A new road for development is being constructed which goes toward the location.

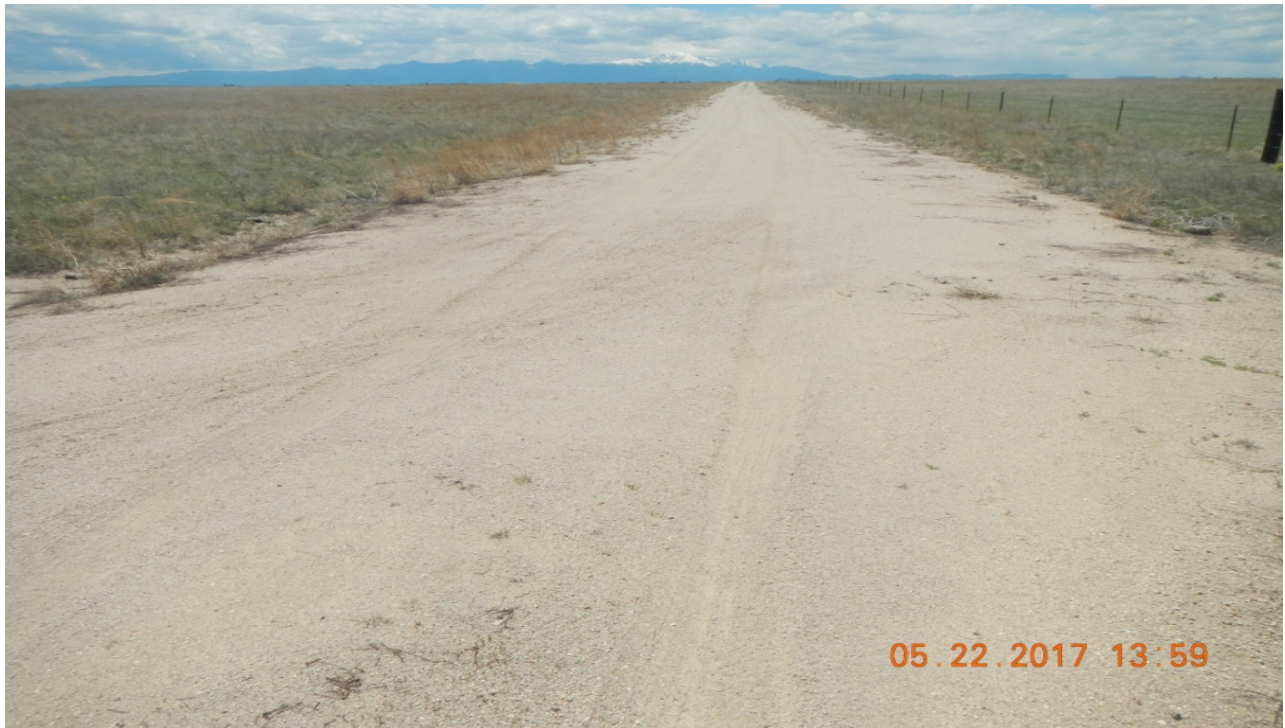
photo 7: The point where access road turns toward the west along the fence line.

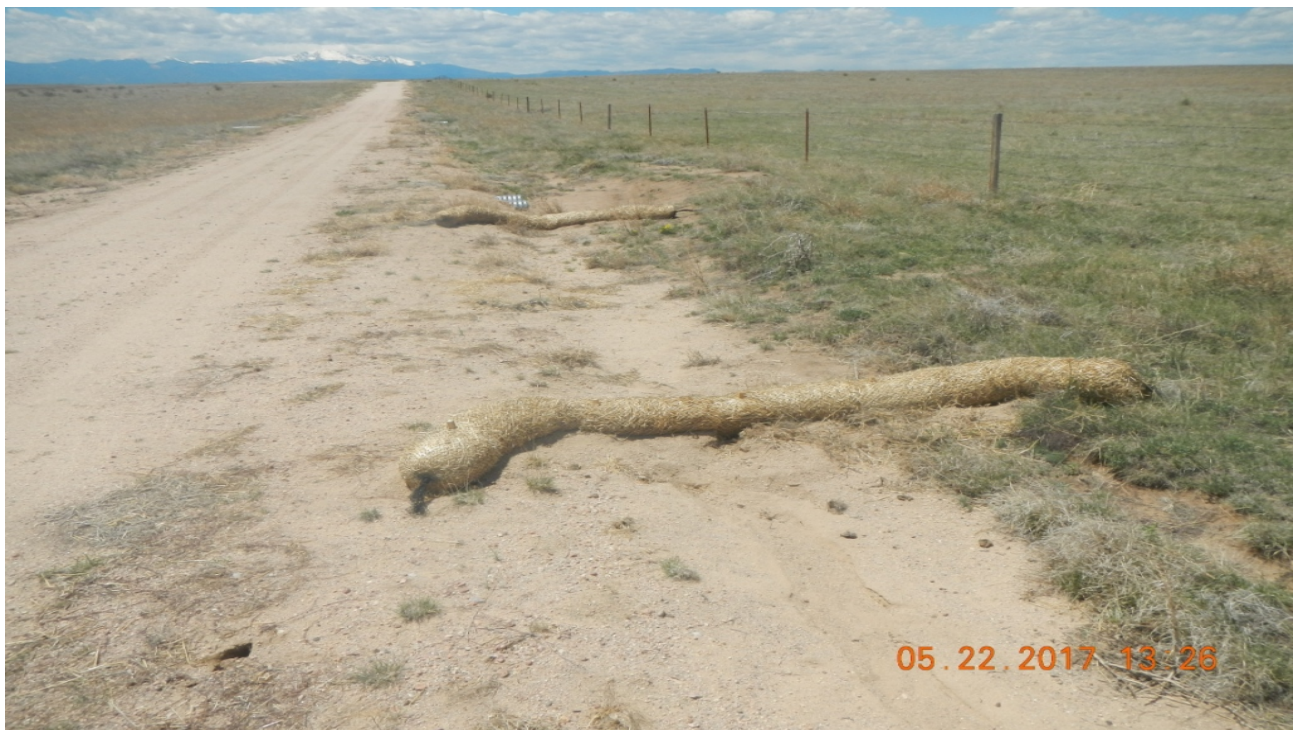
photo 8: Straw wattles are installed along the access road near this culvert.

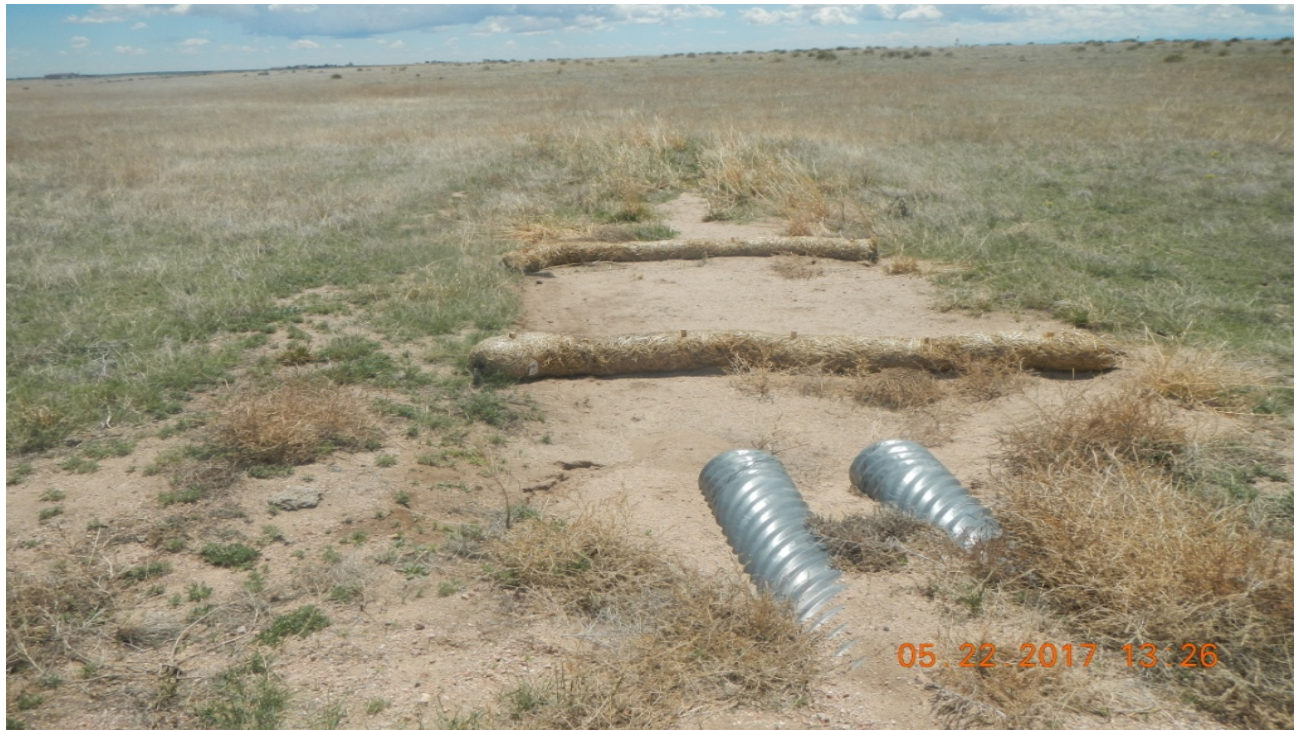
photo 9: The outlet of the culvert along the access road. The sediment has not been removed which will restrict water flow. Straw wattles were installed.

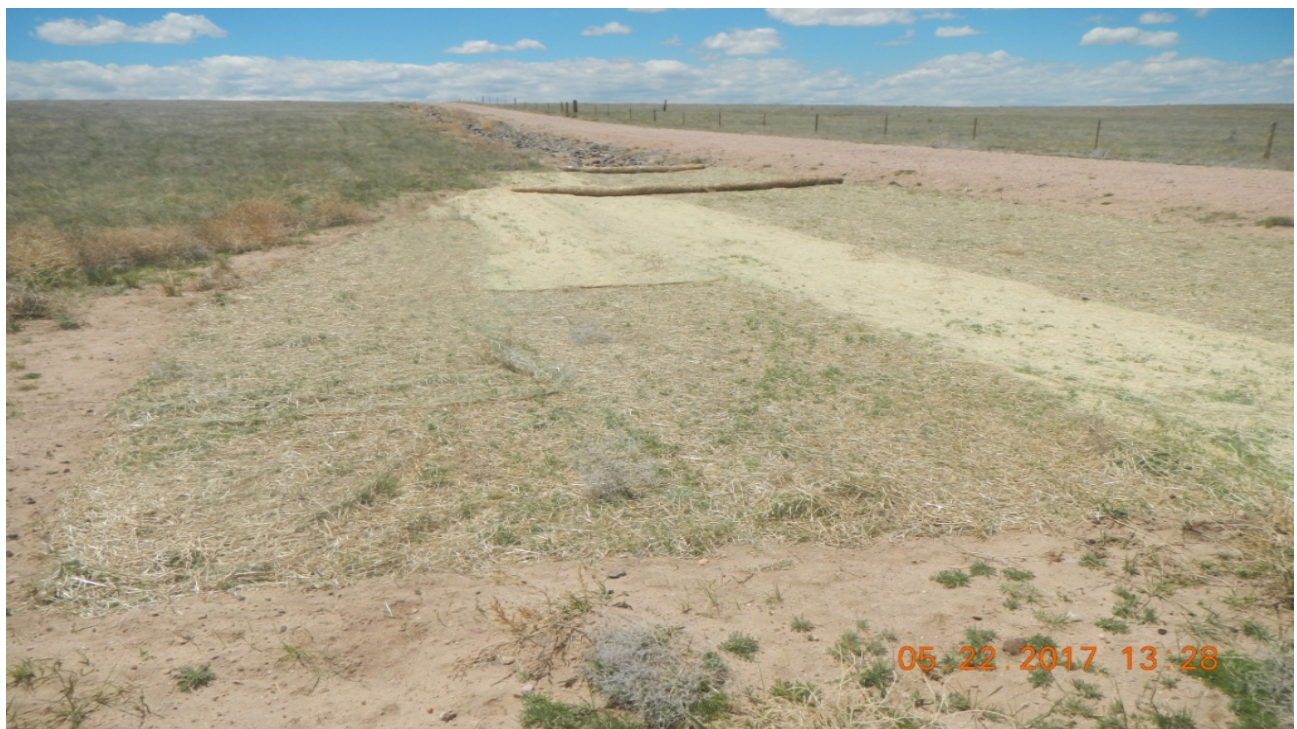
photo 10: Facing northwest along the side of the access road. Erosion straw blanket was installed and there appears to be vegetation beginning to establish.

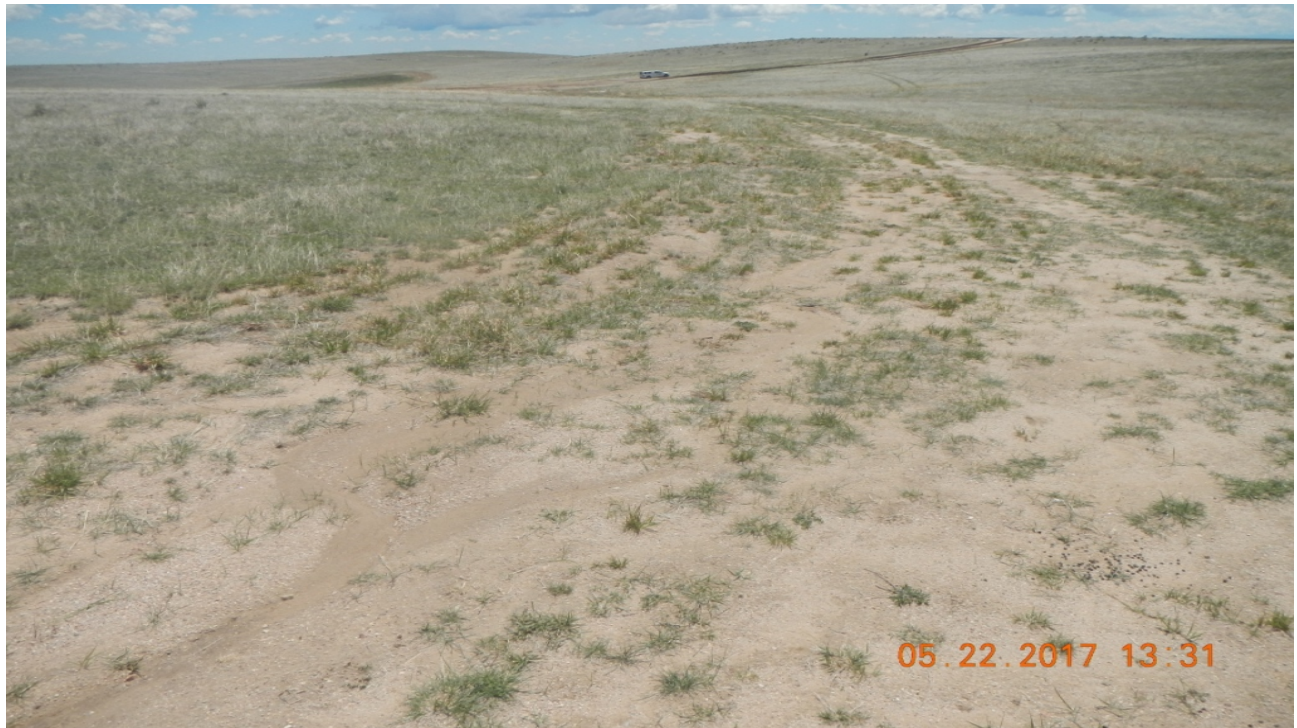
photo 11: Facing south toward the location. This area has inadequate vegetation establishment and does not appear to have been reseeded.

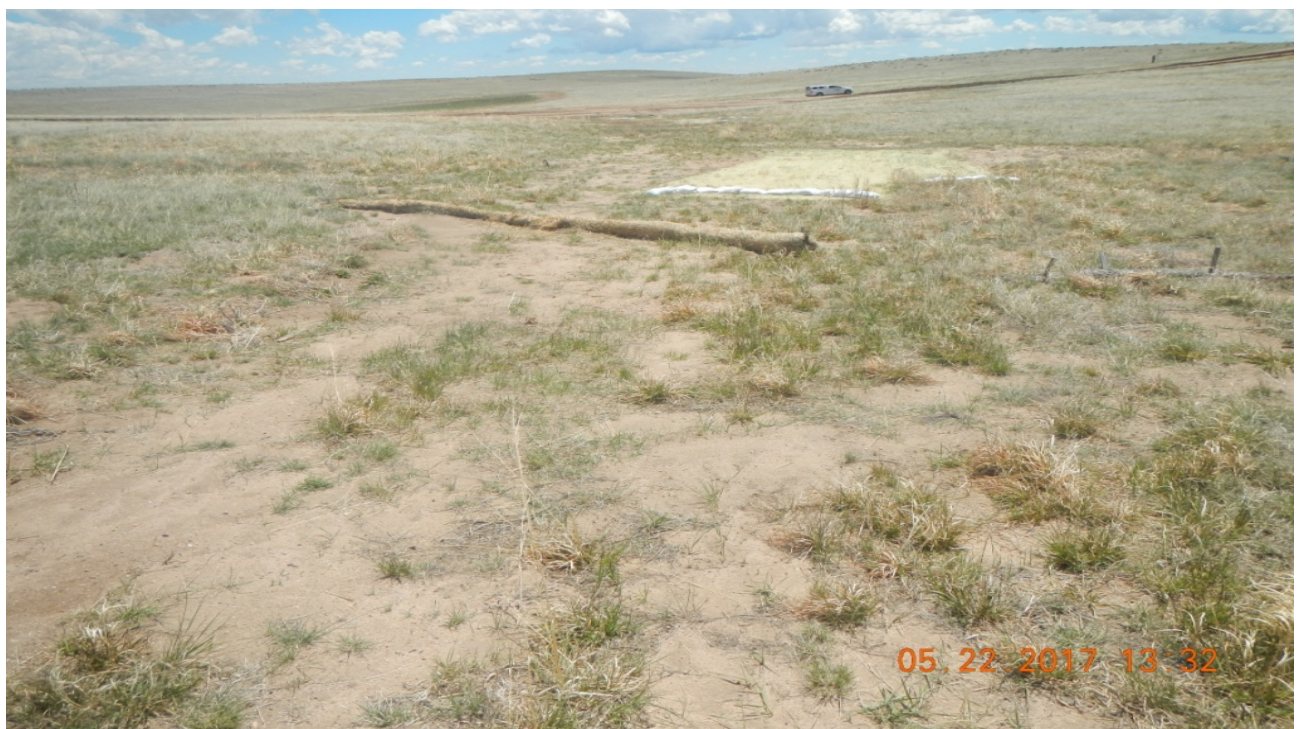
photo 12: Facing south at the location. The wire fence around this area was removed.

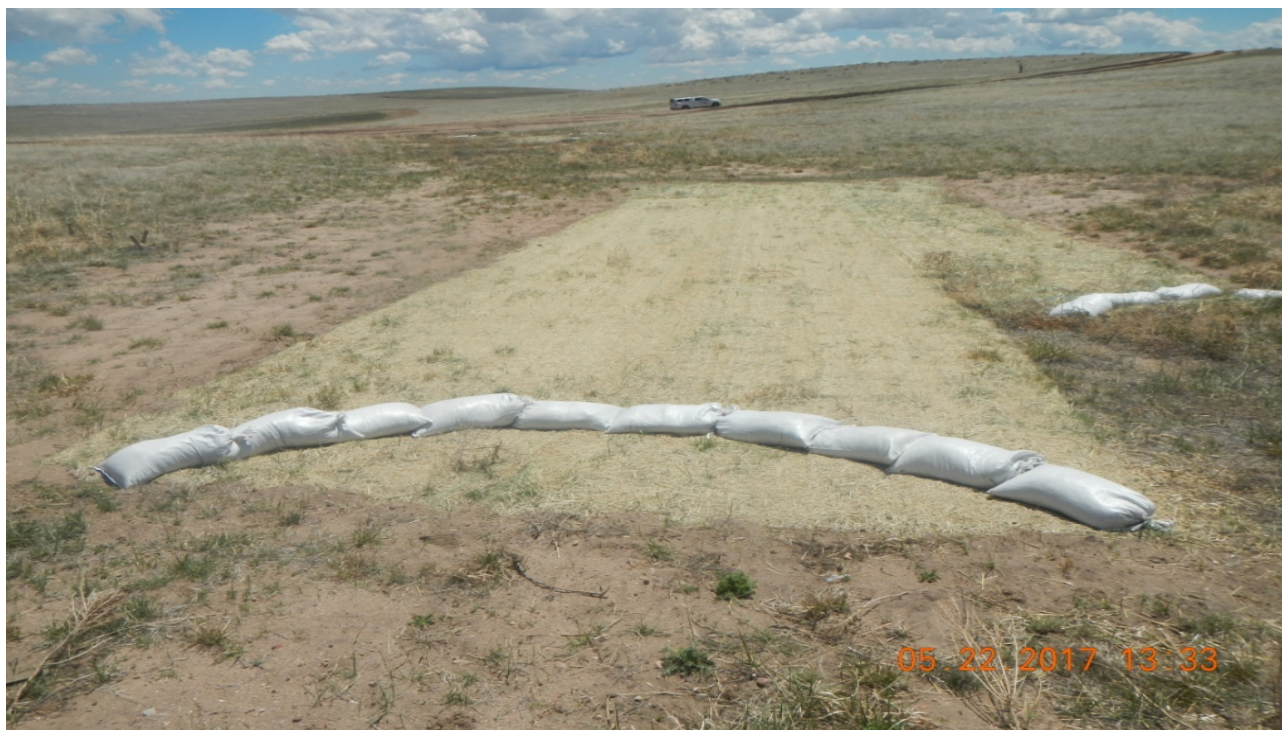
photo 13: Straw blanket and sand bags are installed in this area.

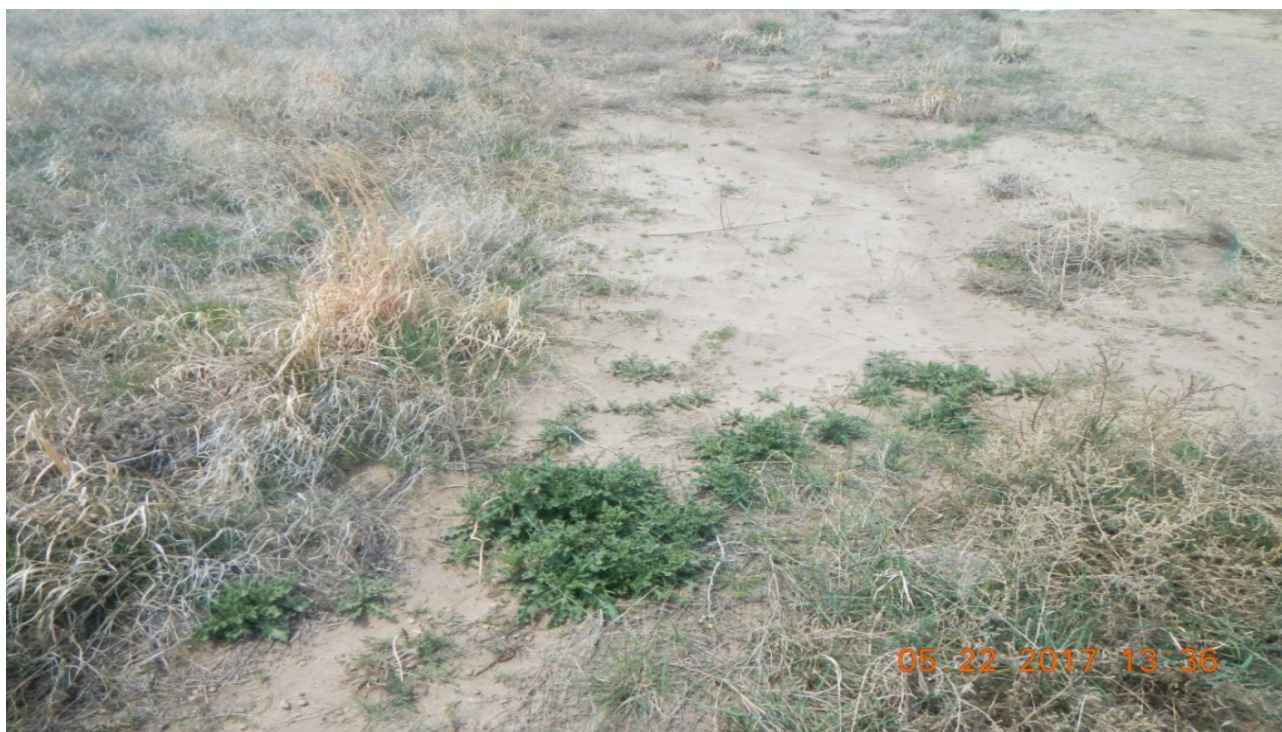
photo 14: There is a patch noxious weeds (Canada thistle) found at approximate Lat/Long: 38.86573, -104.49155.

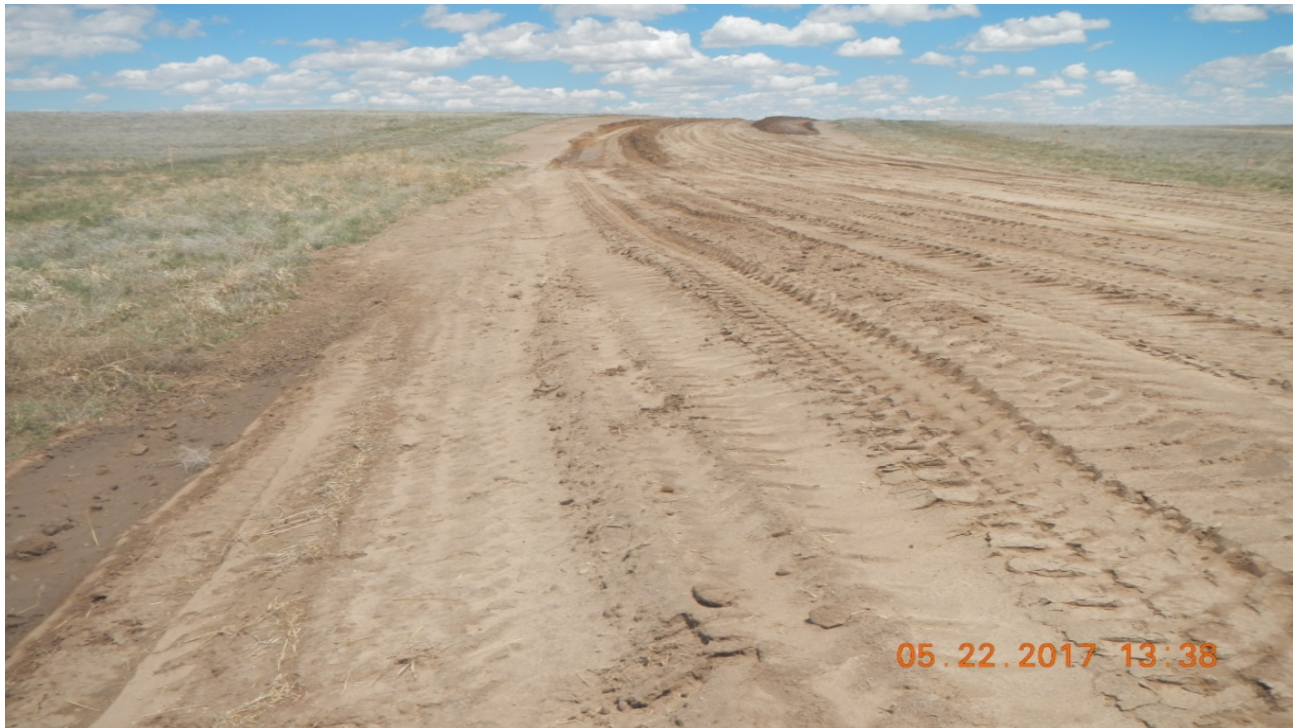
photo 15: A new road has been constructed which goes thru the location.

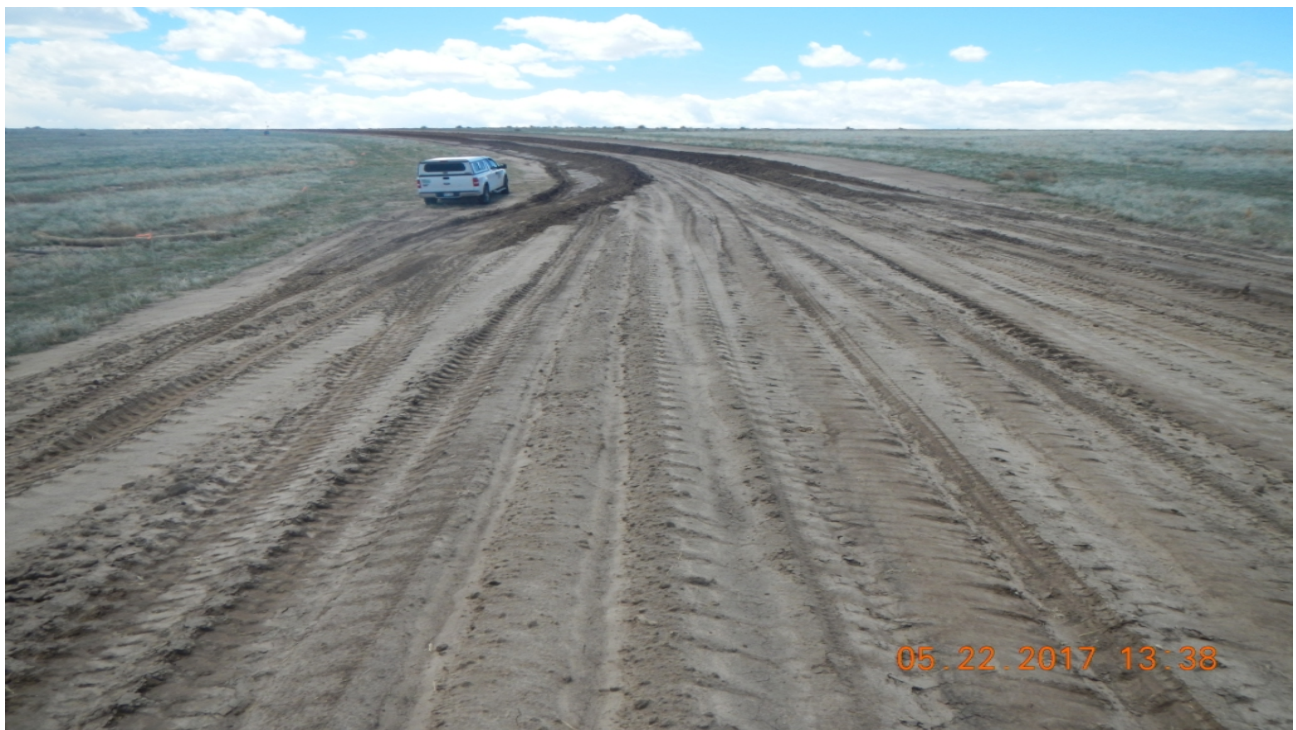
photo 16: Facing west toward the newly constructed road.

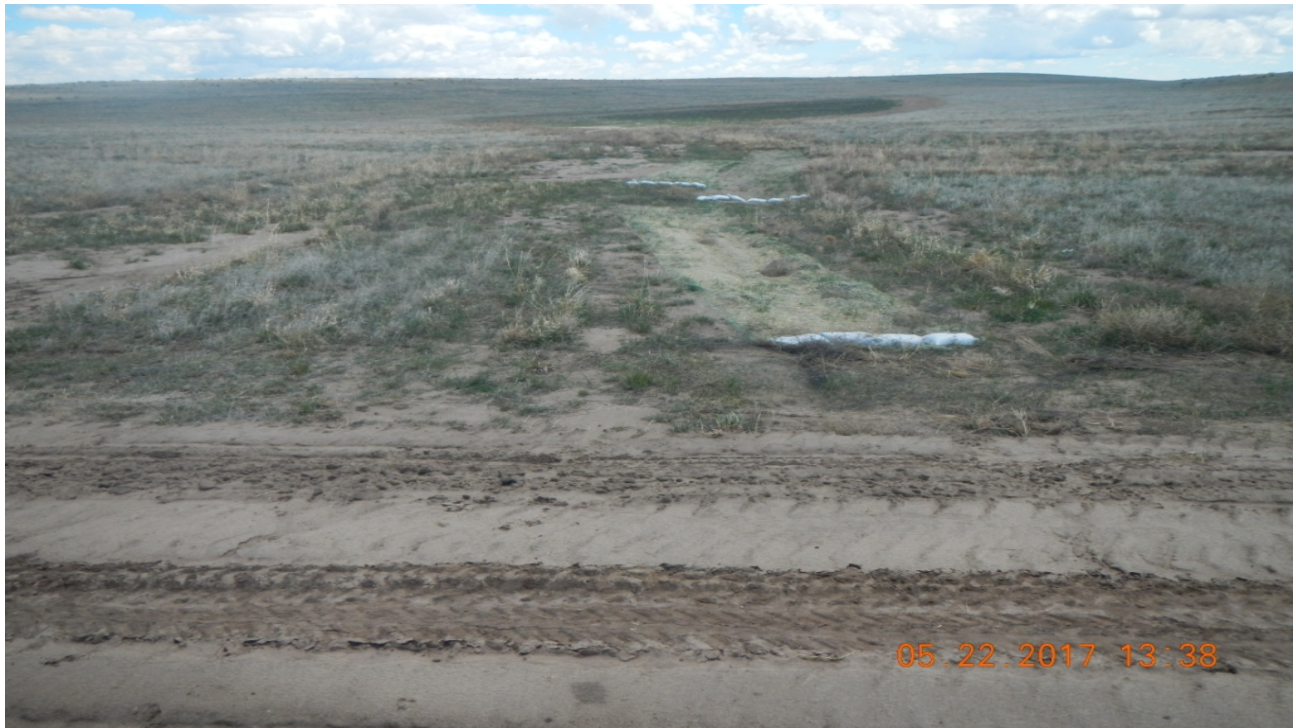
photo 17: Facing south at the location standing from new road.

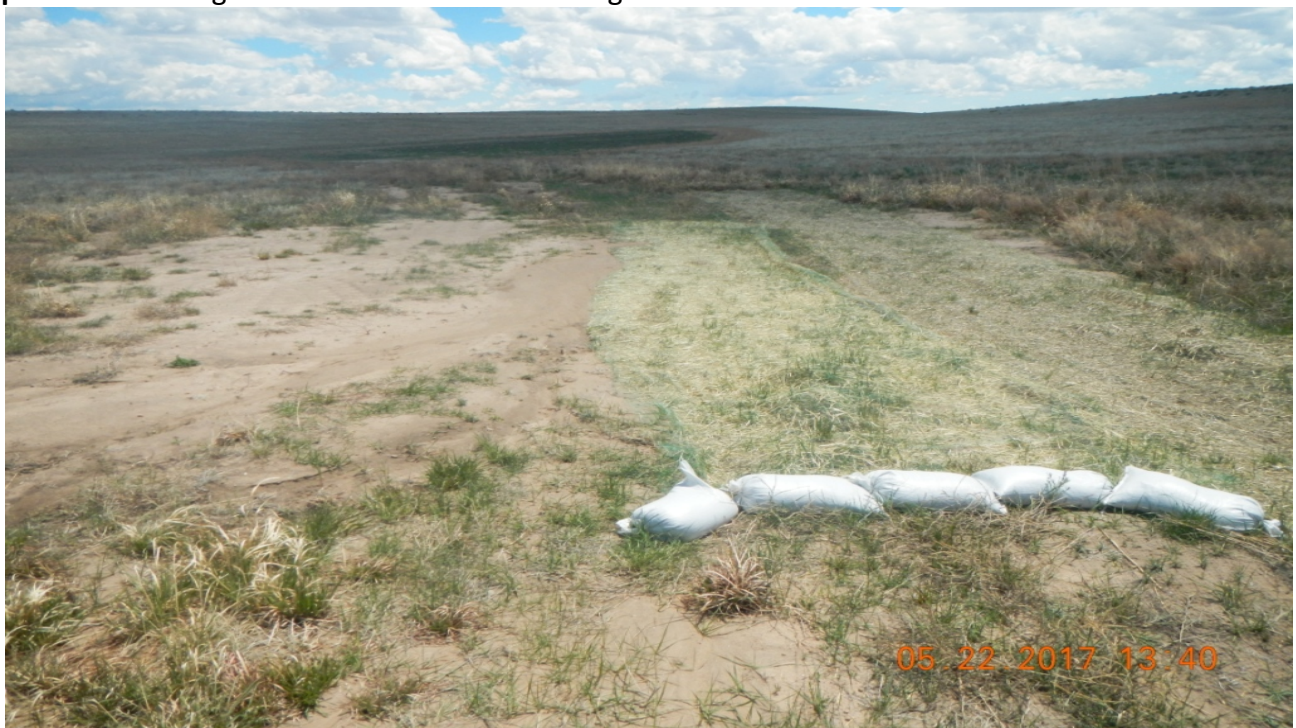
photo 18: Facing south at the location. It appears that the area of the right side of the photo was seeded and a straw blanket was installed. It does not appear the area at the left side was seeded.

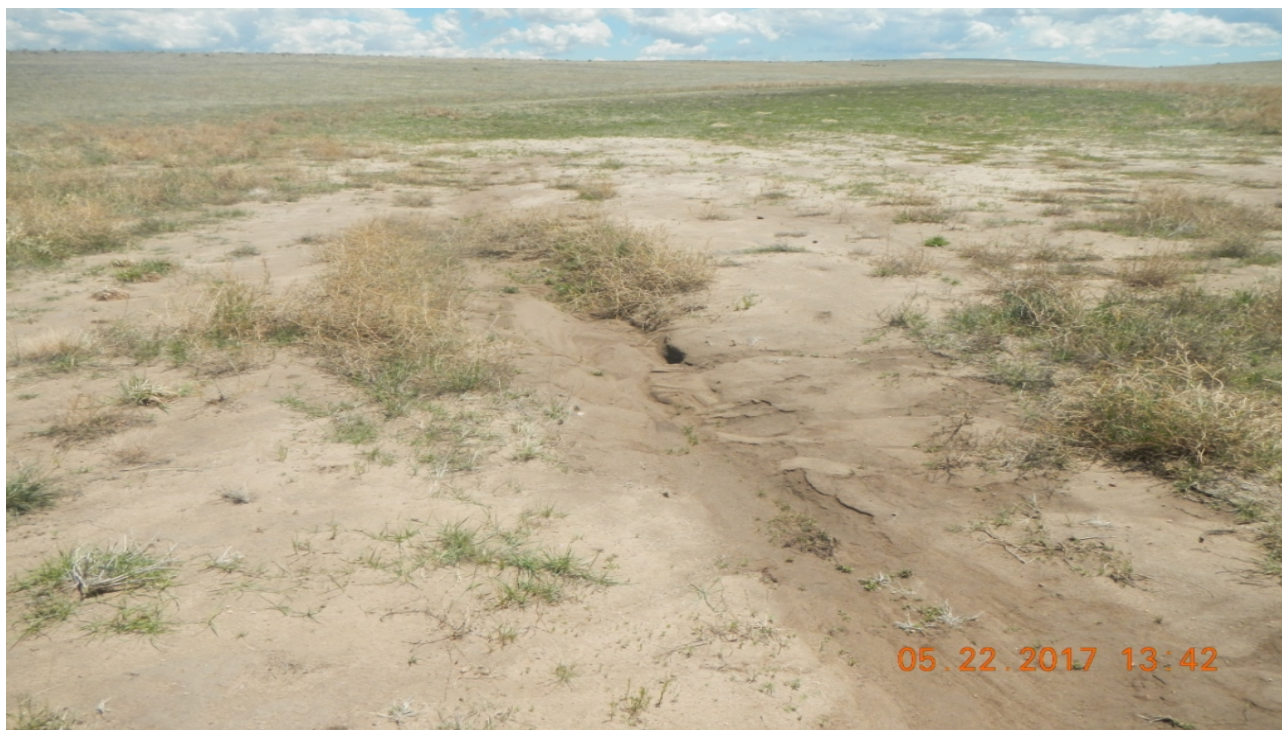
photo 19: Facing toward the south side of the location. There are signs of erosion in this area and inadequate vegetation establishment.

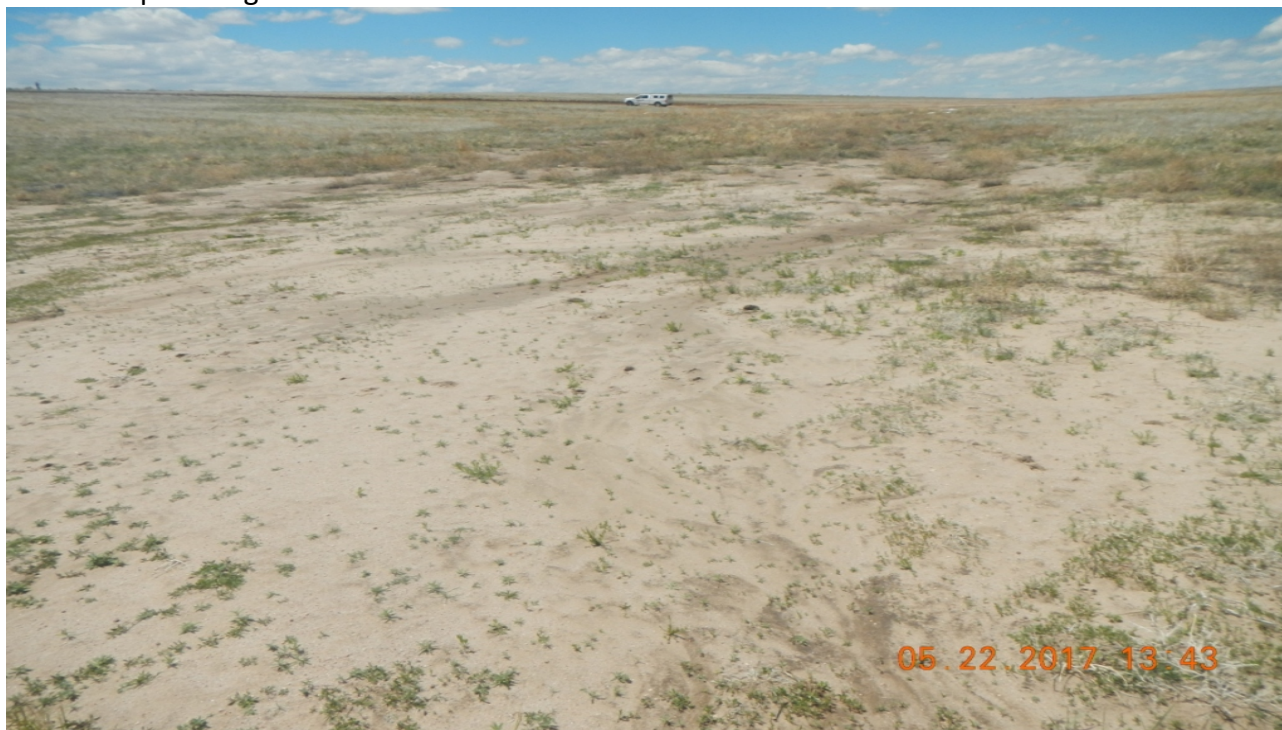
photo 20: South side of the location facing northwest. This area does not have adequate vegetation establishment and does not appear to have been reseeded.

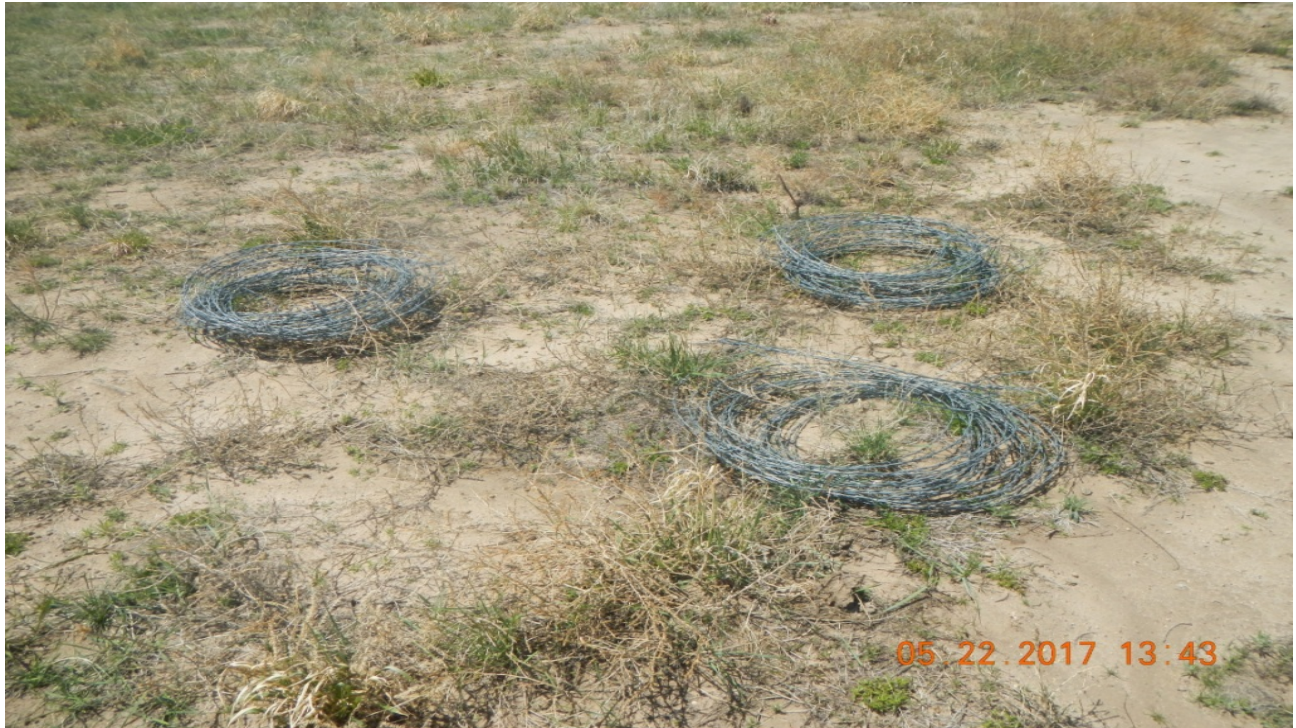
photo 21: There are rolls of barbed wire at the south side of the location that must be removed.

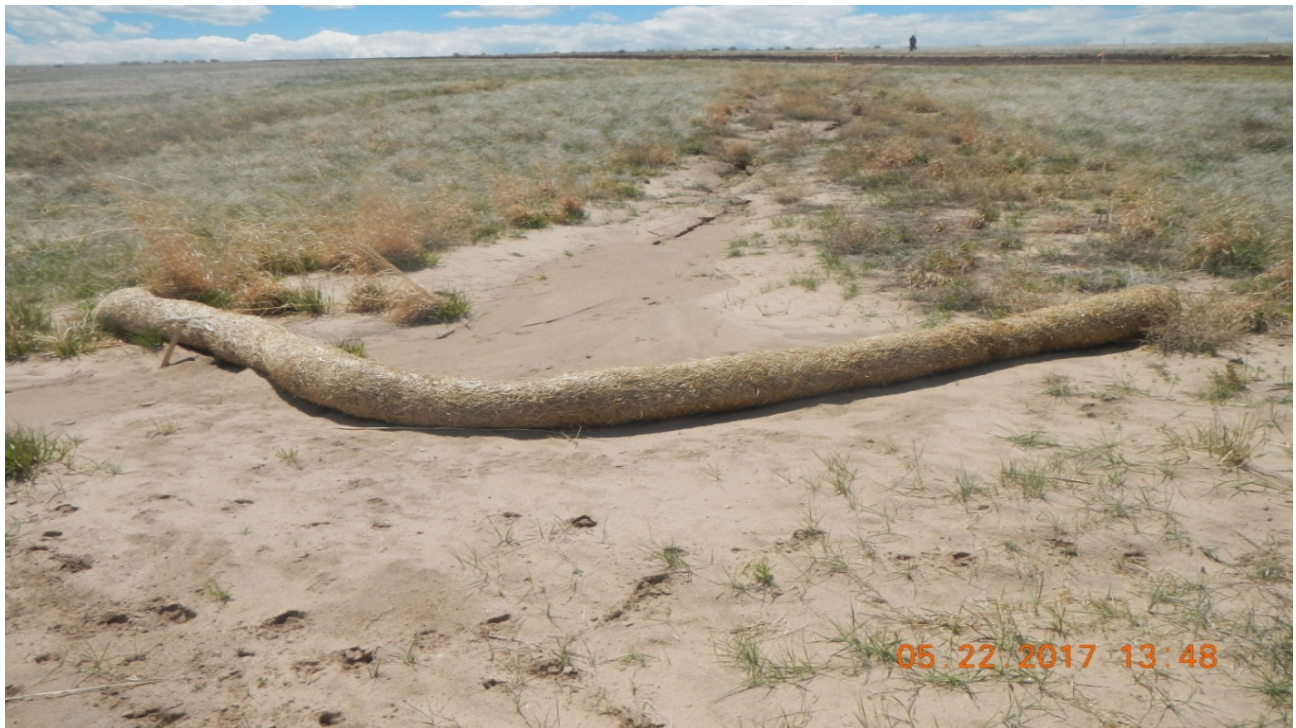
photo 22: There are signs that stormwater is eroding underneath the straw wattle which was not properly installed.

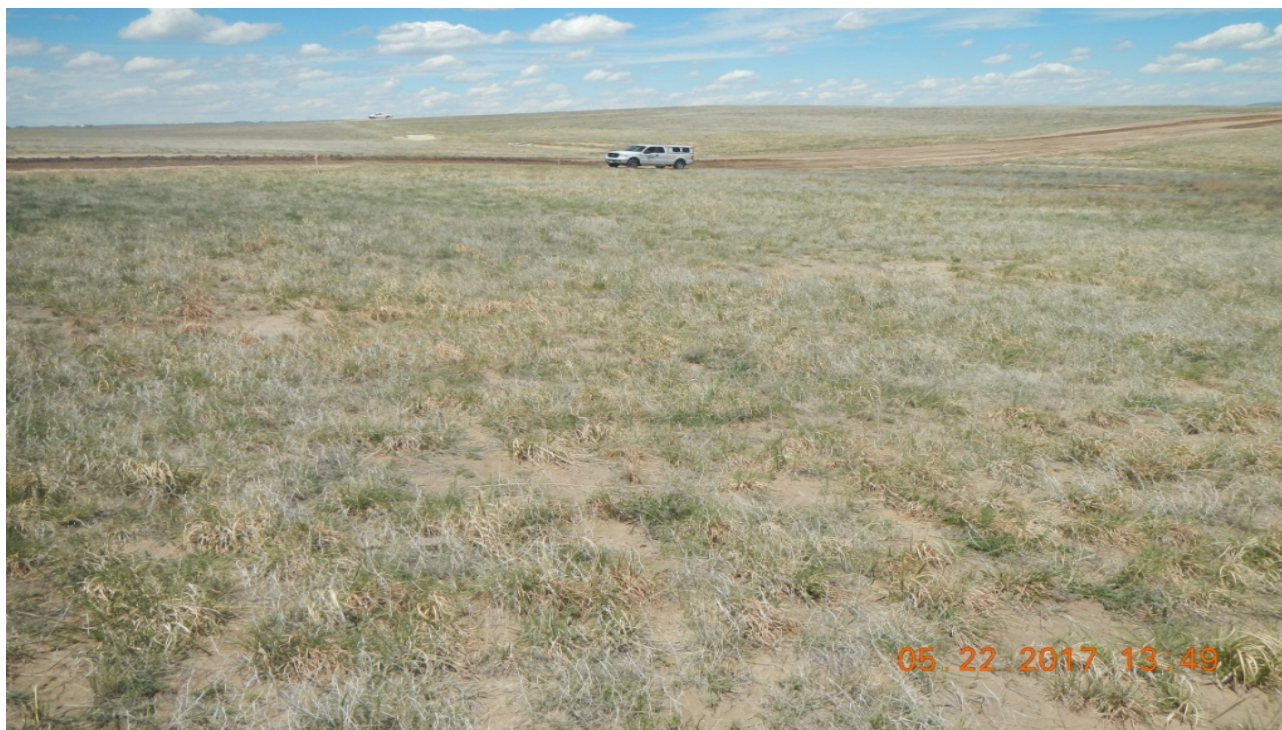
photo 23: Overview of the location facing north. The vegetation is well established in this immediate area.

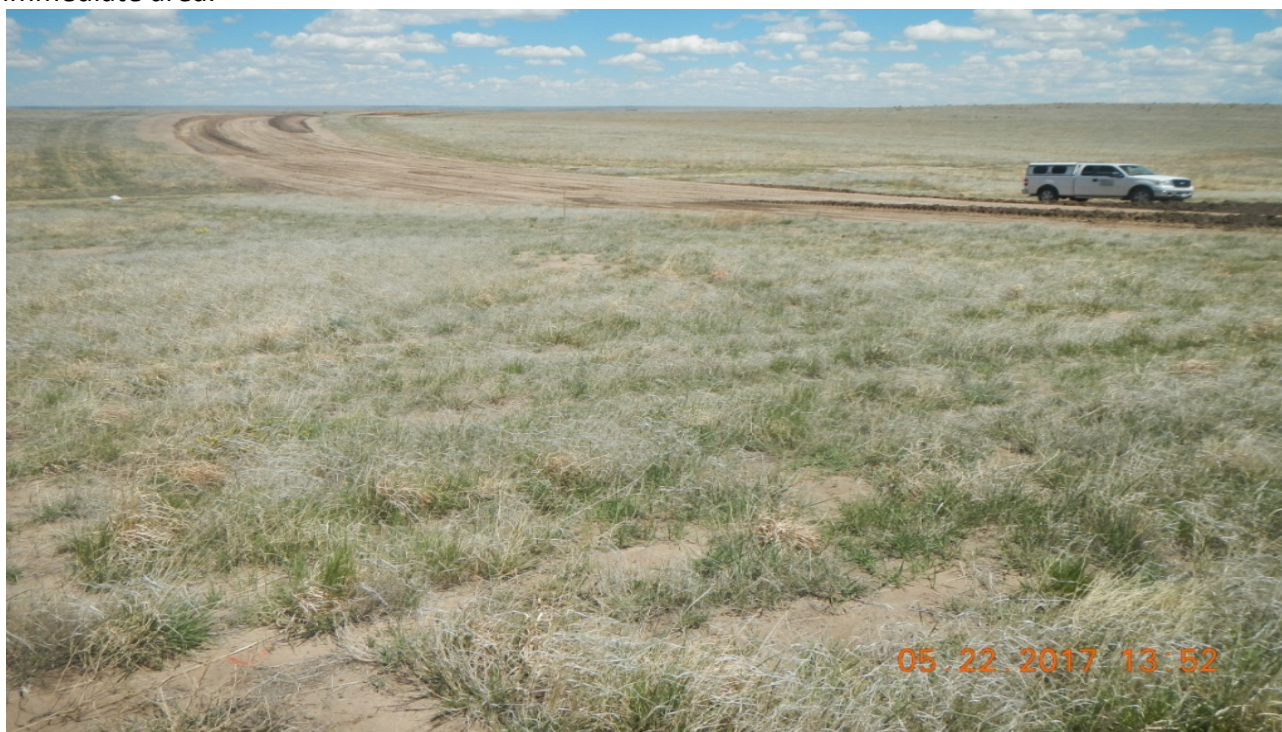
photo 24: Facing southeast at the location. The newly constructed road intersects the location.
