## Flowline Inspection Photos

Location Name: Frank #5

API: 05-123-23186

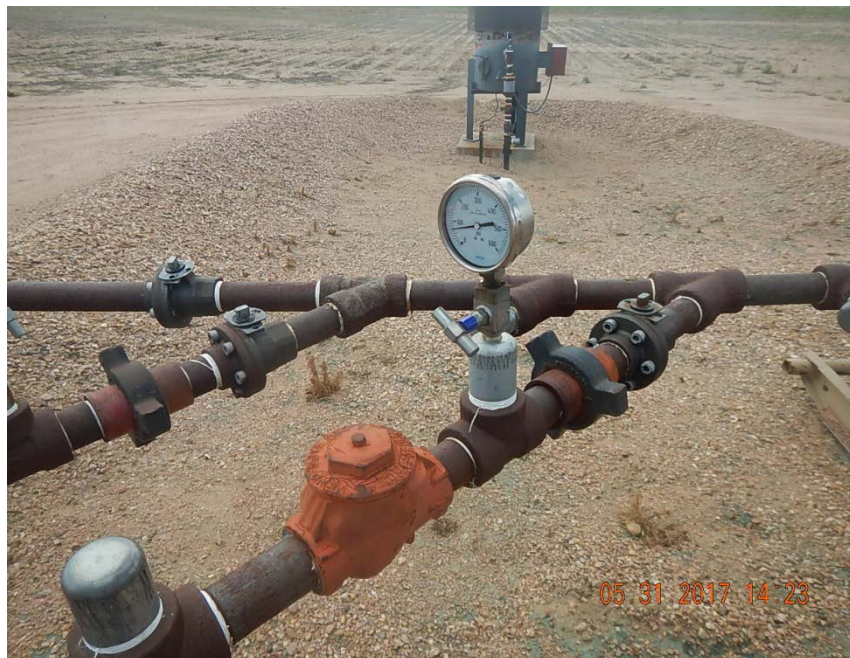
**Photo 1: Pressure test**

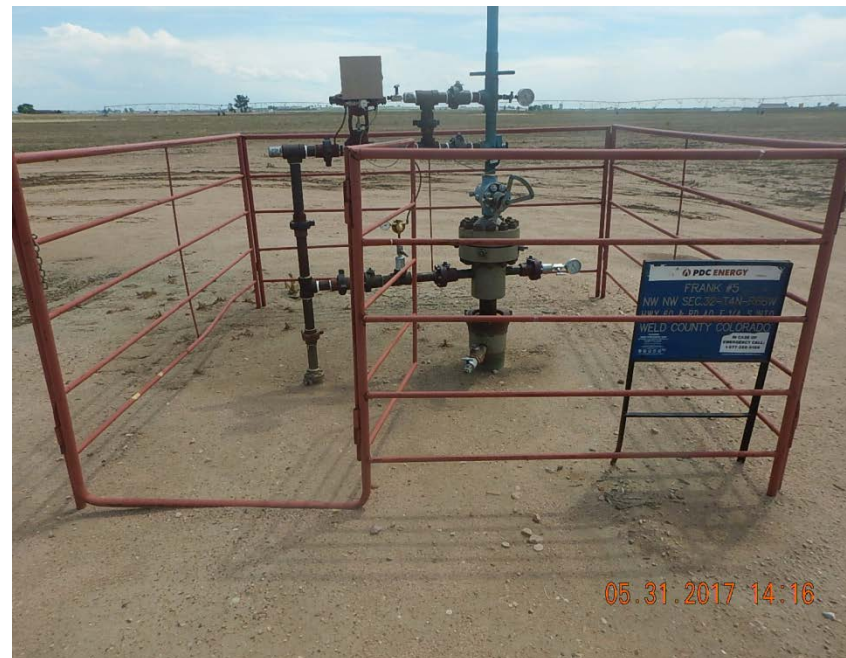
**Photo 2: Risers at wellhead**

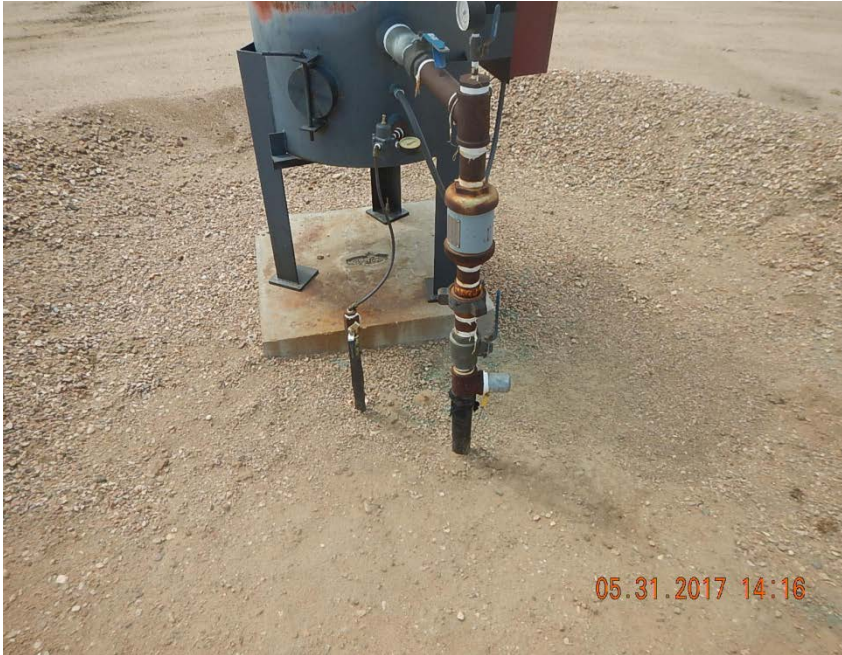
**Photo 3: Risers at ECD**

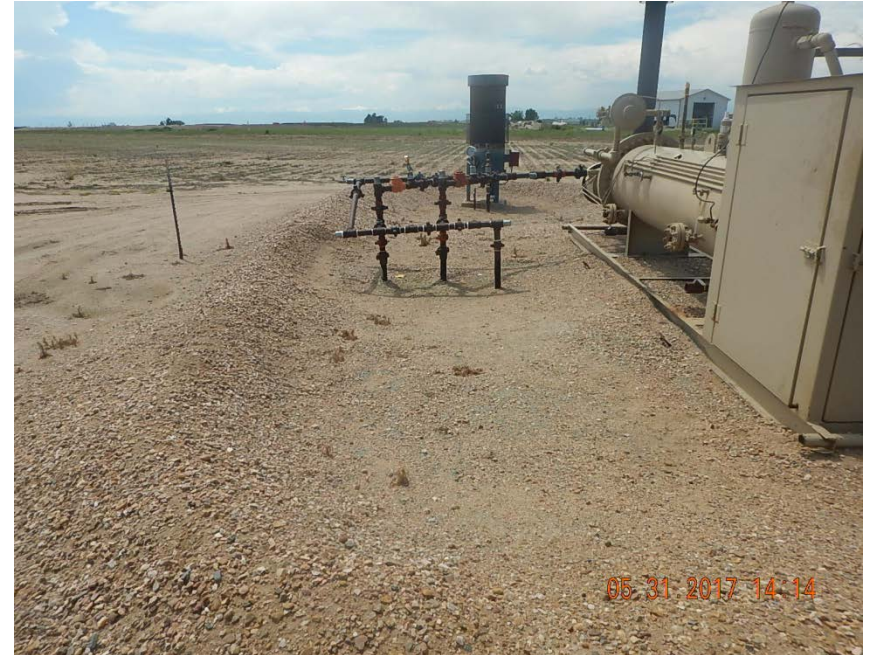
**Photo 4: Risers at separator**

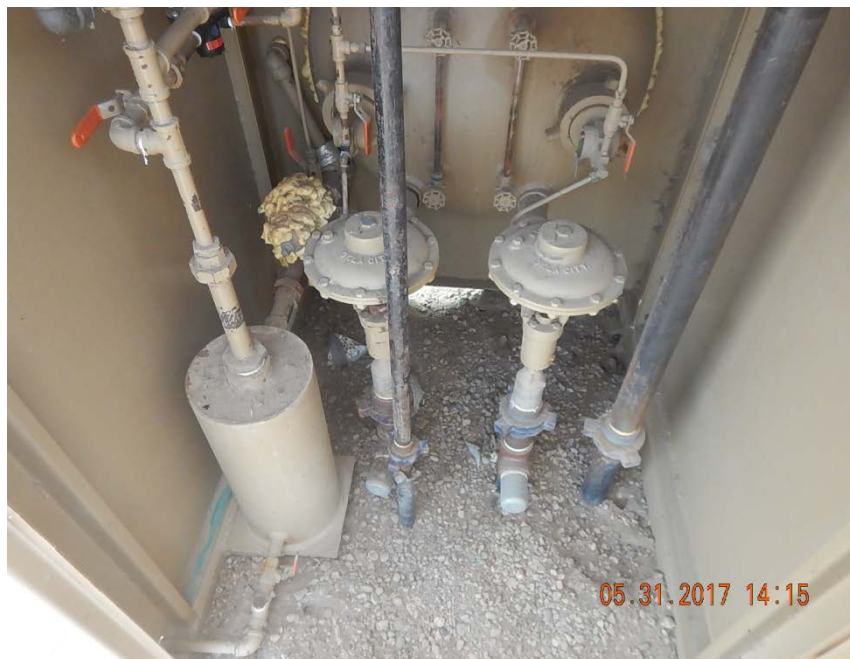
**Photo 5: Risers in separator**

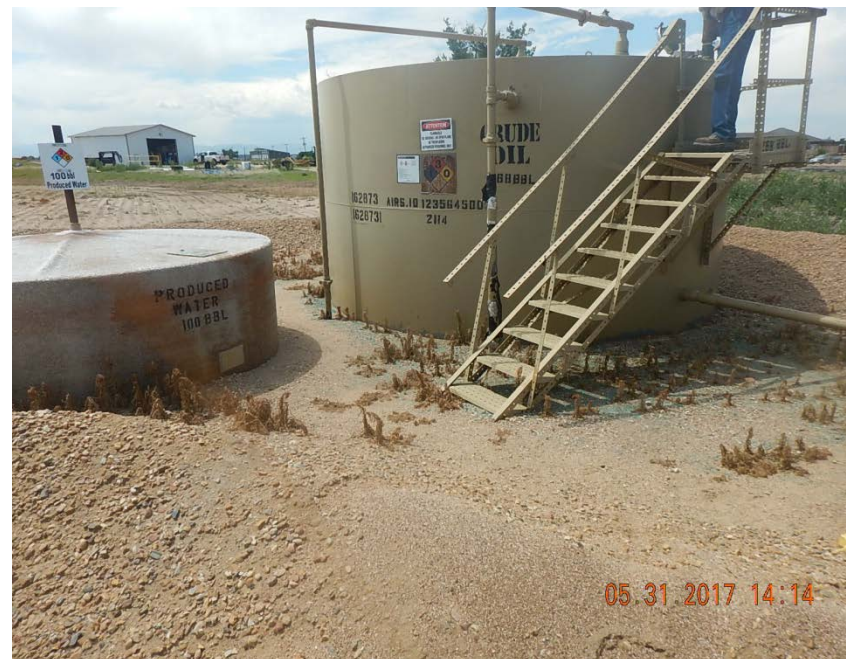
**Photo 6: Risers in tank battery**
