Inspection Photos - 2017 Flowline NTO
Inspection
Location Name: McWilliams 4-31
API: 05-081-06521

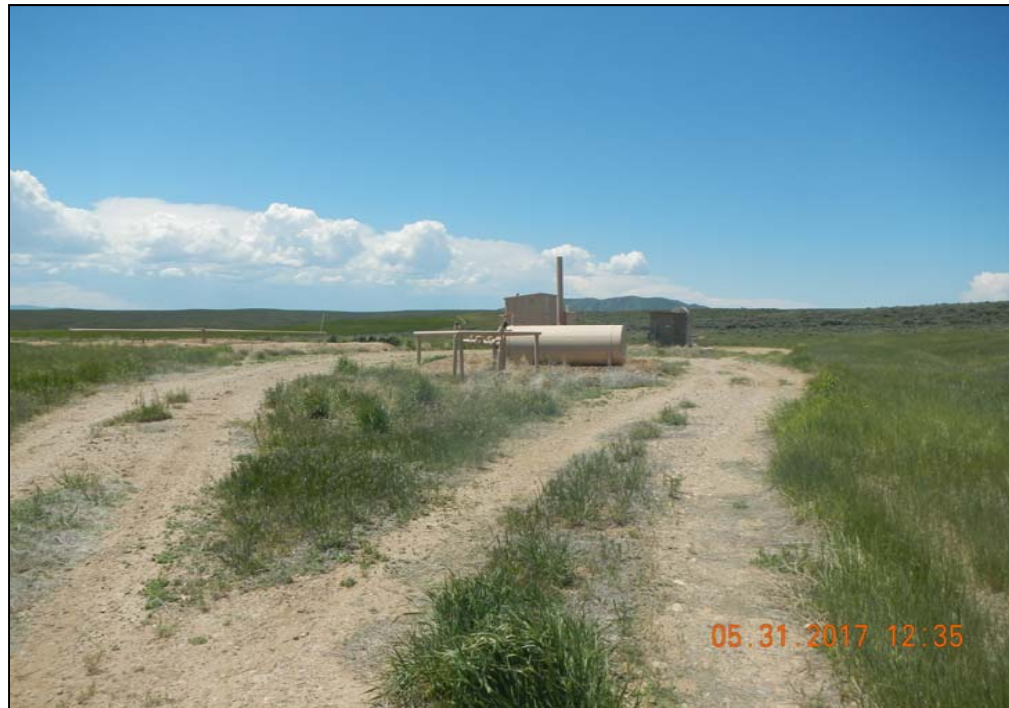
Photo 1. Overview of location taken at entrance facing south.

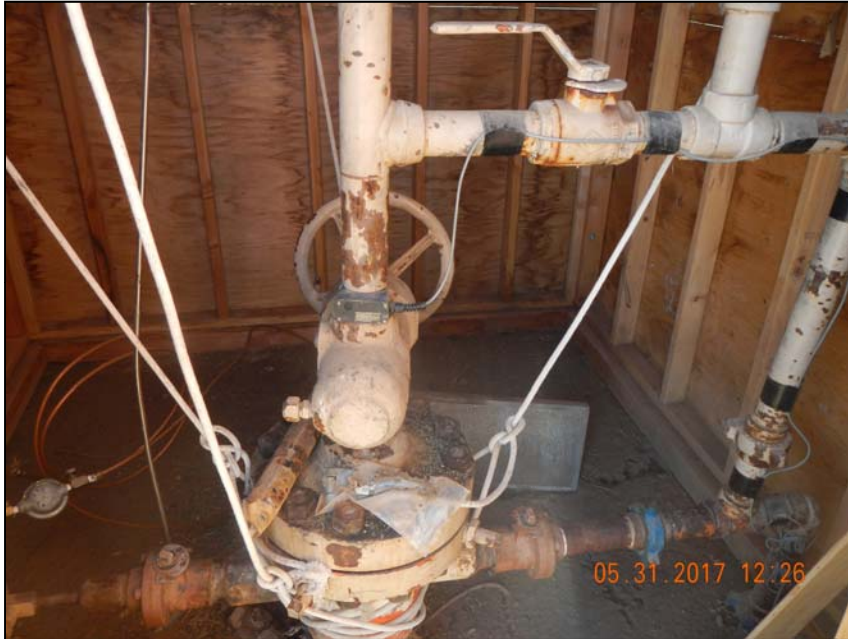
Photo 2. Wellhead with 1 – 2” riser on right.

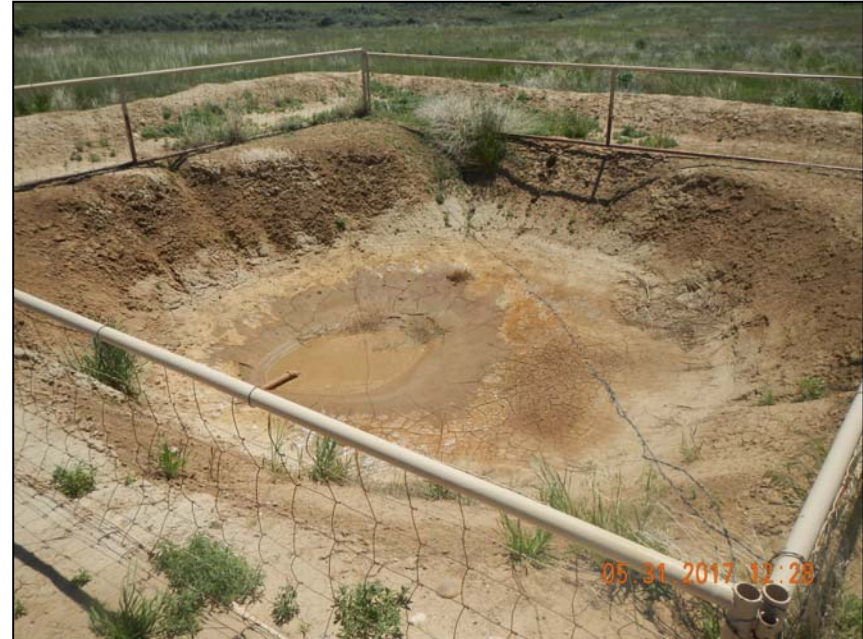
Photo 3. Pit with 2” steel flowline entering from separator.

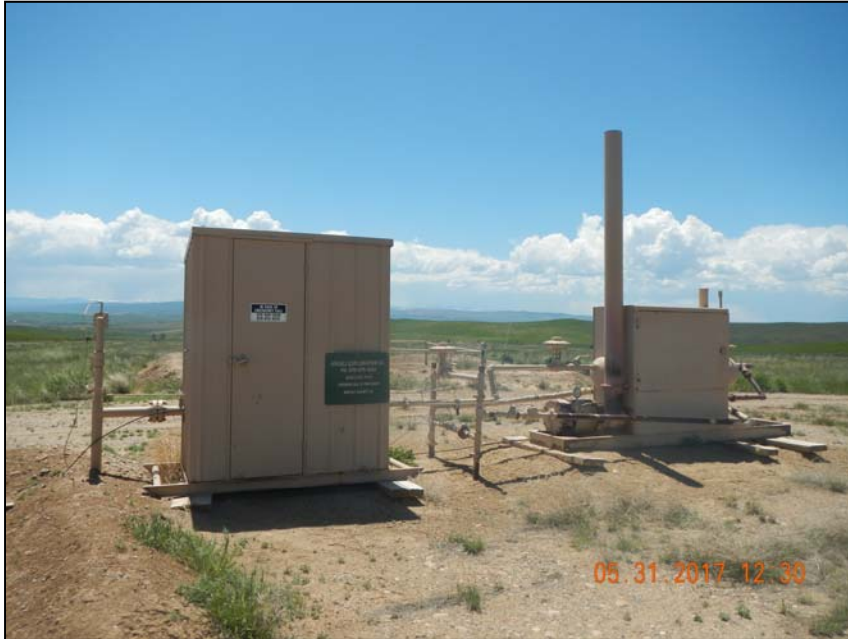
Photo 4. Meter run with 1 – 2” steel riser and separator with 2 -2” steel risers.

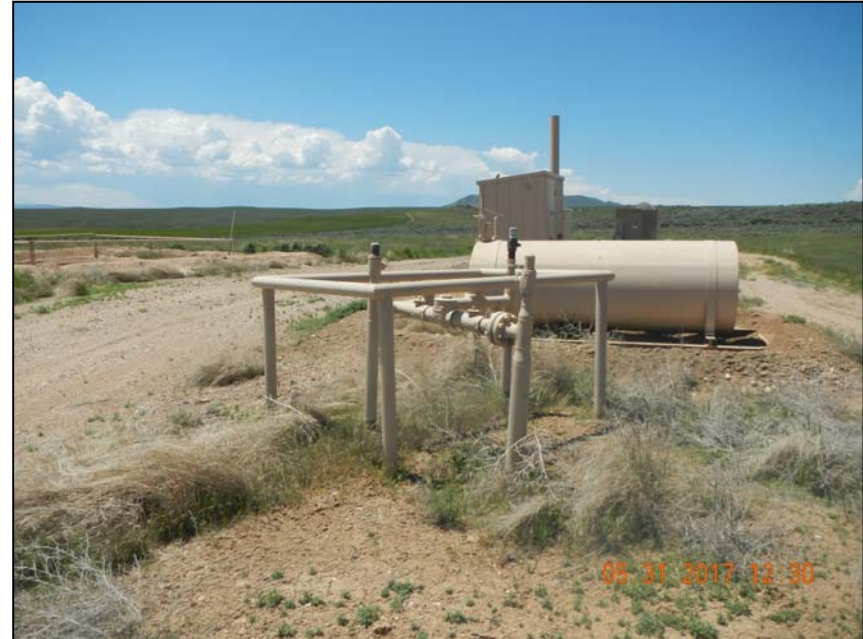
Photo 5. Riser cluster with 3 – 2” insulated risers at 40.61391, -107.54092
