Inspection Photos - 2017 Flowline NTO
Inspection
Location Name: McWilliams 2-31
API: 05-081-06351

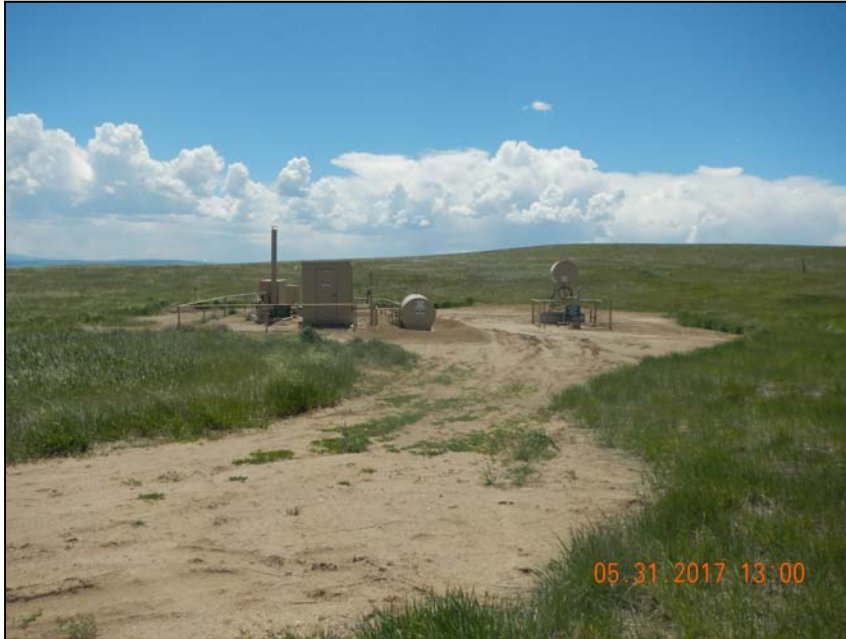
Photo 1. Overview of location taken at entrance facing south.

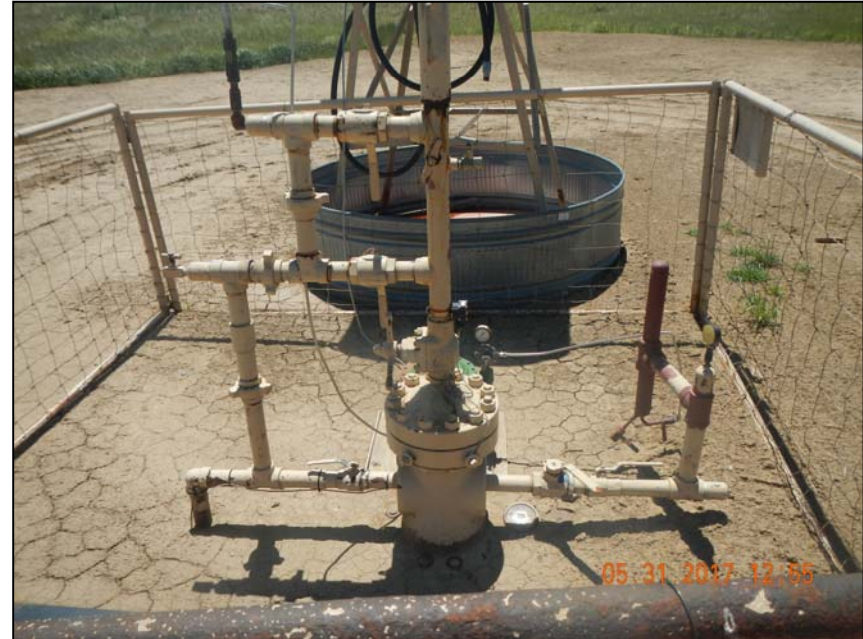
Photo 2. 1 - 2" steel riser at wellhead.

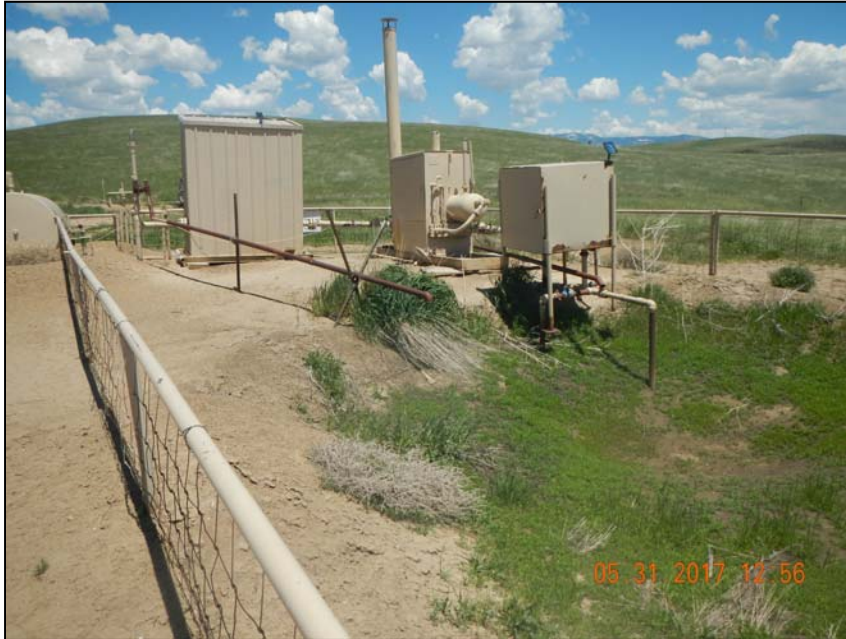
Photo 3. Pit with separator and meter run and risers.

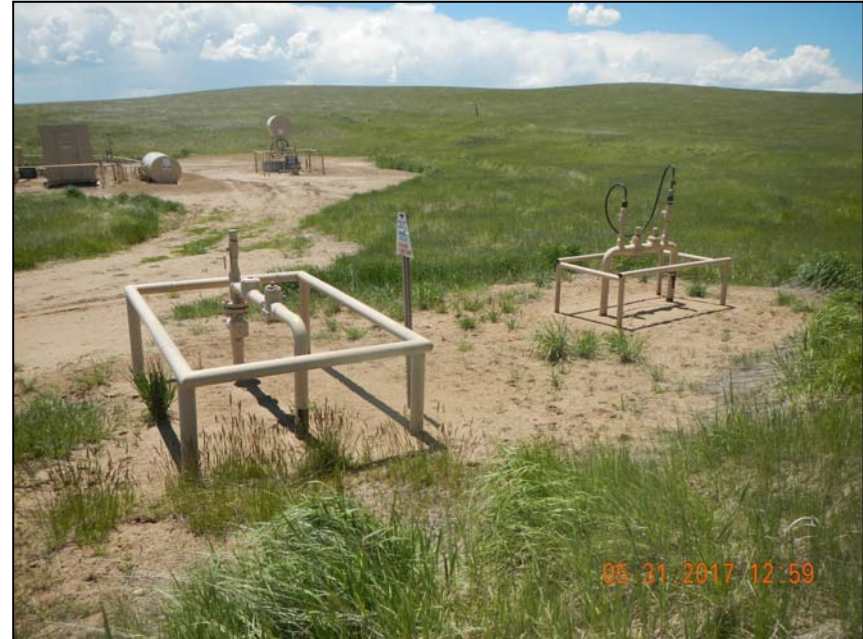
Photo 4. Riser cluster with 4 – 2” insulated steel risers at 40.61253, -107.52946
