Inspection Photos - 2017 Flowline NTO
Inspection
Location Name: Carpenter 2-32
API: 05-081-05363

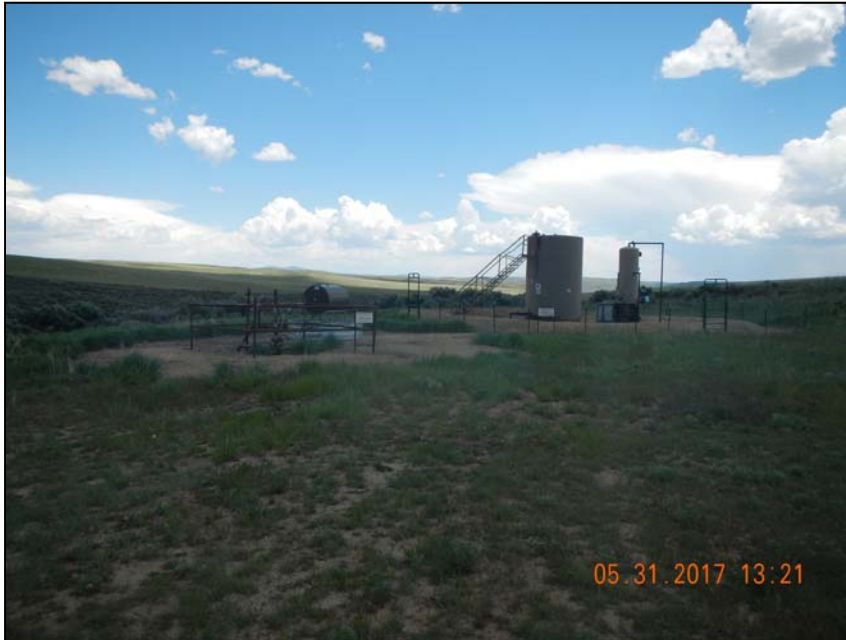
Photo 1. Overview of location taken at entrance facing east.

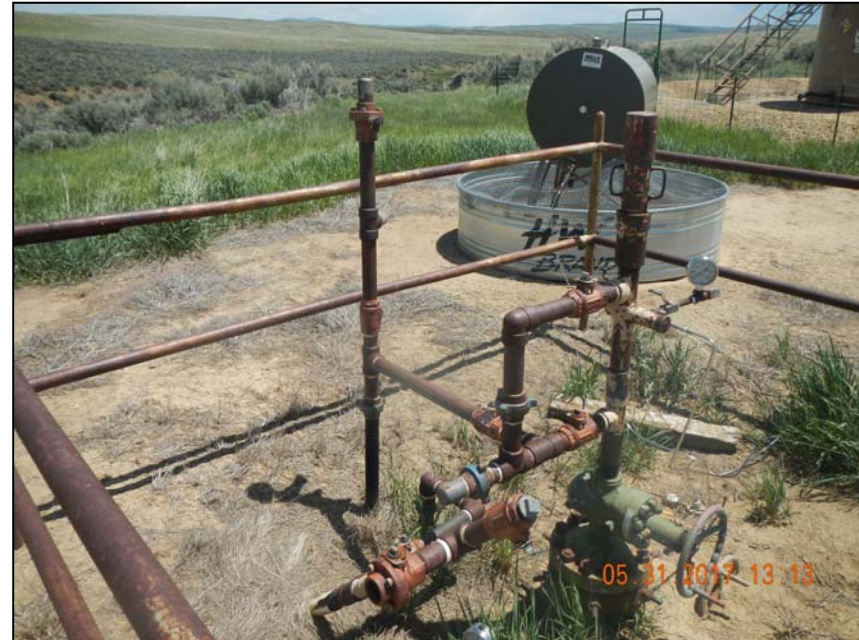
Photo 2. 3 - 2" steel riser at wellhead.

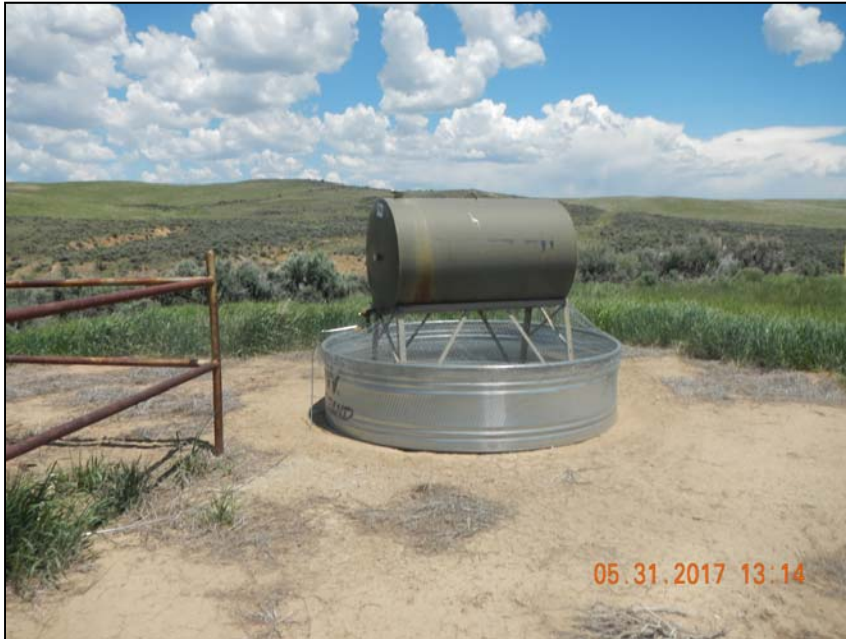
Photo 3. Unlabeled container at wellhead.

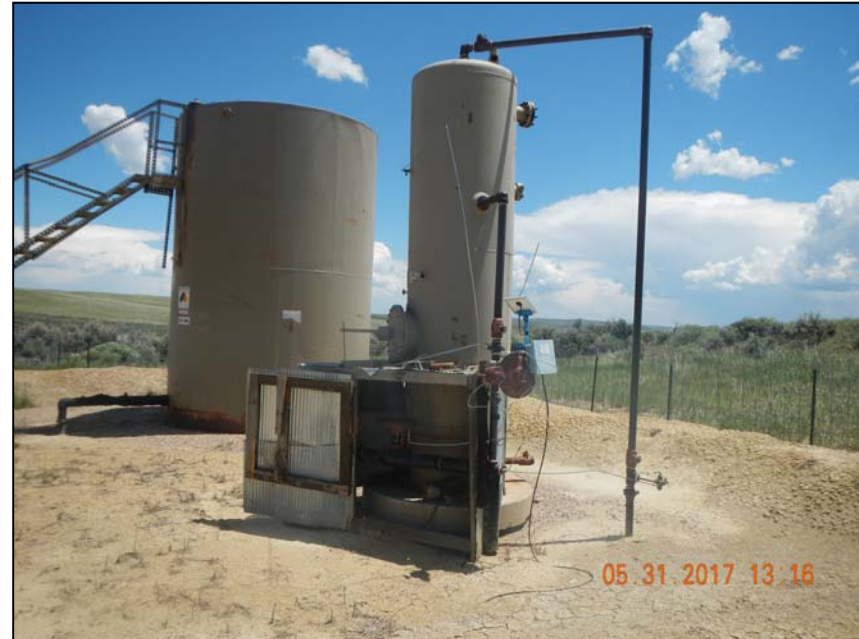
Photo 4. Risers at separator and tank.
