Inspection Photos - 2017 Flowline NTO
Inspection
Location Name: Schieck 11-31
API: 05-081-06530

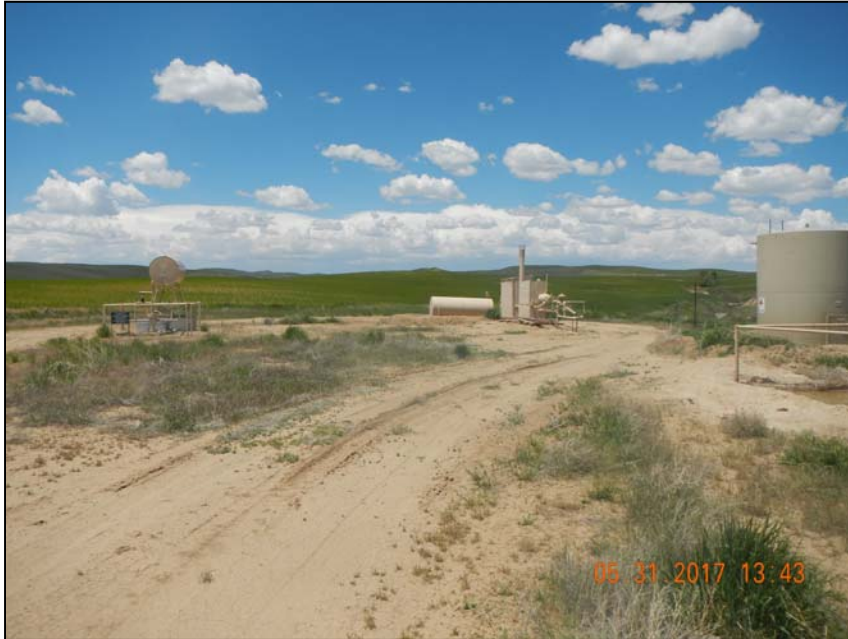
Photo 1. Overview of location taken at entrance facing north.

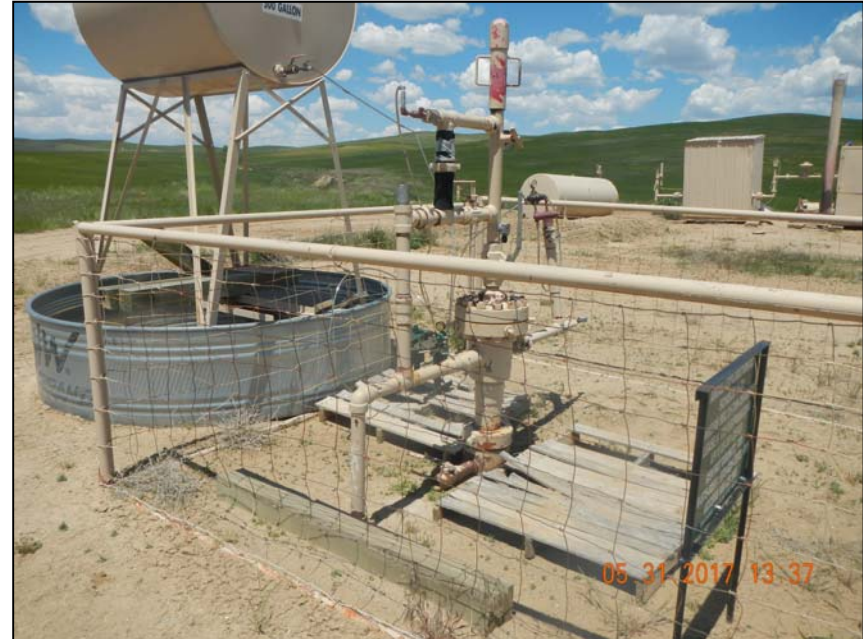
Photo 2. 1 – 2" steel riser at wellhead.

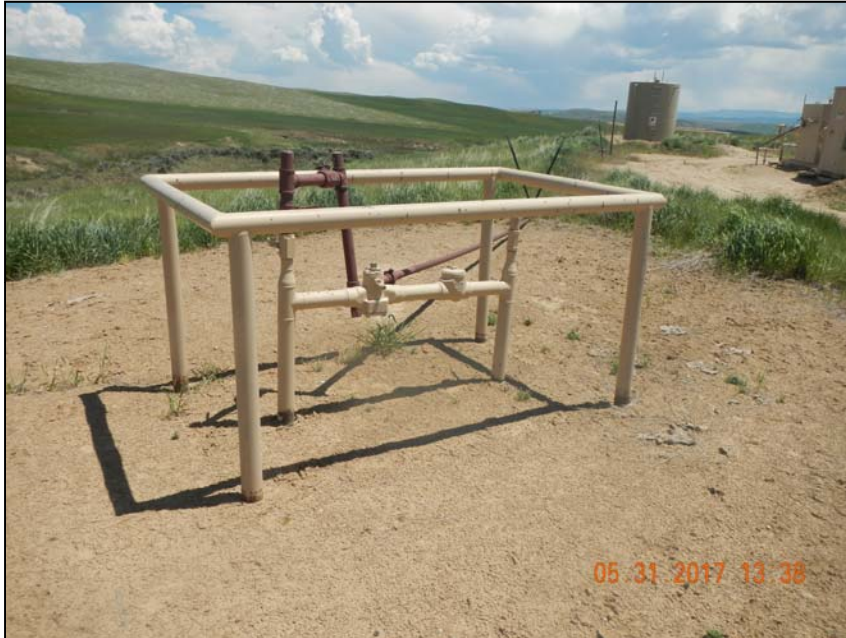
**Photo 3. Riser cluster with 2 – 2” and 1 – 1” steel risers
at 40.60605, -107.53705**

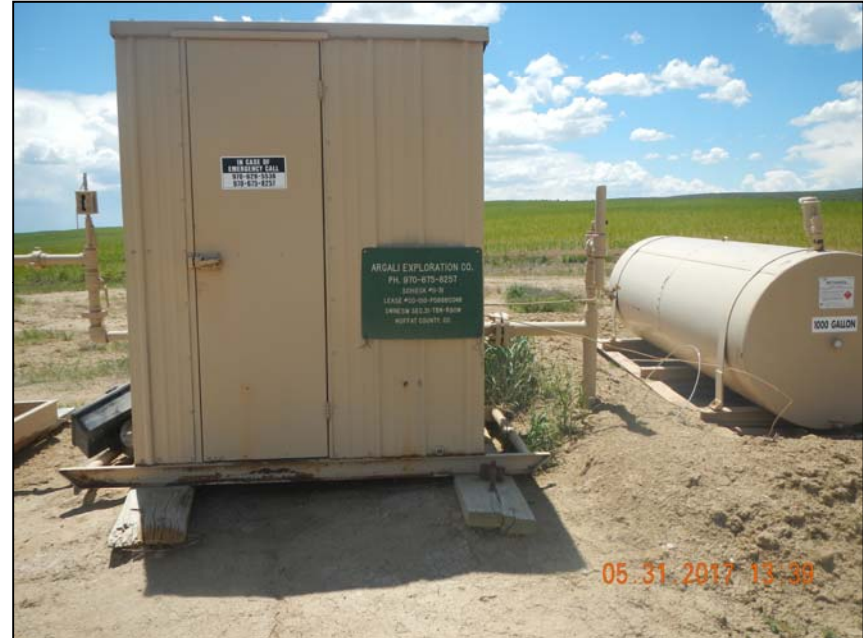
Photo 4. 1 – 2” steel riser at meter run.

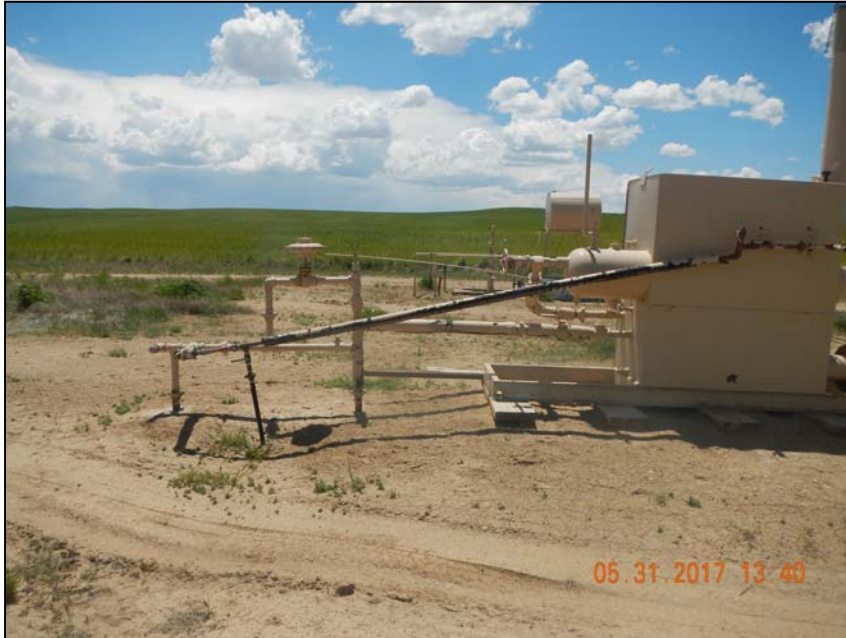
Photo 5. 2 – 2" and 1 – 1" steel risers at separator.

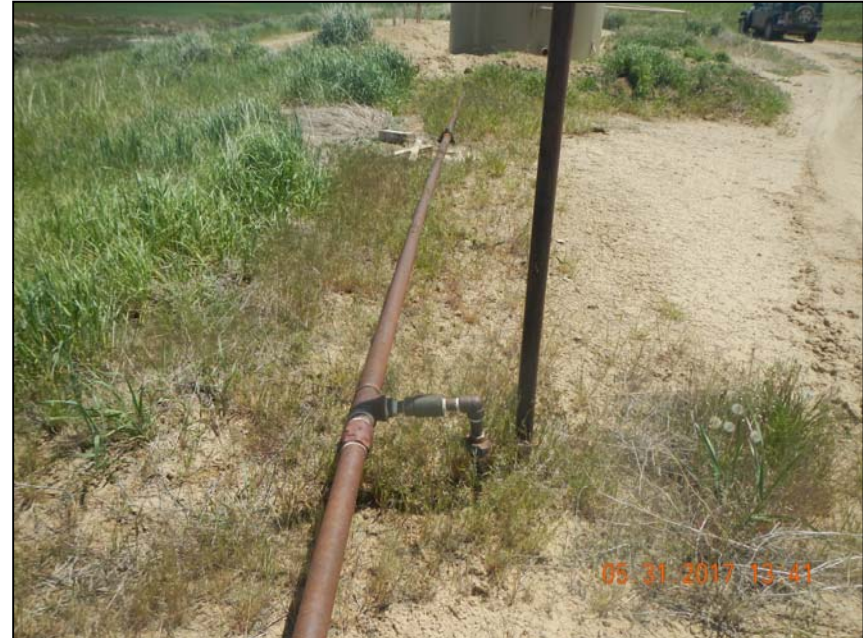
Photo 6. Steel flowline from separator to tank with 1 – 1" steel riser at midway point.

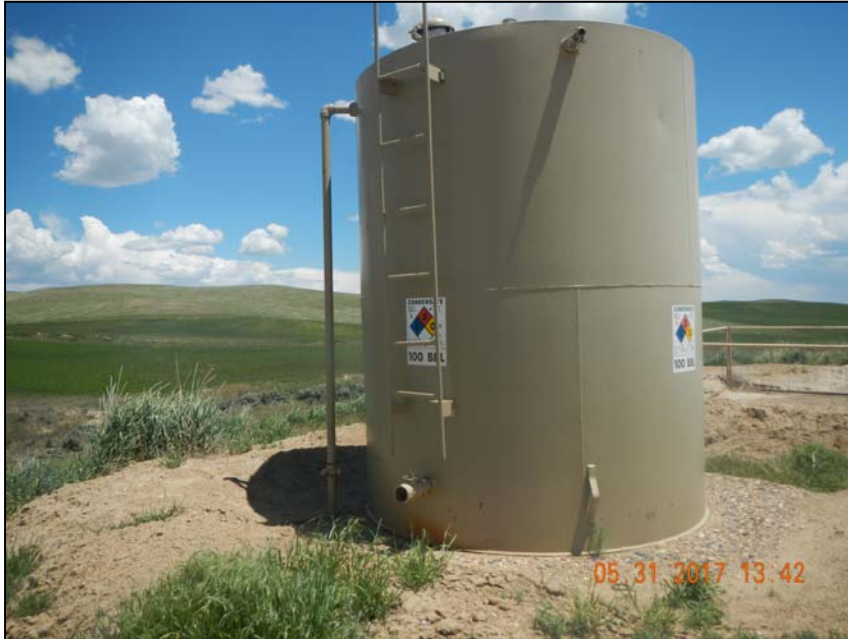
Photo 7. 1 – 2" steel riser at tank.
