Inspection Photos - 2017 Flowline NTO  
Inspection  
Location Name: Government Treleven 6  
API: 05-081-05238

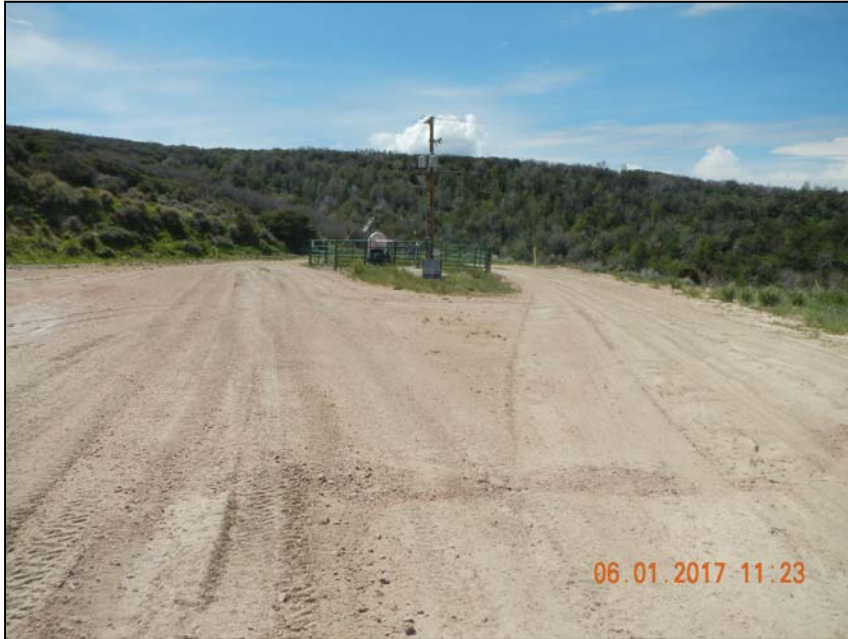
Photo 1. Overview of location taken at entrance facing southeast.

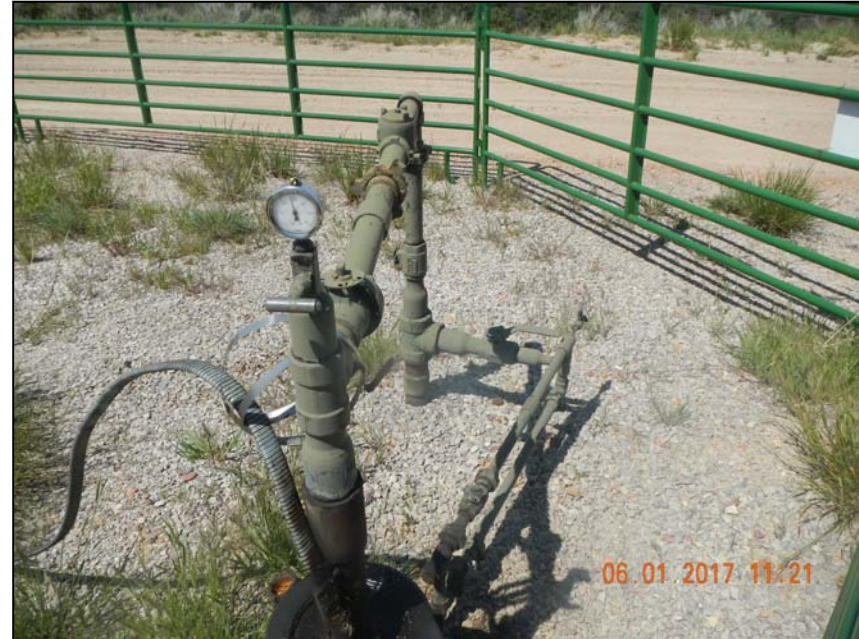
Photo 2. 1 - 2" steel riser at wellhead.
