Inspection Photos - 2017 Flowline NTO  
Inspection  
Location Name: Gov't-Treleaven 9  
API: 05-081-06119

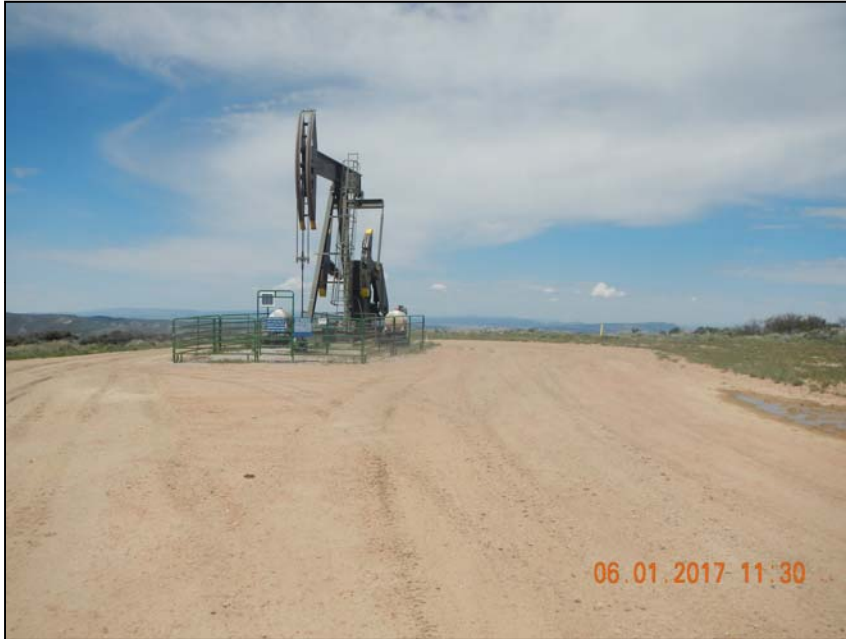
**Photo 1. Overview of location taken at entrance facing north.**

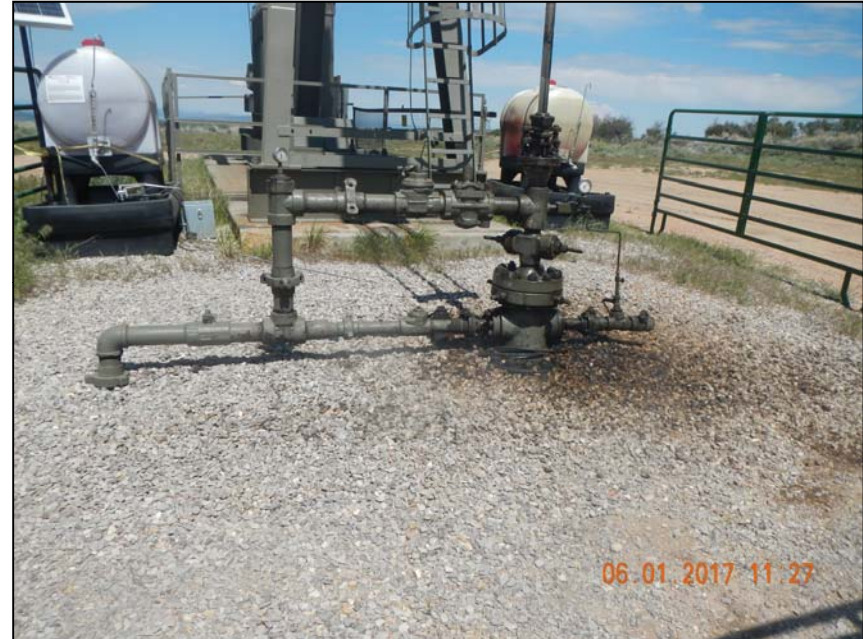
**Photo 2. 1 – 2" steel riser at wellhead. Stained soil at wellhead.**
