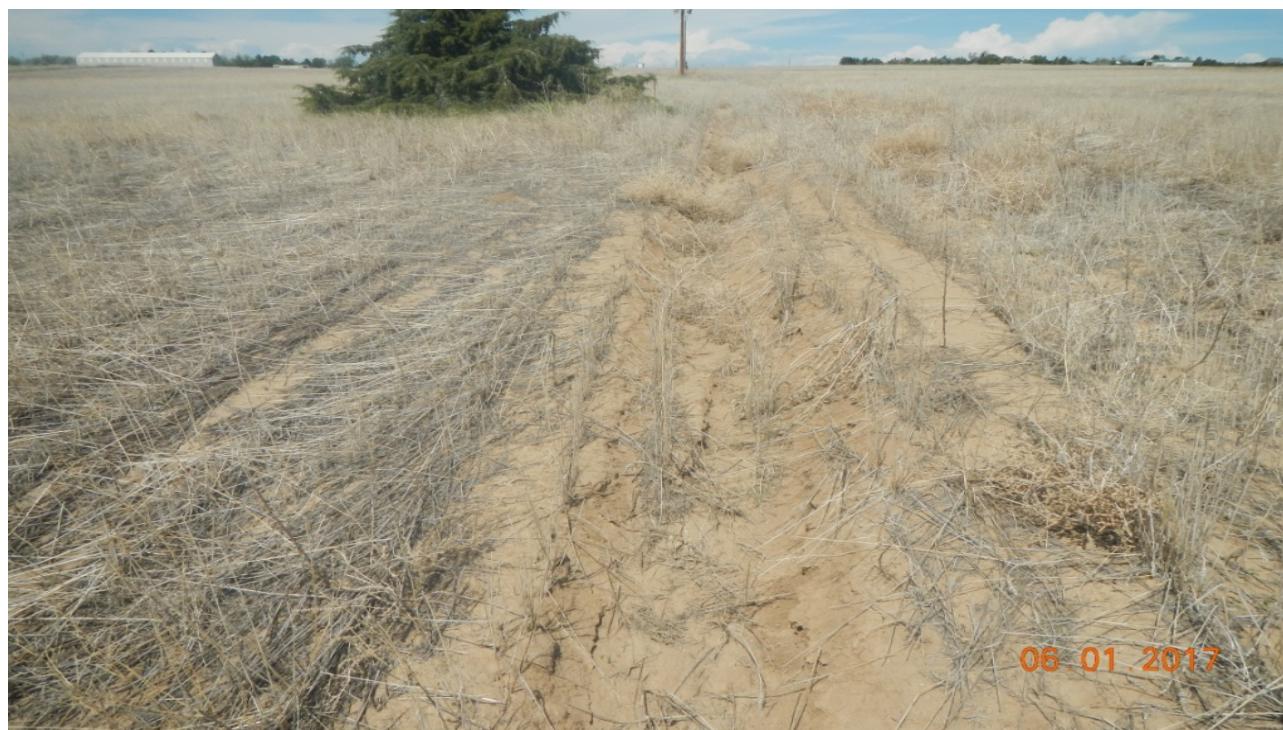
**photo 1:** There is an area of subsidence going east toward the location.

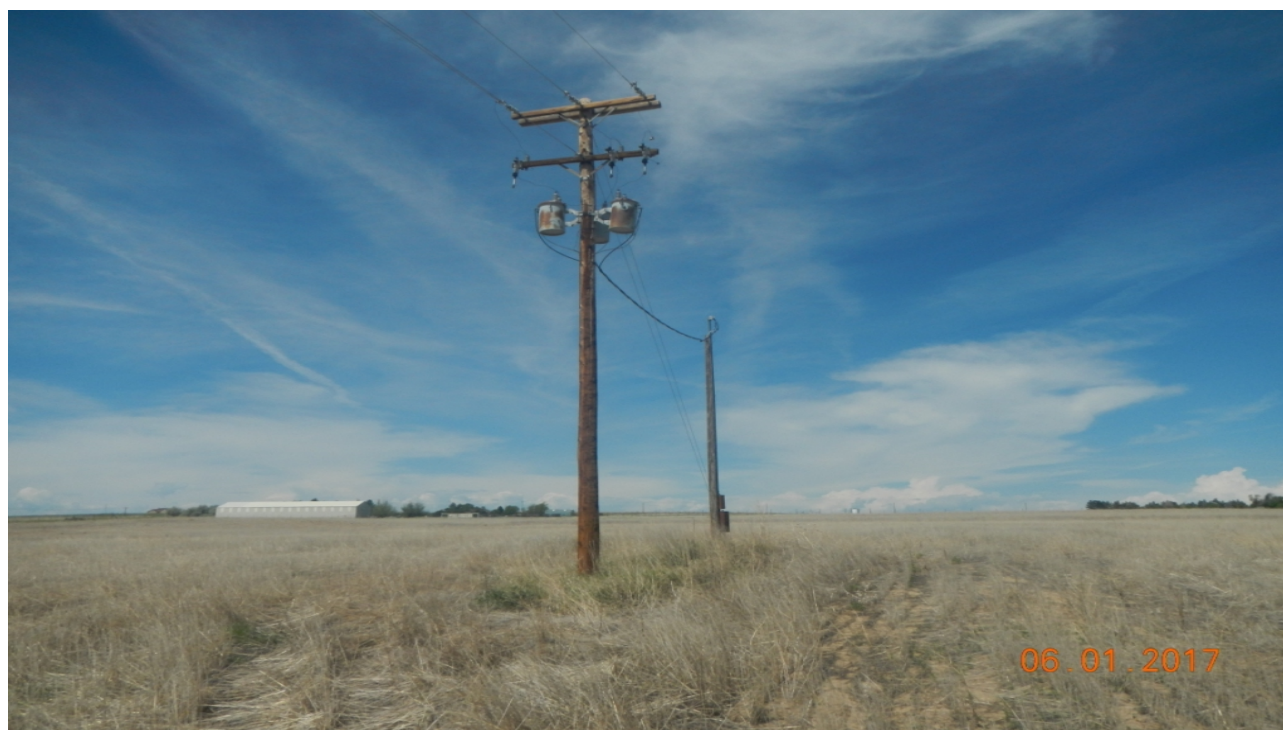
**photo 2:** Facing west toward the location. The powerline utility terminates at the location.

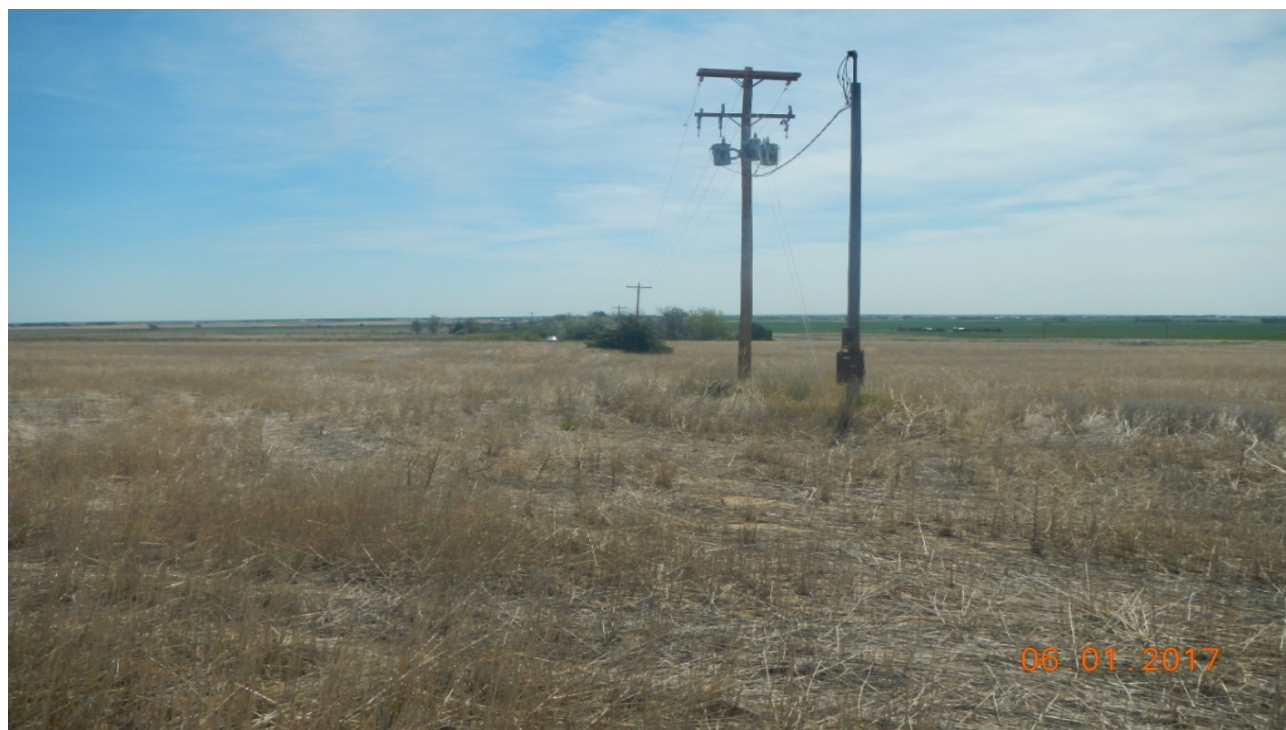
**photo 3:** Facing east at the location.

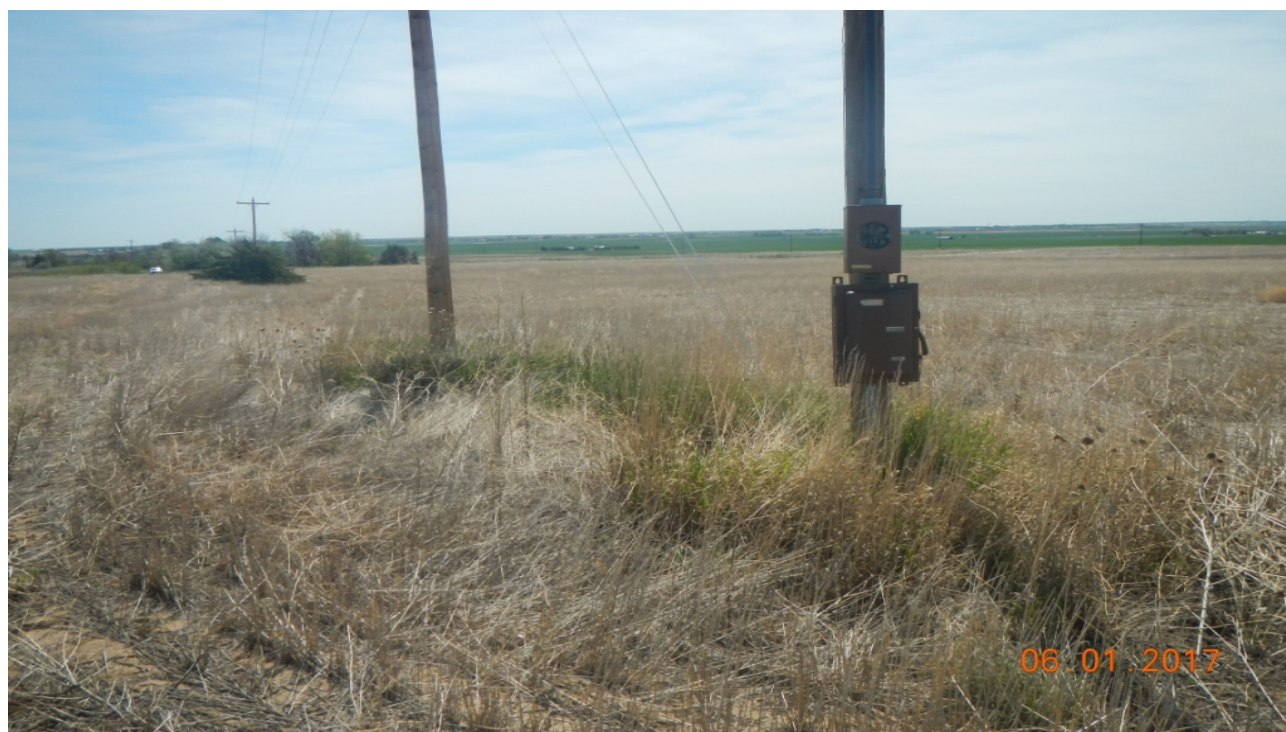
**photo 4:** The electric powerline utility terminates at the location.
