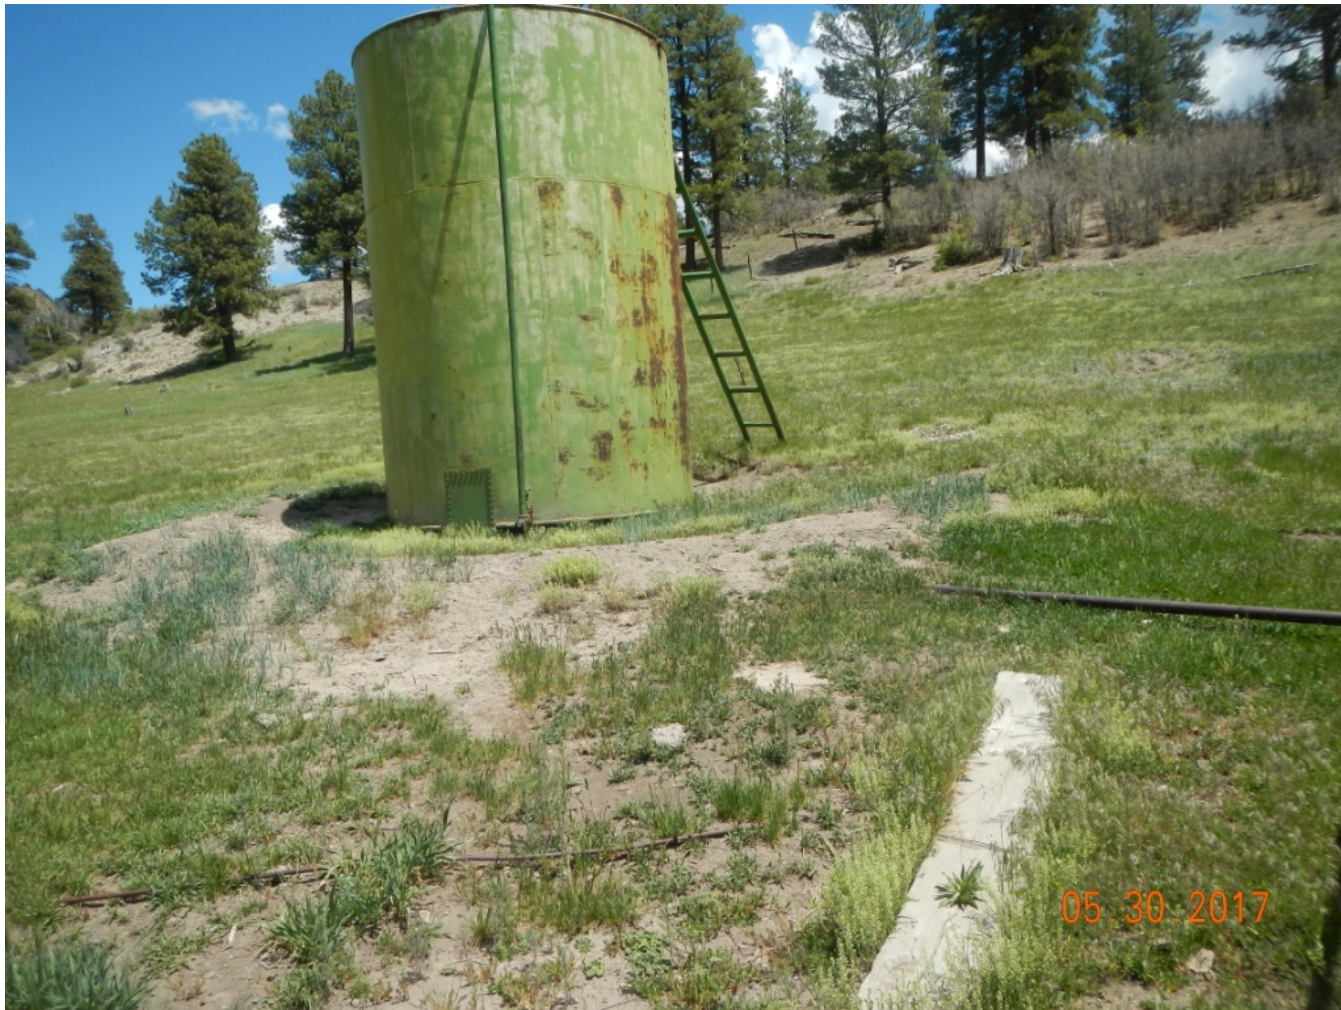
Photo 1. View of the tank in the northeastern portion of the project area.

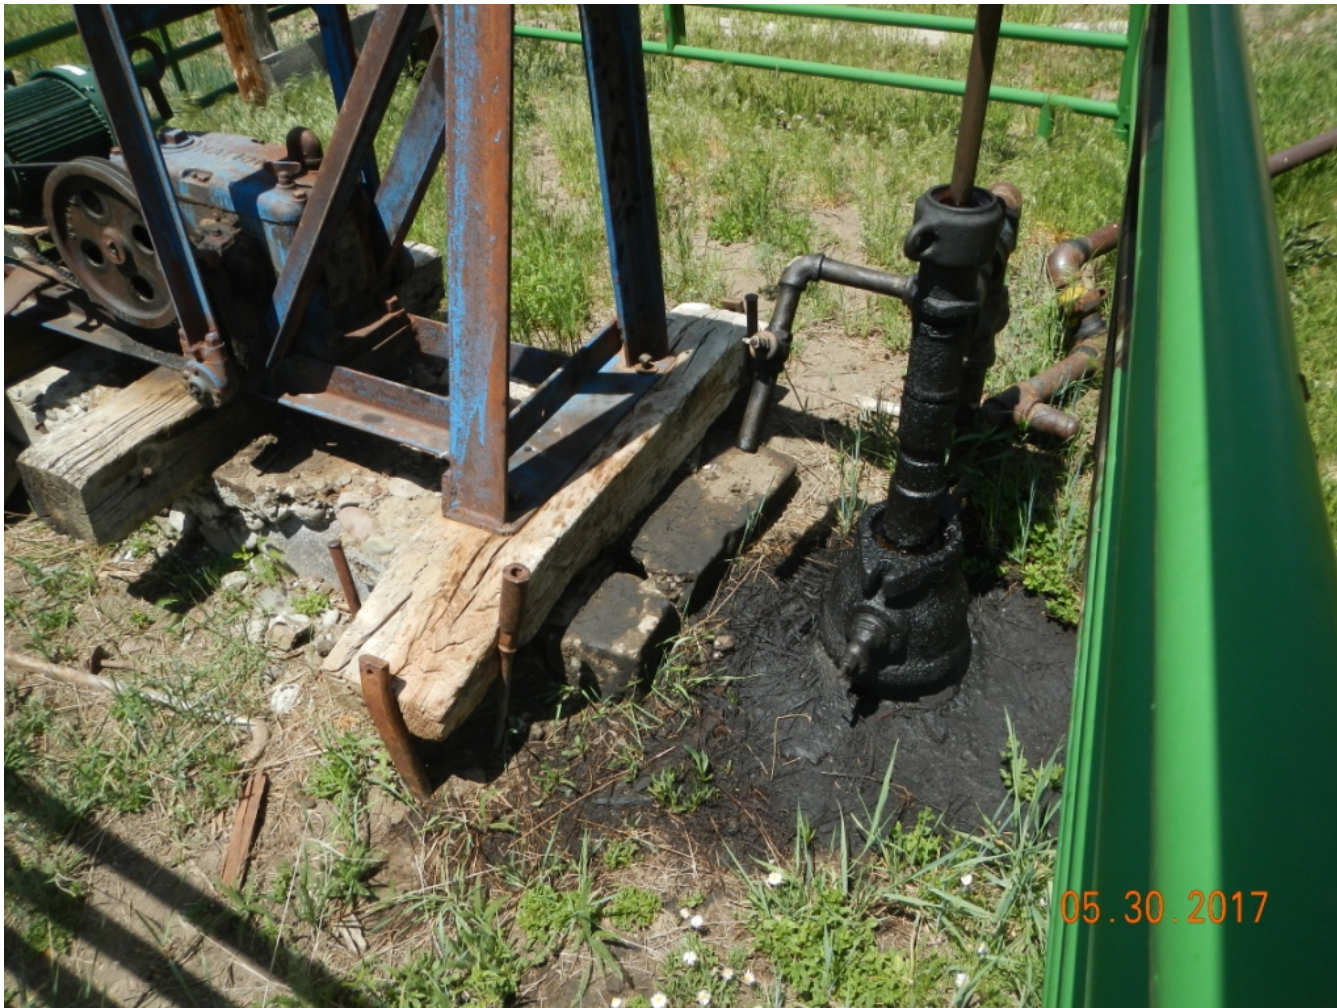
Photo 2. View of discharged oily material appears to be leaking from wellhead.

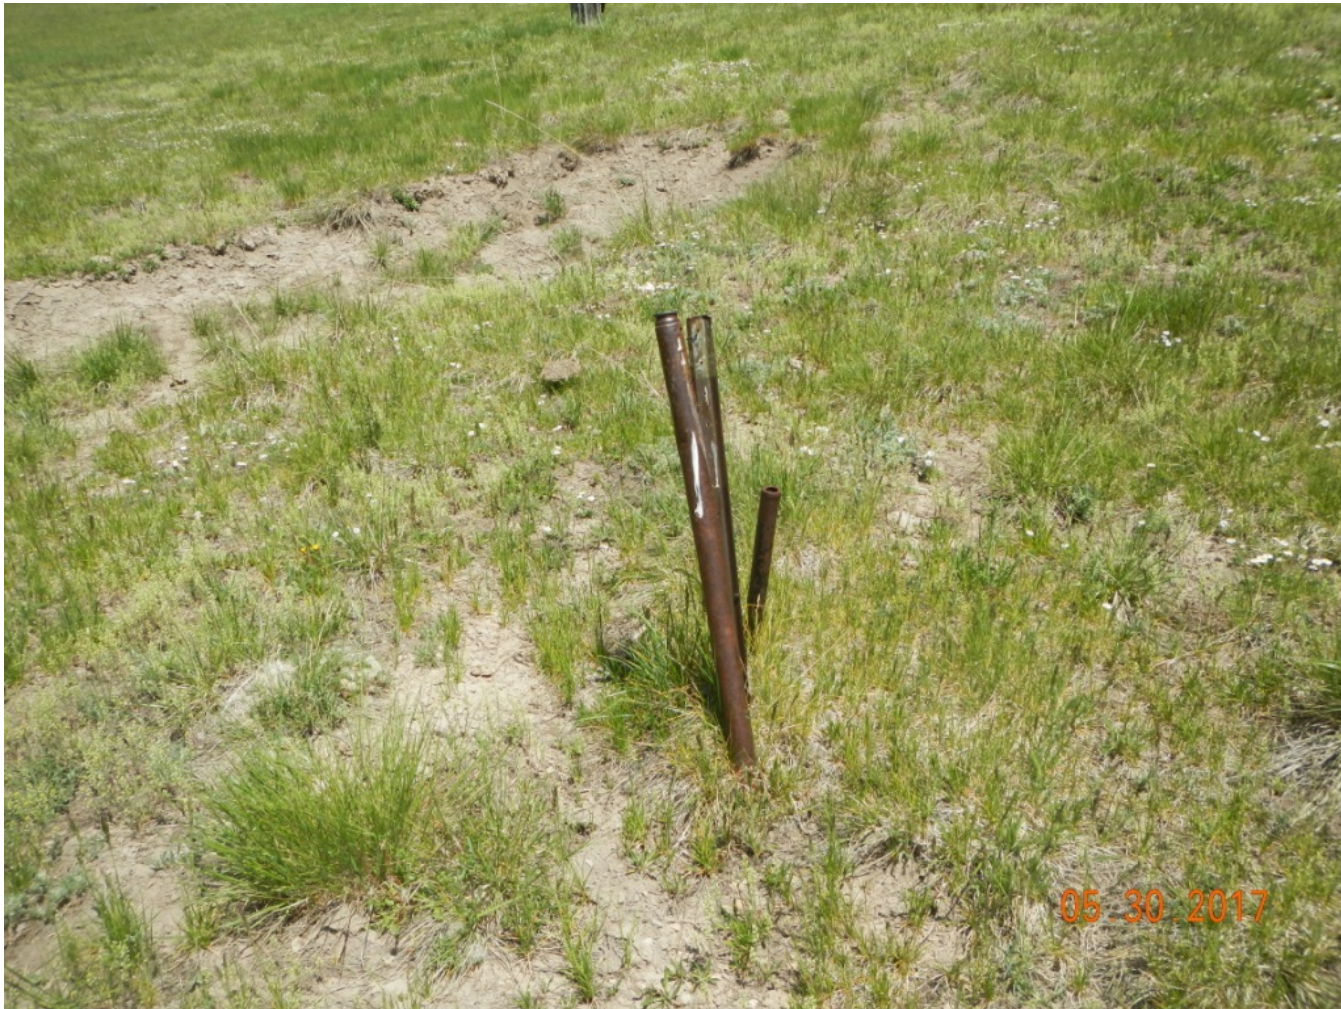
Photo 3. View of risers in the project area.

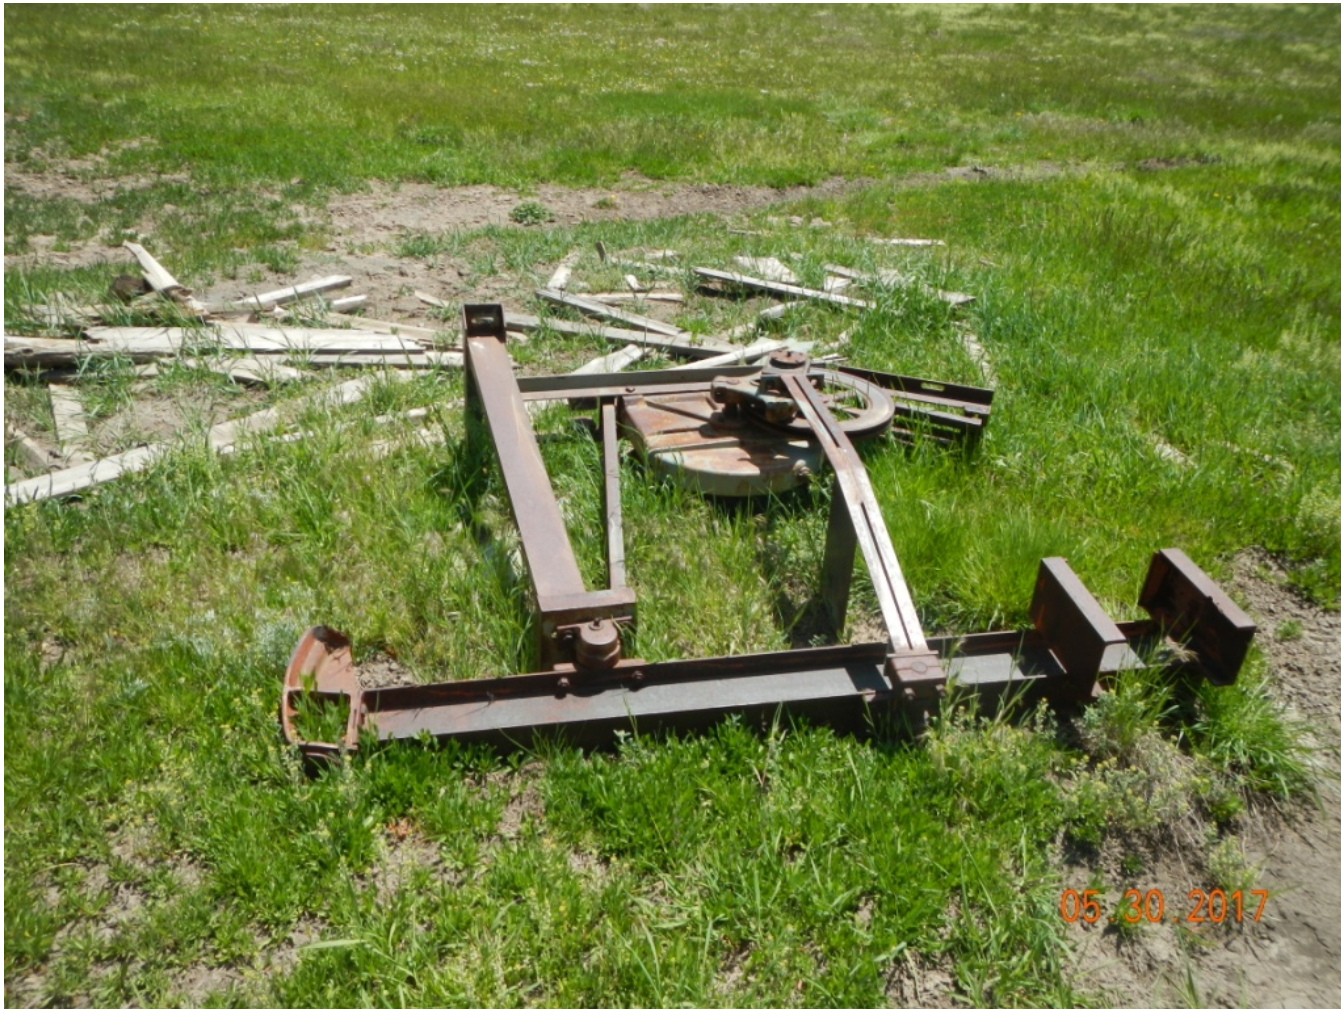
Photo 4. View of unused equipment in the project area.
