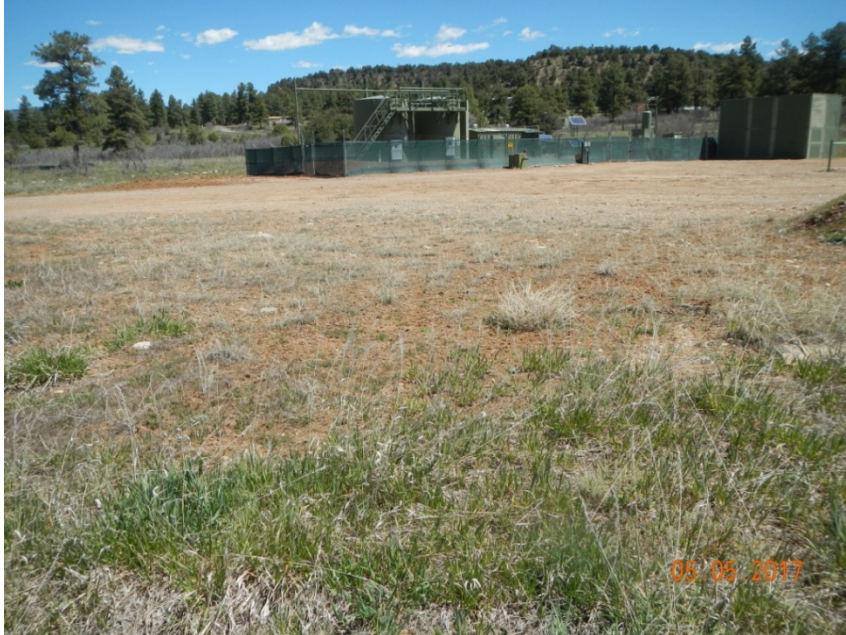
Photo 1: View of the project area from the southwestern corner facing center.

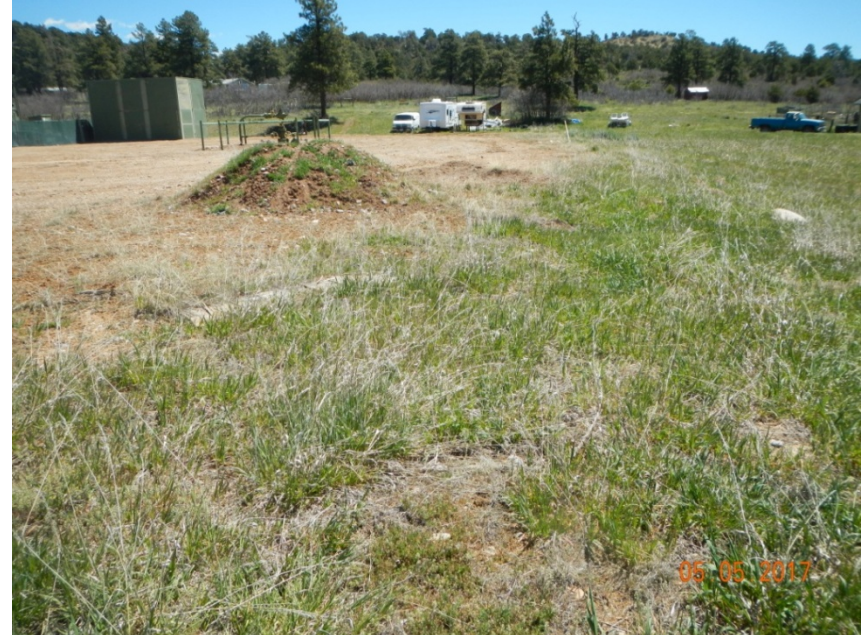
Photo 2: View of the southern portion of the project area from the southwestern corner facing eastward. Revegetation is largely comprised of grasses such as western wheatgrass (*Pascopyrum smithii*), smooth brome (*Bromus inermis*), and dropseed (*Sporobolus* sp.)

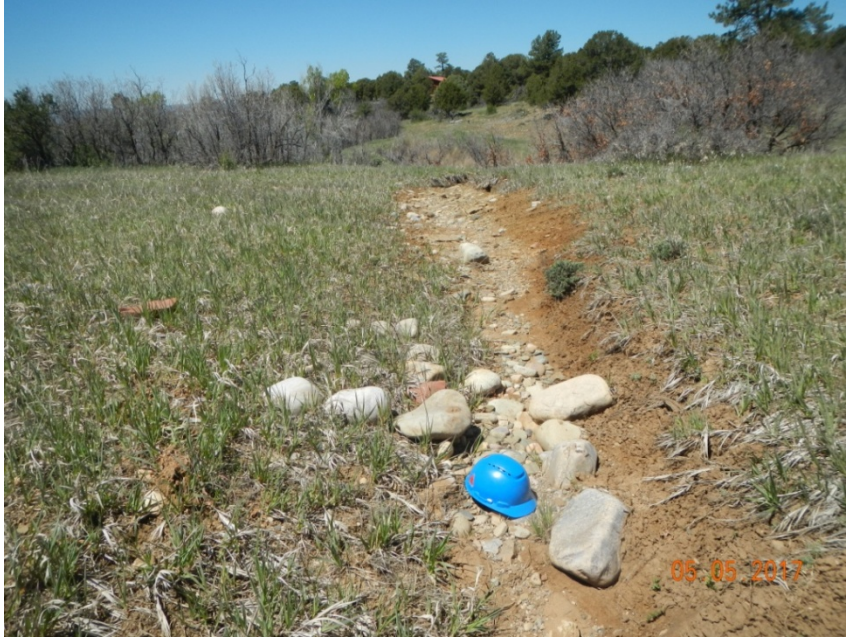
Photo 3: View of erosion occurring within the northern portion of the project area facing westward. Stormwater controls need to be installed to de-energize flows.

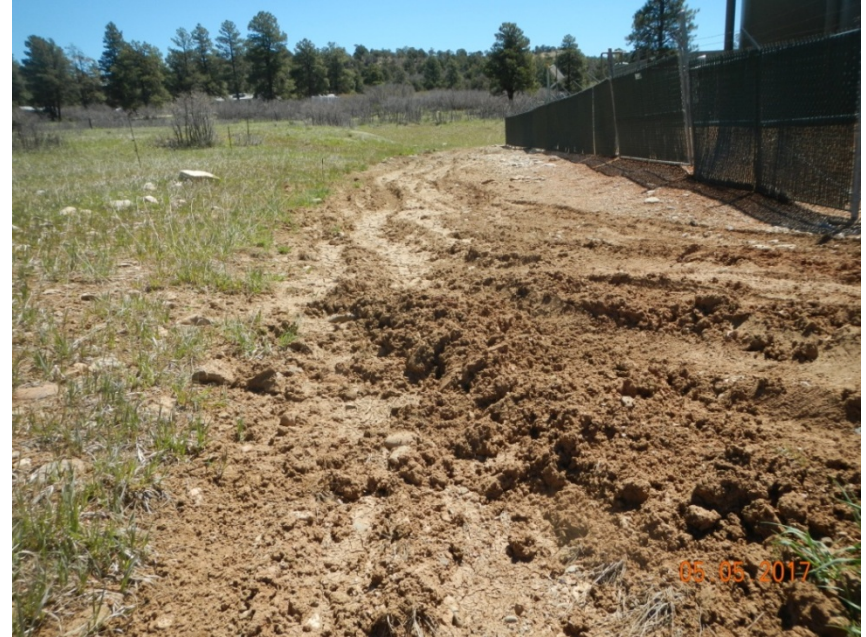
Photo 4: View of northern diversion facing eastward, damaged with deep ruts and disturbed soil. Diversion needs repair and stormwater controls.
