# Flowline and Final Reclamation Inspection

June 6, 2017

Operator: TOP OPERATING COMPANY- #39560

API: 05-013-06096

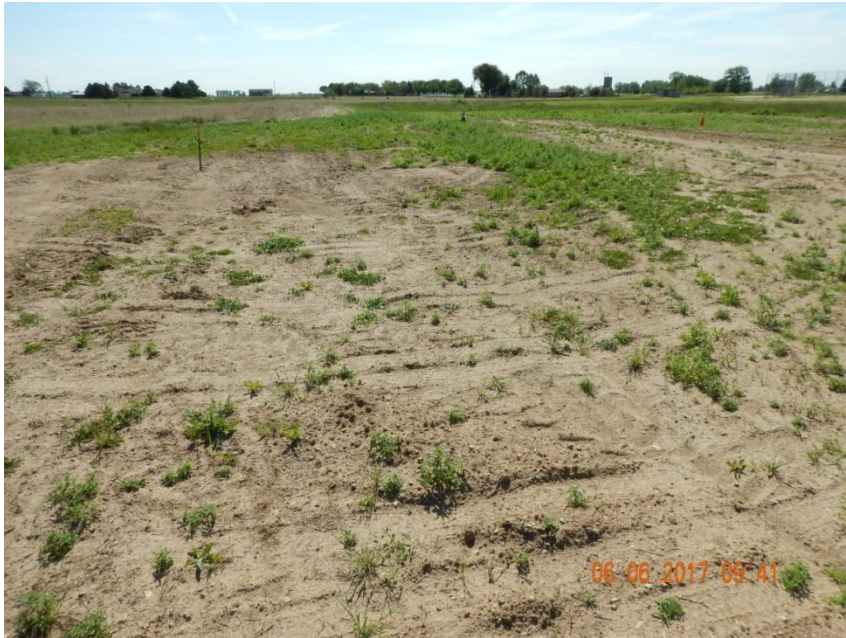
**Photo 1.** Photo taken from the northern well location, facing East. Does not appear final reclamation activities have been performed based on the lack of grass species and the abundance of weedy annuals, mostly Kochia.

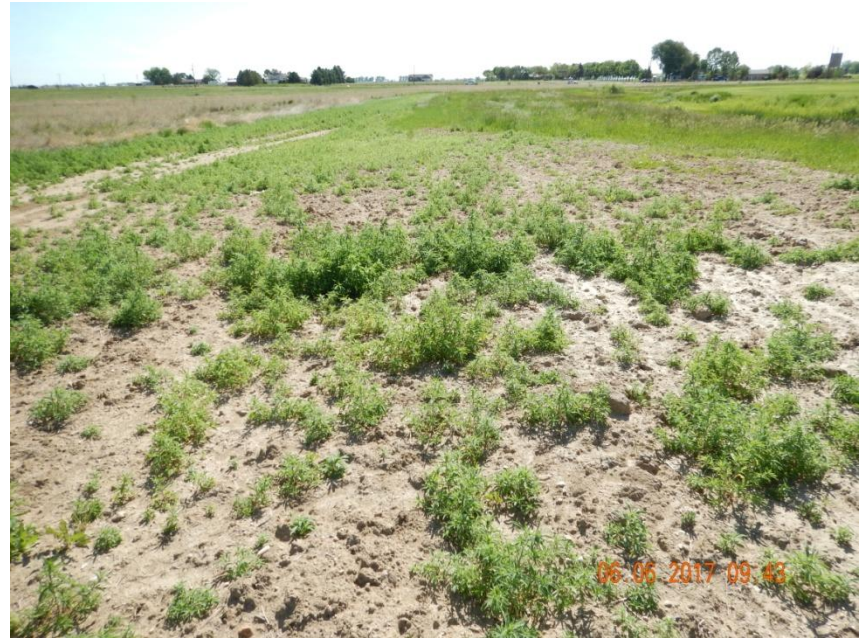
**Photo 2.** Photo taken from the southern well location, facing East. Does not appear final reclamation activities have been performed based on the lack of grass species and the abundance of weedy annuals, mostly Kochia.

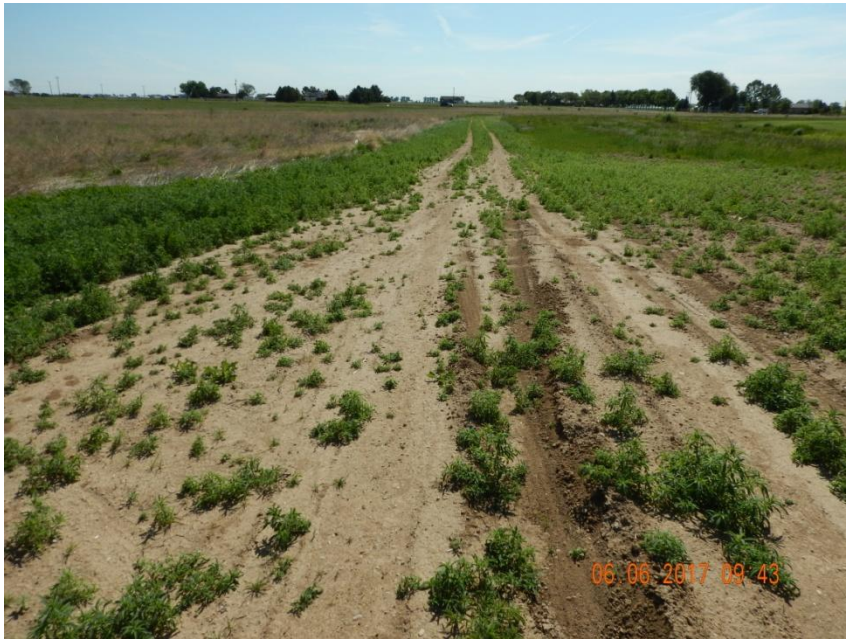
**Photo 3.** Photo taken from the well location along the access road, facing East. Access road is evident and does not appear final reclamation activities have been performed based on the lack of grass species and the abundance of weedy annuals, mostly Kochia.

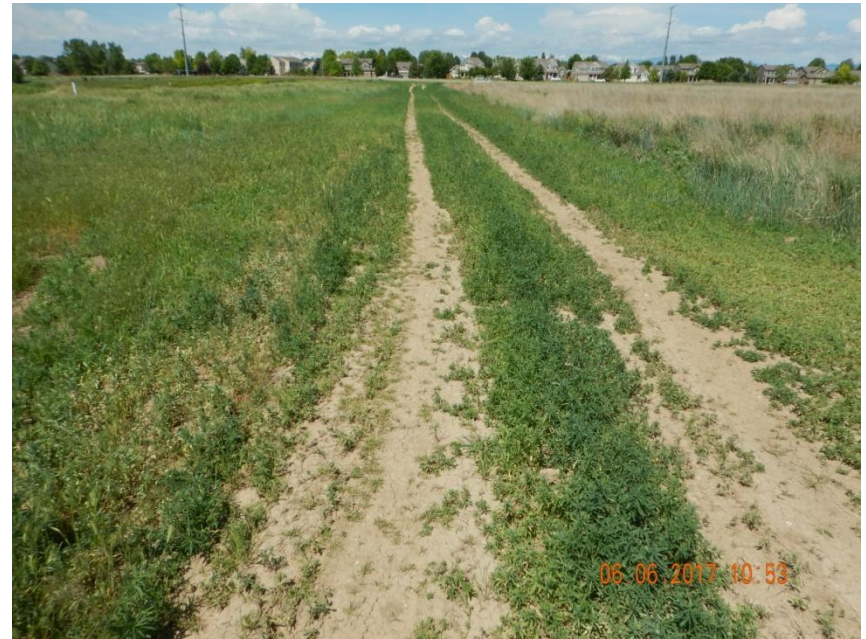
**Photo 4.** Photo taken from the eastern access road, facing West towards the well location. Access road is evident and does not appear final reclamation activities have been performed based on the lack of grass species and the abundance of weedy annuals, mostly Kochia.

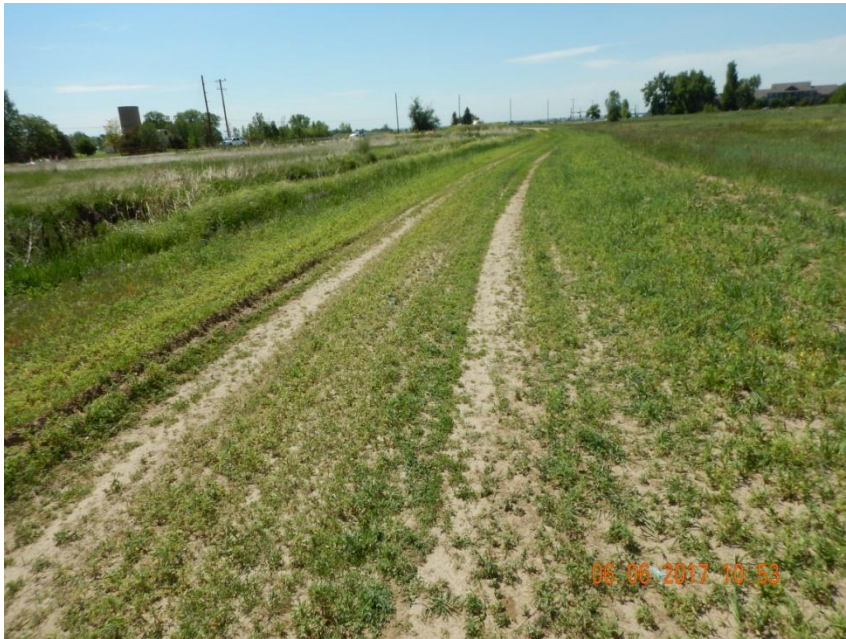
**Photo 5.** Photo taken from the previous photo location, facing South. Access road is evident and does not appear final reclamation activities have been performed based on the lack of grass species and the abundance of weedy annuals, mostly Kochia.

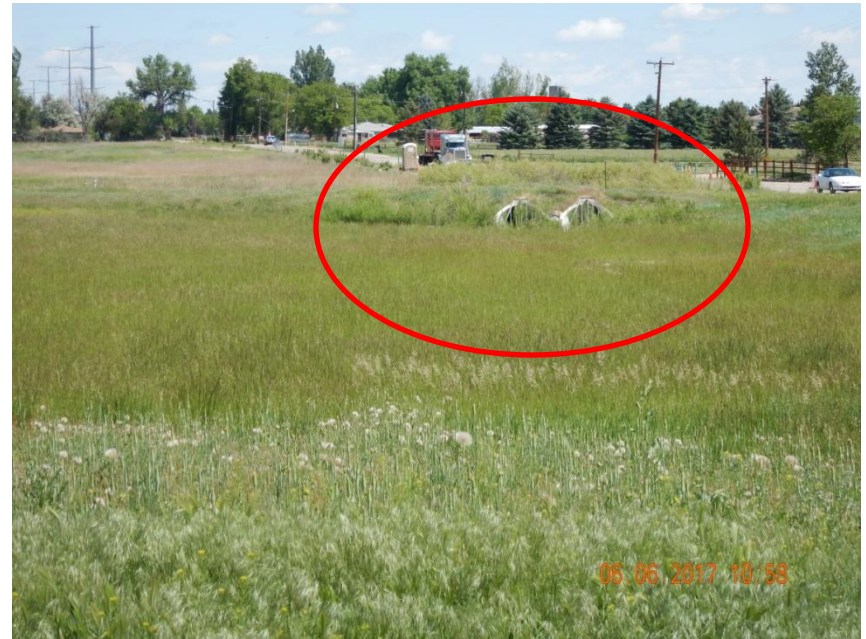
**Photo 6.** Photo taken of the access road entrance off CR 1. Culverts remain at location and have not been removed per Rule 1004.

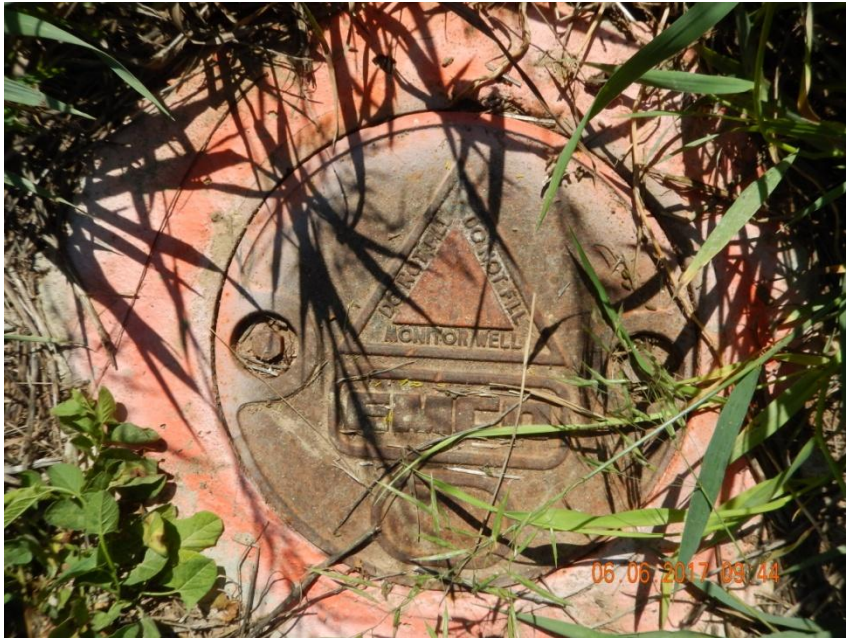
**Photo 7.** Photo taken of a monitoring well on the well location. It is unclear whether all monitoring wells have been properly plugged.
