Inspection Photos  
Location Name: USA Shaw 19  
API: 05-081-60020

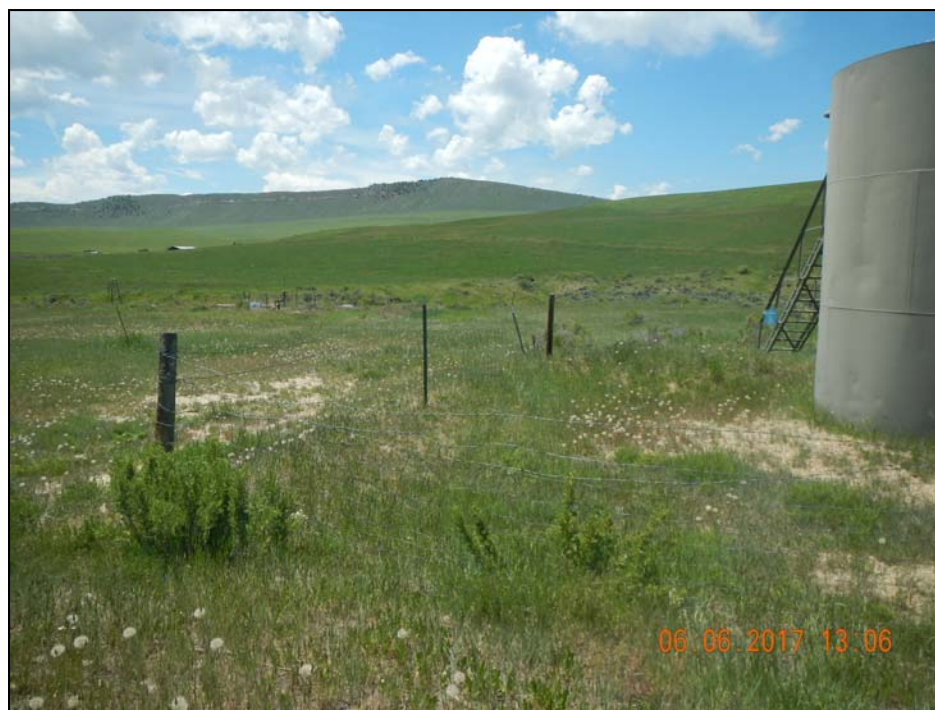
**Photo 1. Overview of location taken at entrance facing southwest.**

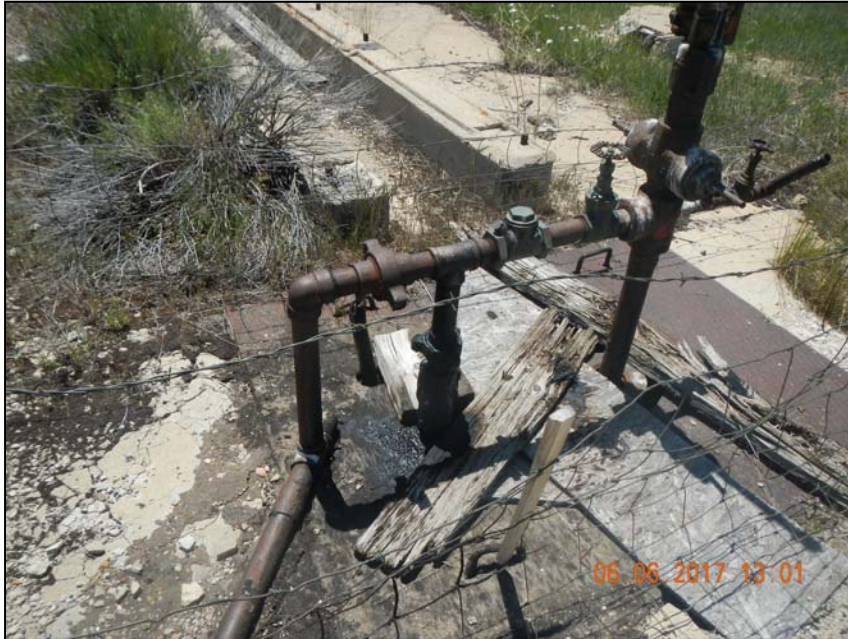
Photo 2. Wellhead with active leak and 1 – 2” steel riser

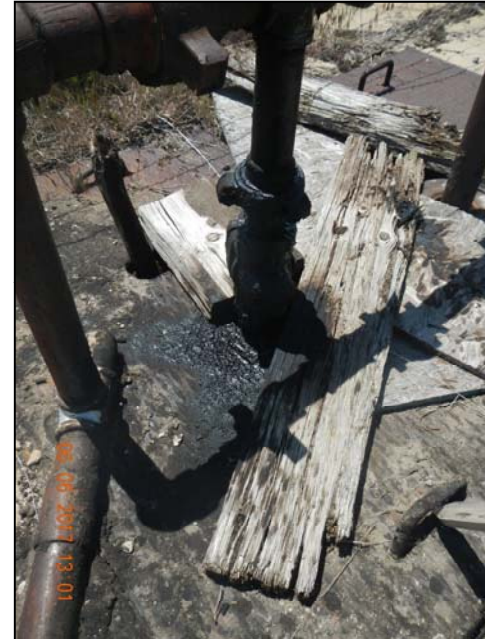
Photo 3. Close up of active leak occurring at wellhead.

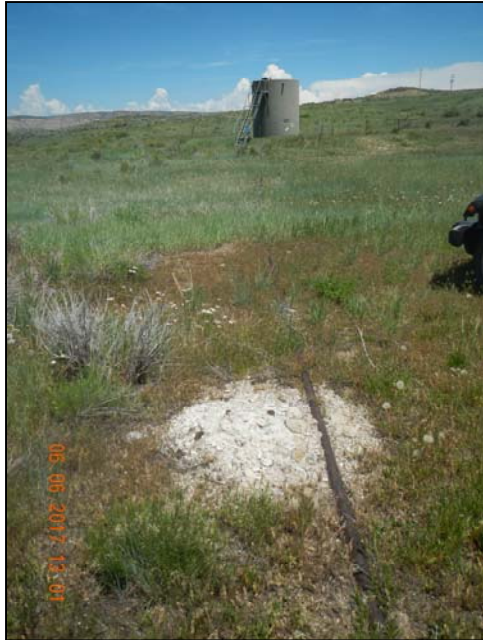
**Photo 4. View of leaking flowline standing at wellhead looking towards tank.**

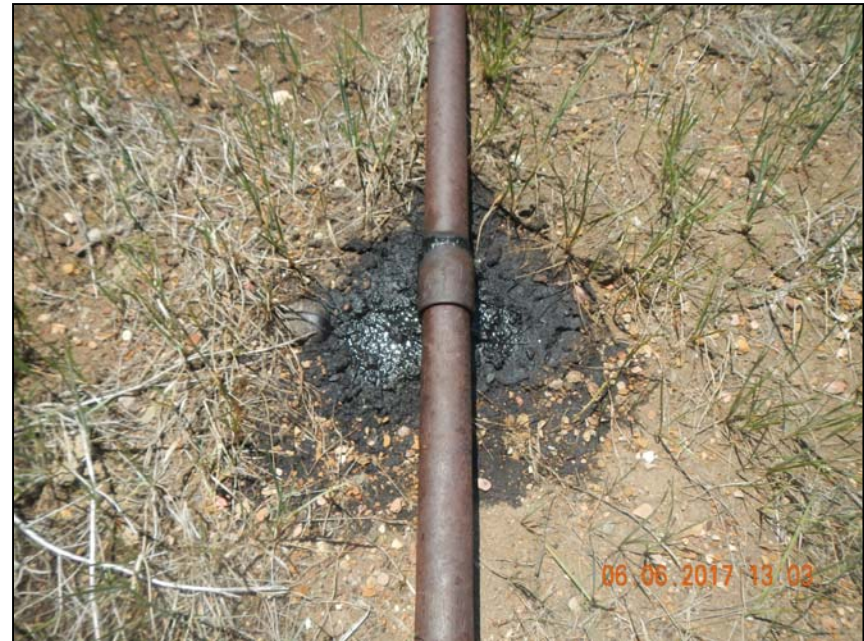
**Photo 5. Leak 1 of 3.**

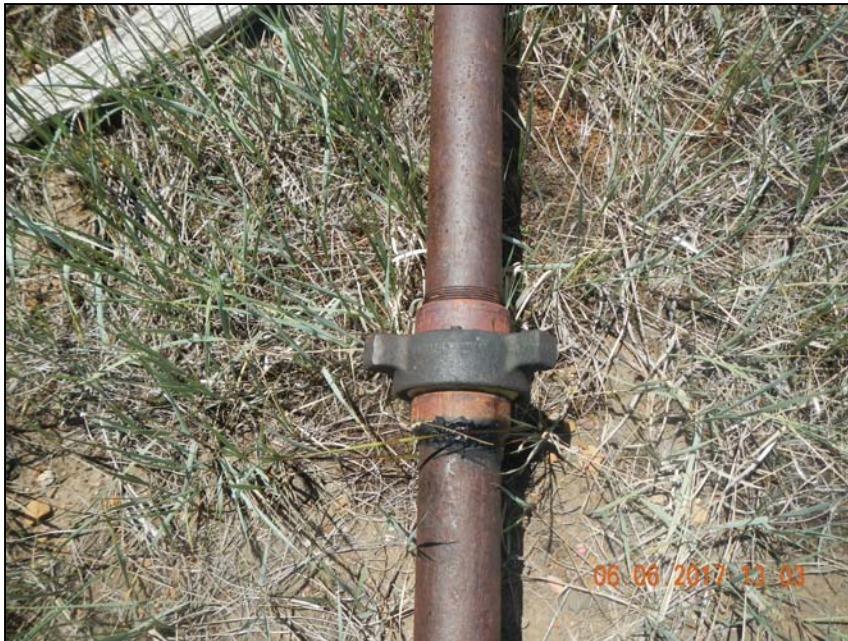
Photo 6. Leak 2 of 3.

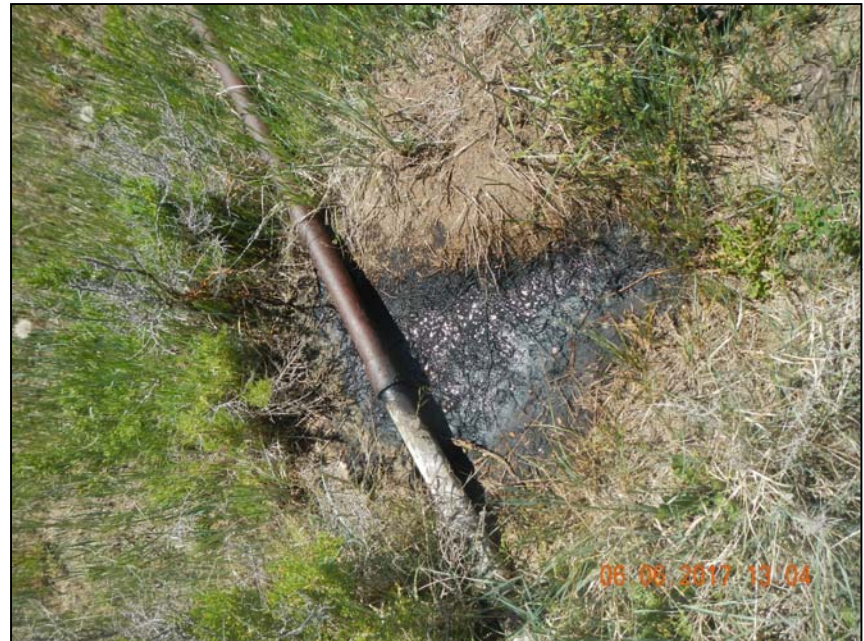
Photo 7. Leak 3 of 3.

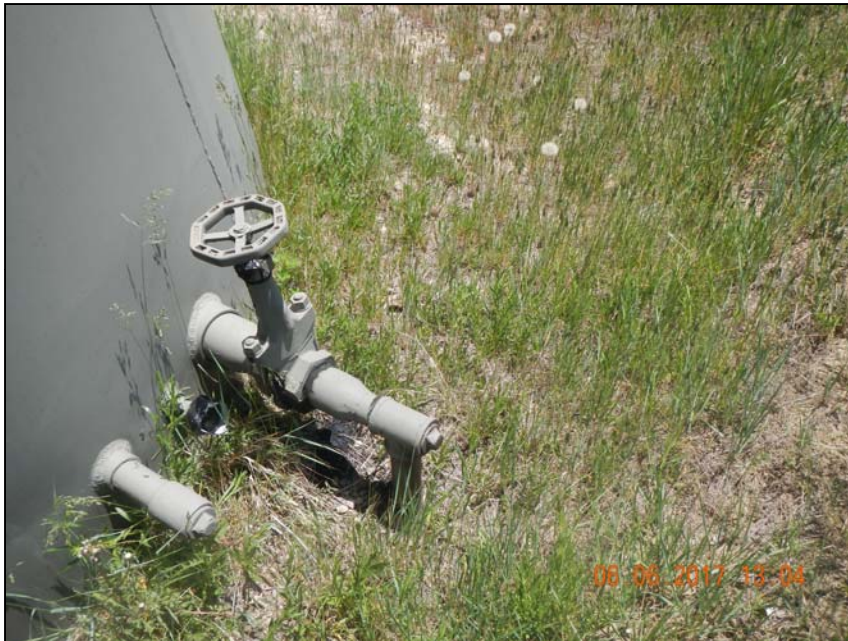
Photo 8. Steel riser into tank. Stained soil below it.

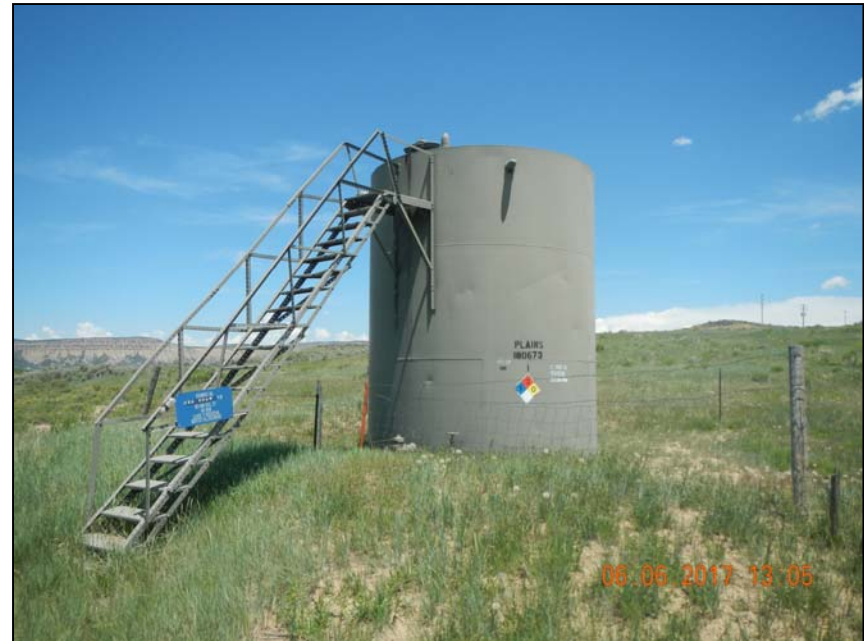
Photo 9. Overgrown berm.
