Inspection Photos

Operator: PDC ENERGY INC - 69175

Location ID: 319218

Inspection Doc. Number: 682502162

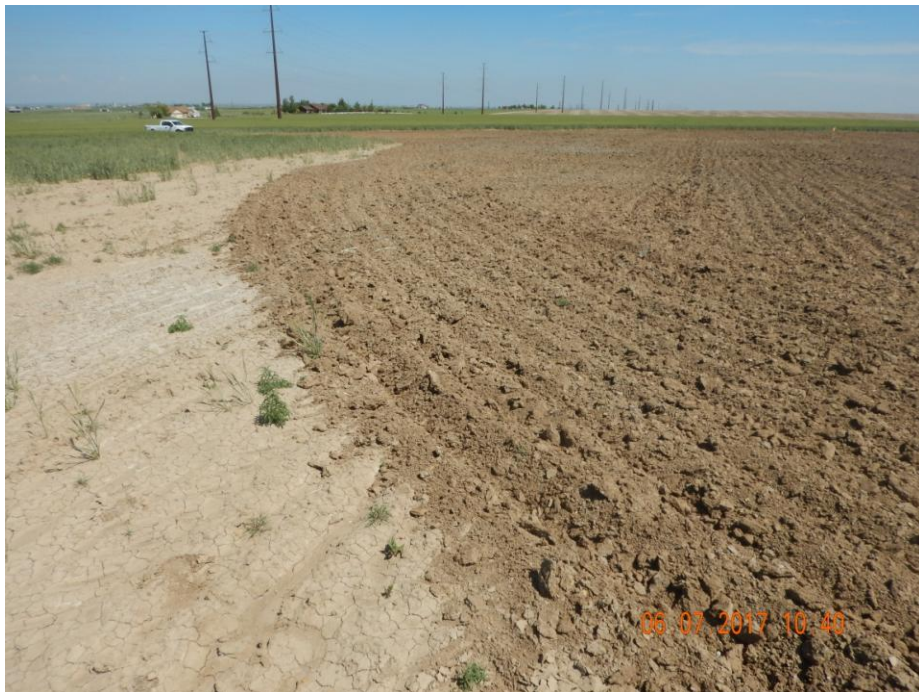
Photo 1: Photo taken from the south end of the location, facing northwest. Photo shows location has had surface roughening implemented. Surface roughening is a temporary BMP that should be used in conjunction with other BMPs. Photo also shows no perimeter BMP controls have been installed.

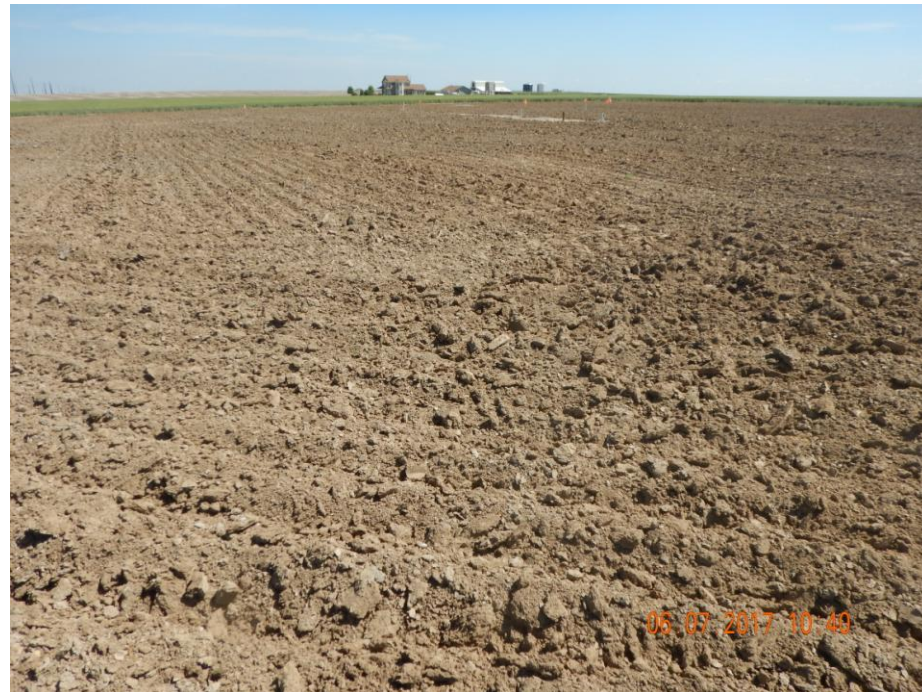
Photo 2: Photo taken from the south end of the location, facing north. Photo shows location has had surface roughening implemented. Surface roughening is a temporary BMP that should be used in conjunction with other BMPs. Photo also shows no perimeter BMP controls have been installed.

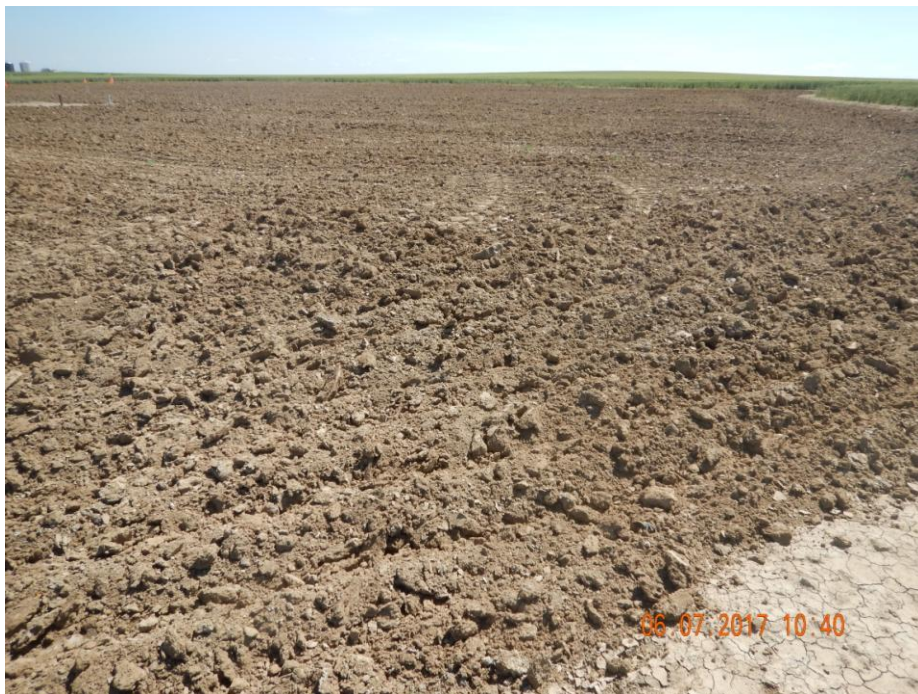
Photo 3: Photo taken from the south end of the location, facing northeast. Photo shows location has had surface roughening implemented. Surface roughening is a temporary BMP that should be used in conjunction with other BMPs. Photo also shows no perimeter BMP controls have been installed.

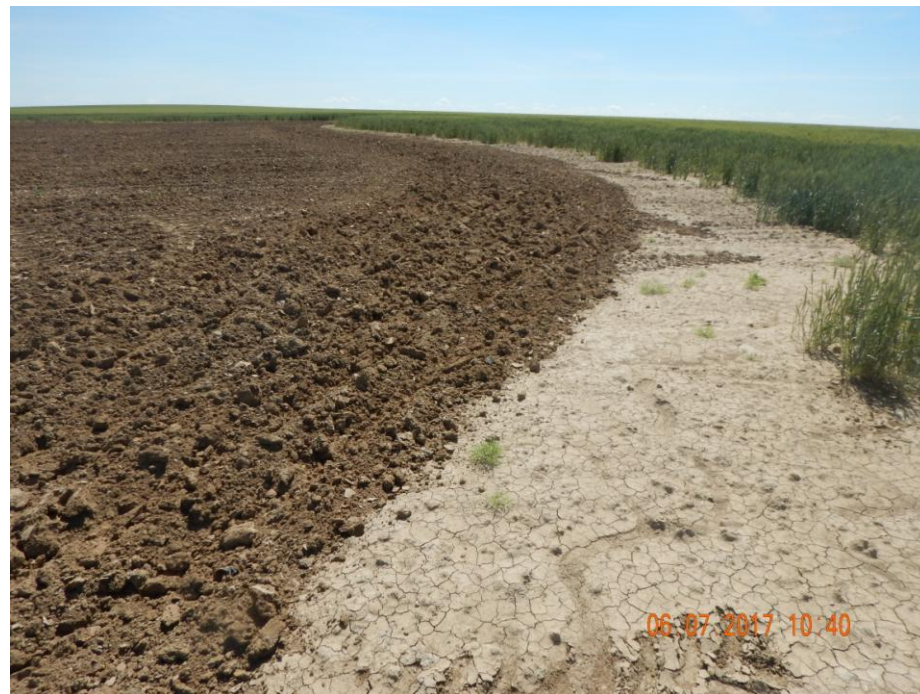
Photo 4: Photo taken from the south end of the location, facing east. Photo shows location has had surface roughening implemented. Surface roughening is a temporary BMP that should be used in conjunction with other BMPs. Photo also shows no perimeter BMP controls have been installed.

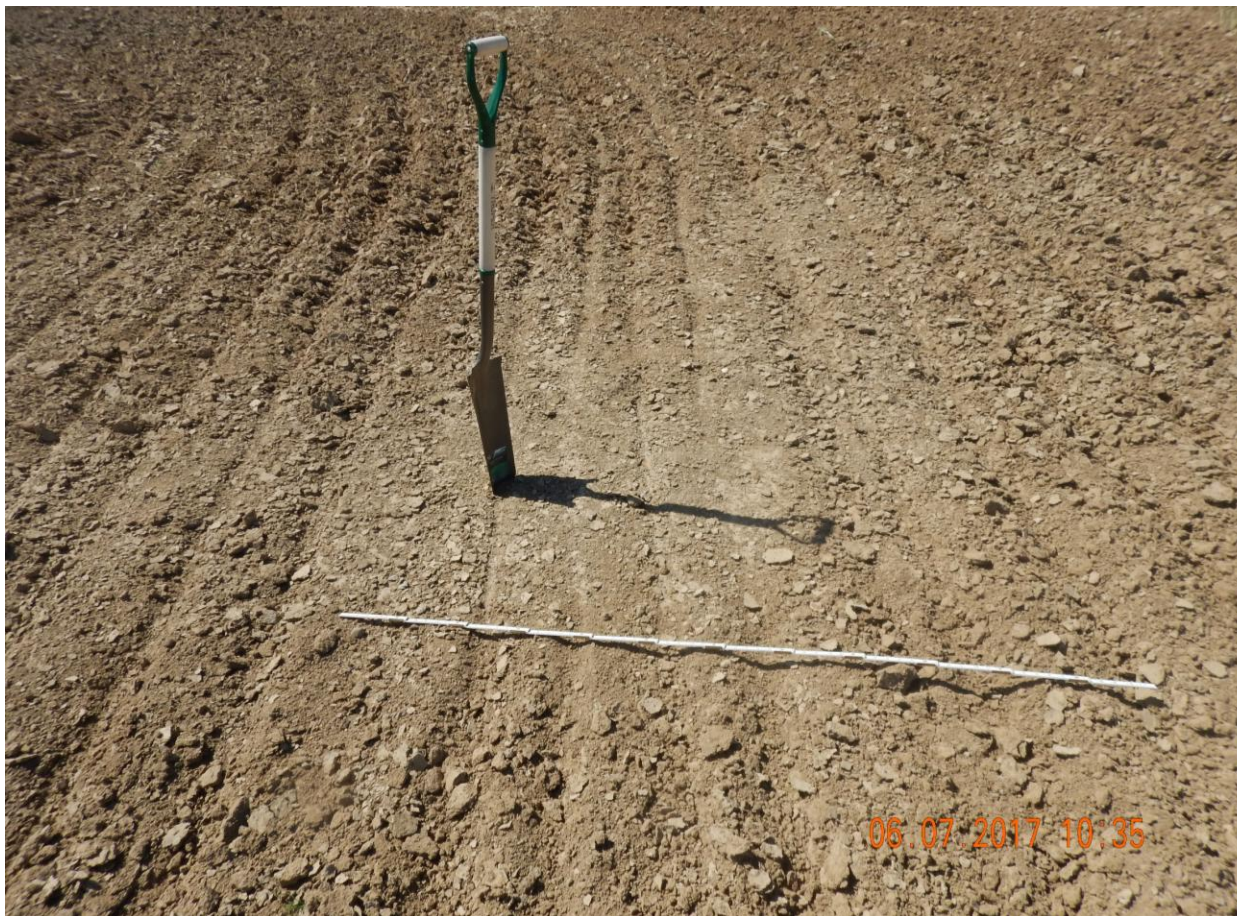
Photo 5: Photo taken from the west end of the location. Photo shows area where a compaction test pit was dug. 6 foot measuring stick for reference.

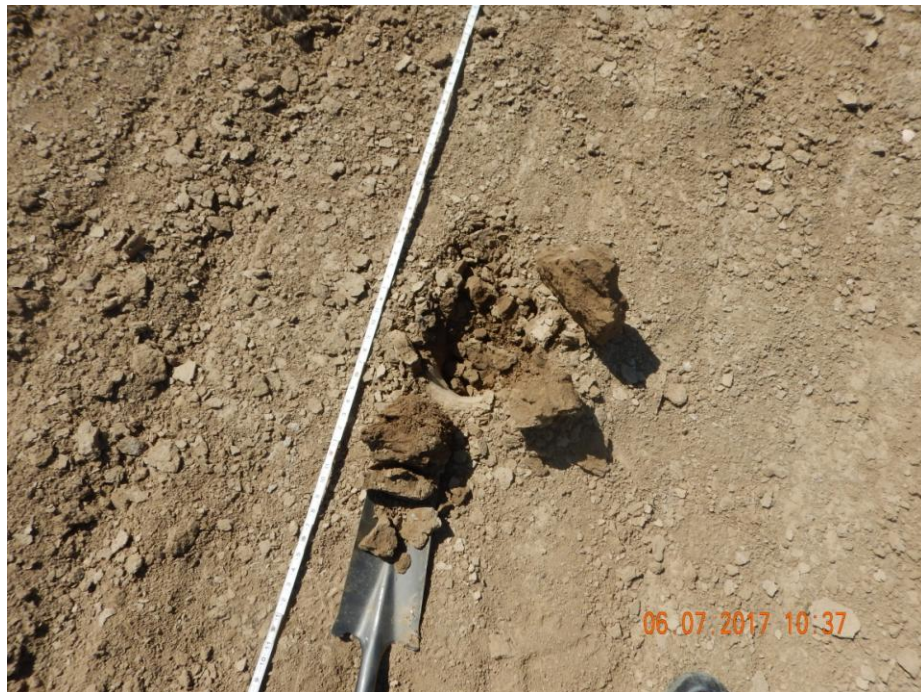
Photo 6: Photo of compaction test pit from the west end of the location. Photo shows compaction layers found in the first 9 inches of soil.

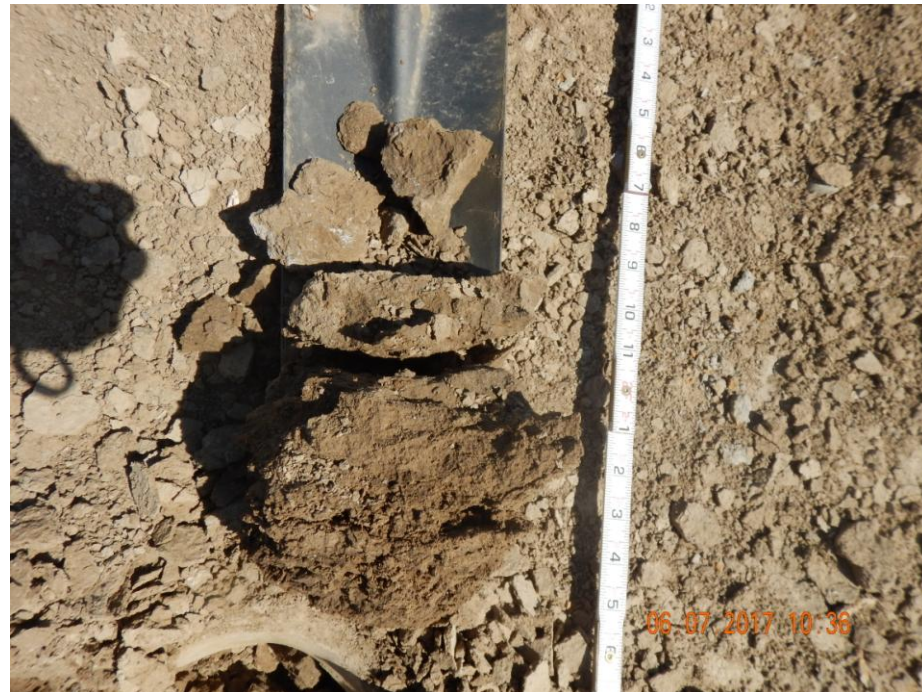
Photo 7: Photo of compaction test pit from the west end of the location. Photo shows compaction layers found in the first 9 inches of soil.

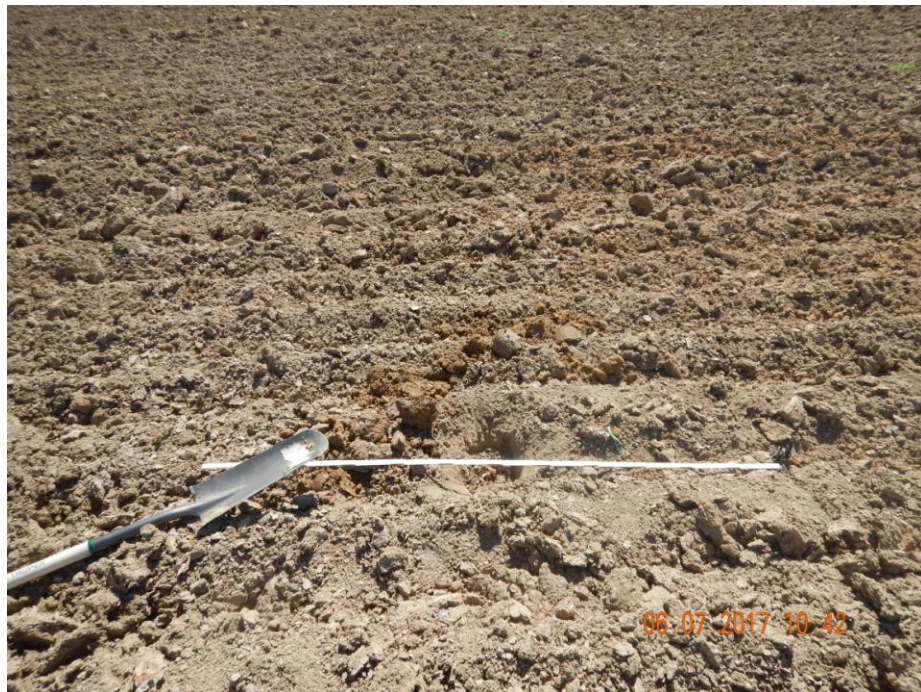
Photo 8: Photo taken from the east end of the location. Photo shows area where a compaction test pit was dug. 6 foot measuring stick for reference.

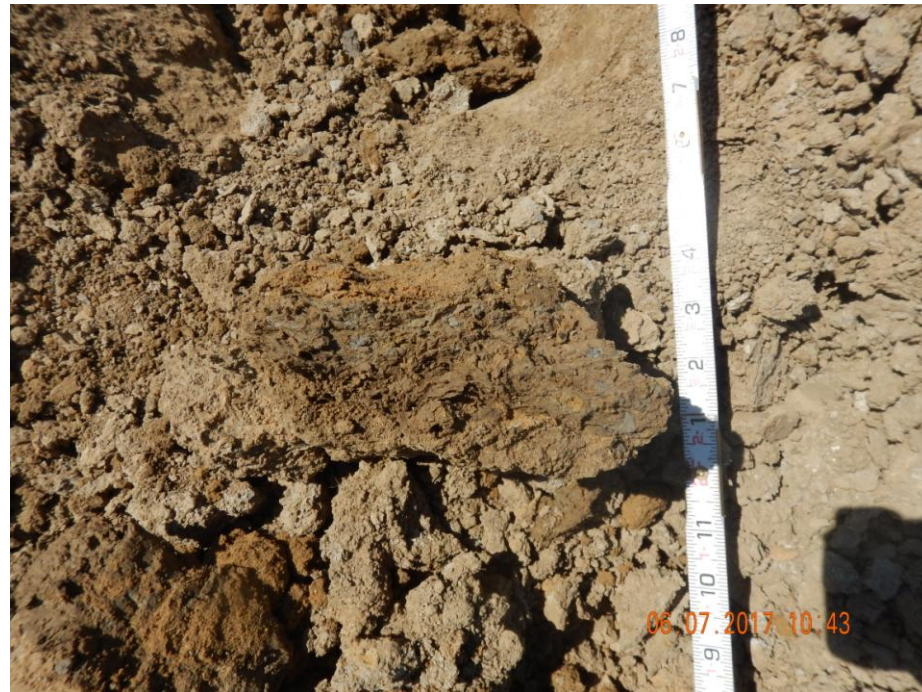
Photo 9: Photo taken from the east end of the location. Photo shows compaction layers found in the first 12 inches.
