# Inspection Photos

Operator: EDDY OIL COMPANY - 26420

Location ID: 322675

Inspection Doc. Number: 682502199

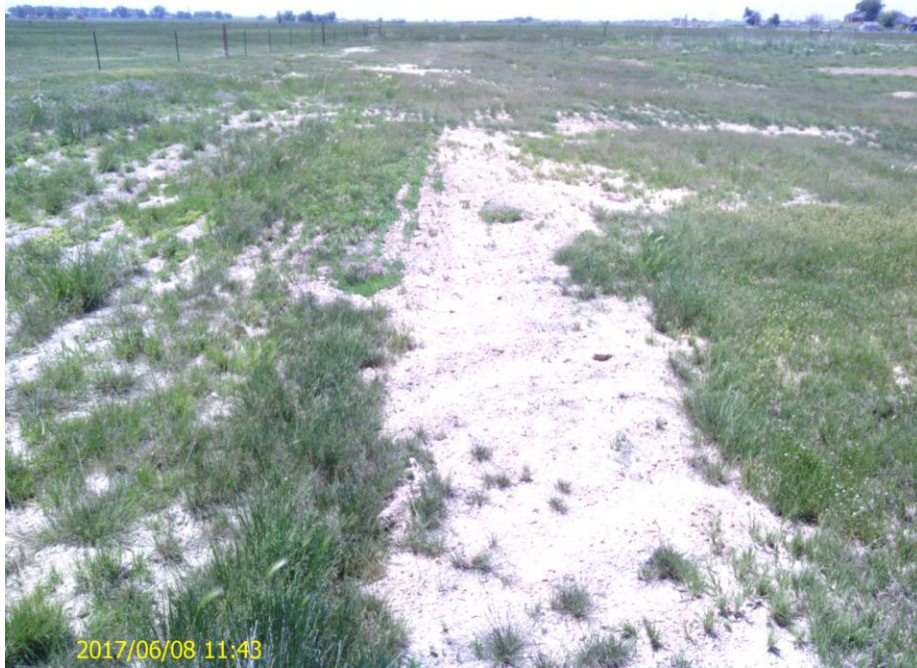
**Photo 1:** Photo taken from the northeast end of the location, facing south. Photo shows large areas of the location remain bare and unvegetated. Location is not progressing towards COGCC 1000 series reclamation standards.

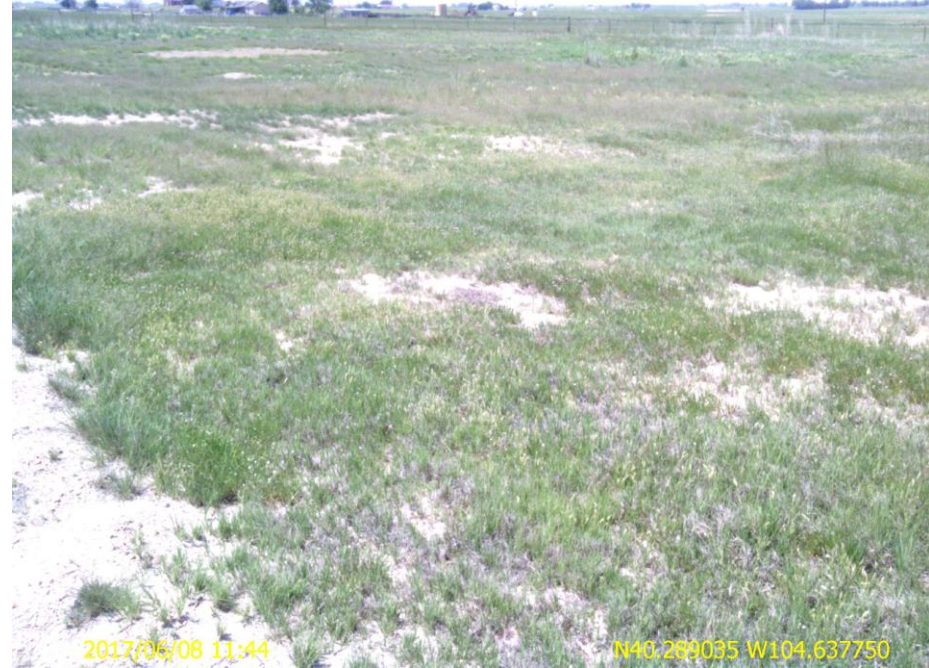
**Photo 2:** Photo taken from the northeast end of the location, facing southwest. Photo shows large areas of the location remain bare and unvegetated. Location is not progressing towards COGCC 1000 series reclamation standards.

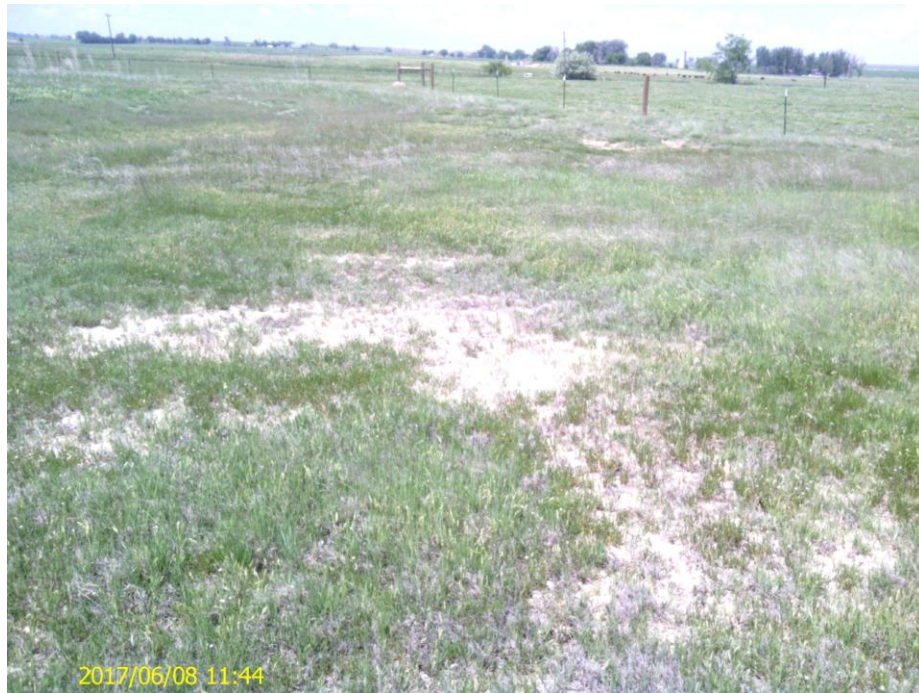
**Photo 3:** Photo taken from the northeast end of the location, facing west. Photo shows large areas of the location remain bare and unvegetated. Location is not progressing towards COGCC 1000 series reclamation standards.

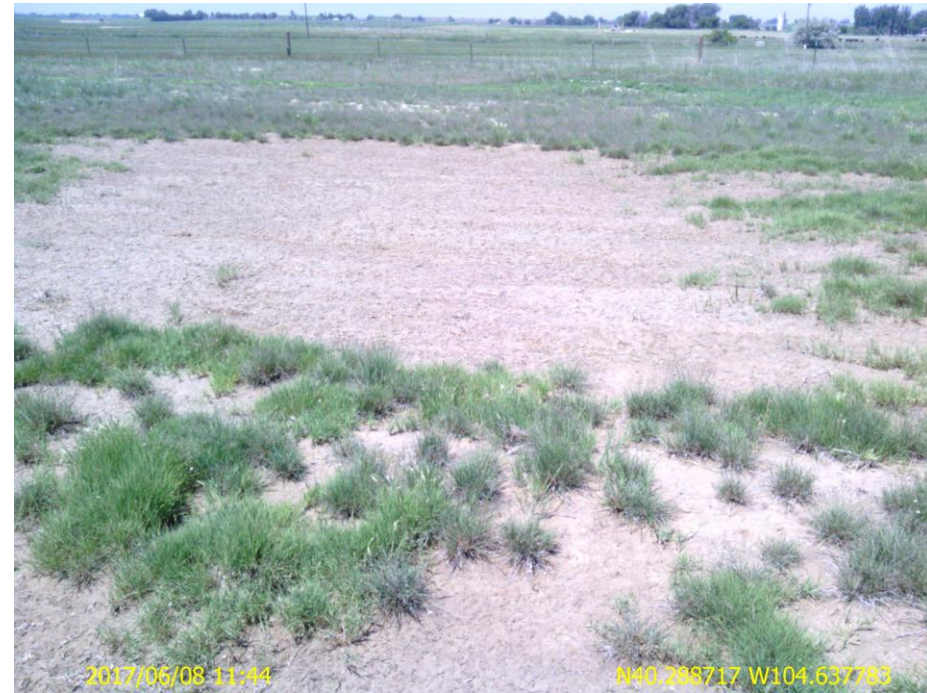
**Photo 4:** Photo taken from the center of the location, facing west. Photo shows large areas of the location remain bare and unvegetated. Location is not progressing towards COGCC 1000 series reclamation standards.

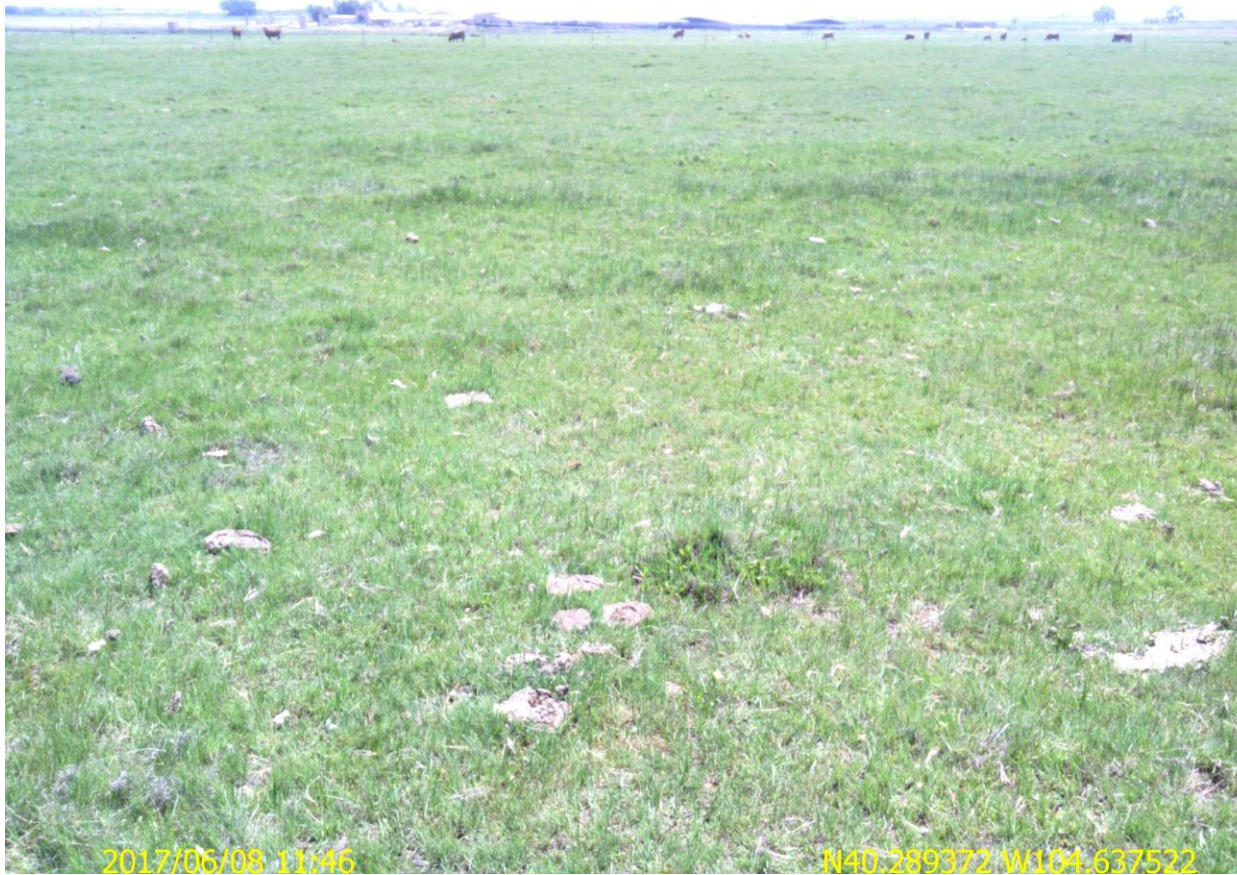
**Photo 5:** Photo taken from the adjacent reference area, facing east. Photo shows vegetation over the reference area.

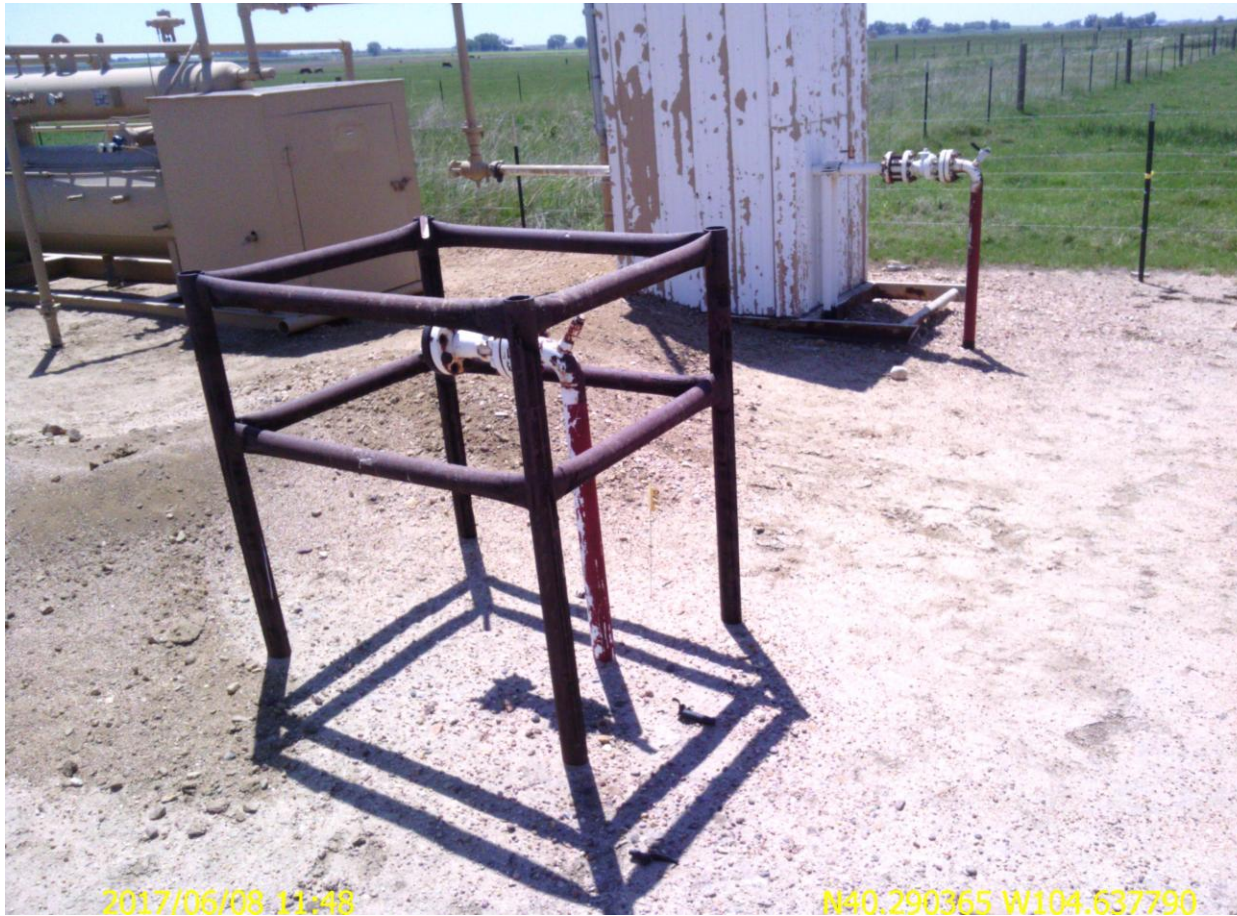
**Photo 6:** Photo taken from the tank battery south of the location. Photo shows riser located on the northwest corner of the horizontal separator. Riser does not have the required markings, or lockout/tagout required per the May 2, 2017 Flowline or Pipeline NTO. Riser will need to be removed per Phase II of the NTO.
