Inspection Photos
Location Name: Westward 2
API #069-06103

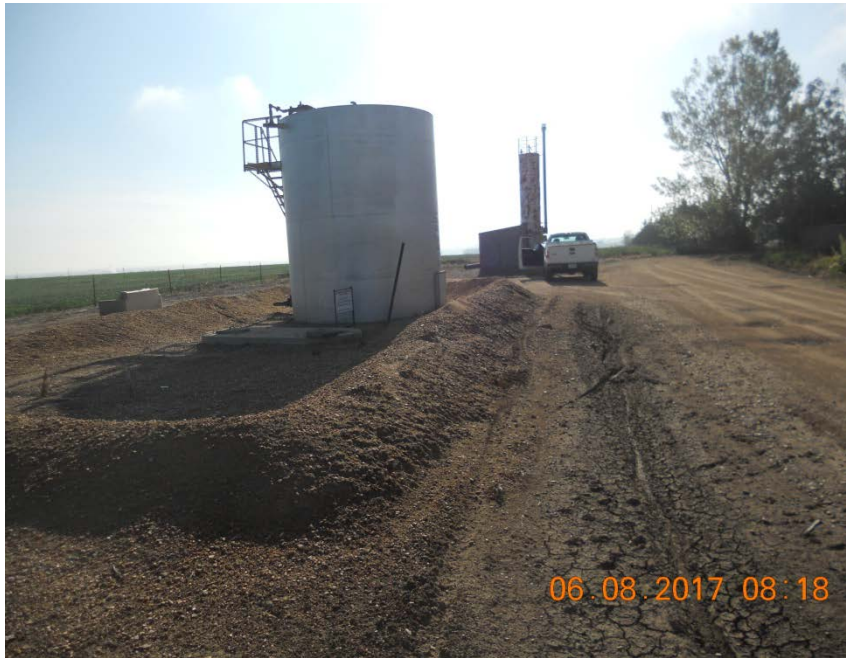
Photo 1. Tank battery looking east. Note tanks are visible from Hwy 287 are not painted as required. No NFPA label on oil tank.

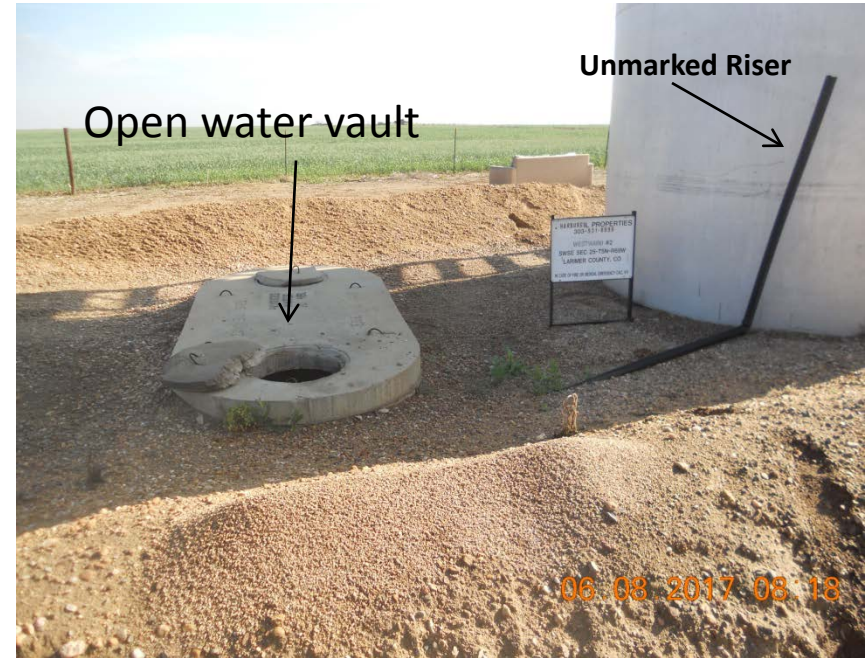
Photo 2. Water vault lid not in place. Wildlife entrance possible. Unmarked 2" poly riser.

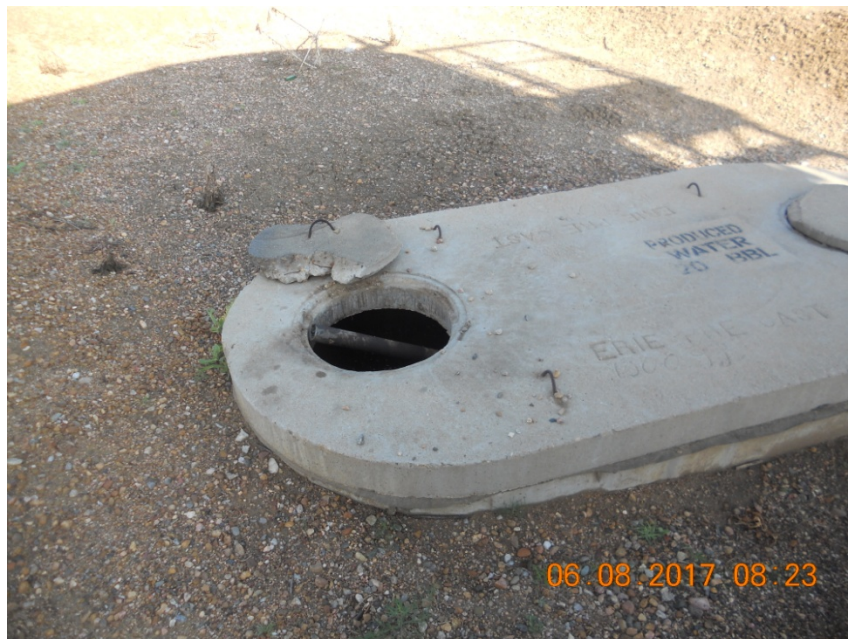
Photo 3. No NFPA label on water vault. Contents and capacity stenciled on top, but not readily visible from outside of berm

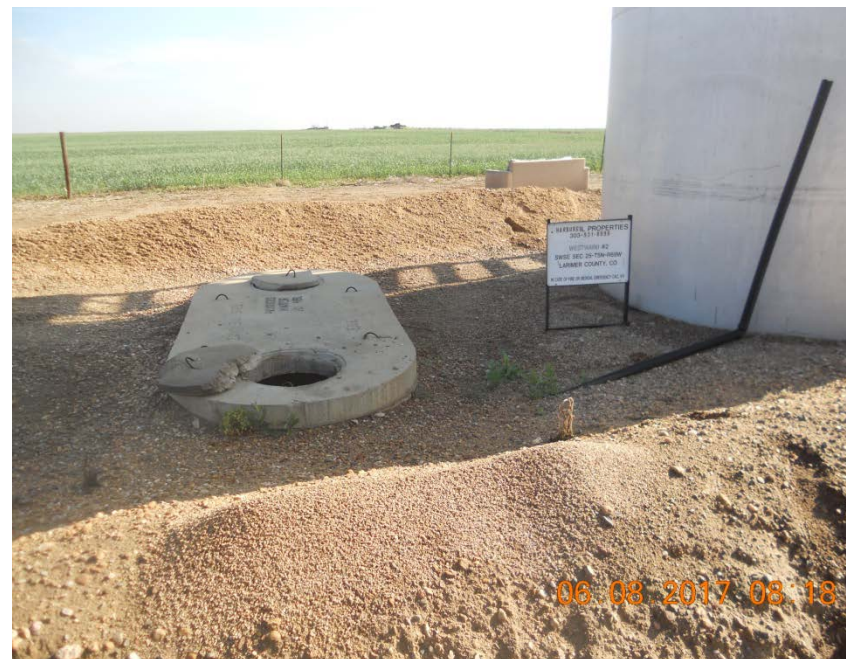
Photo 4. Signage for water vault not readily visible

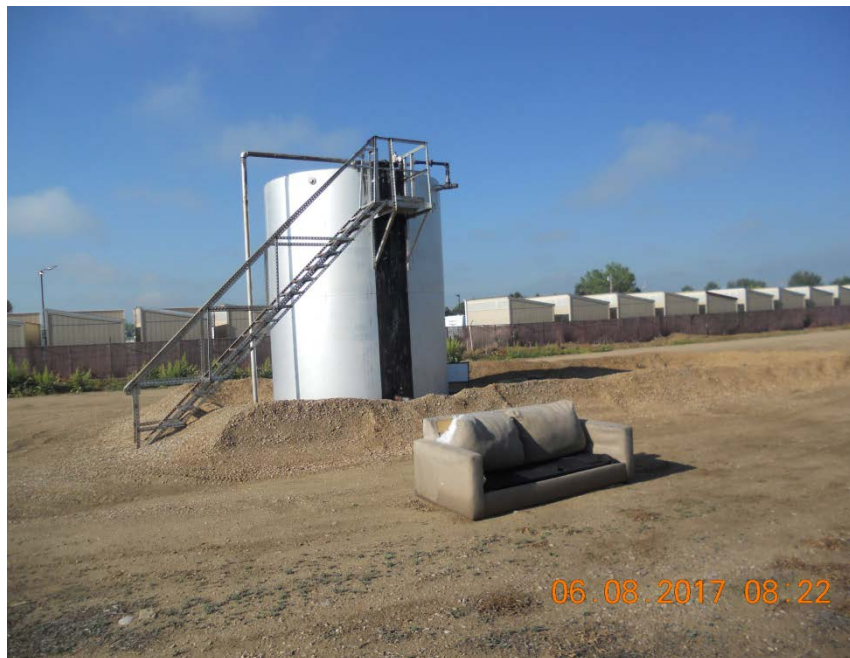
Photo 5. Tank painted silver. Debris on location.

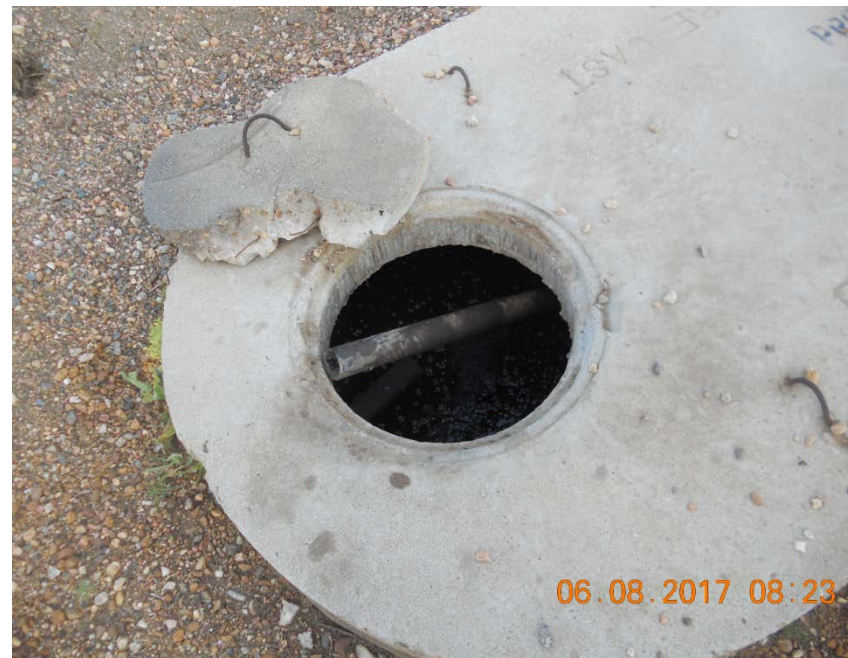
Photo 6. Open vault oily substance on water

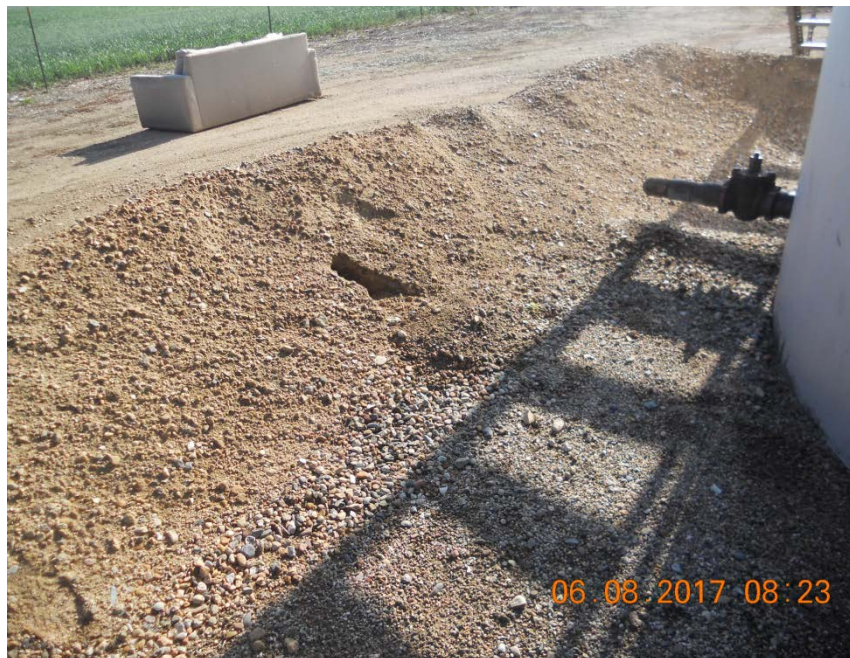
Photo 7. Animal burrow in berm.

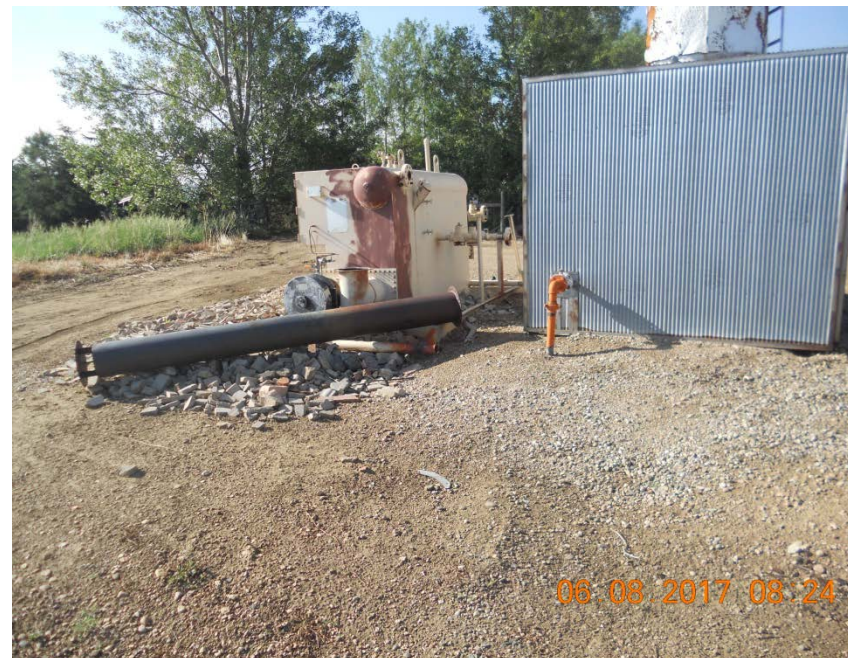
Photo 8. Unused separator at vertical heater treater

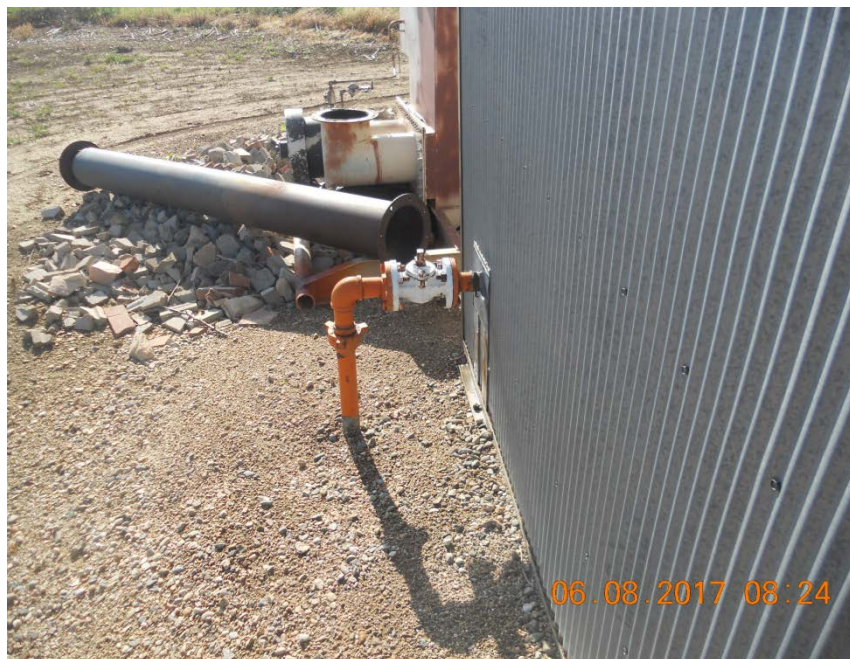
Photo 9. Gas sales riser on north side of treater shed. Valve in closed position

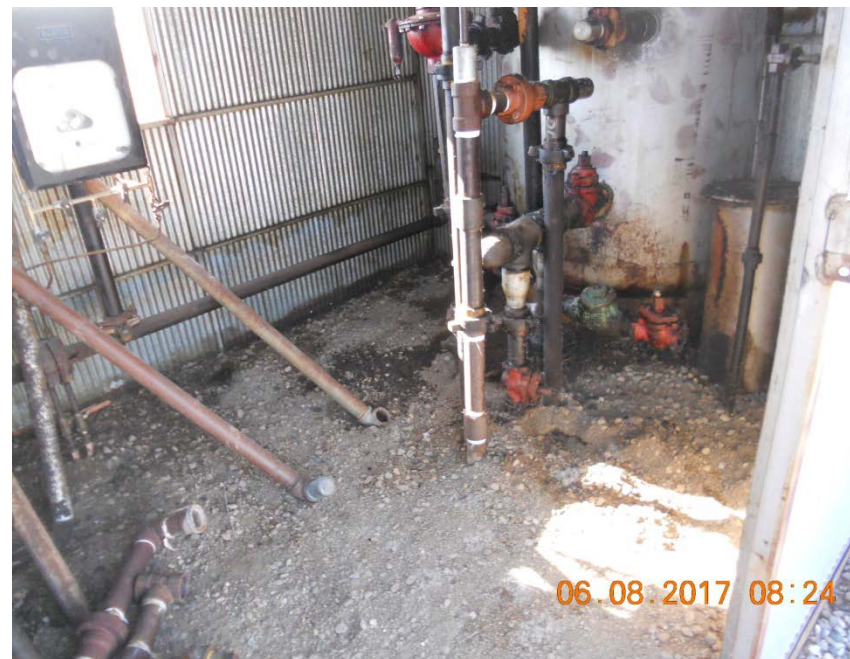
Photo 10. Stained soil in treater shed

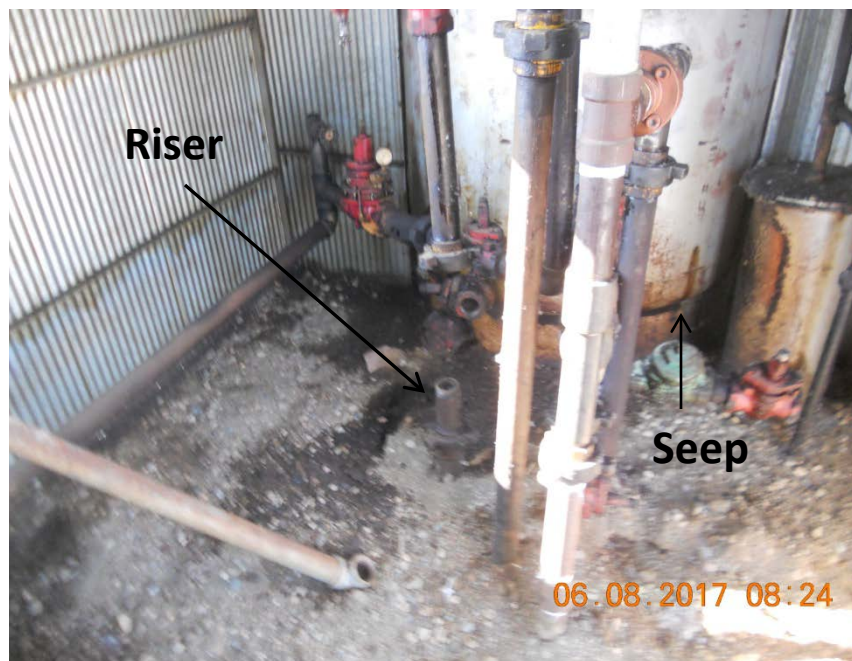
Photo 11. Stained soil and abandoned unmarked uncapped 3" riser in treater shed . Seep in treater wall.

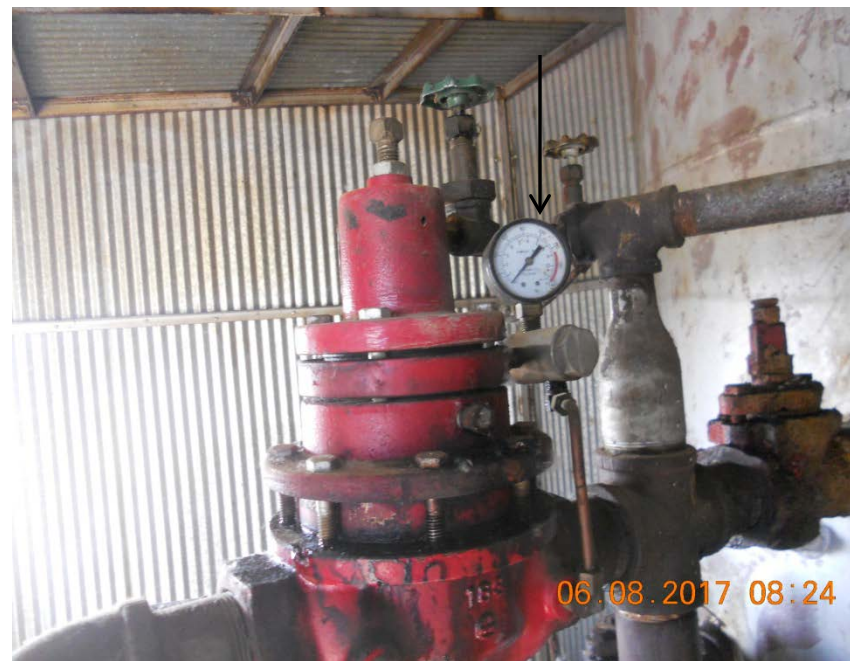
Photo 12. Gauge indicates no pressure on treater

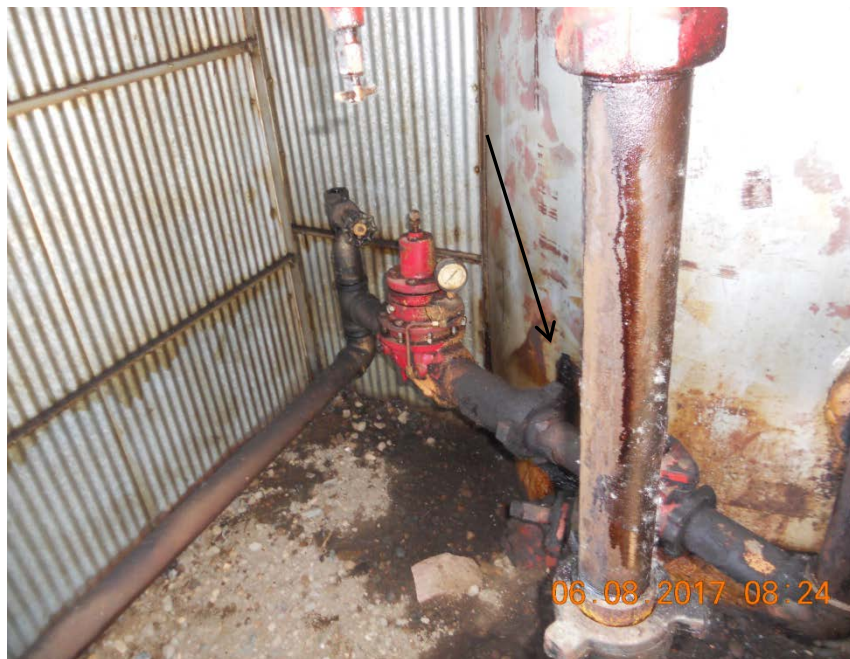
Photo 13. Second seep in treater wall

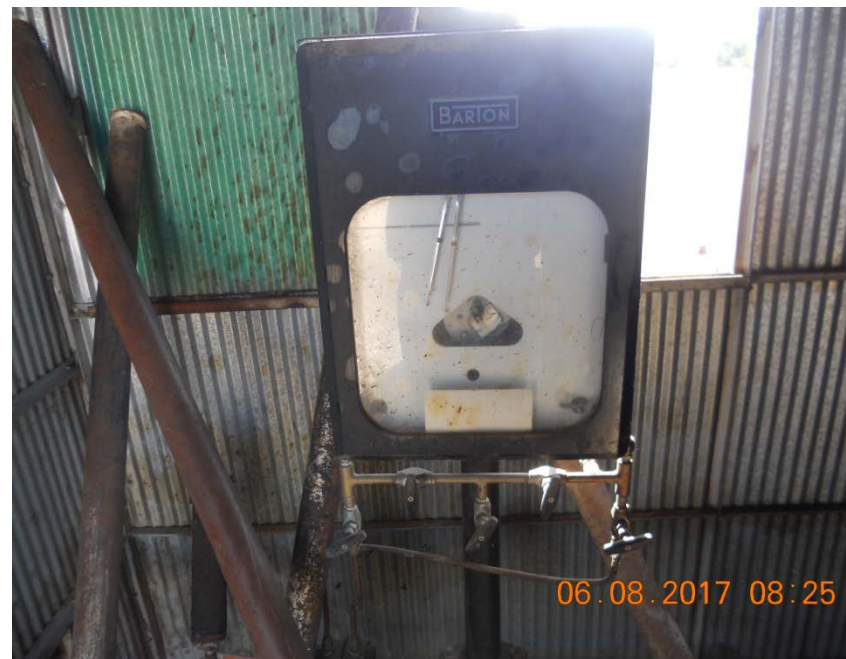
Photo 14. No chart to indicate gas sales

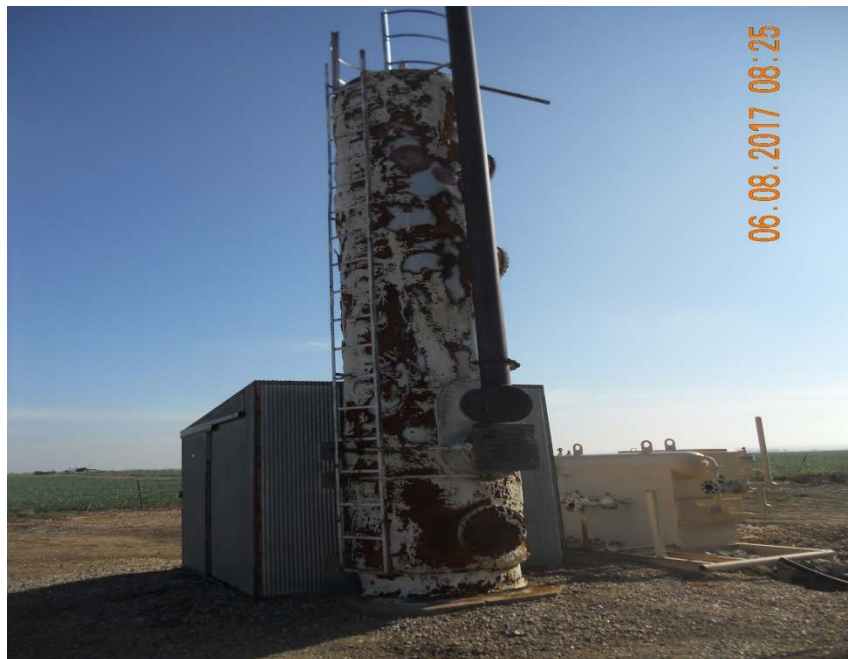
**Photo 15. Vertical heater treater with insulation coming off.
Unused horizontal separator**

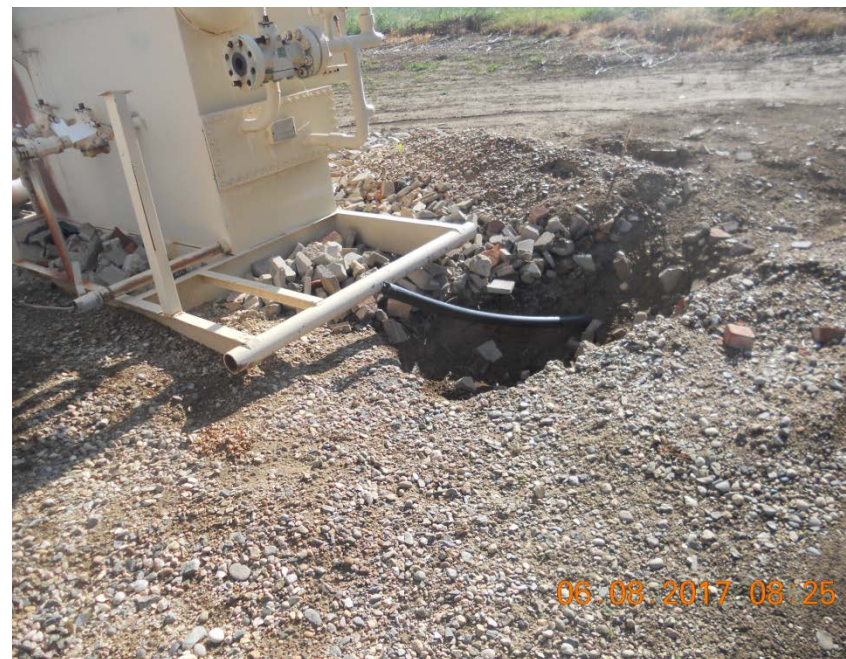
**Photo 16. Unmarked 2" poly line stubbed out on south side
of unused separator**

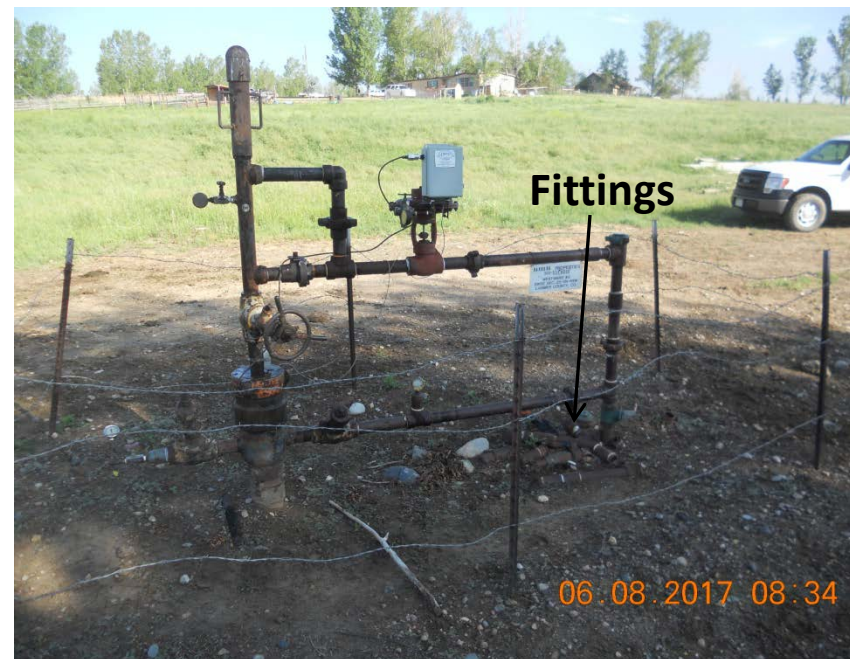
Photo 20. Looking west at wellhead. Note misc fittings at wellhead

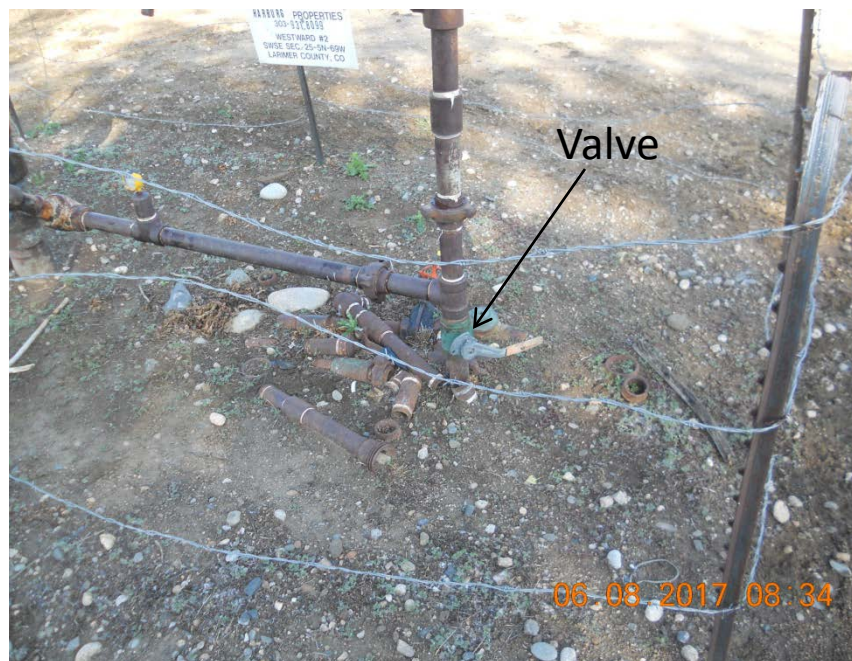
Photo 21. Misc fittings at wellhead. Note closed flowline valve.

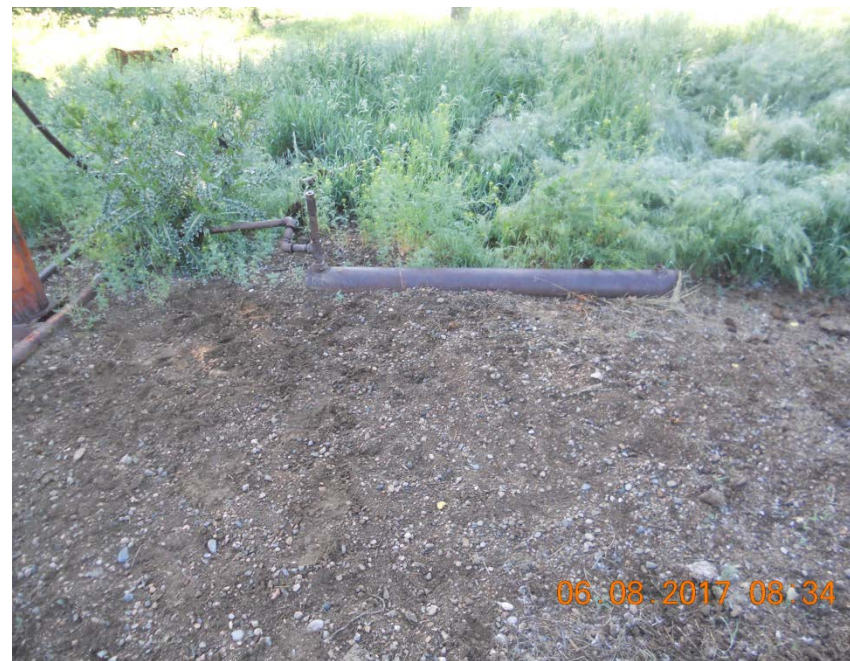
Photo 22. Unused gas volume pot to east of wellhead. Attempted to determine if discarded or plumbed in. Unable to move assume it is plumbed in

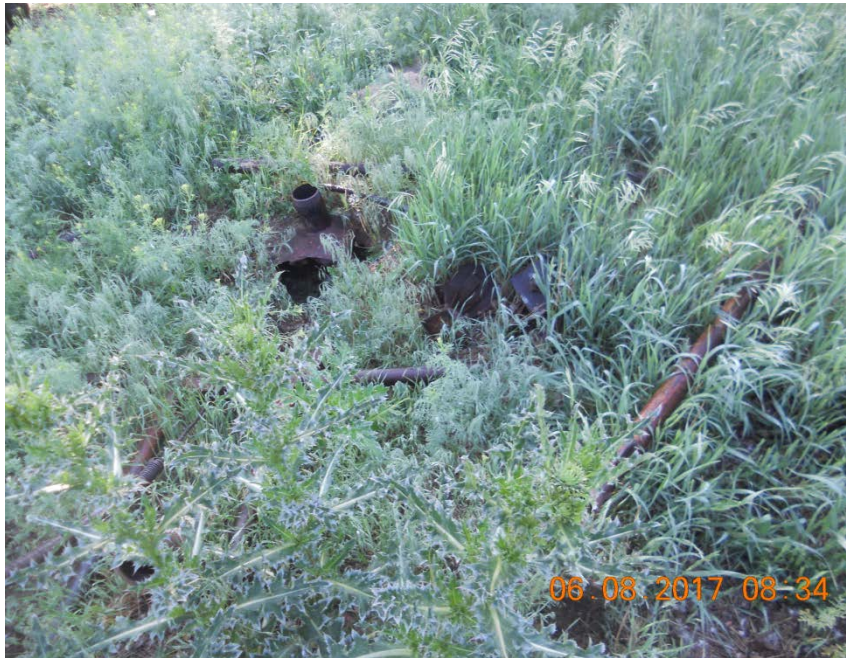
Photo 23. Misc debris in grass east on volume pot. Piping and rig anchors can be visualized.

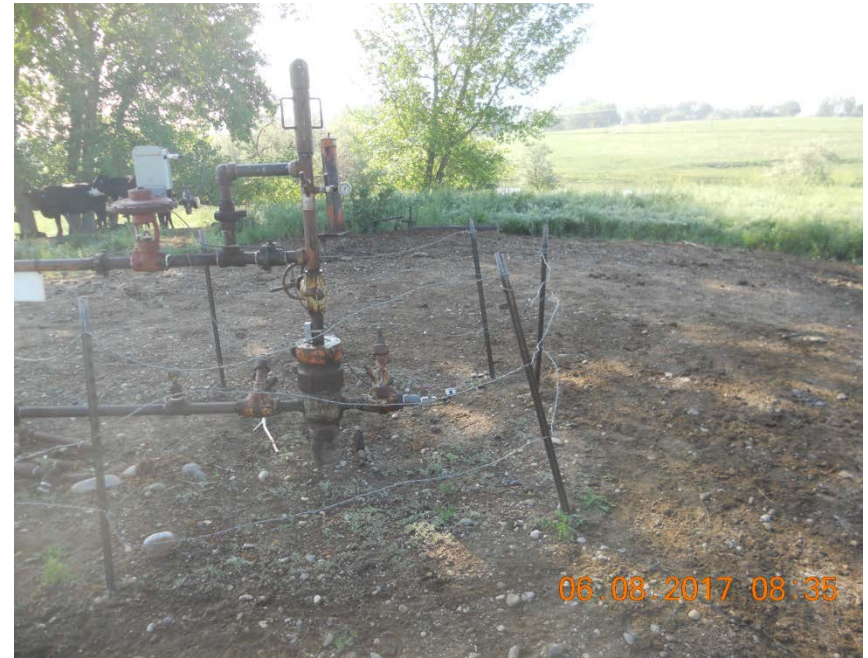
Photo 24. Wellhead looking east. Fencing is not appropriate for livestock on site
