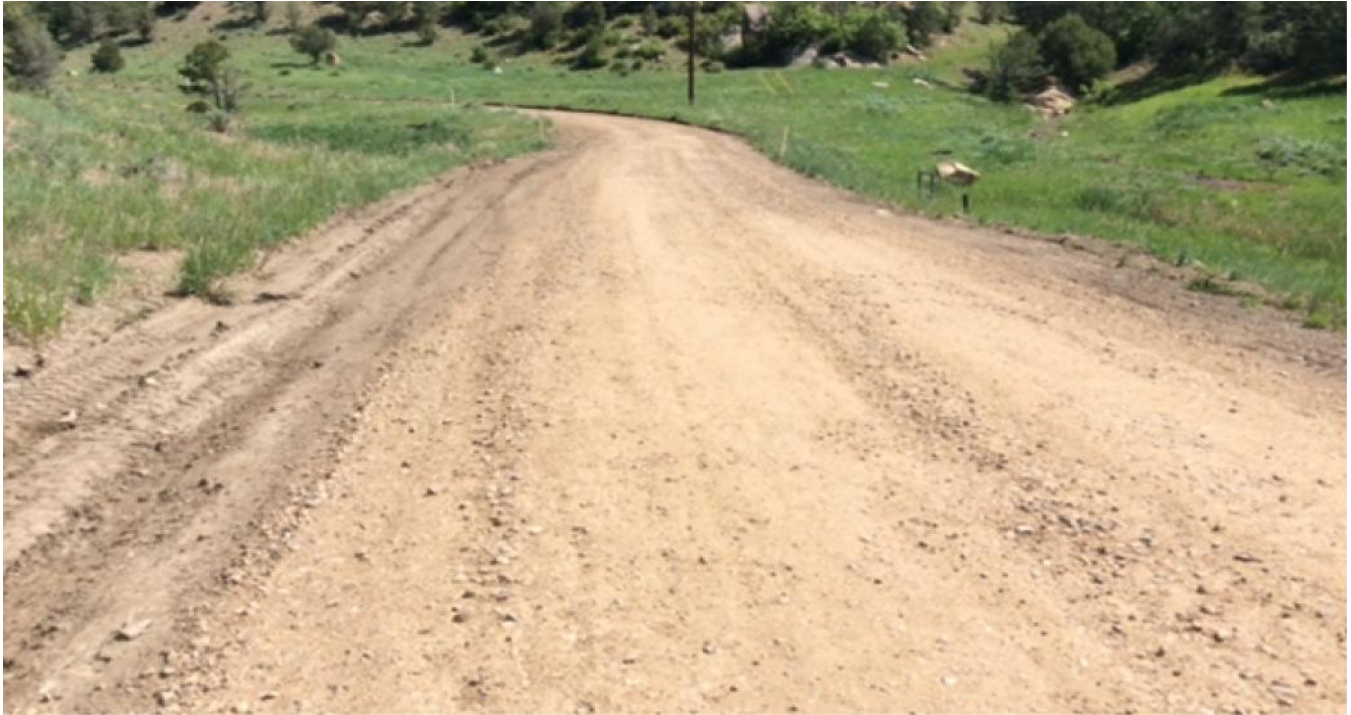
Photo 1: Facing northeast along the main access road. Installed gravel and crowned the driving surface to establish sheet flow.

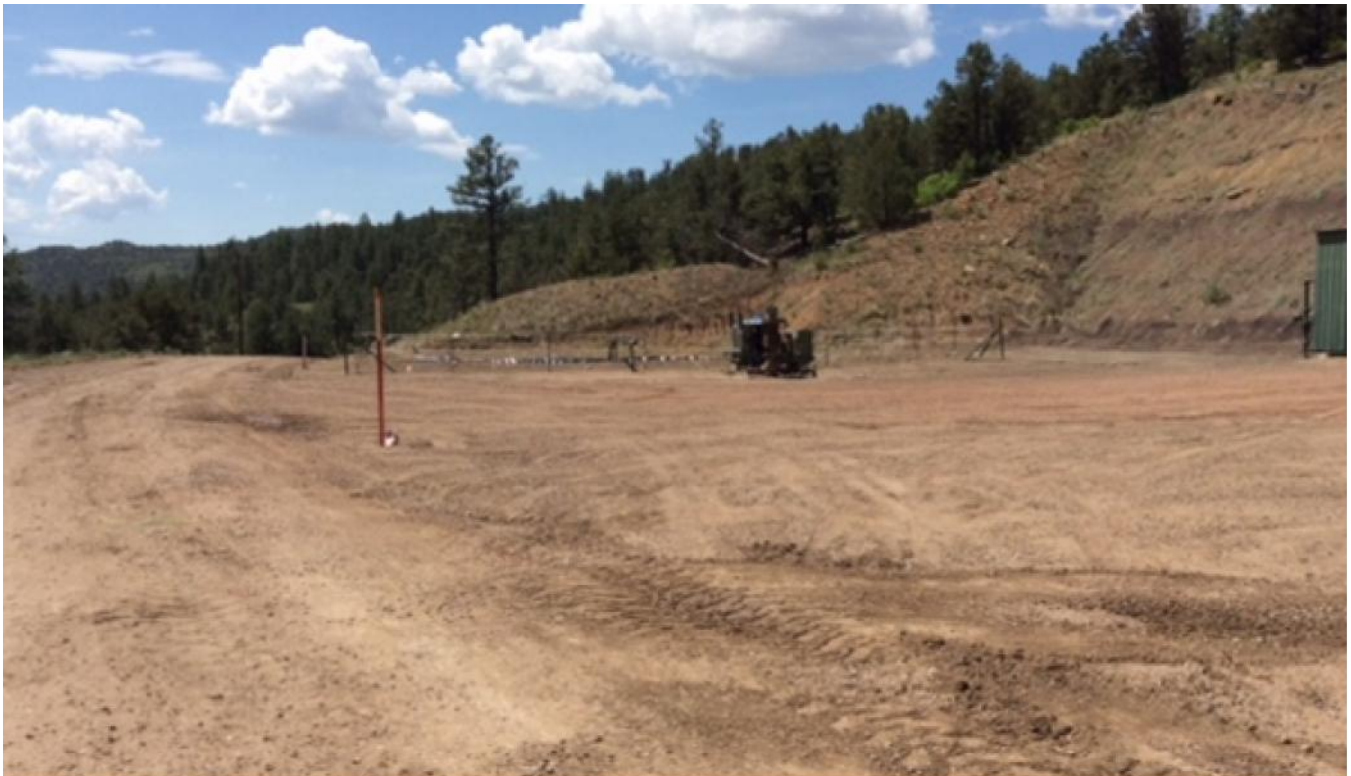
Photo 2: Pulled gravel back onto the driving surface.

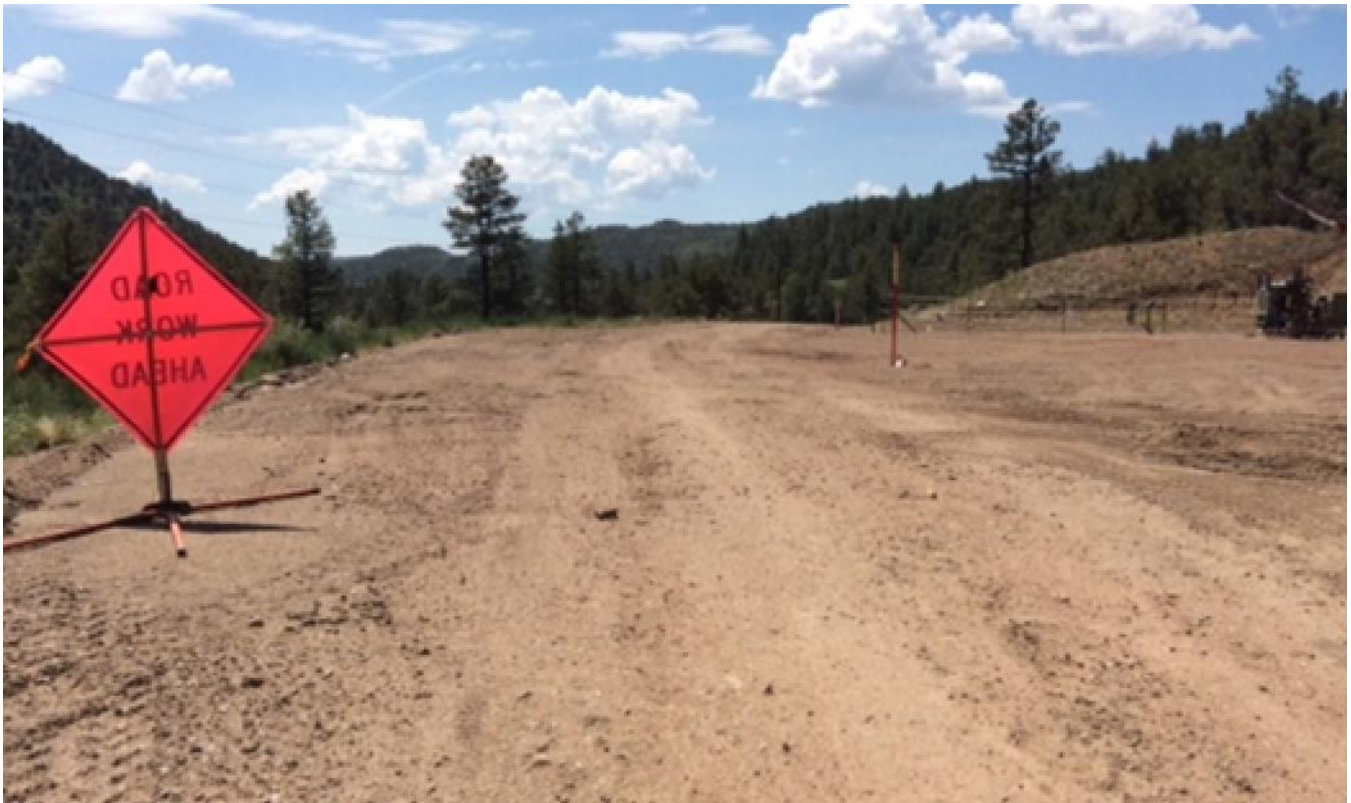
Photo 3: Facing south along the main road which goes through location. Pulled gravel back onto the driving surface.

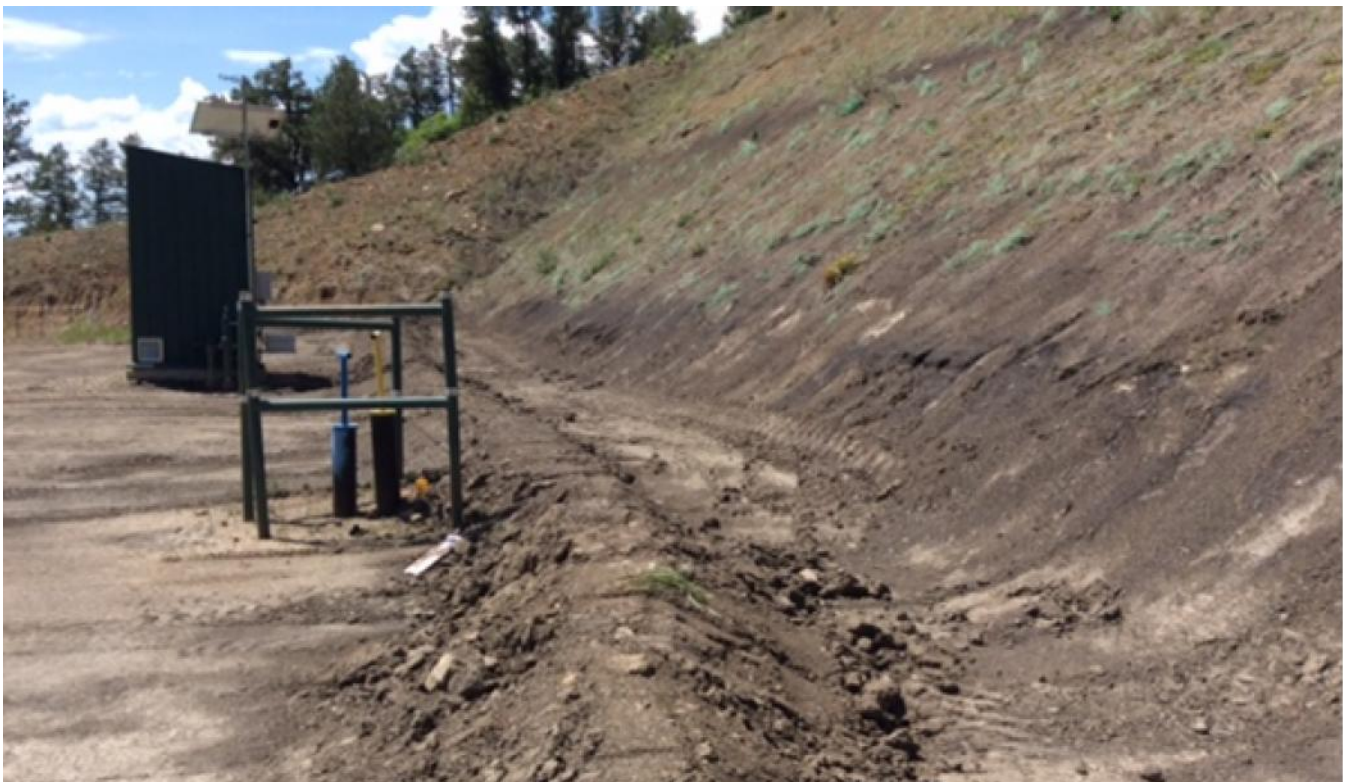
Photo 4: Facing southwest toward the cut slope of the location. The rills were raked out, the sediment accumulation was removed and a dirt berm was installed at the toe of the cut slope.
