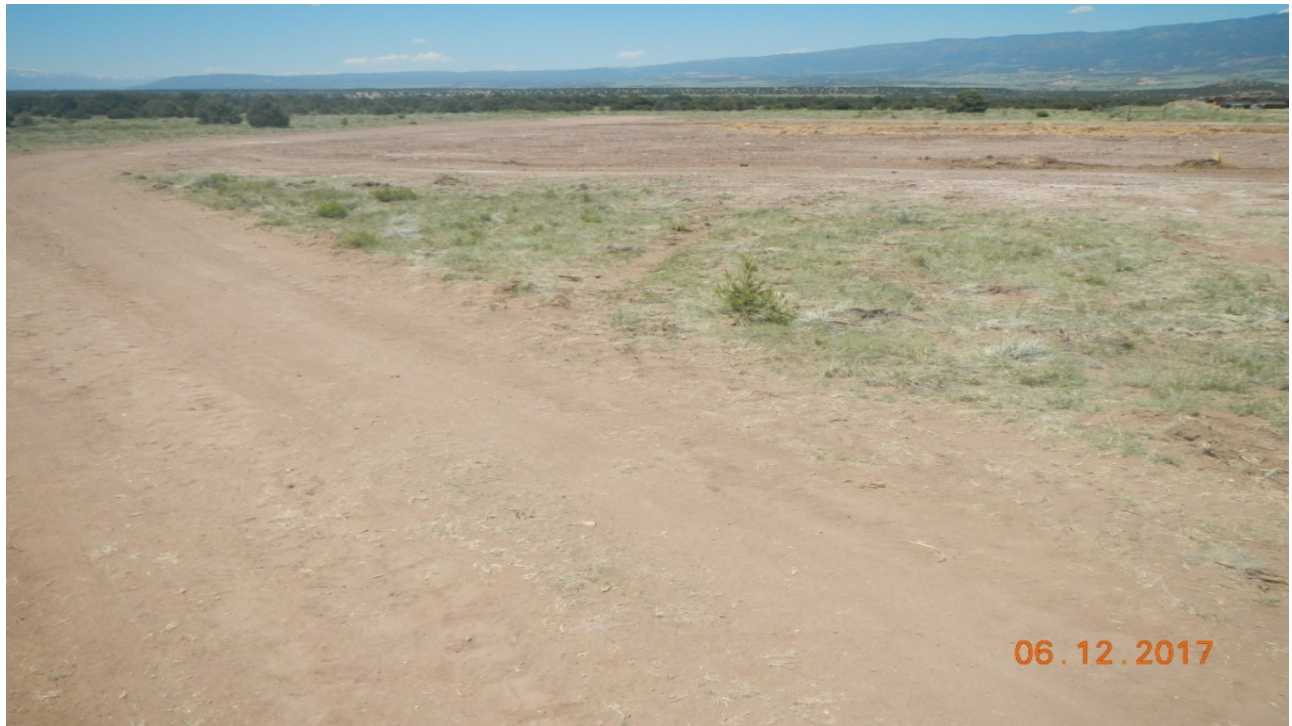
photo 1: Facing northwest toward the area of disturbance off of county road 530.

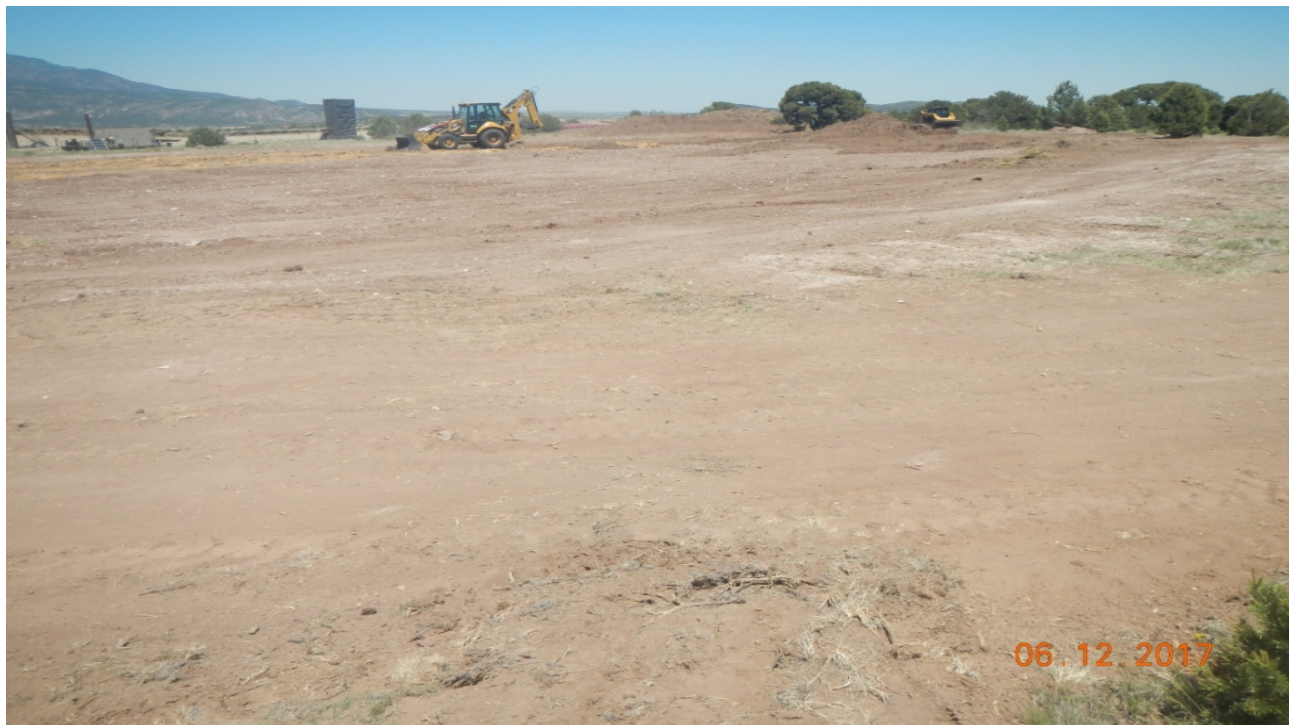
photo 2: Facing northeast toward the area of disturbance southwest of the Freeman 3-24 location. Equipment was in the process of replacing soil piles.

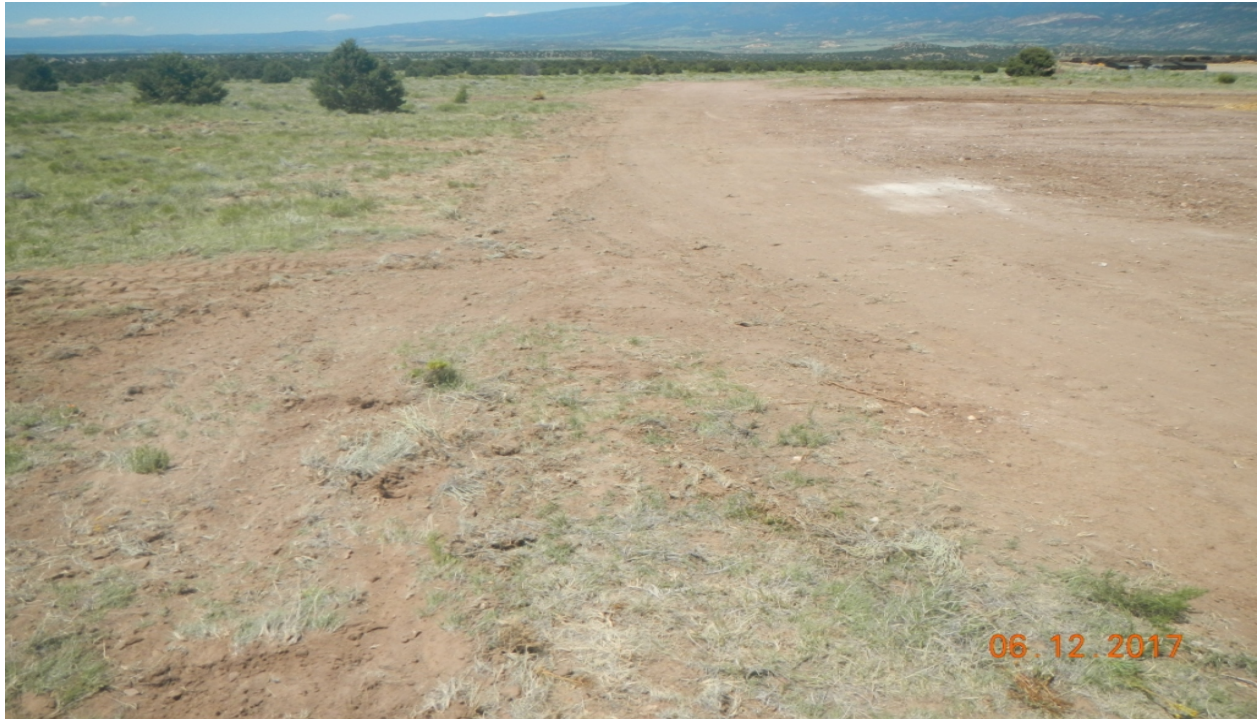
photo 3: Facing north toward the disturbance area. There are no stormwater controls in place along the perimeter.

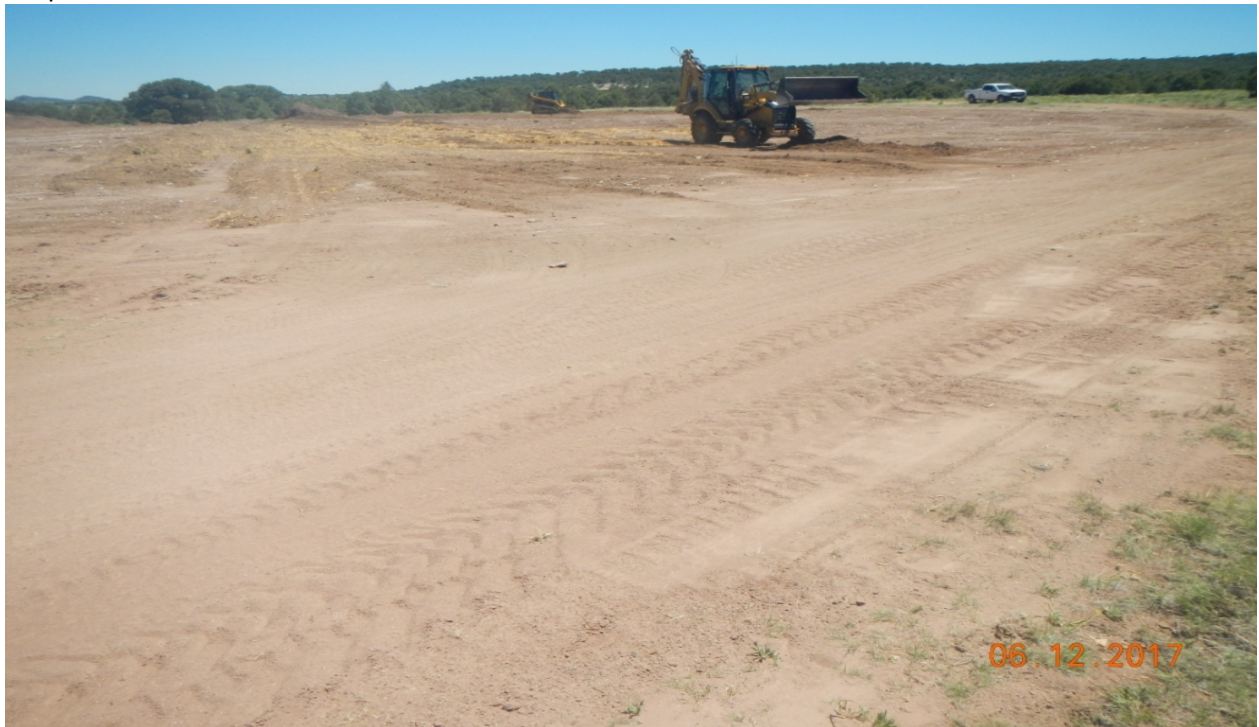
photo 4: Facing southeast toward the area of disturbance. The disturbed soils create a potential for wind erosion.

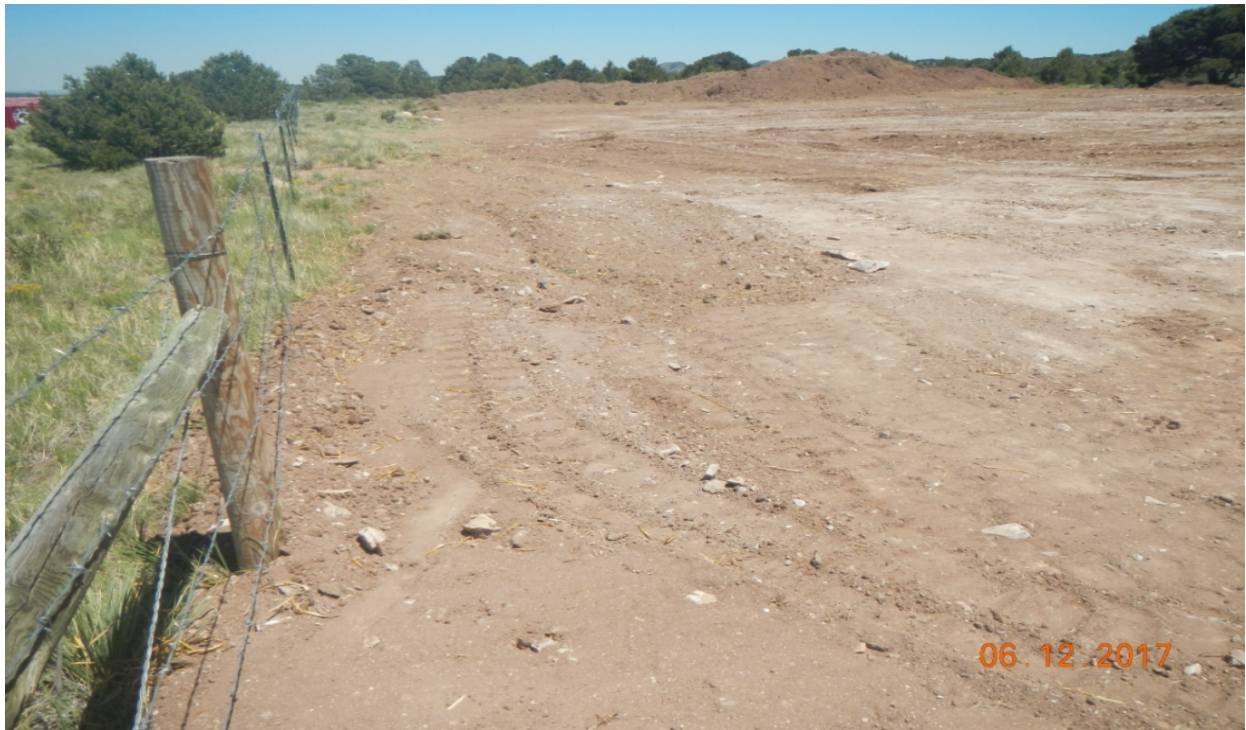
photo 5: Southwest corner of the Freeman 3-24 location facing east toward the area of disturbance.

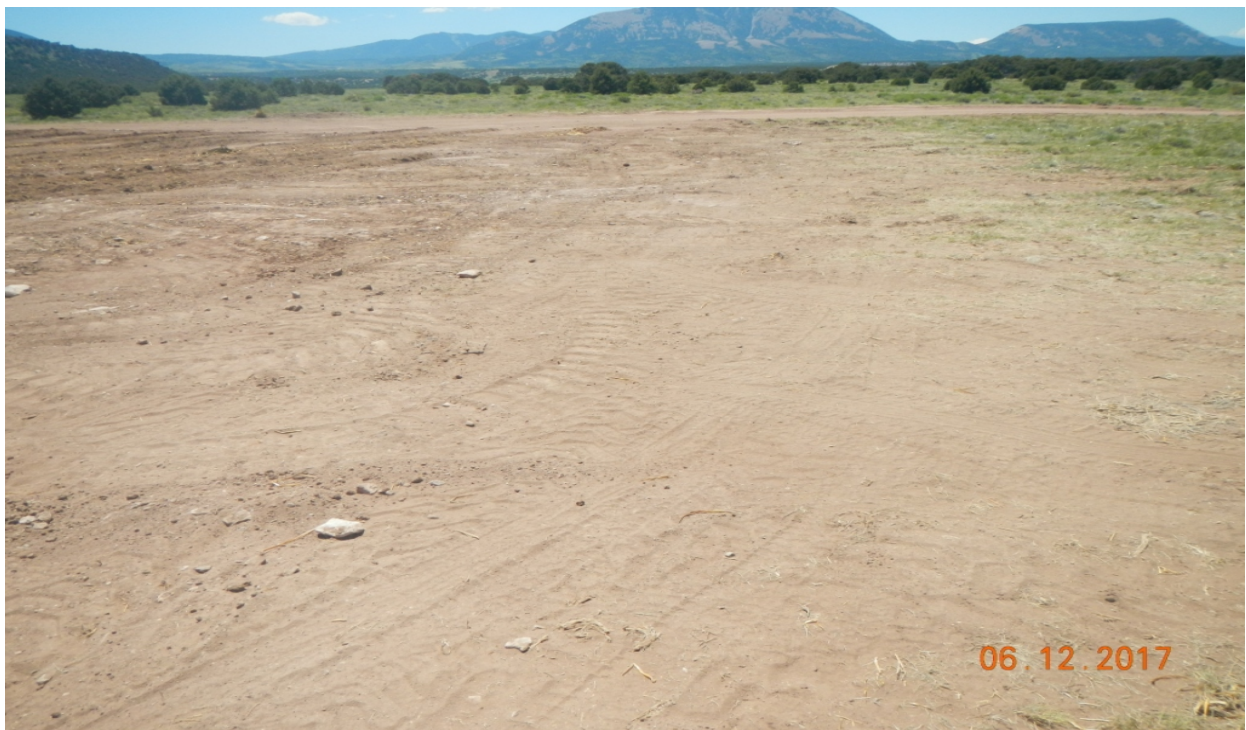
photo 6: Southwest corner of the Freeman 3-24 location facing west toward the area of disturbance.

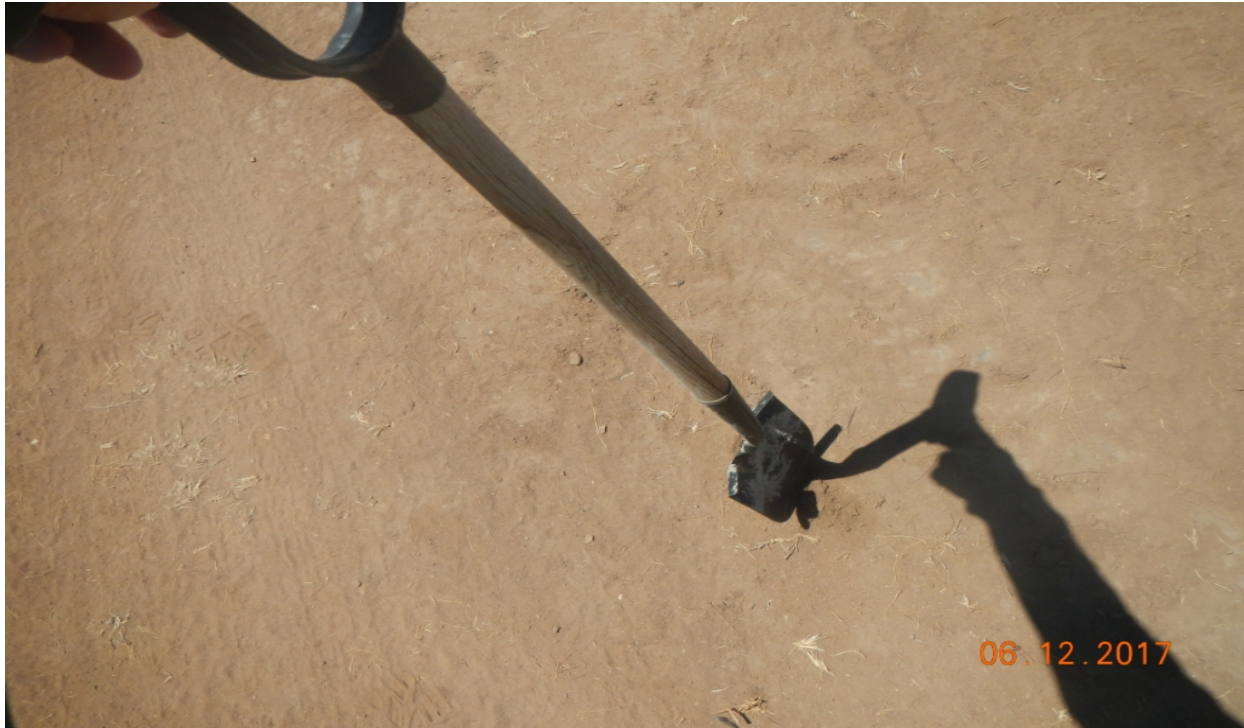
photo 7: The soils at the disturbed area have become heavily compacted. Soil decompaction must occur by cross-ripping to a depth of 18 inches.

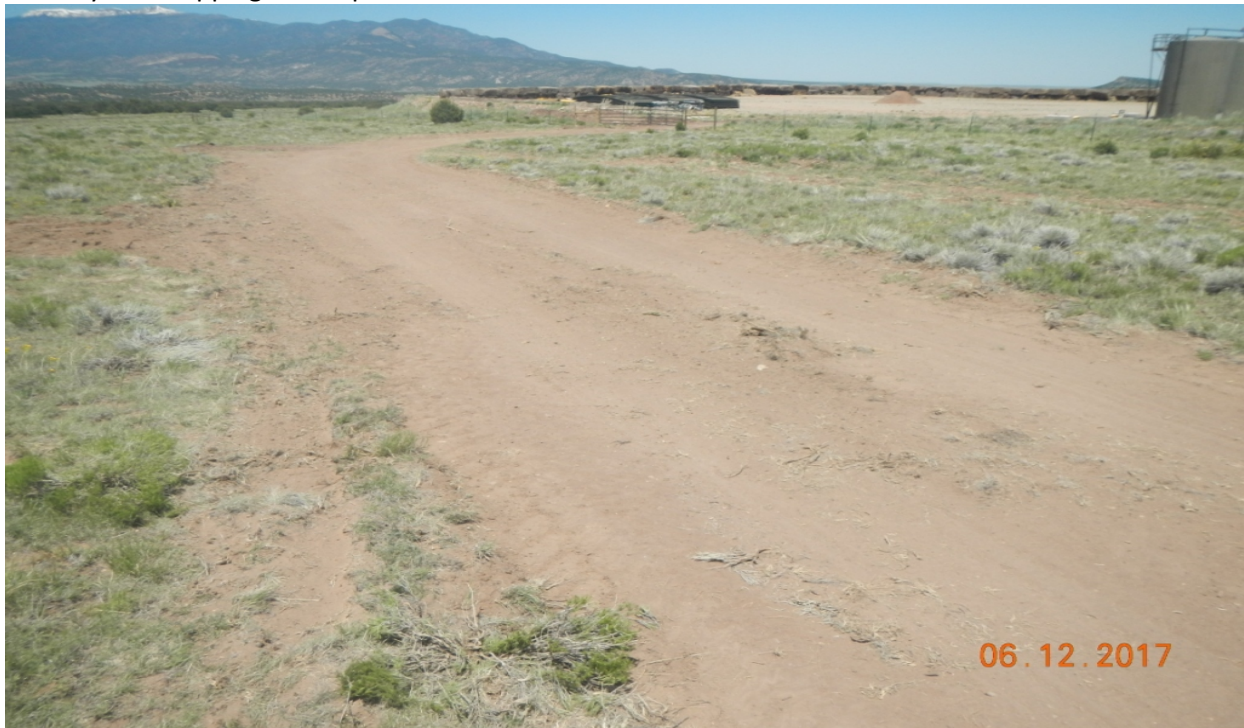
photo 8: Facing northeast toward the Freeman 3-24 location. A newly disturbed access road has been created that enters the west side of the location. No stormwater controls are in place.

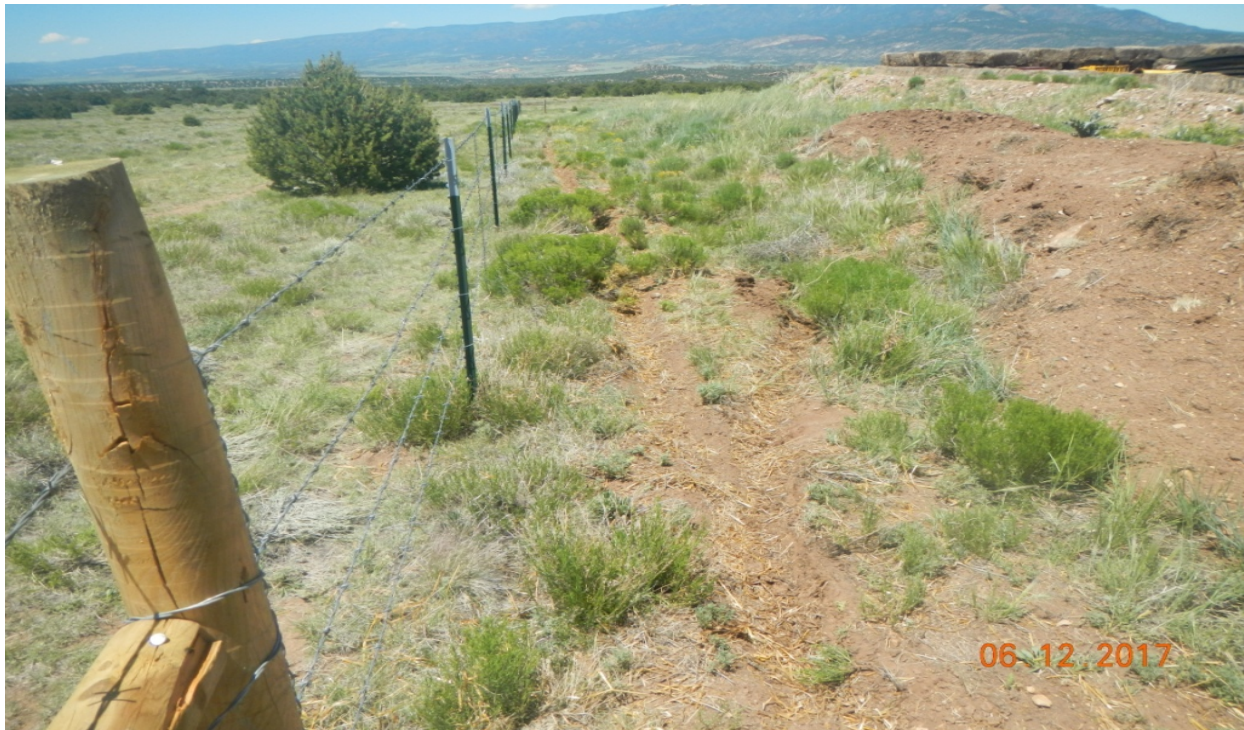
photo 9: Facing north at the Freeman 3-24 location. The wattle debris observed in the previous inspection has been removed.

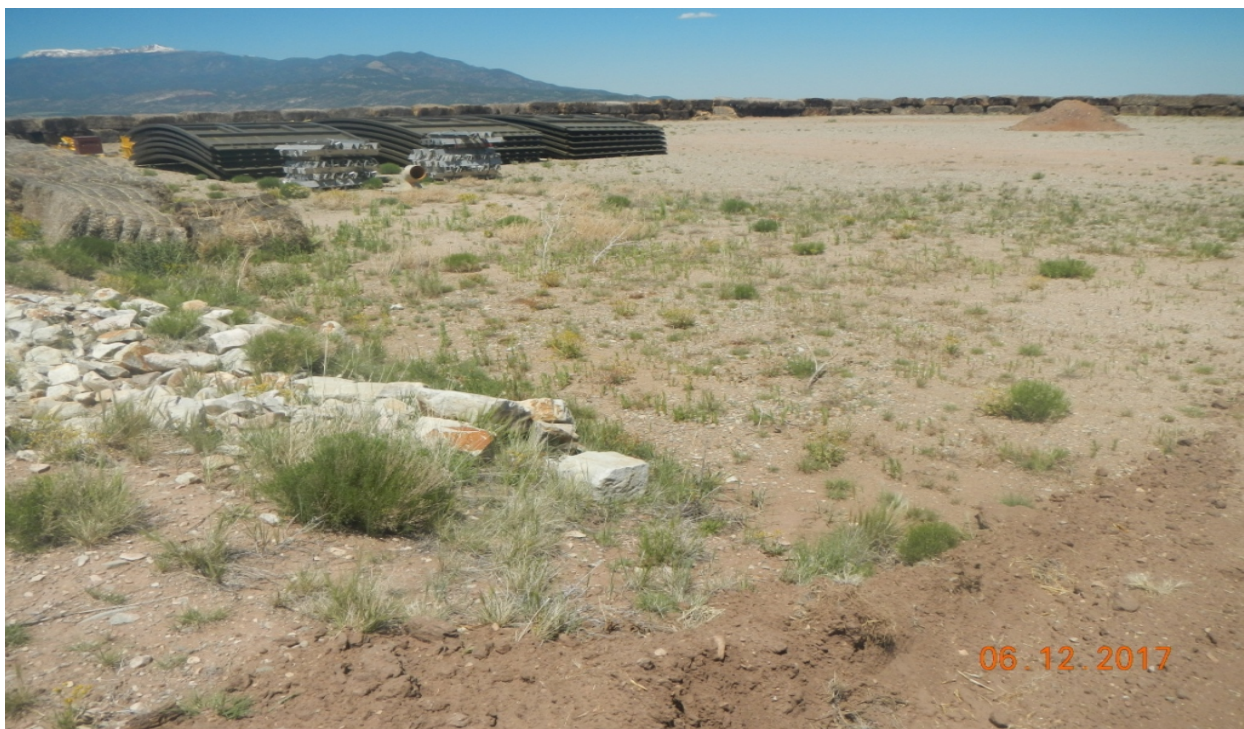
photo 10: Facing northwest toward the location. There is equipment being stored in this area of the location.

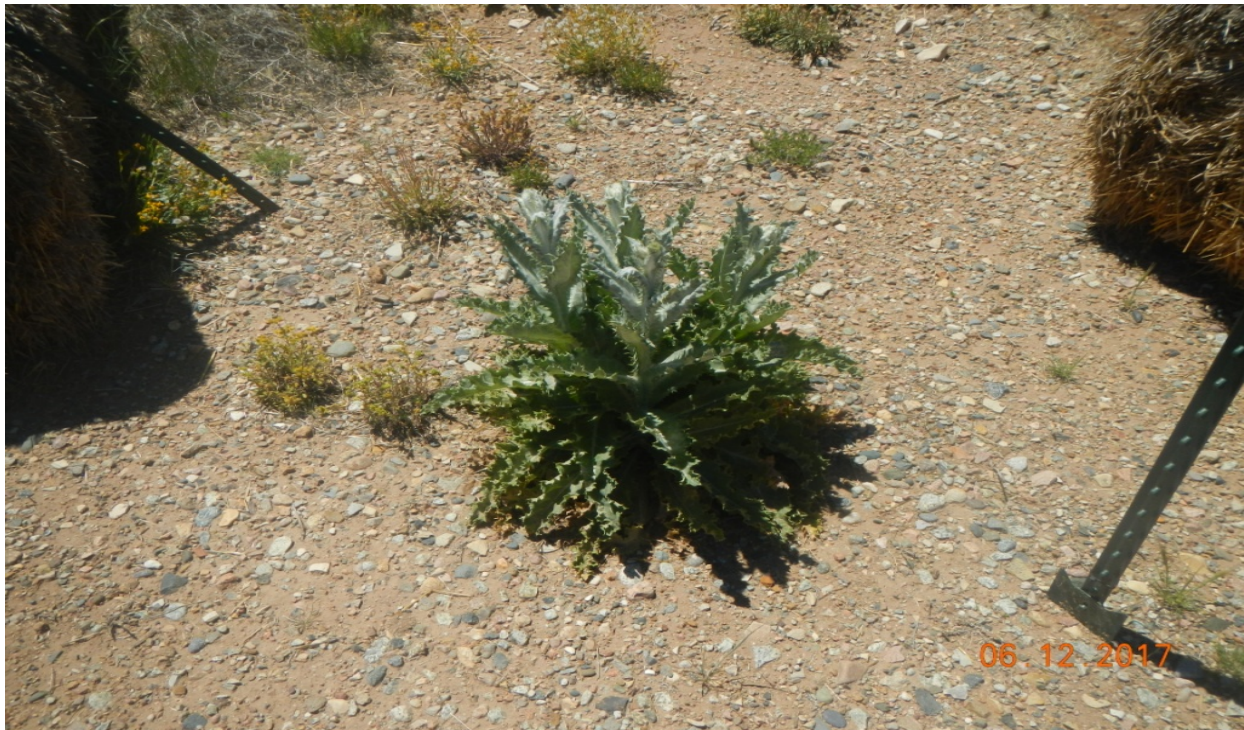
photo 11: There is List B noxious weeds at the location which are beginning to develop seed heads.

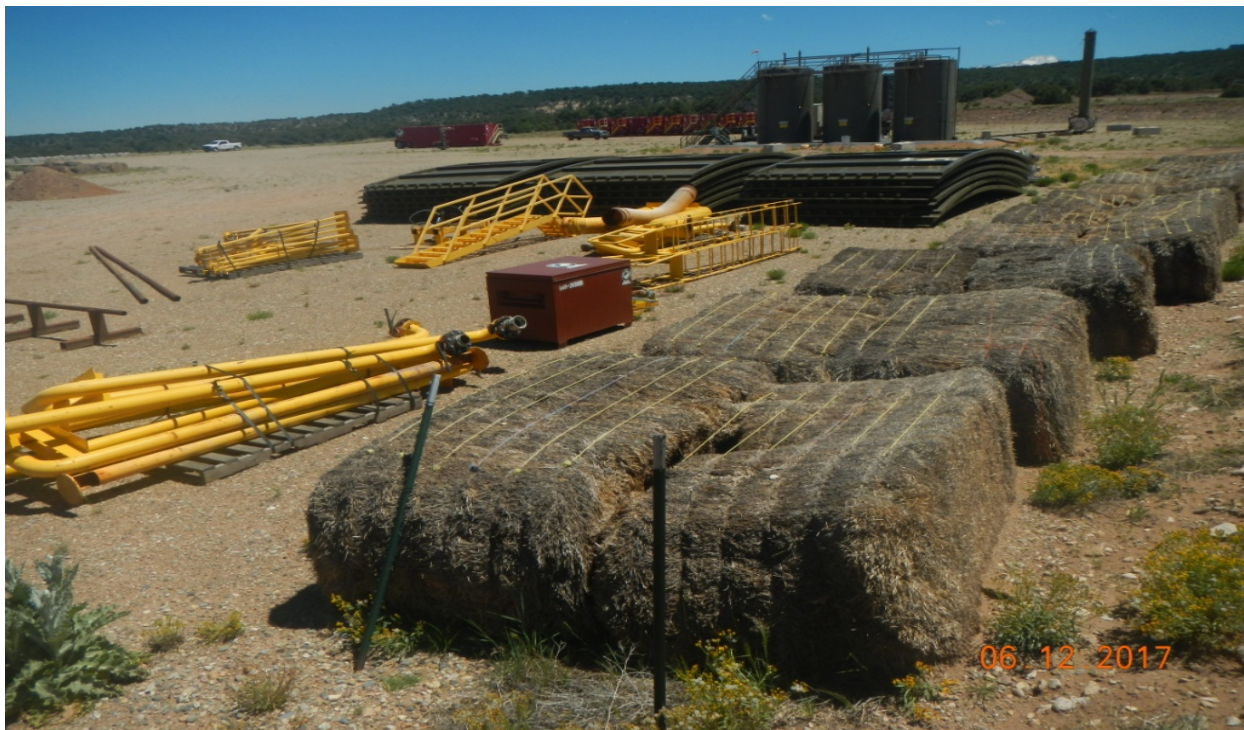
photo 12: West side of the location facing southeast. There are degraded bales and equipment being stored in this area.

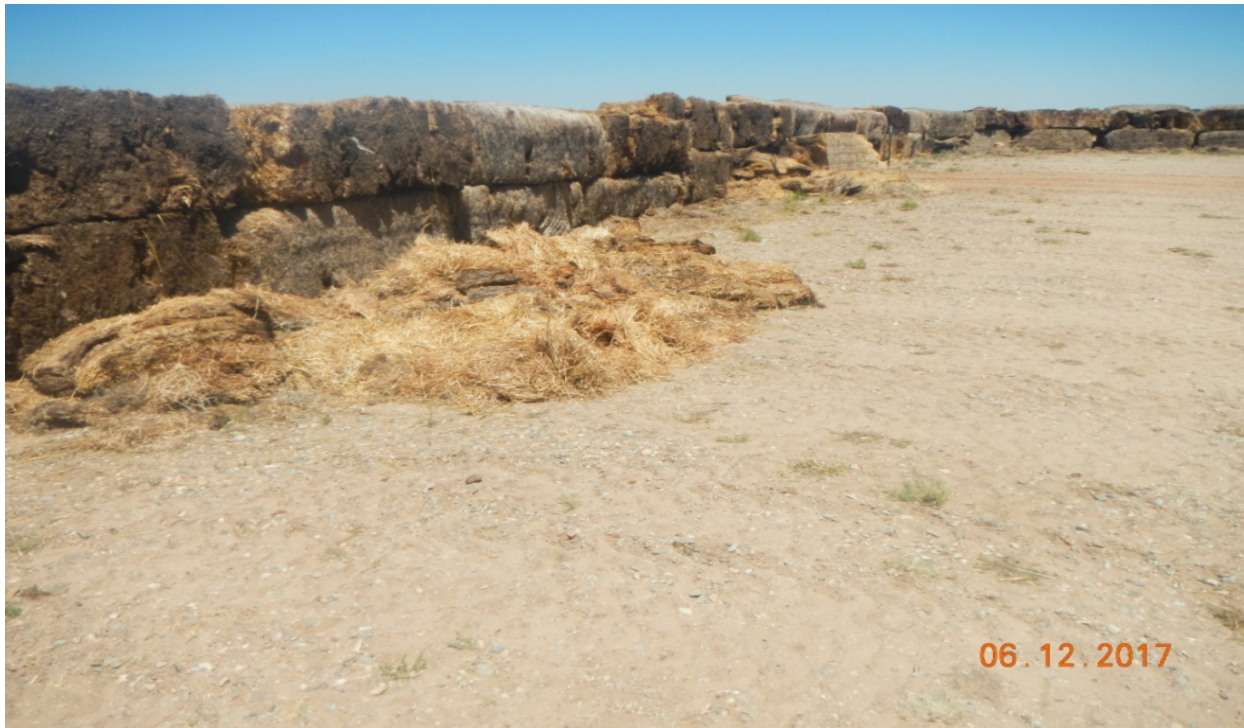
photo 13: The degraded bales remain around the north perimeter. The bales have been staked since the previous inspection and many have fallen apart.

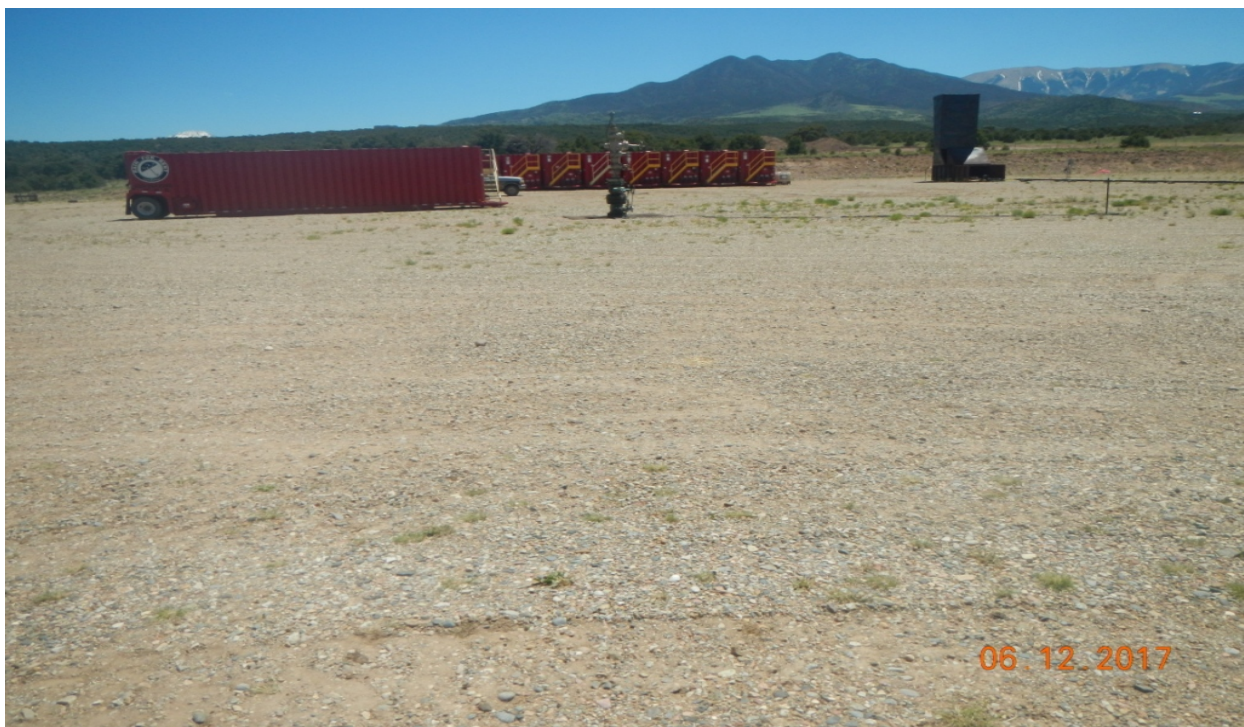
photo 14: Facing south at the location toward the wellhead. There are more frac tanks that have been brought in to the location.
