Inspection Photos: API# 05-001-06729

Date: June 14, 2017

COLORADO
Oil & Gas Conservation
Commission
Department of Natural Resources

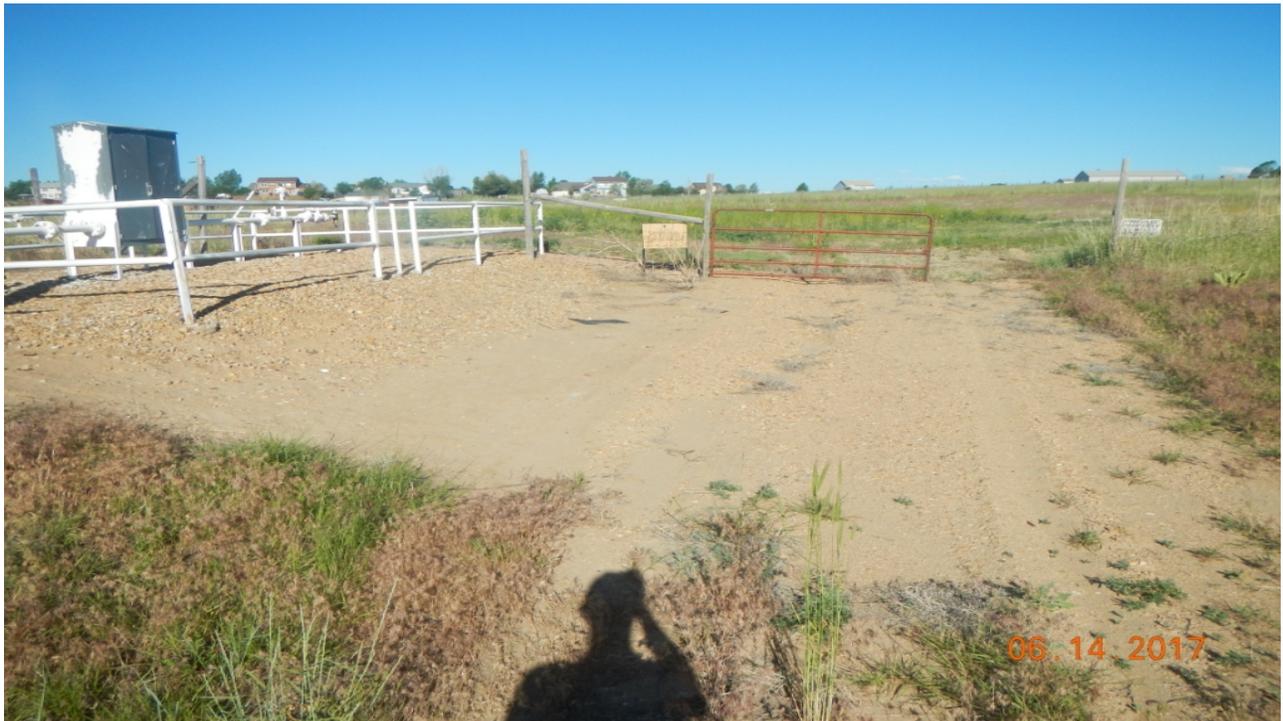
photo 1: Facing west toward the location. There is equipment that remains at the east side of the location.

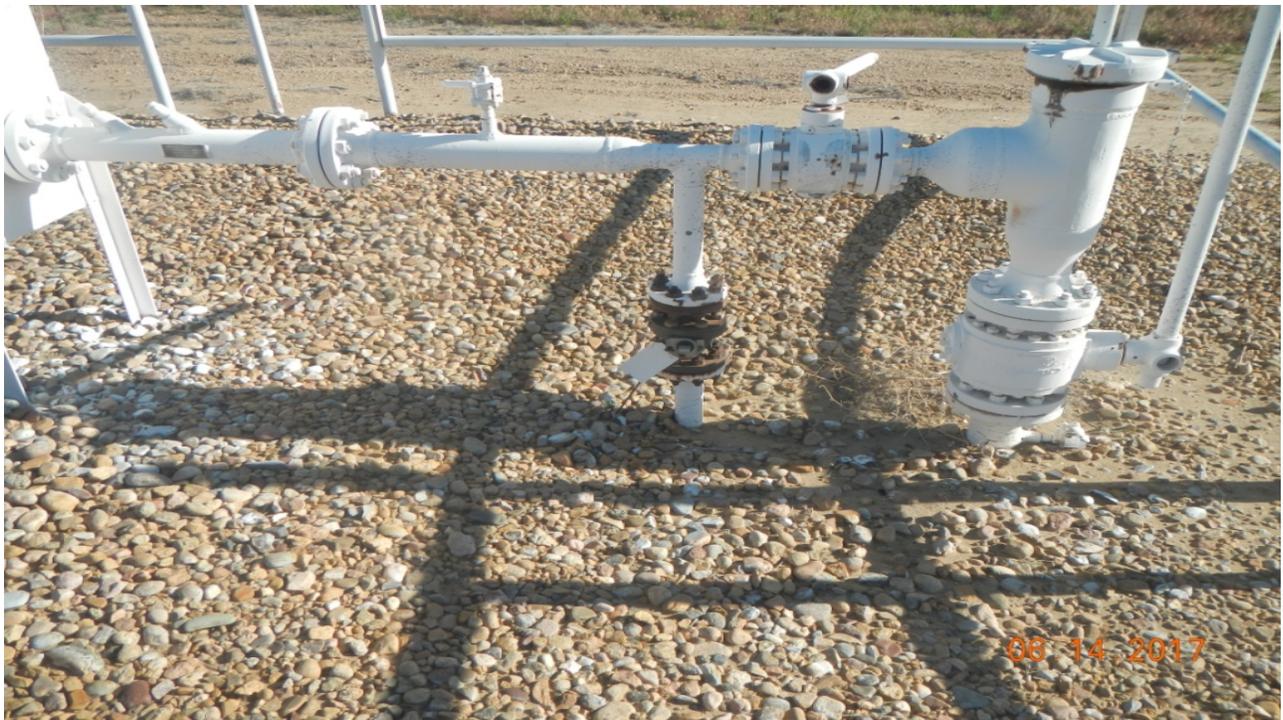
photo 2: The pipe infrastructure has valve handles that have not been locked and tagged out.

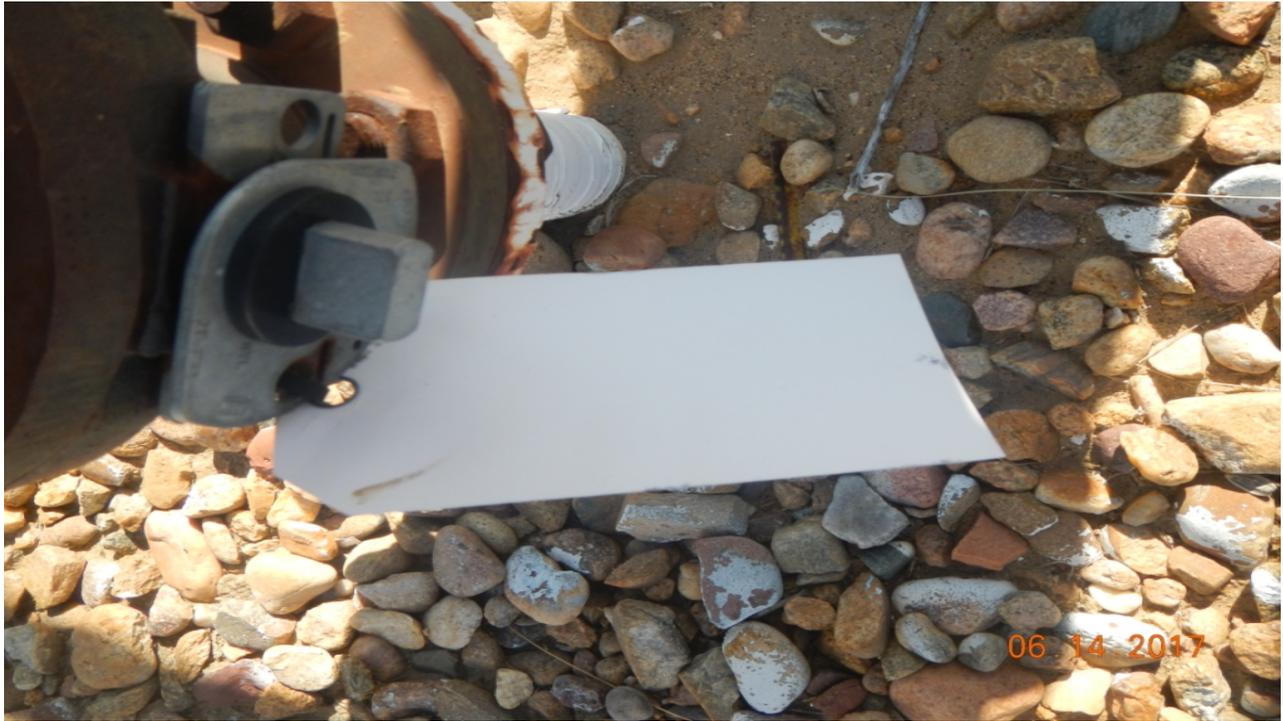
photo 3: There is a tag on the pipe line which is faded and not readable.

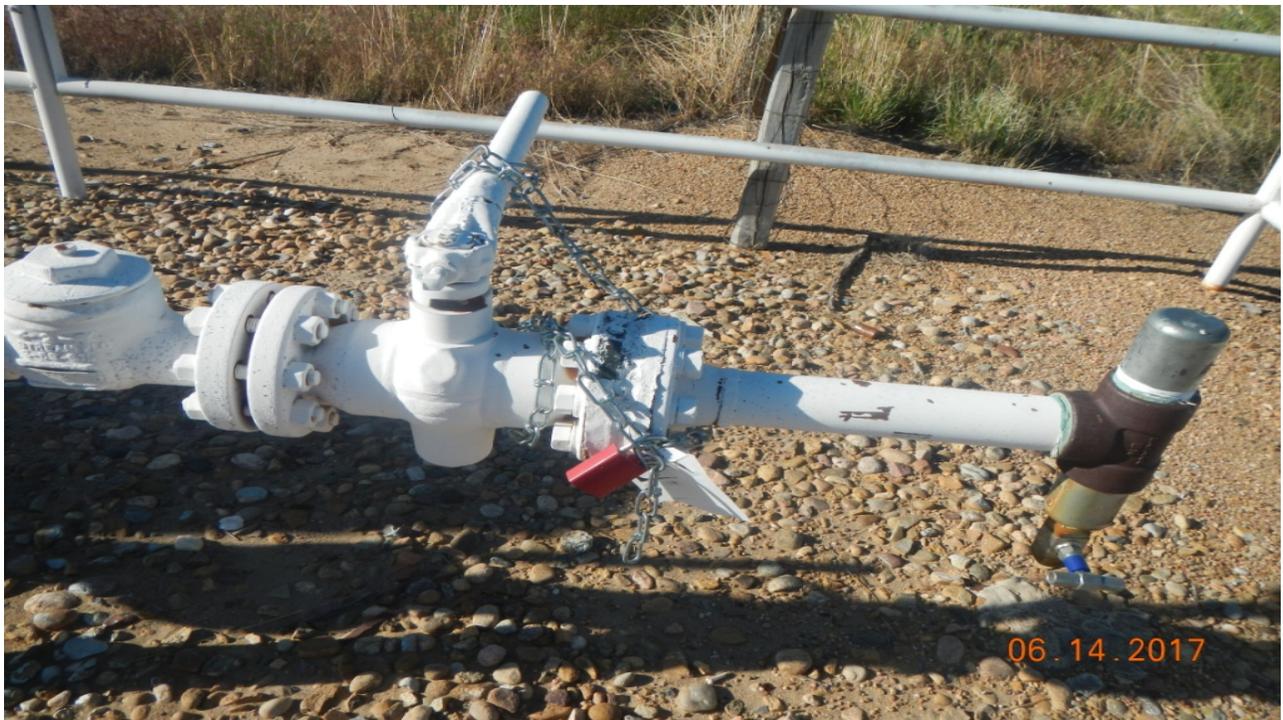
photo 4: There valve is locked out however the tagged is faded and cannot be identified.

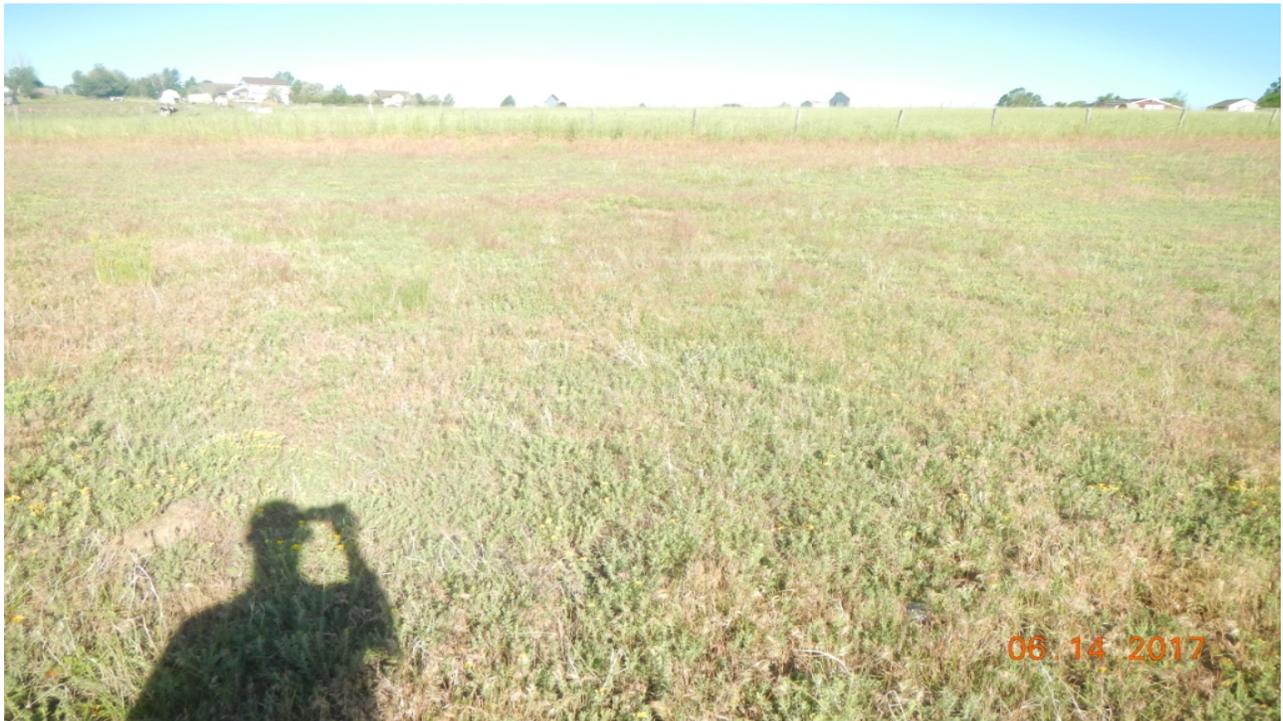
photo 7: Center of the location facing west. The vegetation is establishing well at the western side of the location.

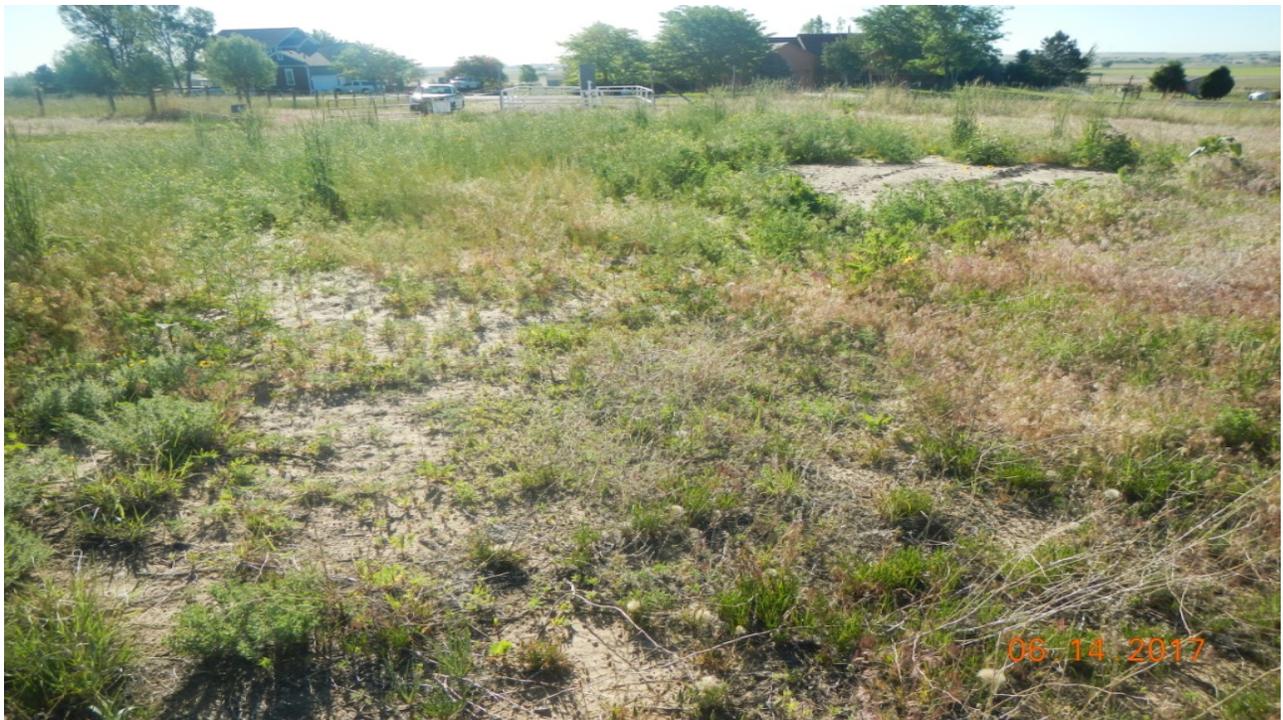
photo 8: Center of the location facing east. The vegetation has not established at the east side of the location and there are predominately undesirable weeds and noxious weeds.

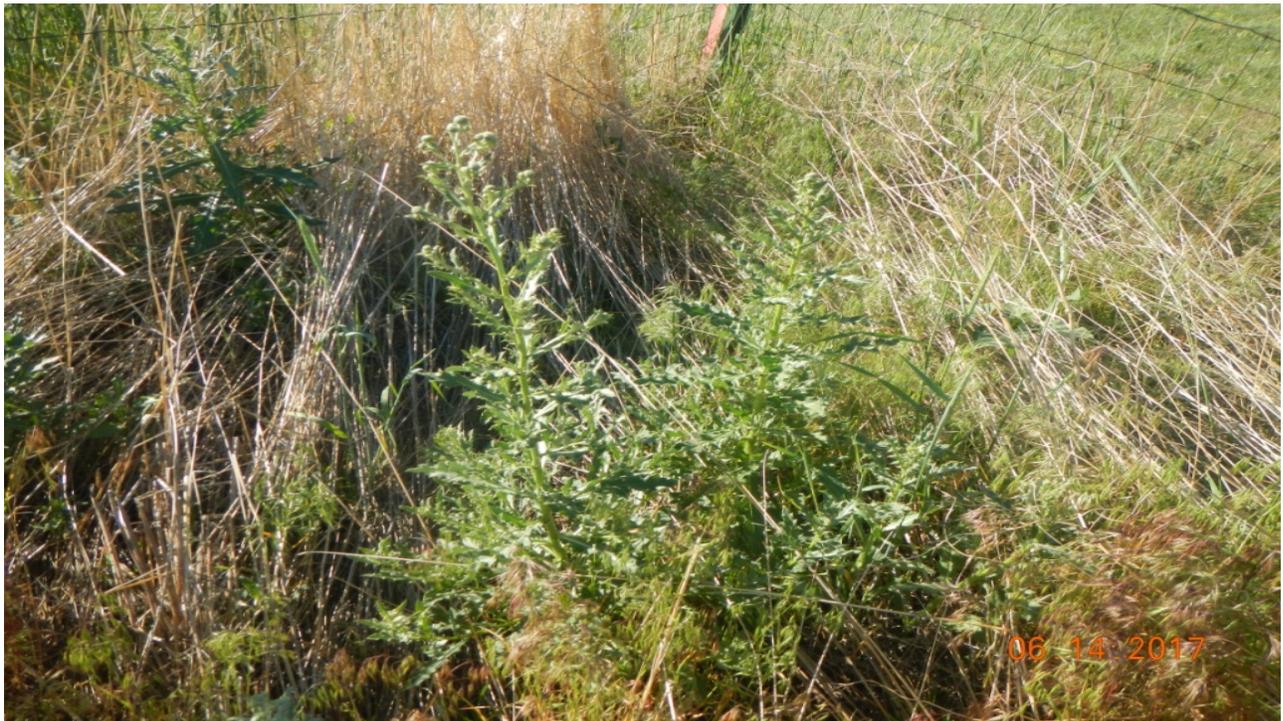
photo 9: There are noxious weeds growing at the location (Canada thistle).

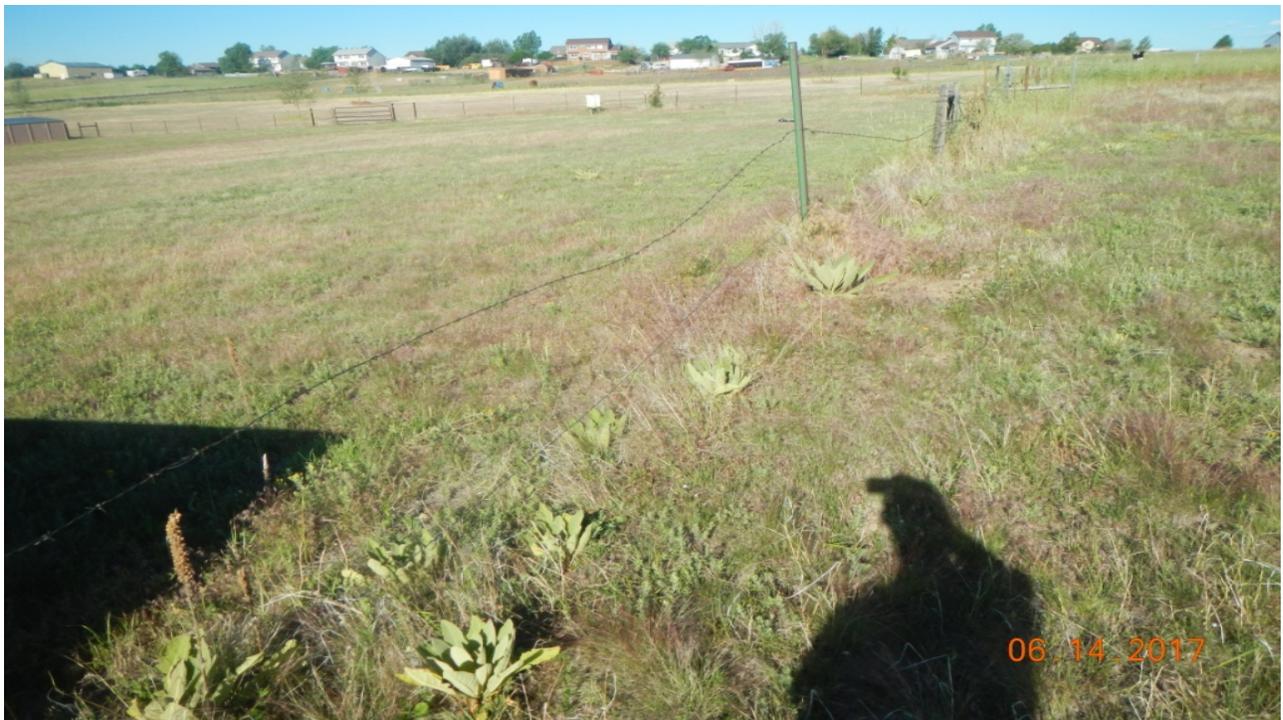
photo 10: The fence around the location is in disrepair. There are also noxious weeds shown in the photo (Common mullien).
