Inspection Photos  
Location Name: Iles Investment Co 1-23  
API: 05-081-05136

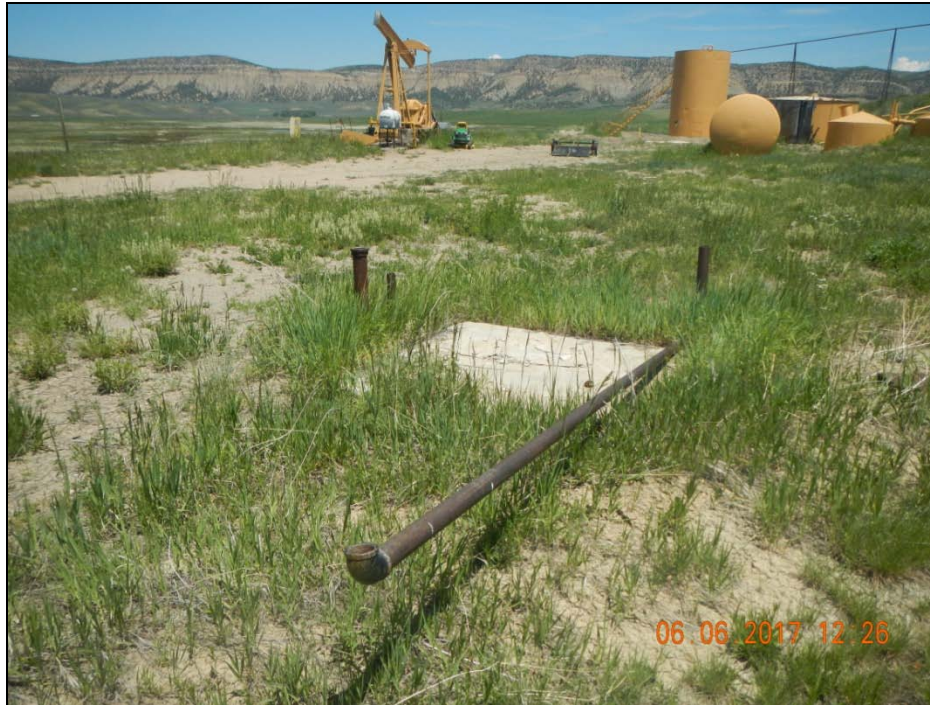
**Photo 1. Overview of location taken at entrance facing north.  
Unused riser cluster in foreground.**

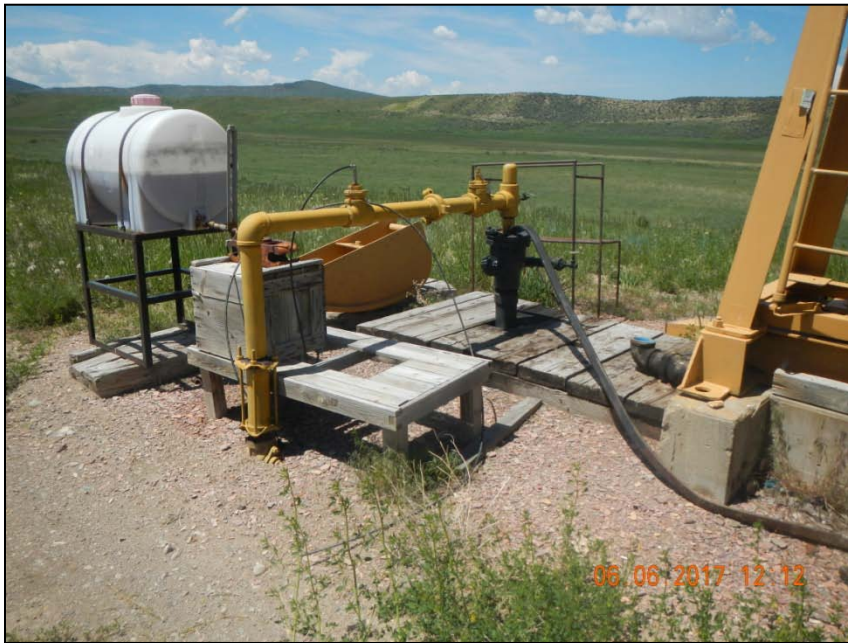
Photo 2. Risers at wellhead. No wellhead sign.

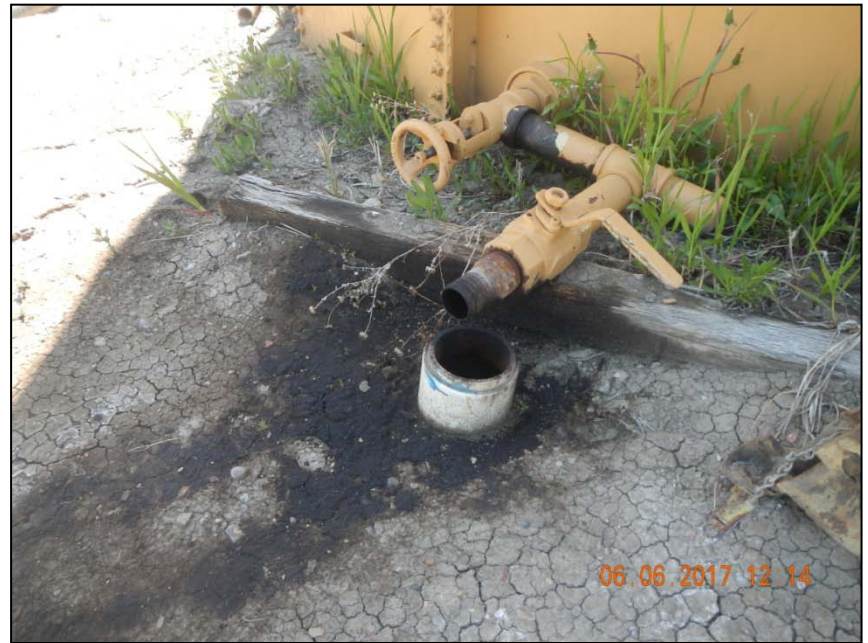
Photo 3. Stained soil at tank base.

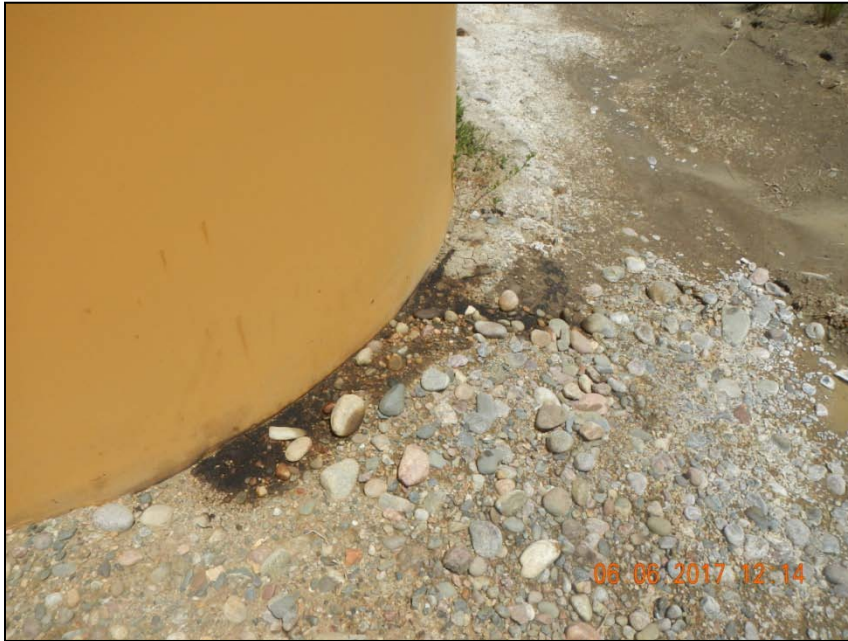
**Photo 4. Stained soil at tank base.**

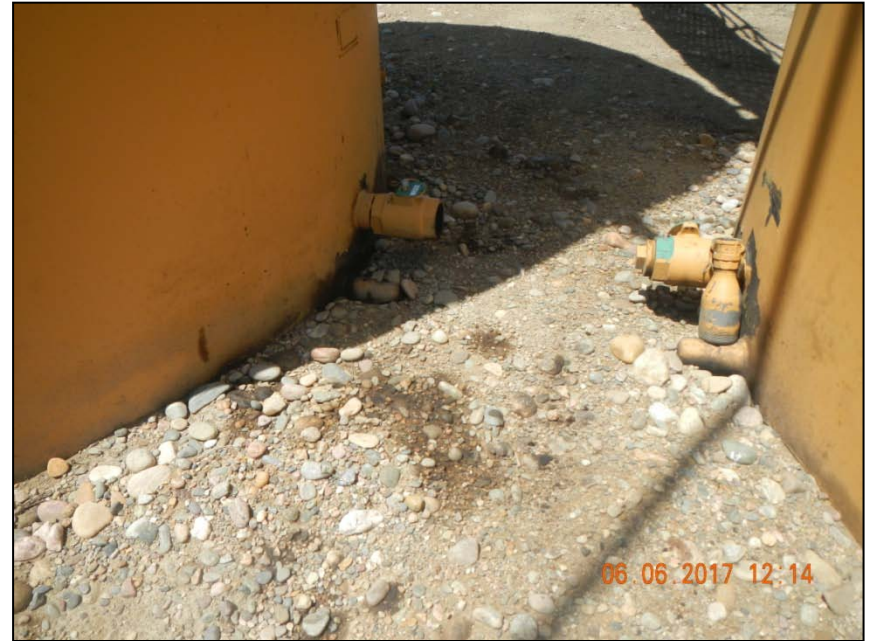
**Photo 5. Stained soil at tank base.**

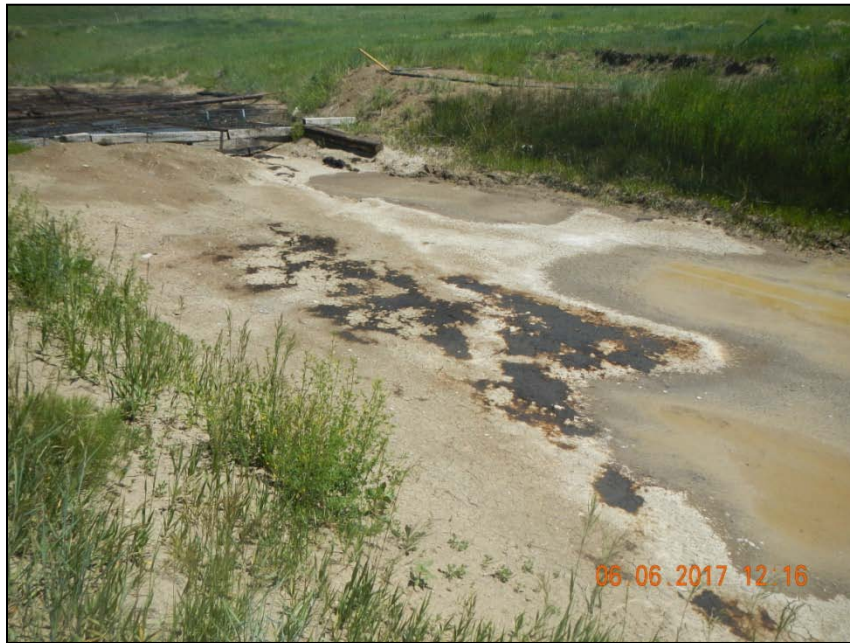
**Photo 6. Stained soil between tan tanks and pit in background.**

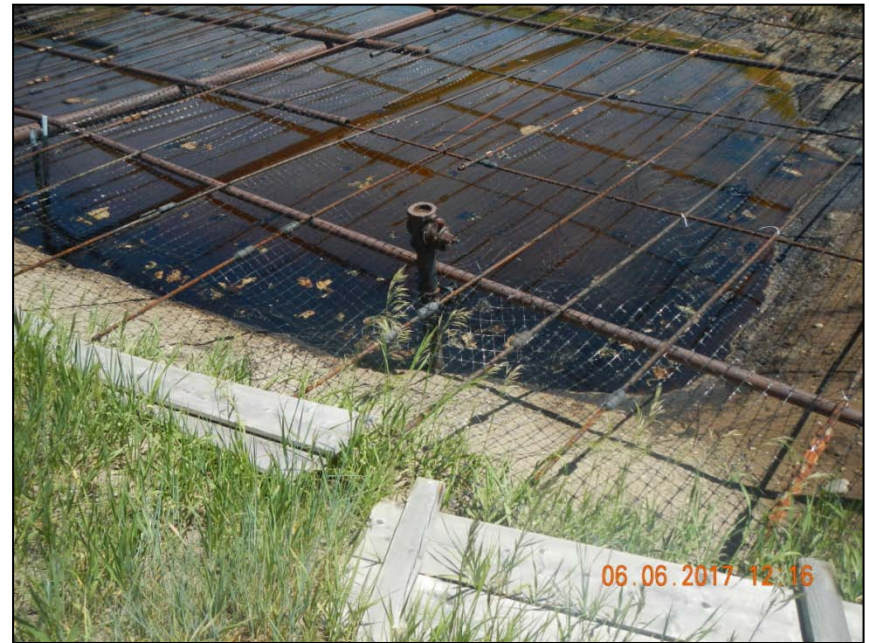
**Photo 7. Pit with unused riser and sagging netting. Oil in pit.**

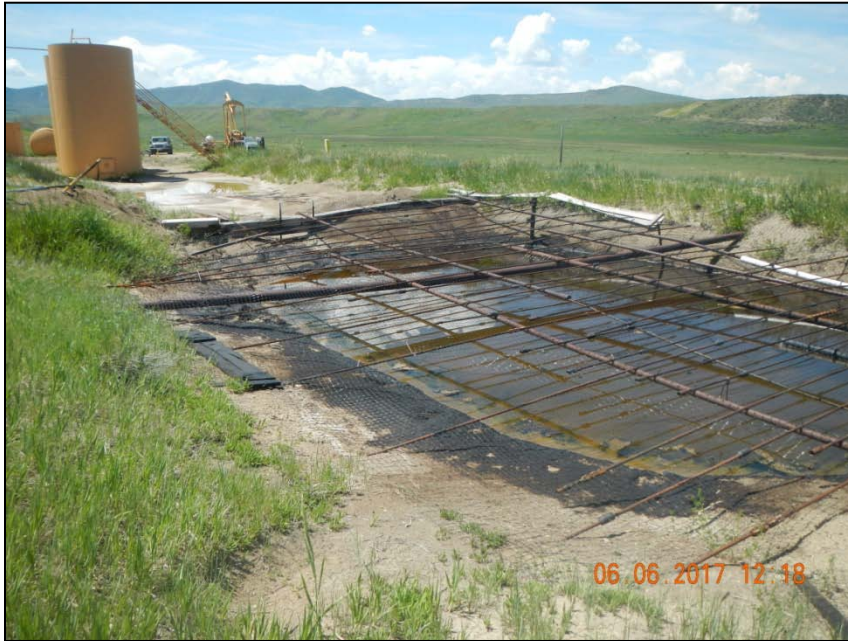
**Photo 8. Pit with tanks in background.**

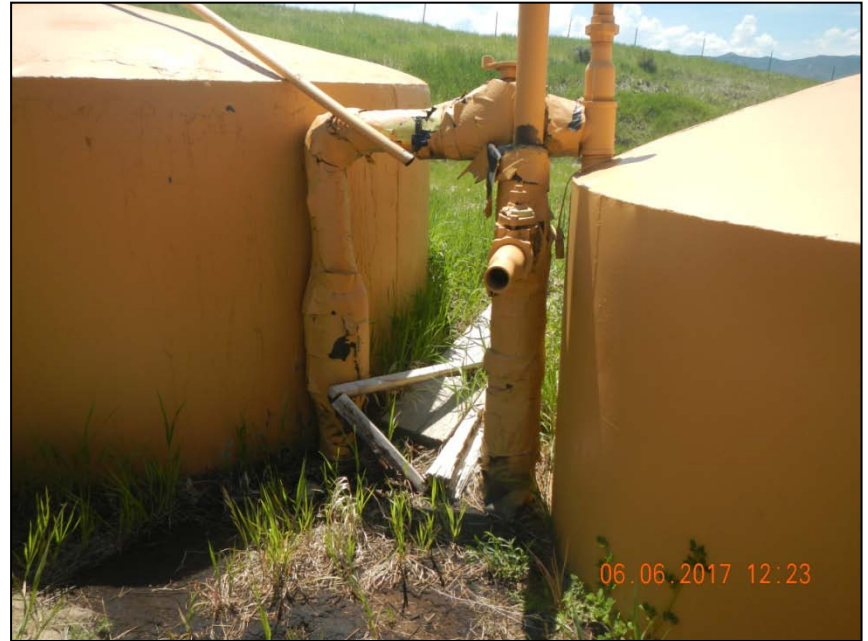
**Photo 9. Riser cluster, stained soil, unlabeled tanks.**
