Inspection Photos
Location Name: Moyer Unit 16-29
API: 05-123-07014

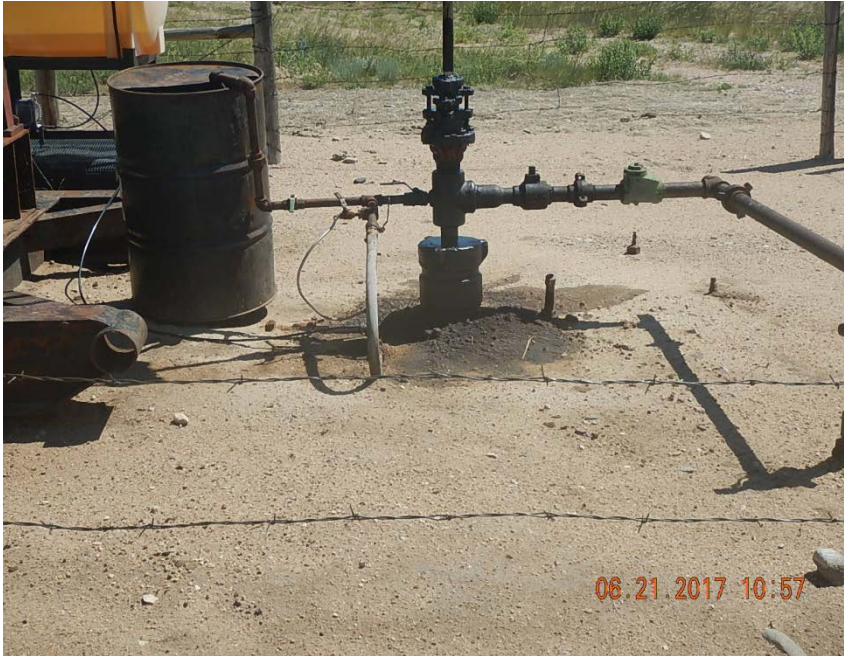
Photo 1: Stained soil at wellhead
