Inspection Photos
Location Name: Moyer Unit 15-29
API: 05-123-07023

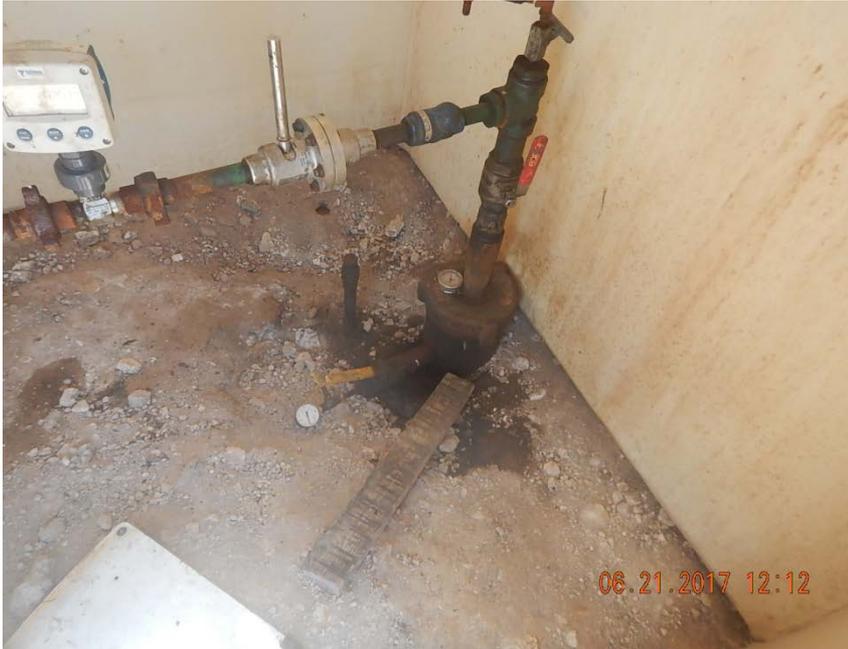
Photo 1: Stained soil at wellhead
